Visual Site Inspection Report

Project Name	Transco Interconnect Station		AFE	124300113	Spread	Transco Interconnect Station	
Contractor	Kanahwa				Report #	15918	
Inspector	Dave Burkhart				Date/Time	4/16/2019 12:44 PM	
Permit #	TBD	Inspection Type	VA SWPP		Station Begin	+1	
State	VA	Inspection Area	Full		Station End	+1	
County	Pittsylvania	Ground	Damp		Temperature (°F)	60.00	
Municipality	Chatham	Weather	Sunny		Rain Gauge (in)	0.00	
					Rain Accumulation Time (days)	1.00

Project Name	H-600 Pipeline Spread I	AFE	124300139	Spread	H-600 Pipeline Spread I
Contractor	Precision			Report #	15968
Inspector	Ben Davenport			Date/Time	4/16/2019 7:16 AM
Permit #	TBD	Inspection Type	VA SWPP	Station Begin	13670+00
State	VA	Inspection Area	Full	Station End	16027+46
County	Franklin/Pittsylvania	Ground	Damp	Temperature (°F)	65.00
Municipality	Chatham	Weather	Sunny	Rain Gauge (in)	0.00
				Rain Accumulation Time (days)	0.00

Project Name	H-600 Pipeline Spread I	AFE	124300139	Spread	H-600 Pipeline Spread I
Contractor	Precision			Report #	16030
Inspector	Glenn Mike Renfro			Date/Time	4/16/2019 3:05 PM
Permit #	TBD	Inspection Type	VA SWPP	Station Begin	0000+00
State	VA	Inspection Area	Full	Station E

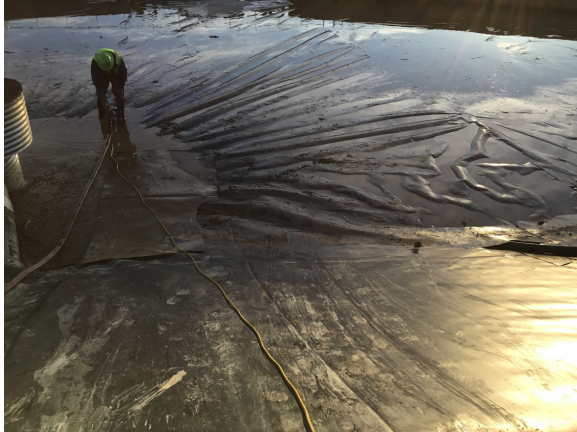
GPS Location		36.83		Field Station#		+1		GPS Location		36.83	
Field Station#		+1		Description		Basin being dewatered and holes being patched by subcontractor ECI		Description		Damaged area in and near channel L

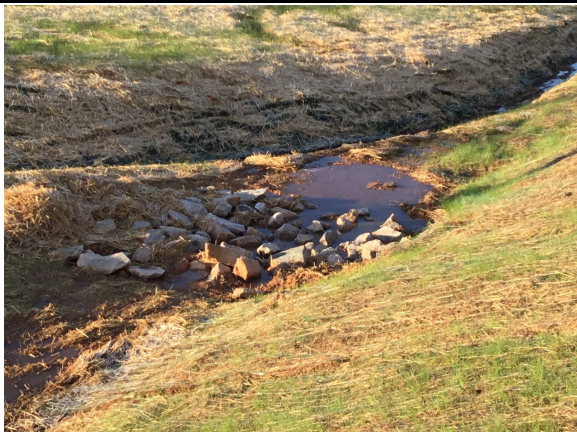
GPS Location		36.83		Field Station#		+1		GPS Location		36.83	
Field Station#		+1		Description		Channel F Area holding water at intersect of channels of FML		Description		Seeding and mulching north side of temp pad

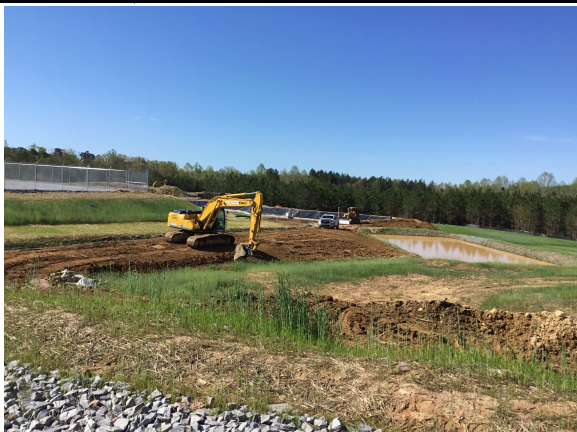
GPS Location		36.83		Field Station#		+1		GPS Location		36.83	
Field Station#		+1		Description		Rebuilding channel I		Description		Patched seem of liner around riser baffle in sed basin

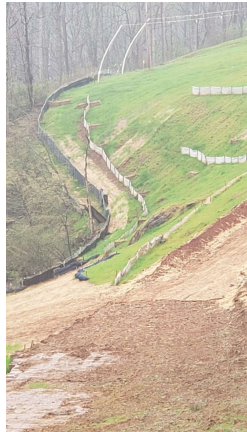
GPS Location	36.98	Field Station#	13816+00	GPS Location	36.98	Field Station#	14376+00
Description	ECD's functioning properly along stabilized ROW			Description	CFS maintenance required

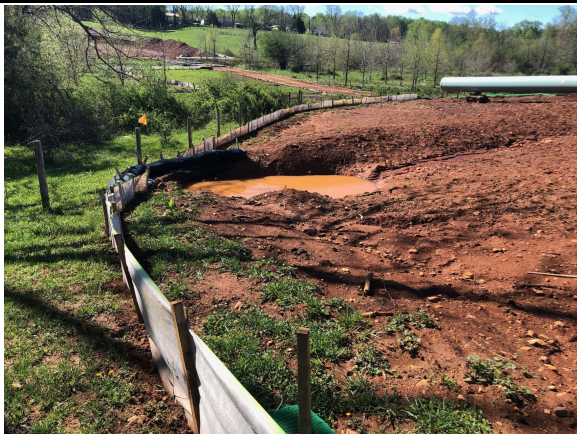
GPS Location	36.98	Field Station#	14388+50	GPS Location	36.99	Field Station#	14389+80
Description	New P1 fence installed			Description	Maintenance required on P1 fence

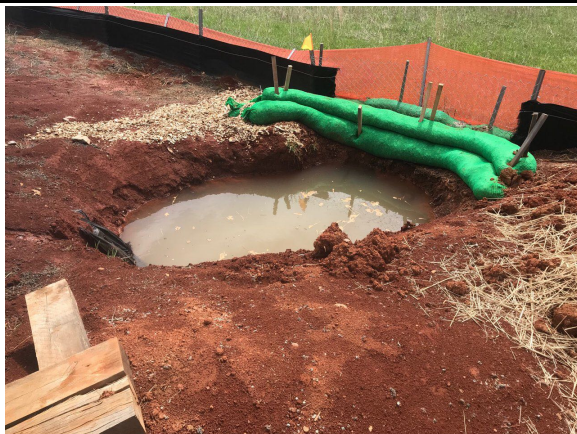
GPS Location	36.99	Field Station#	14240+00	GPS Location	36.99	Field Station#	14236+75
Description	Sump and triple stack end treatment functioning properly			Description	CWD piping and level spreader functioning properly
