## Visual Site Inspection Report

<b>Project Name</b>	H-600 Pipeline Spread H	<b>AFE</b>	124300138	<b>Spread</b>	H-600 Pipeline Spread H
<b>Contractor</b>	Precision			<b>Report #</b>	16151
<b>Inspector</b>	Glenn Mike Renfro			<b>Date/Time</b>	4/22/2019 1:18 PM
<b>Permit #</b>	TBD	<b>Inspection Type</b>	VA SWPP	<b>Station Begin</b>	13415+00
<b>State</b>	VA	<b>Inspection Area</b>	Full	<b>Station End</b>	13670+00
<b>County</b>	Franklin	<b>Ground</b>	Damp	<b>Temperature (°F)</b>	67.00
<b>Municipality</b>	N/A	<b>Weather</b>	Sunny	<b>Rain Gauge (in)</b>	1.80
				<b>Rain Accumulation Time (days)</b>	6.00

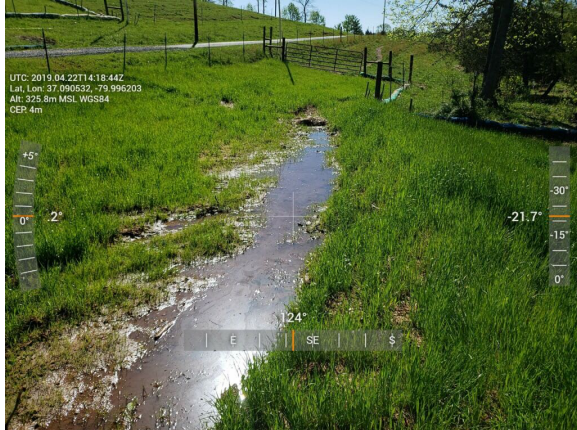
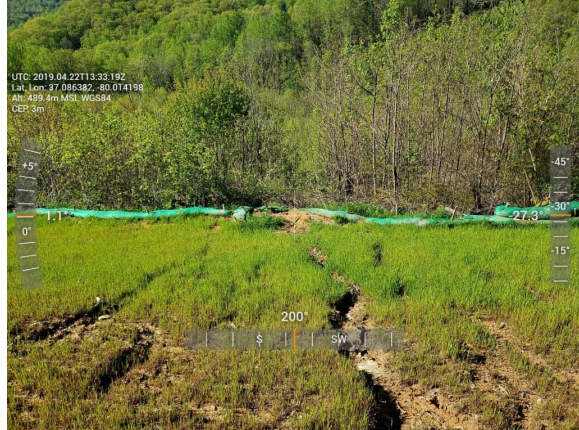
GPS Location	36.97	Field Station#	13525+90	GPS Location	36.97	Field Station#	13473+20
Description	Water ponding water, grade to drain.			Description	Rill erosion channel leading to sediment build up on CFS

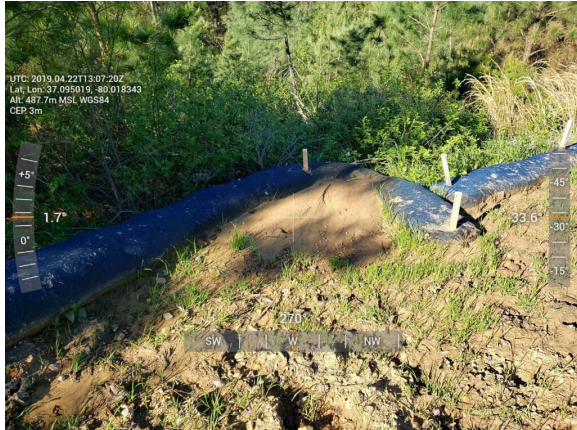
GPS Location	36.97	Field Station#	13432+00	GPS Location	36.97	Field Station#	13426+35
Description	Sediment build up on CFS			Description	Vegetated RoW, Rock checks and breakers in place.

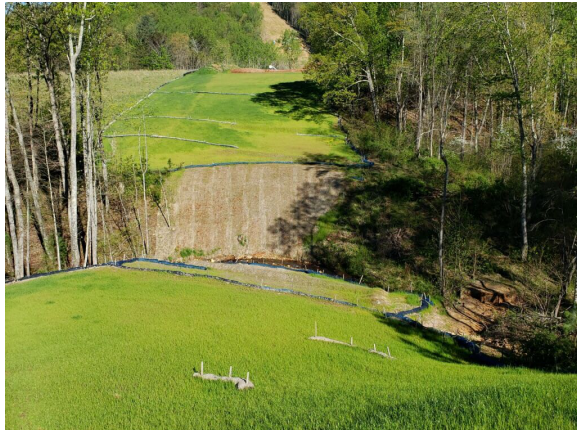
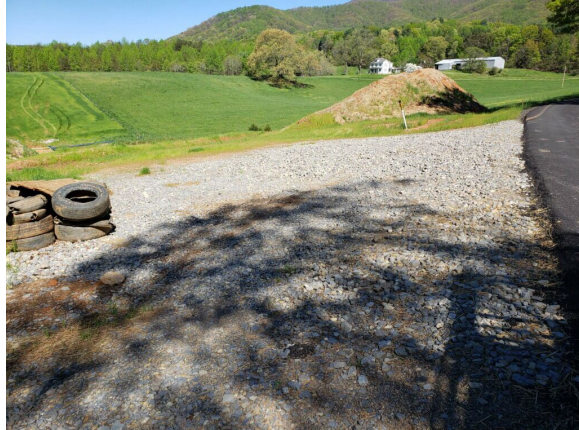
GPS Location	36.97	Field Station#	13425+01	GPS Location	36.97	Field Station#	13541+66
Description	Stream crossing with ECD's in place and functioning.			Description	RCE in good condition on CIS House Rock

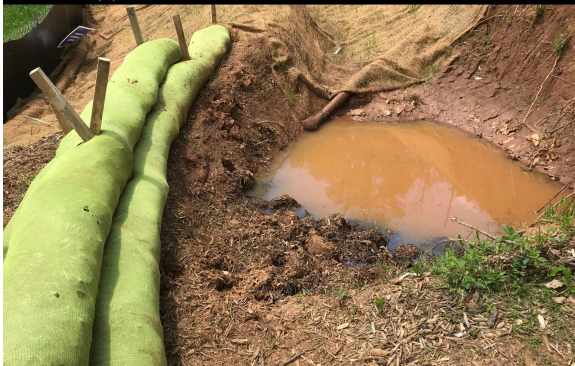
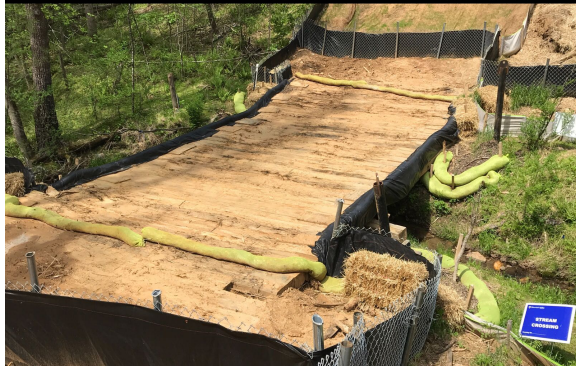
Description		13334+60_042519 evidence of livestock walking around sump. Looking S. See photo for gps data.		Description		13337+13_042529 S-GH9 mat bridge clean and closed. Looking N. See photo for gps data.	
<div>DIRECTION NW (T) +37.10582° -080.04890° ACCURACY 33 ft DATUM WGS84</div>

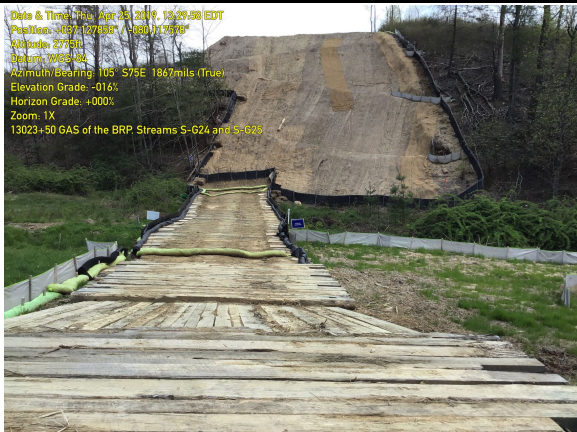
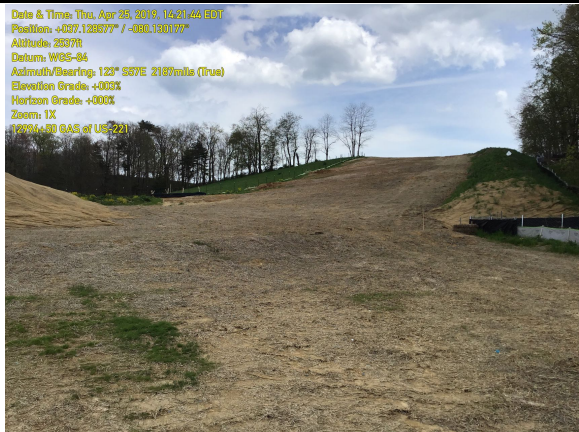
<p>Date &amp; Time: Thu, Apr 25, 2019, 13:29:08 EDT Position: +437.12783° / +89.11781° Altitude: 277ft Datum: WGS-84 Azimuth/Bearing: 105° S75E 1867mils (True) Elevation Grade: -016° Horizon Grade: +000° Zoom: 1X 13023+50 GAS of the BRP Streams S-G24 and S-G25</p>				<p>Date &amp; Time: Thu, Apr 25, 2019, 14:31:24 EDT Position: +437.12877° / +89.13017° Altitude: 267ft Datum: WGS-84 Azimuth/Bearing: 123° S57E 2187mils (True) Elevation Grade: +003° Horizon Grade: +000° Zoom: 1X 12994+00 GAS of US-22</p>											
<b>GPS Location</b>		37.12	<b>Field Station#</b>		13023+50		<b>GPS Location</b>		37.12	<b>Field Station#</b>		12994+50			
<b>Description</b>		Equipment bridge and other ECD's remain in compliance. No impacts observed in the area.						<b>Description</b>		No issues found in the area. Environmental reseeded the area this morning.

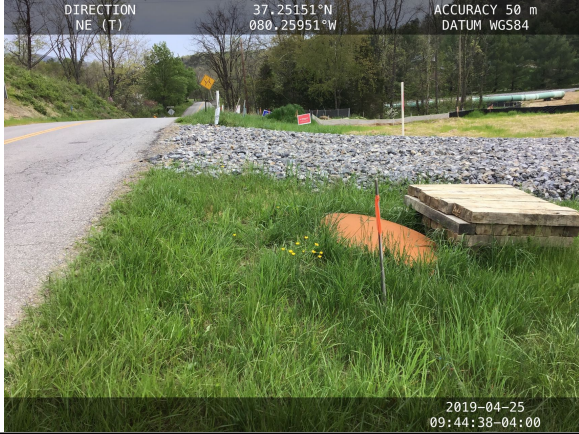
Virginia Department of Transportation has directed that there be a 15 inch culvert installed in the rock construction entrance on the going away side of the Bradshaw Road Crossing at station 12191+00. There is no preexisting ditch in this location, nor any indication that water has ever traveled along this roadside. The topography is actually a slope falling away from the road in this area.					
<b>Note:</b> It is a condition of National Pollutant Discharge Elimination System and Erosion and Sediment permits that a maintenance program be conducted to provide for the operation and maintenance of all BMPs to be inspected on a weekly basis and after each stormwater event. Please list in the space provided comments to note if repairs or replacement are needed or have been made for BMPs as a result of the inspection. Failure to conduct the required inspection may result in permit suspension or the imposition of civil penalties. If supplemental monitoring is required as part of a permit condition this form may be used to meet those monitoring requirements.

GPS Location	37.25	Field Station#	12191+00	GPS Location	37.25	Field Station#	12076+95
Description	A 15 inch culvert is called for by VDOT at the construction entrance on the going away side of Bradshaw Road, station 12191+00.			Description	Stream S-MM15, facing northeast.

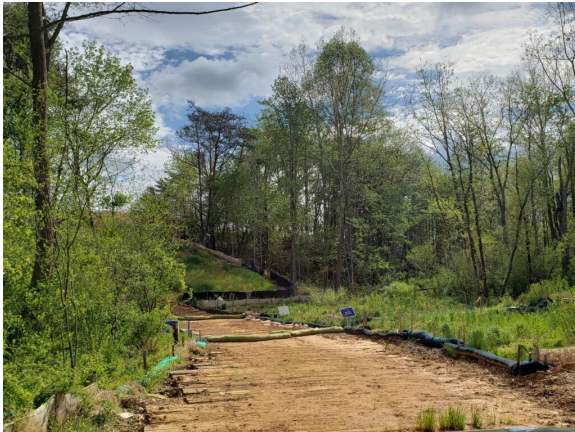
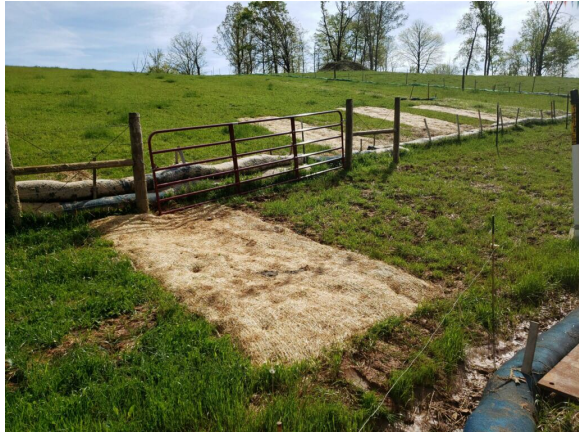
GPS Location 36.97		Field Station# 13659+03		GPS Location 36.97	
Field Station# 13659+03		Field Station# 13526+01		Field Station# 13526+01	
Description		ECD's in place at stream crossing and vegetative stabilization in good condition.		Description	
		Repair completed at erosion channel.

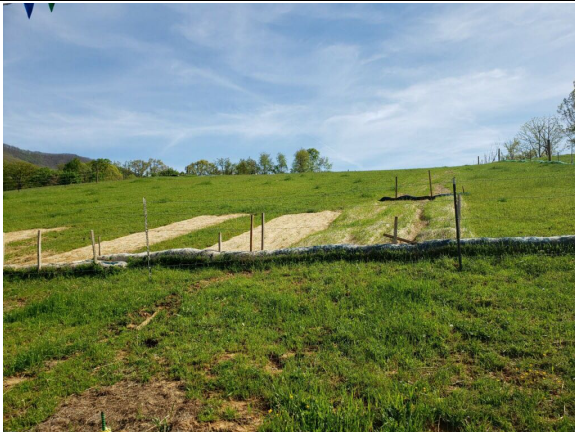
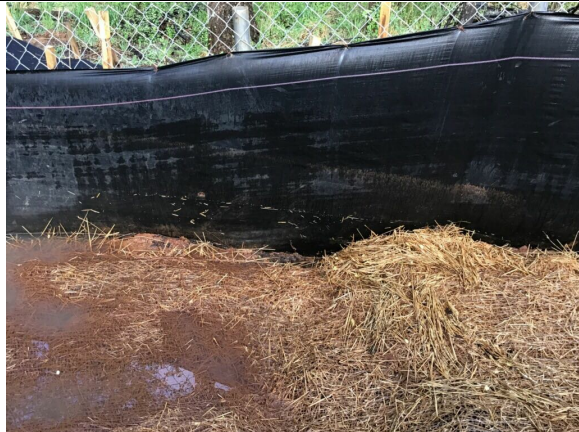
GPS Location 36.97		Field Station# 13526+25		GPS Location 36.97	
Field Station# 13526+25		Field Station# 13416+21		Field Station# 13416+21	
Description		Repair made to erosion channels		Description	
		Small area of SSF undermined, needs maintenance.

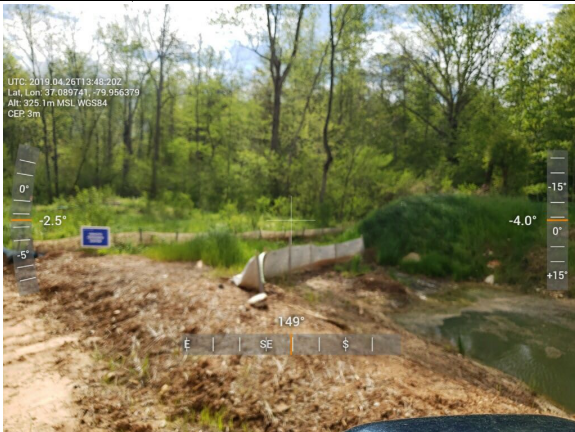
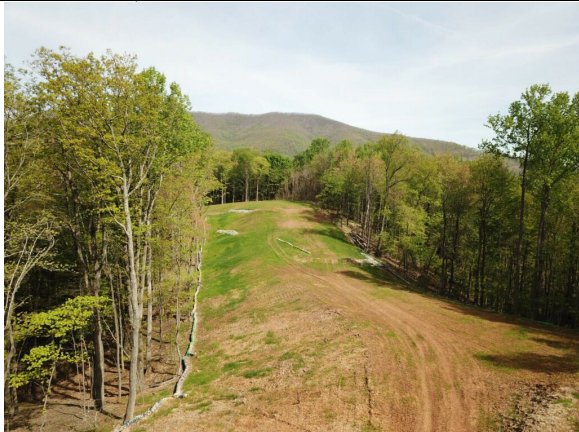
GPS Location 36.97		Field Station# 13658+90		GPS Location 36.97	
Field Station# 13658+90		Field Station# 13590+00		Field Station# 13590+00	
Description		P1 silt fence needs repaired.		Description	
		Vegetative stabilization growth long ROW
