Visual Site Inspection Report

Project Name	H-600 Pipeline Spread I	AFE	124300139	Spread	H-600 Pipeline Spread I
Contractor	Precision			Report #	16121
Inspector	Ben Davenport			Date/Time	4/22/2019 6:14 AM
Permit #	TBD	Inspection Type	VA SWPP	Station Begin	13670+00
State	VA	Inspection Area	Full	Station End	16027+46
County	Franklin	Ground	Damp	Temperature (°F)	68.00
Municipality	N/A	Weather	Sunny	Rain Gauge (in)	0.00
				Rain Accumulation Time (days)	0.00

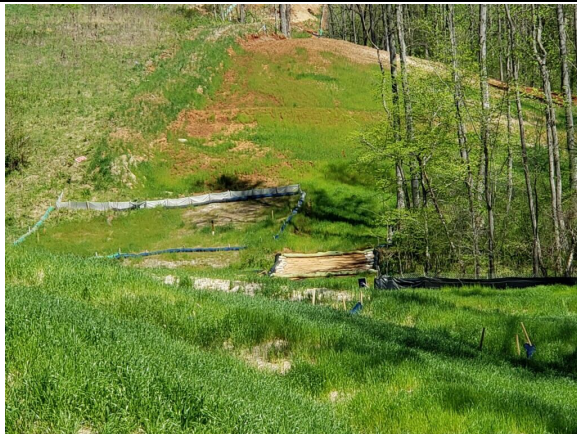
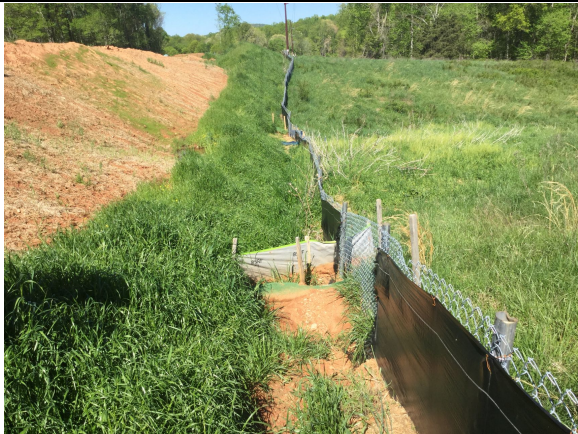
GPS Location		36.97		Field Station#		13847+40		GPS Location		36.97	
Field Station#		14835+50		Description				Vegetated ROW with functioning slope breakers			
Description		CFS requires maintenance

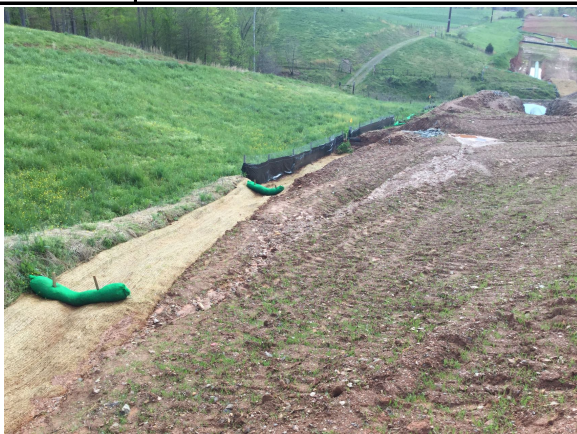
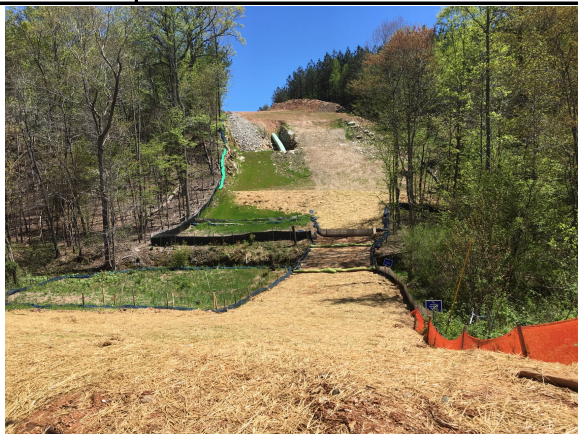
GPS Location		36.97		Field Station#		14930+00		GPS Location		36.97	
Field Station#		14950+47		Description				Newly installed erosion control blanket and CFS check dam performing intended function			
Description		Recently stabilized ROW on approach to each side of S-G13

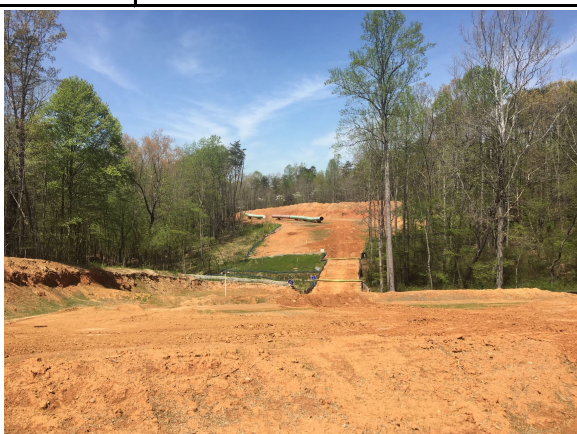
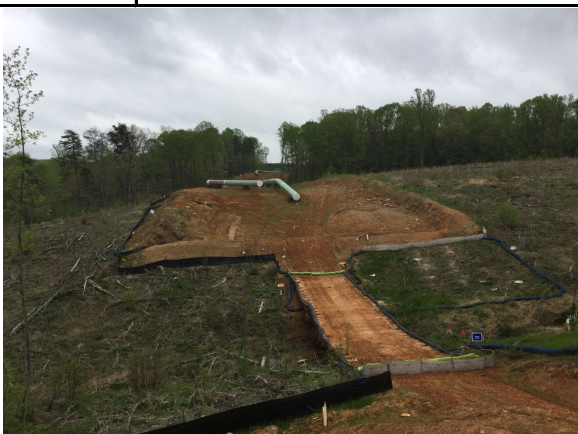
GPS Location		37.00		Field Station#		15437+00		GPS Location		37.00	
Field Station#		15556+00		Description				Vegetation beginning to grow on stabilized ROW with functioning ECD's and perimeter controls			
Description		Functioning ECD's and perimeter controls along ROW

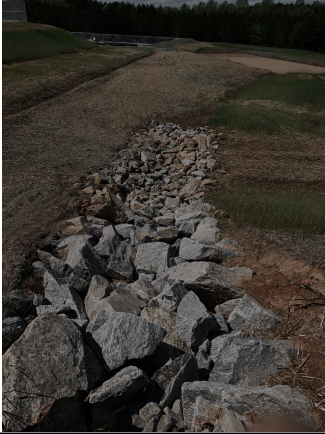
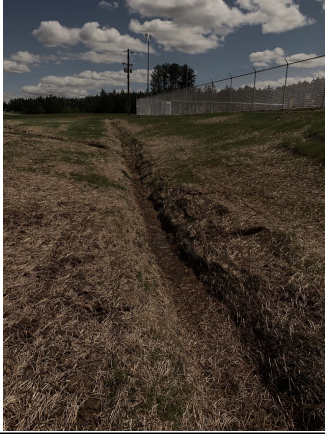
GPS Location	36.97	Field Station#	00+00	GPS Location	36.97
Description	Observing rock channel.		Description	Observing channel

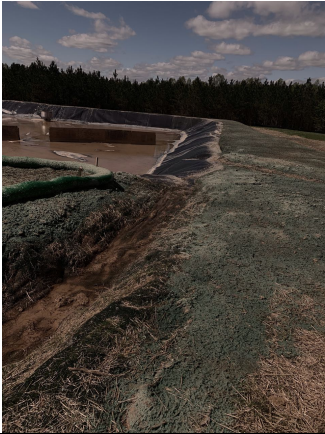
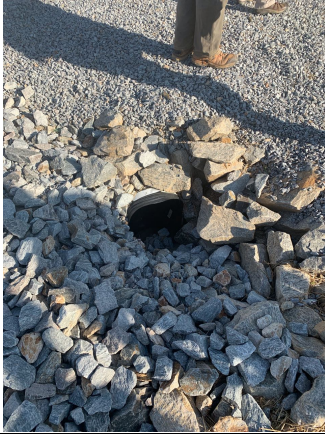
GPS Location	36.97	Field Station#	00+00	GPS Location	36.97
Description	Observing channel.		Description	Observing inlet protection.	
Insert image here			Insert image here		
GPS Location		Field Station#		GPS Location	
Description			Description

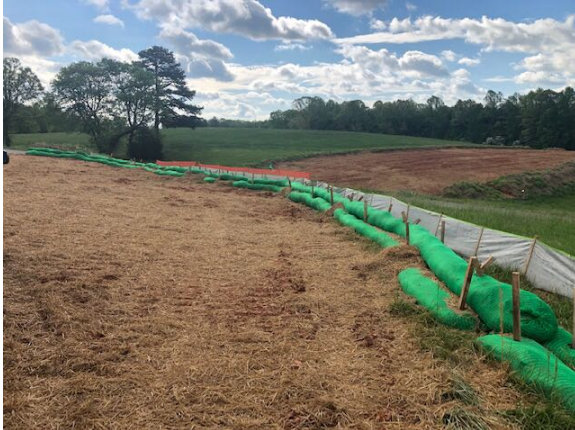
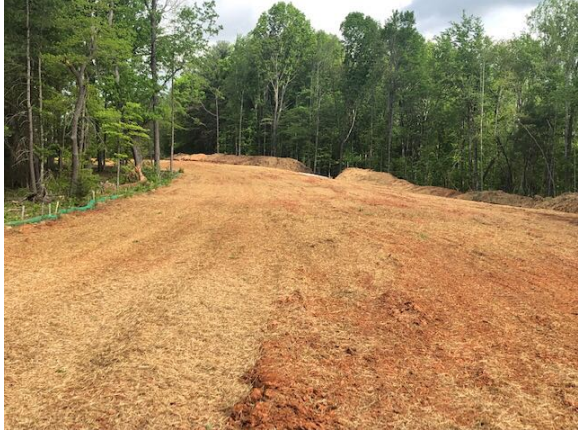
GPS Location		37.00		Field Station#		14131+00		GPS Location		37.00	
Field Station#		14100+00		Description		New ECDs installed along LOD perimeter		Description		Straw mulch applied to ROW behind temporary stabilization process

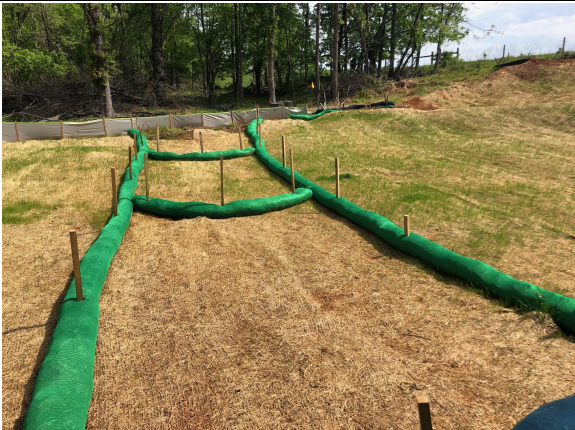
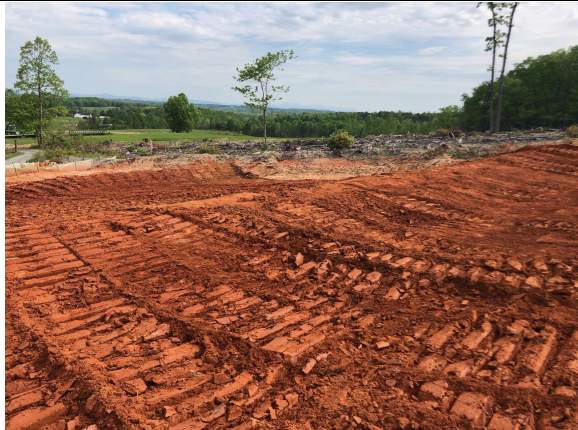
GPS Location		36.97		Field Station#		14354+48		GPS Location		36.97	
Field Station#		14323+00		Description		ECD's at stream S-A40 performing intended function		Description		Flow path cleaned out and water bars reworked along ROW

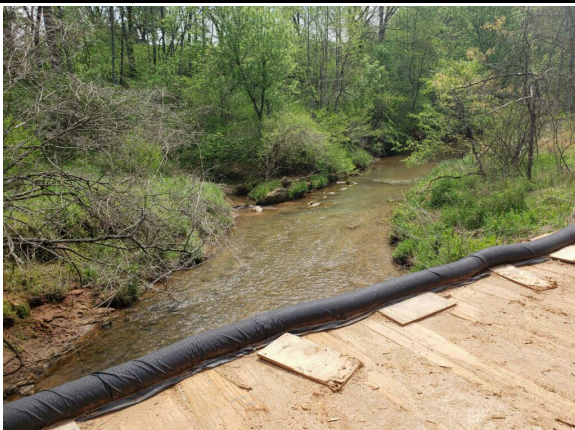
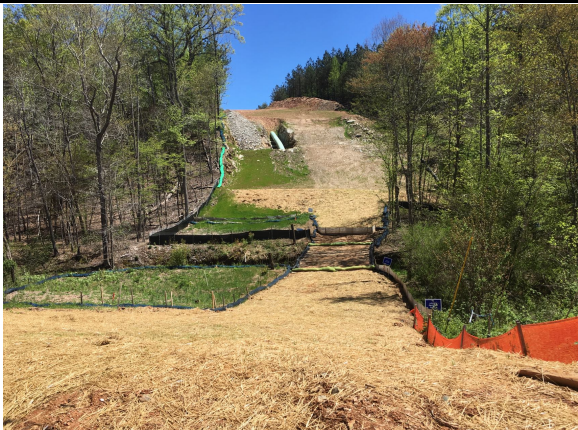
GPS Location		36.97		Field Station#		13834+10		GPS Location		36.97	
Field Station#		14950+00		Description		Downstream view at crossing of S-C14		Description		Function ECD's and recently stabilized ROW near S-G13

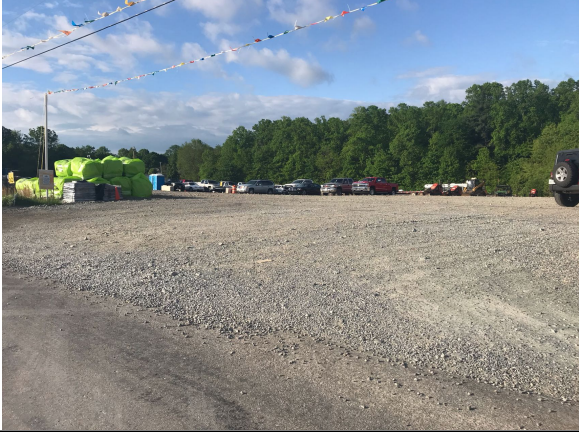
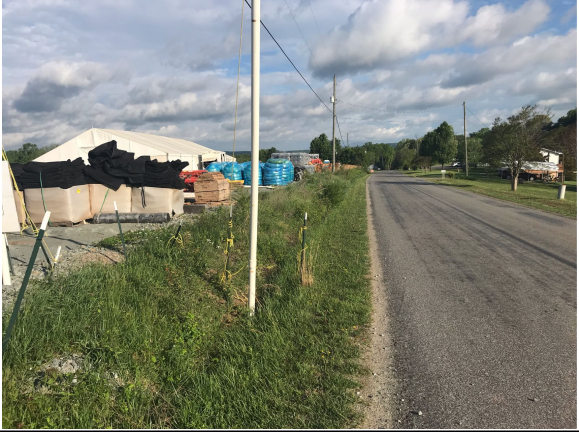
GPS Location 36.97		Field Station# 0000+00		GPS Location 36.97	
Description RCE at gravel yard in good condition.		Description Roadside ditch along Triple Creek Rd clean of trash		Field Station# 0000+00

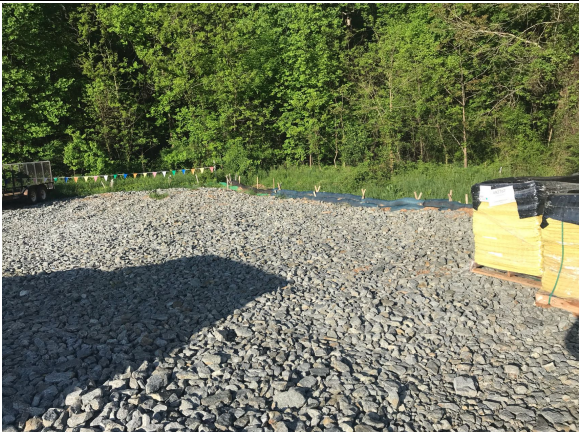
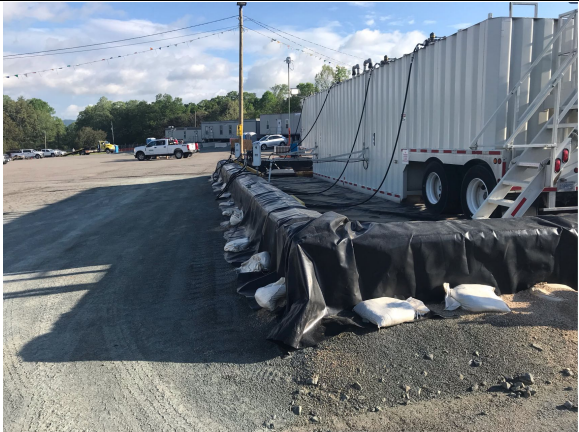
GPS Location 36.97		Field Station# 0000+00		GPS Location 36.97	
Description Perimeter ECD's on west side of gravel yard in good condition		Description Secondary containment structure for fuel cell in compliance		Field Station# 0000+00

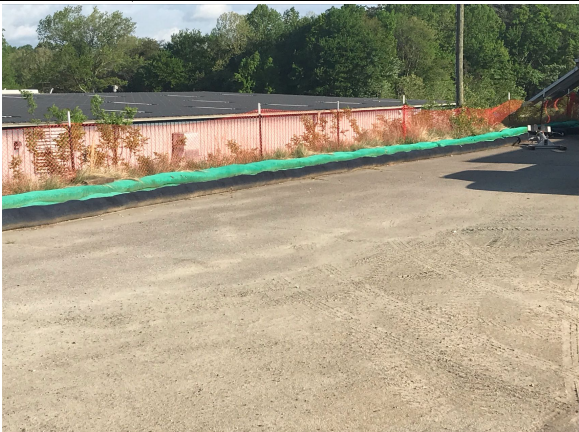
Insert image here		
GPS Location 36.97		Field Station# 0000+00		GPS Location	
Description Perimeter ECD's on west side of paved yard in good condition.		Description		Field Station#
