# Visual Site Inspection Report

| <b>Project Name</b> | H-600 Pipeline Spread G | <b>AFE</b> | 124300137 | <b>Spread</b> | H-600 Pipeline Spread G |
| <b>Inspector</b> | Len Kruizenga | | | <b>Date/Time</b> | 4/22/2019 8:51 AM |
| <b>Permit #</b> | TBD | <b>Inspection Type</b> | VA SWPP | <b>Station Begin</b> | 11788+00 |

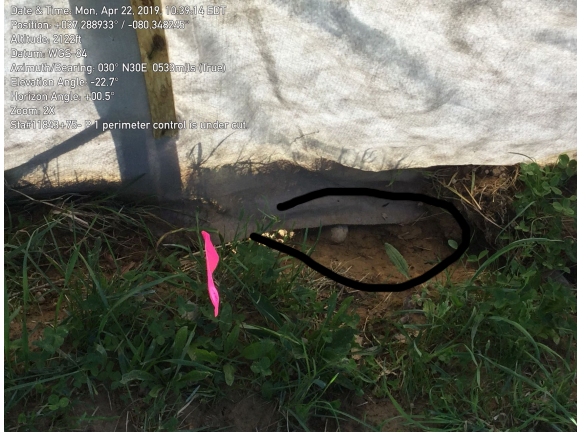
| GPS Location | 37.28 | Field Station# | 11843+75 | GPS Location | 37.28 |

| Description | | P1 perimeter controls are under cut. | | Field Station# 11857+50 | |
| Description | | P1 perimeter control has a hole in it. | | | |

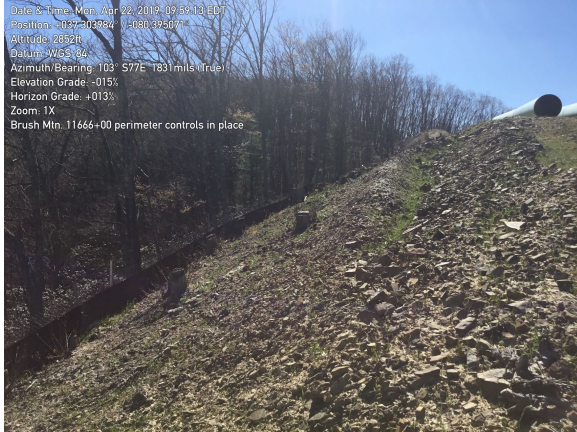
| Description | Correct coordinates on photo. Brush Mountain perimeter controls in place. | | | Description | Correct coordinates on photo. Brush Mountain vegetation coverage has improved. | | |

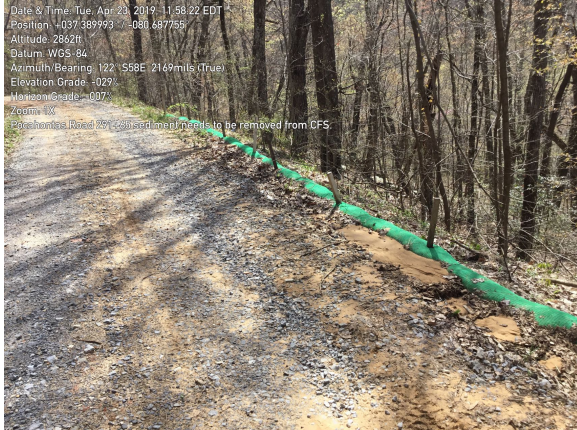
| Description | Correct coordinates on photo. Sediment deposits on CFS to be removed | | | Description | Correct coordinates on photo. Failed culvert on Pocahontas Road. | | |

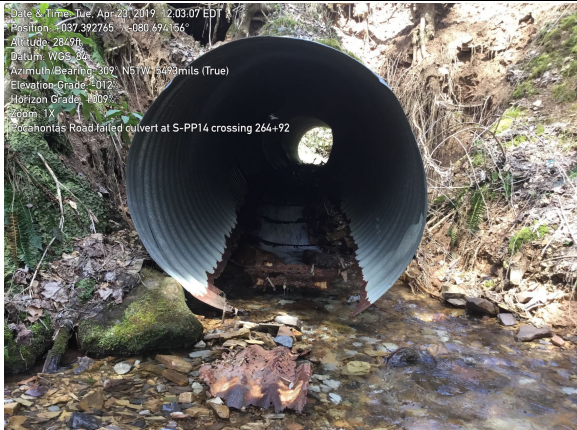
| Description | Correct coordinates on photo. Culvert has rusted out causing roadway to settle. | | | Description | Correct coordinates on photo. End treatments collected sediment transported by runoff. | | |

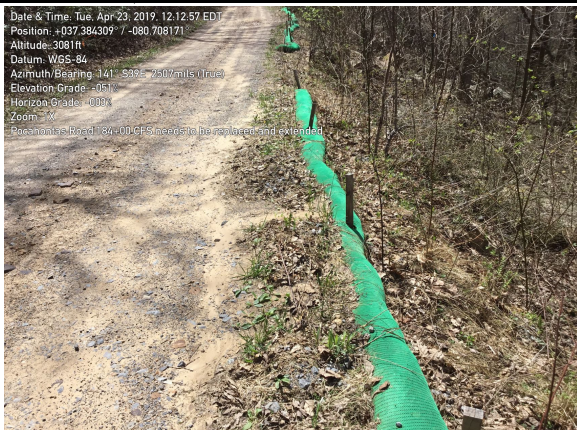
| Description | Correct coordinates on photo. CFS maintenance needed. | | | Description | Correct coordinates on photo. Runoff is channeling down Pocahontas Road. | | |

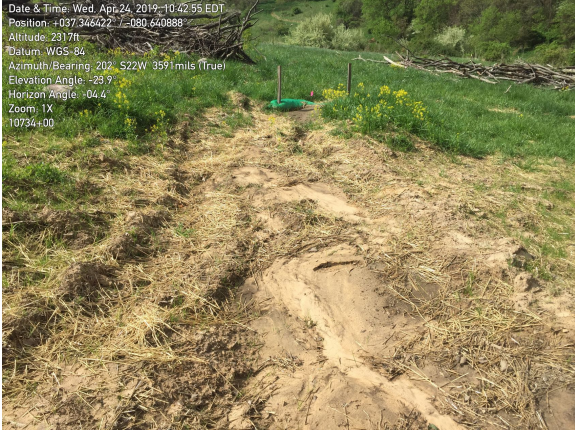
| Description | Maintenance needed on CFS check | | | Description | ECDs in good condition on stream buffer | | |

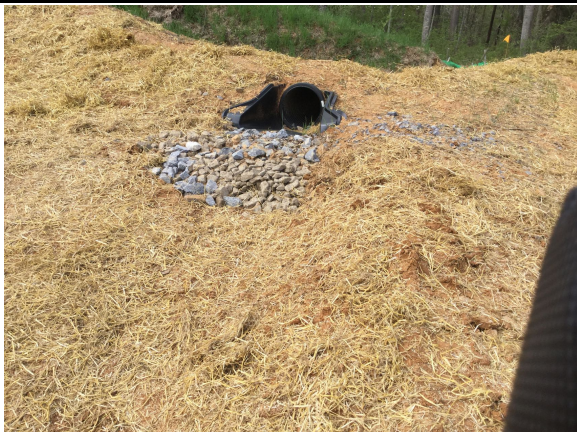
| Description | Re- freshed slope drain inlet rock | | | Description | Water bar flow line eroded | |
