Visual Site Inspection Report

Project Name	H-600 Pipeline Spread H	AFE	124300138	Spread	H-600 Pipeline Spread H	
Contractor	Precision			Report #	16588	
Inspector	Pat Davis			Date/Time	5/1/2019 5:24 PM	
Permit #	TBD	Inspection Type	VA SWPP	Station Begin	+0	
State	VA	Inspection Area	Partial	Station End	+0	
County	Montgomery	Ground	Dry	Temperature (°F)	90.00	
Municipality	N/A	Weather	Sunny	Rain Gauge (in)	0.00	
				Rain Accumulation Time (days)	0.00

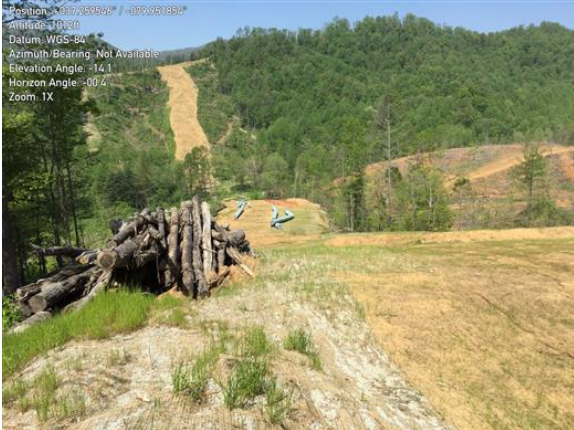
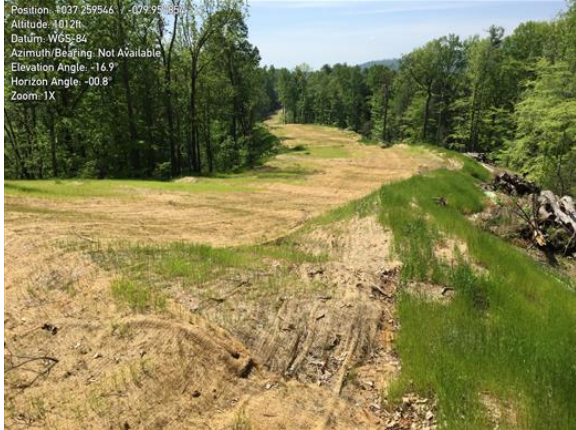
GPS Location	37.23	Field Station#	13274+00	GPS Location	37.23	Field Station#	13275+00
Description	Hillside looking down upon Flanders Road, GAS. View: West from southern edge of LOD, see photo for GPS data			Description	Hilltop PI at the GAS of Flanders Road. View: South from western edge of LOD, see photo for GPS data

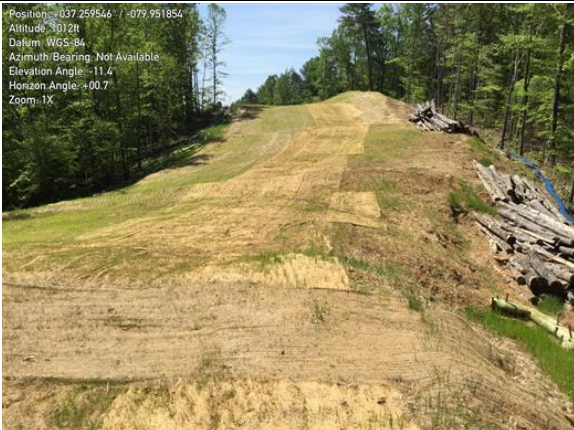
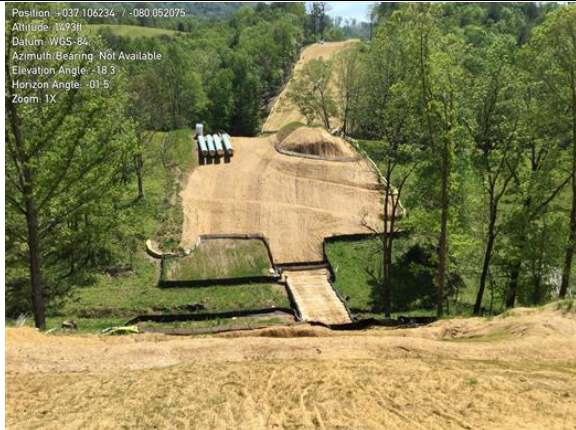
GPS Location	37.23	Field Station#	13285+00	GPS Location	37.23	Field Station#	13321+00
Description	View: South from center of LOD, see photo for GPS data			Description	Blanketed hillside looking down upon waterway S-GH15. View: East from center of LOD, see photo for GPS data

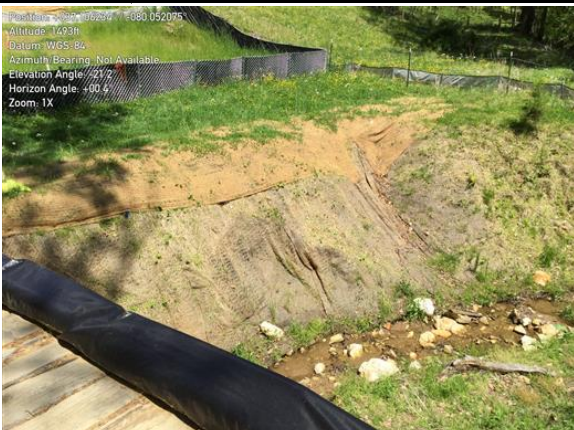
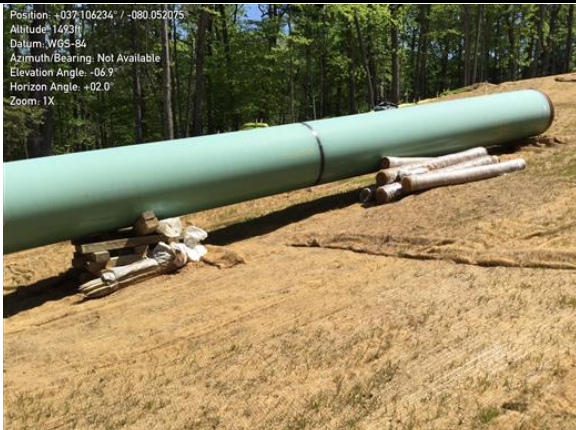
GPS Location	37.23	Field Station#	13325+30	GPS Location	37.23	Field Station#	13327+00
Description	Western bank of S-GH14. View: Northwest from center of LOD, see photo for GPS data			Description	Staged ECB & silt fence. View: Northeast from center of LOD, see photo for GPS data

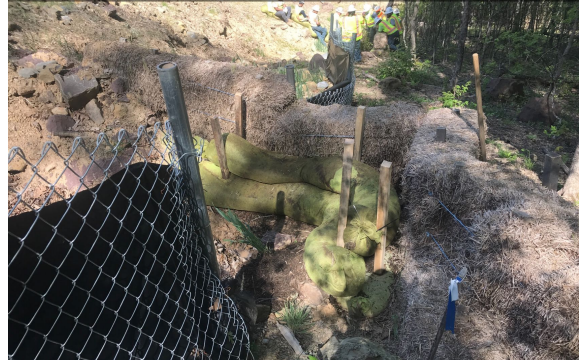
<div>12023+00</div> <div>Replaced worn J-hook</div> <div>2019-05-01 10:50:39-04:00</div>

GPS Location	37.25	Field Station#	12052+00	GPS Location	37.25	Field Station#	12923+00
Description	See photo for gps data. Photo shows the ROW condition from about 12039+00 to 12052+00.			Description	See photo for gps data. Photo shows the newly installed triple stacked CFS j-hook at 12023+00.		
<div>DIRECTION 297 deg(T)</div> <div>+37.26597° -080.31125°</div> <div>ACCURACY 10 m DATUM WGS84</div>

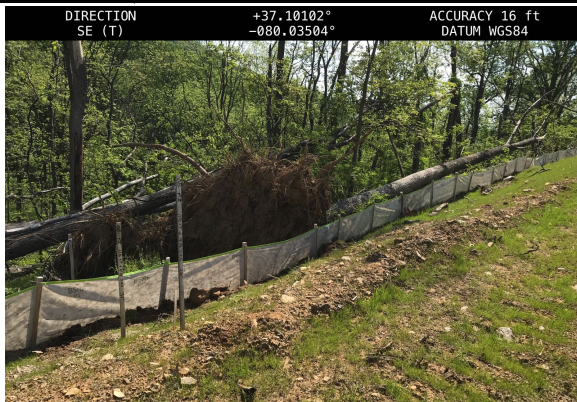
<div>DEQ item 2018 station 13374+50 2019-05-01 11:04:59-04:00</div>			<div>DIRECTION SE (T)</div> <div>+37.09699° -080.03241°</div> <div>ACCURACY 33 ft DATUM WGS84</div>

<div>DEQ item 2017 station 13391+30 repaired 2019-05-01 11:30:46-04:00</div>				
GPS Location	37.10	Field Station#	13374+50	GPS Location	37.10	Field Station#	13391+30
Description	13374+50_050119 P1 silt fence repaired after tree up rooted. Looking SE. See photo for gps data.			Description	13391+30_050119 P1 silt fence Repaired after tree up rooted. Looking SE. See photo for gps data.

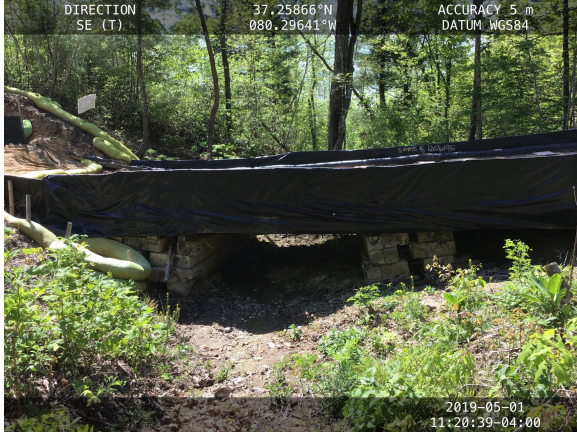
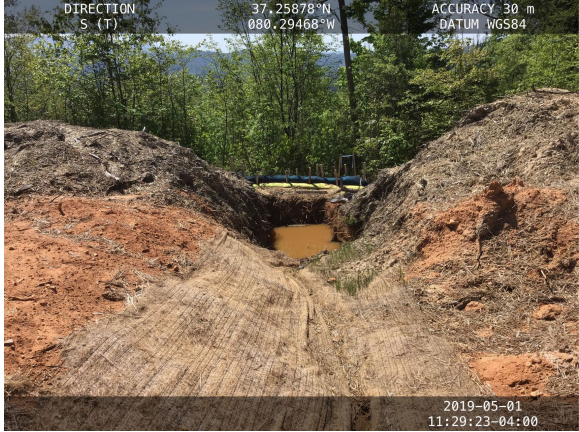
GPS Location	37.25	Field Station#	12076+95	GPS Location	37.25	Field Station#	12082+00
Description	Stream S-MM15, facing southeast. No issues.			Description	Sumps are all in satisfactory condition.

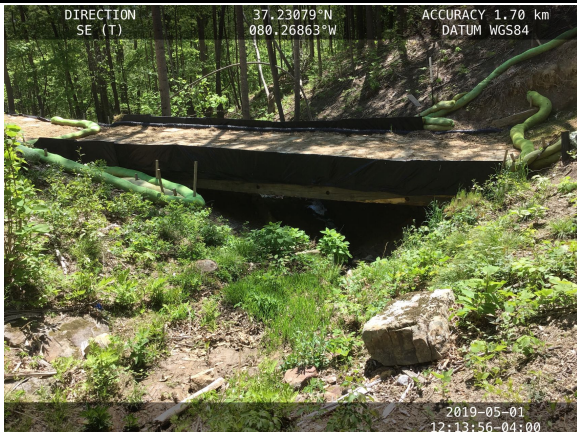
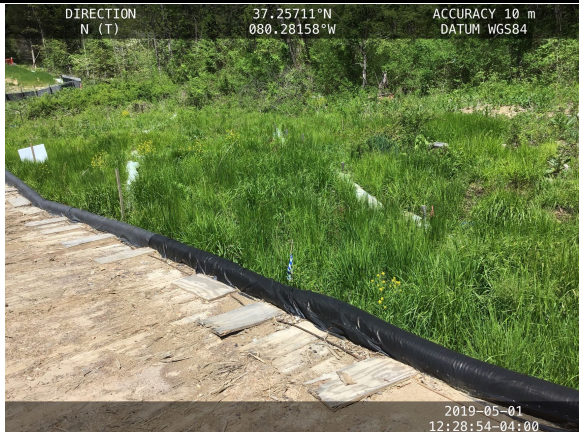
GPS Location	37.25	Field Station#	12098+44	GPS Location	37.25	Field Station#	12121+83
Description	Stream S-MM13, facing southeast. No issues.			Description	Stream S-C36, facing north. No issues.

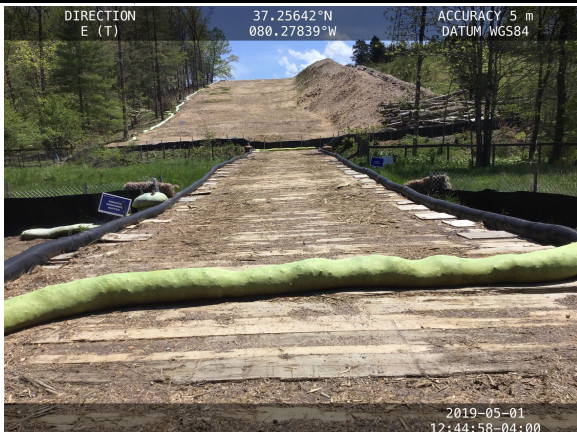
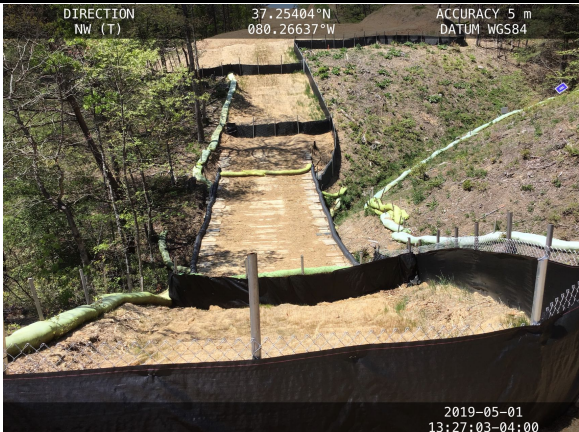
GPS Location	37.25	Field Station#	12132+73	GPS Location	37.25	Field Station#	12166+47
Description	Stream S-C29, facing east. No issues			Description	Stream S-C24, facing northwest. No issues.

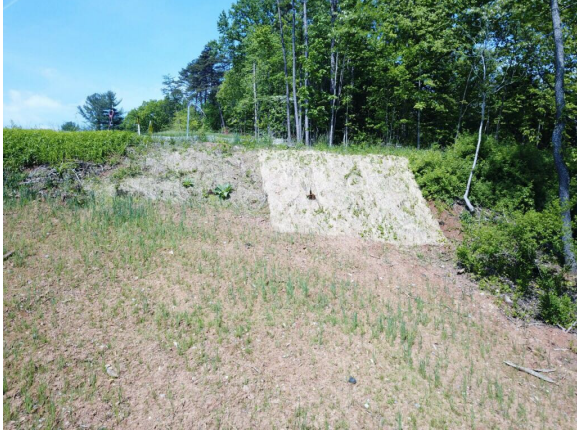
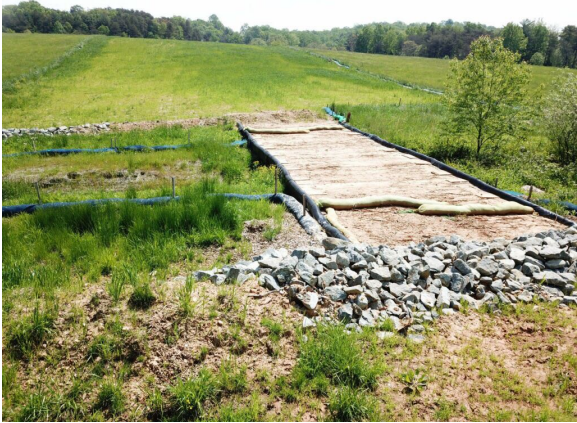
GPS Location 36.97		Field Station# 13562+73		GPS Location 36.97	
Description		Erosion repaired on edge of Bethlehem rd on RoW		Description	
				Rock check and breaker in place at stream crossing

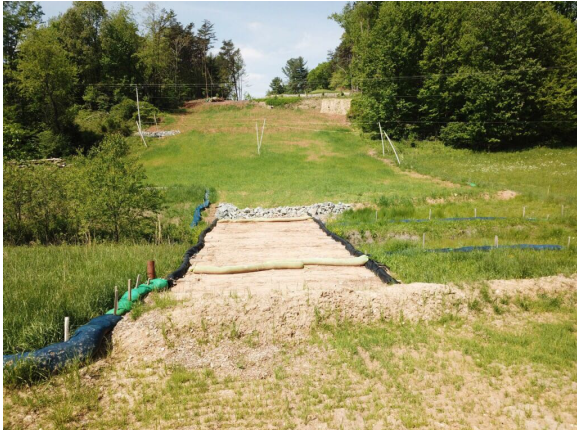
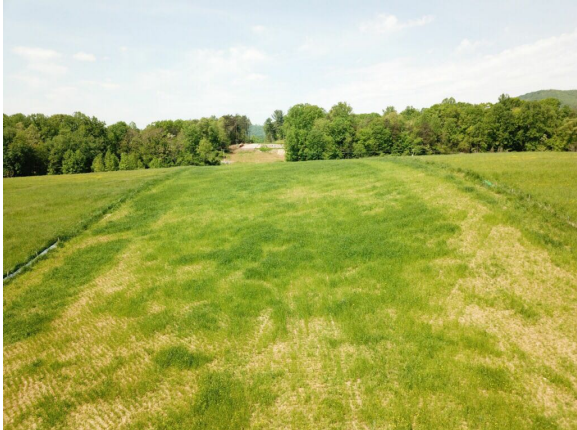
GPS Location 36.97		Field Station# 13565+61		GPS Location 36.97	
Description		Wetland/stream crossing, breakers and ECD's in place and functioning.		Description	
				Vegetative stabilization is good condition.

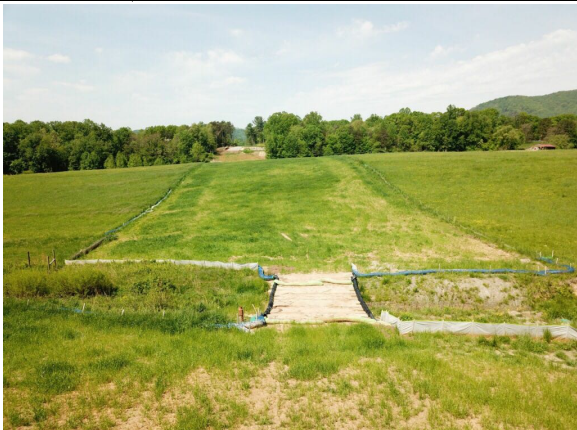
Insert image here		
GPS Location 36.97		Field Station# 13572+83		GPS Location	
Description		ECD's in place and functioning at natural drain feature.		Description
