Visual Site Inspection Report

Project Name	Transco Interconnect Station		AFE	124300113	Spread	Transco Interconnect Station	
Contractor	Kanahwa				Report #	16639	
Inspector	John White				Date/Time	5/2/2019 4:04 PM	
Permit #	TBD	Inspection Type	VA SWPP		Station Begin	00+00	
State	VA	Inspection Area	Full		Station End	00+00	
County	Pittsylvania	Ground	Dry		Temperature (°F)	84.00	
Municipality	Chatham	Weather	Sunny		Rain Gauge (in)	0.00	
					Rain Accumulation Time (days)	1.00

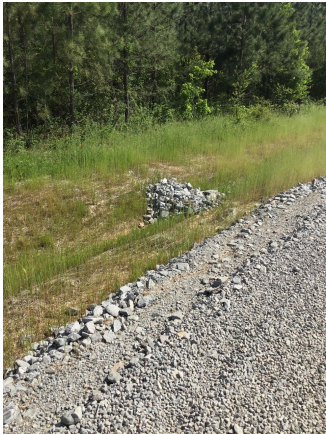
GPS Location		36.83		Field Station#		00+00		GPS Location		36.83		Field Station#		00+00	
Description		Observing rock check dam in drainage channel.						Description		Observing RCE at Transco.

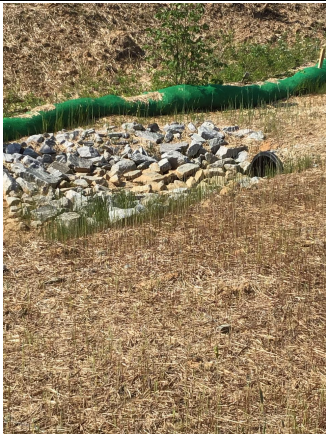
GPS Location		36.83		Field Station#		00+00		GPS Location		36.83		Field Station#		00+00	
Description		Observing culvert and outlet protection.						Description		Observing rock check dams in drainage channel.

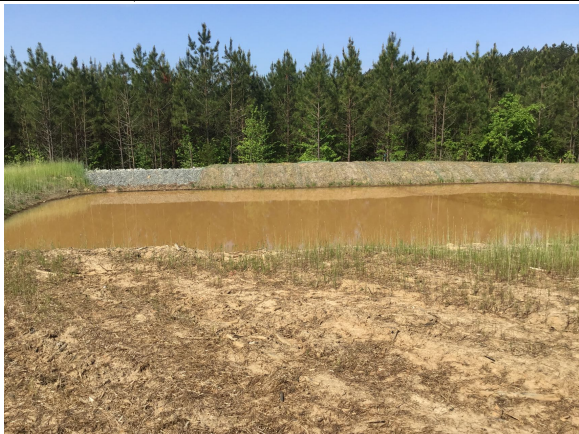
GPS Location		36.83		Field Station#		00+00		GPS Location		36.83		Field Station#		00+00	
Description		Observing sediment basin.						Description		Observing new baffles in storm water pond.

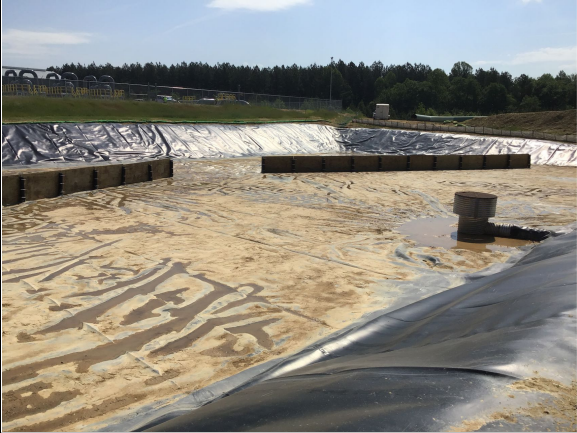
<p>Insert image here</p>			
GPS Location	36.83	Field Station#	00+00	GPS Location	
Description	Observing new baffles in storm water pond.		Description		
<p>Insert image here</p>			<p>Insert image here</p>		
GPS Location		Field Station#		GPS Location	
Description			Description		
<p>Insert image here</p>			<p>Insert image here</p>		
GPS Location		Field Station#		GPS Location	
Description			Description		
<p>Insert image here</p>			<p>Insert image here</p>		
GPS Location		Field Station#		GPS Location	
Description			Description
