Visual Site Inspection Report

Project Name	H-600 Pipeline Spread G	AFE	124300137	Spread	H-600 Pipeline Spread G
Contractor	Precision			Report #	16510
Inspector	Len Kruizenga			Date/Time	4/29/2019 10:18 AM
Permit #	TBD	Inspection Type	VA SWPP	Station Begin	12005+00
State	VA	Inspection Area	Full	Station End	12005+00
County	Giles	Ground	Damp	Temperature (°F)	53.00
Municipality	N/A	Weather	Cloudy	Rain Gauge (in)	0.00
				Rain Accumulation Time (days)	0.00

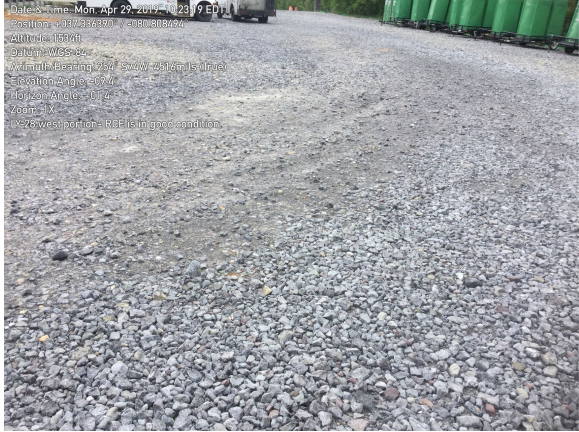
</div></div>			
GPS Location	37.33	Field Station#	12005+00	GPS Location	37.33
Description	LY-28, west side of yard- CFS perimeter controls are in acceptable condition		Description	LY-28- west side of yard- RCE is in good condition	
<div><div><div>Date & Time: Mon, Apr 29, 2019, 10:43:17 EDT Position: +037.336422° / -080.808669° Altitude: 1561ft Datum: WGS-84 Azimuth/Bearing: 186° S06W 3307mils (True) Elevation Angle: -03.9° Horizon Angle: +00.4° Zoom: 1X LY-28 West side of yard - Transport buses</div>

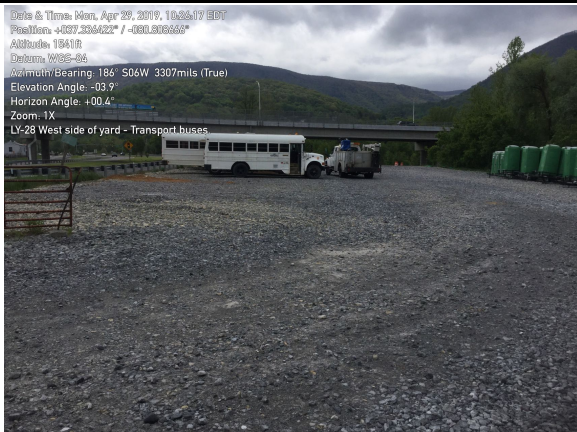
</div></div>		<div><div><div>Date & Time: Mon, Apr 29, 2019, 10:44:19 EDT Position: +037.336420° / -080.800998° Altitude: 1559ft Datum: WGS-84 Azimuth/Bearing: 276° N84W 4907mils (True) Elevation Angle: -06.9° Horizon Angle: +02.0° Zoom: 1X LY-28- East portion of yard- CFS controls along yard road</div>

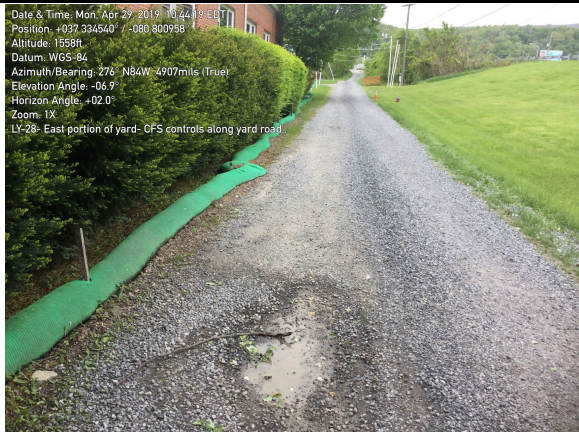
GPS Location	37.33	Field Station#	12005+00	GPS Location	37.33
Description	LY-28, west side of yard- Transport buses stored.		Description	LY-28- east yard- CFS controls along road going into yard	
<div><div><div>Date & Time: Mon, Apr 29, 2019, 10:49:34 EDT Position: +037.336416° / -080.808617° Altitude: 1568ft Datum: WGS-84 Azimuth/Bearing: 224° S44W 3982mils (True) Elevation Angle: -04.7° Horizon Angle: +01.7° Zoom: 1X LY-28- East portion- Truck & trailer Storage, no fluid discharge observed at time of inspection</div>

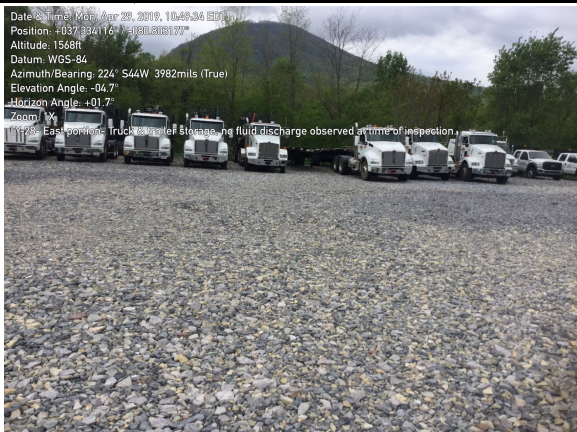
</div></div>		<div><div><div>Date & Time: Mon, Apr 29, 2019, 10:53:00 EDT Position: +037.334282° / -080.808643° Altitude: 1568ft Datum: WGS-84 Azimuth/Bearing: 055° N56E 0976mils (True) Elevation Angle: -04.4° Horizon Angle: +01.7° Zoom: 1X LY-28- east side- CFS perimeter controls</div>

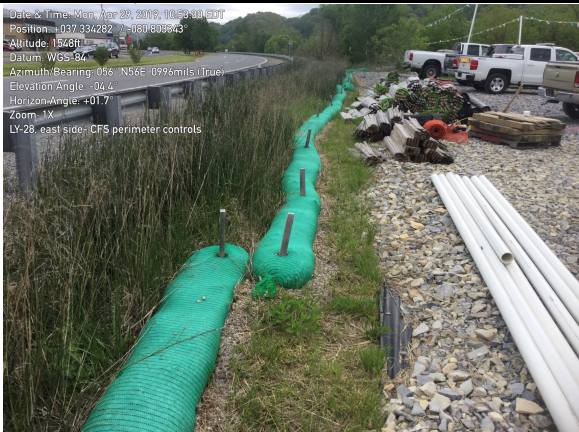
</div></div>			
GPS Location	37.33	Field Station#	12005+00	GPS Location	37.33
Description	LY-28, east portion of the yard- Truck & trailer storage, no fluid discharge observed at the time of inspection.		Description	LY-28, east side- CFS perimeter controls

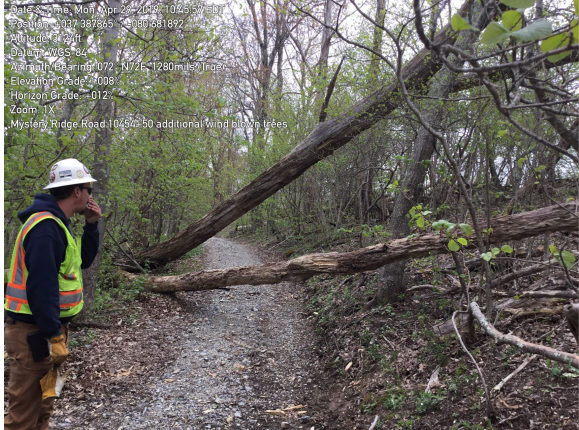
GPS Location	37.31	Field Station#	152+70	GPS Location	37.31	Field Station#	10454+50
Description	Correct coordinates on photo. Steel plate placed over hole in Pocahontas Road at failed culvert.			Description	Correct coordinates on photo. Two new hung trees discovered from weekend storms on Mystery Ridge Road.

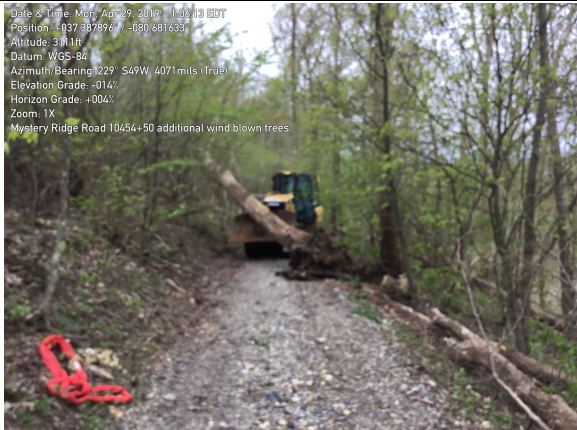
<p>Date & Time: Mon, Apr 29, 2019, 11:26:09 EDT Position: +037.388912 / -080.681290 Altitude: 3111ft Datum: WGS-84 Azimuth/Bearing: 212° S22W 3769mils (True) Elevation Grade: -008% Horizon Grade: -000% Zoom: IX Mystery Ridge Road 10454+00 hung tree dropped</p>

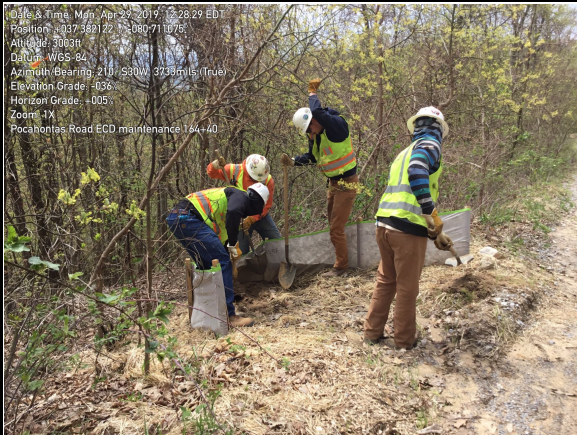
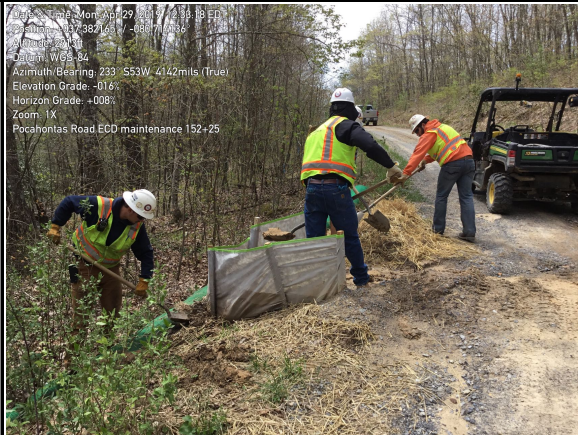
GPS Location	37.31	Field Station#	164+40	GPS Location	37.31 Field Station# 152+25
Description	Correct coordinates on photo. ECD maintenance. Weekend rains damaged controls.

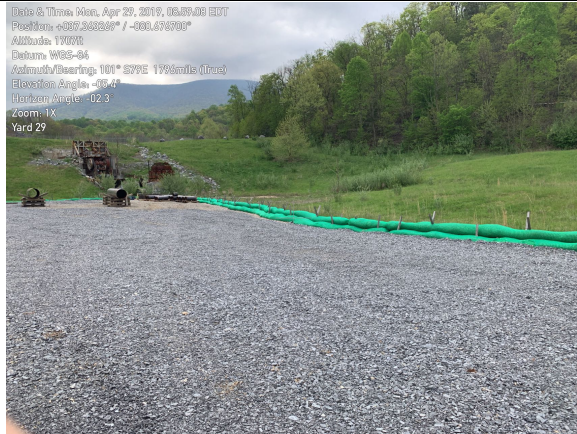
GPS Location	37.31	Field Station#	12005+00	GPS Location	37.31	Field Station#	12005+00
Description	See photo for GPS location. Lay down yard 29 covered with rock.			Description	See photo for GPS location. Triple stack compost filter sock in place

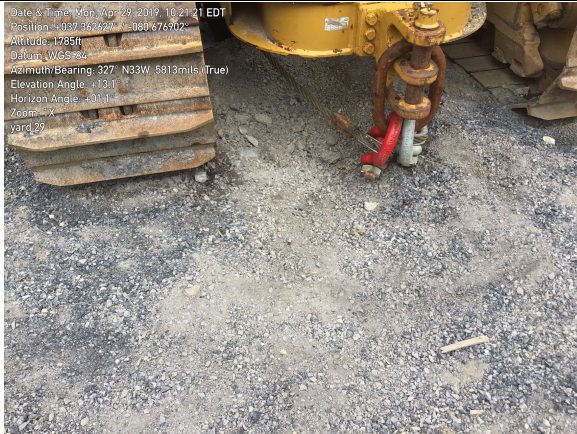
GPS Location	37.31	Field Station#	12005+00	GPS Location	37.31	Field Station#	12005+00
Description	See photo for GPS location. Spill located at lay down yard 29.			Description	See photo for GPS location. Spill cleaned up.

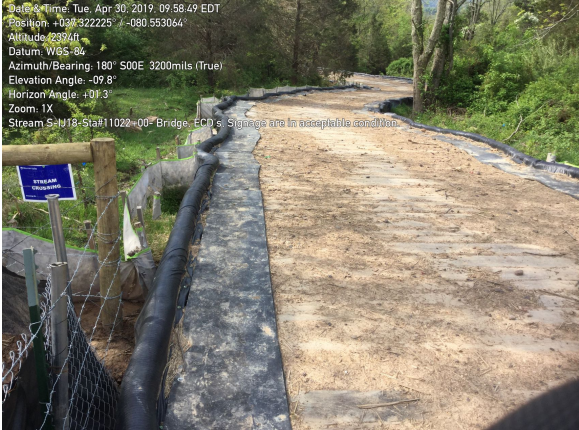
<p>Date & Time: Tue, Apr 30, 2019, 09:58:49 EDT Position: +037 322225 / -080 553064 Altitude: 2336ft Datum: WGS-84 Azimuth/Bearing: 180° S00E 3200mils (True) Elevation Angle: -09.8° Horizon Angle: +01.3° Zoom: 1X Stream S-IJ18- Sta#11022+00- Bridge, ECD's, Signage are in acceptable condition.</p>

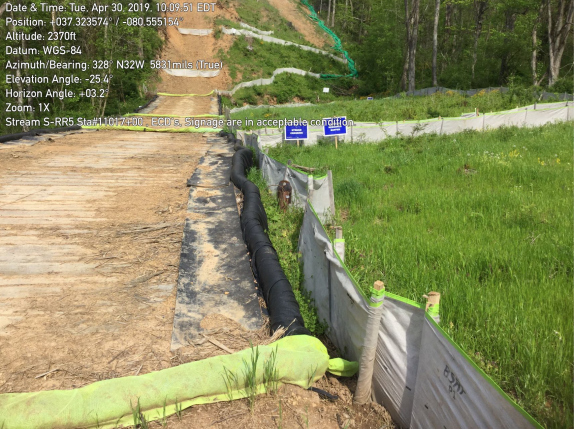
<p>Date & Time: Tue, Apr 30, 2019, 10:09:51 EDT Position: +037 323574 / -080 555130 Altitude: 2370ft Datum: WGS-84 Azimuth/Bearing: 328° N32W 5831mils (True) Elevation Angle: -25.4° Horizon Angle: +03.2° Zoom: 1X Stream S-RR5- Sta#11017+00- ECD's, Signage are in acceptable condition.</p>		
GPS Location	37.32	Field Station#	11022+00	GPS Location	37.32 Field Station# 11017+00
Description	Stream S-IJ18- Bridge, ECD's, signage are in acceptable condition			Description	Stream S-RR5- Bridge, ECD's, signage & Buffers are in acceptable condition

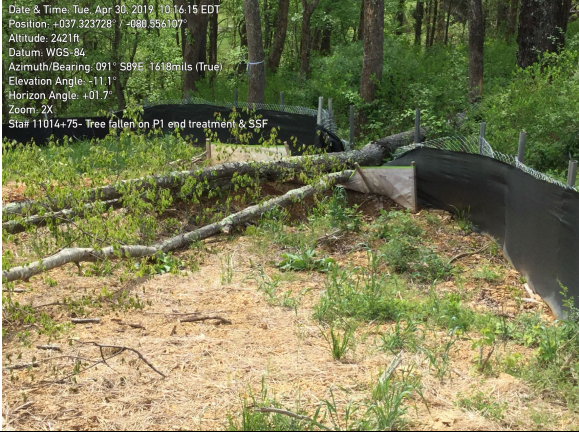
<p>Date & Time: Tue, Apr 30, 2019, 10:16:15 EDT Position: +037 323728 / -080 556107 Altitude: 2421ft Datum: WGS-84 Azimuth/Bearing: 091° S89E 1618mils (True) Elevation Angle: -11.1° Horizon Angle: +01.7° Zoom: 2X Sta#11014+75- Tree fallen on P1 end treatment & SSF</p>

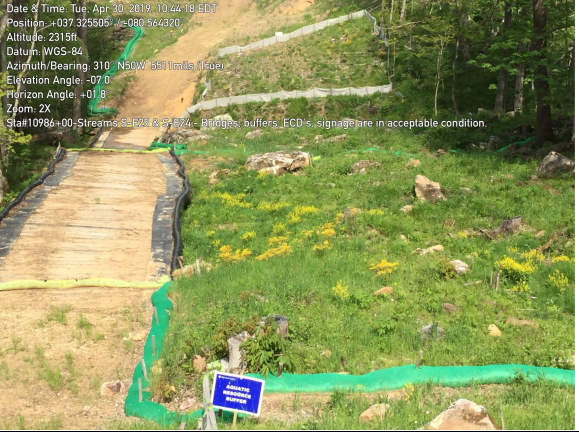
<p>Date & Time: Tue, Apr 30, 2019, 10:44:18 EDT Position: +037 325505 / -080 564320 Altitude: 2315ft Datum: WGS-84 Azimuth/Bearing: 310° N50W 6811mils (True) Elevation Angle: -07.0° Horizon Angle: +01.8° Zoom: 2X Sta#10986+00- Streams S-E24 & S-E25, - Bridges, buffers, ECD's, signage are in acceptable condition.</p>		
GPS Location	37.32	Field Station#	11014+75	GPS Location	37.32 Field Station# 10986+00
Description	Tree fell on P1 end treatment & SSF perimeter control			Description	Streams S-E24 & S-E25, - Bridges, buffers, ECD's, signage are in acceptable condition.

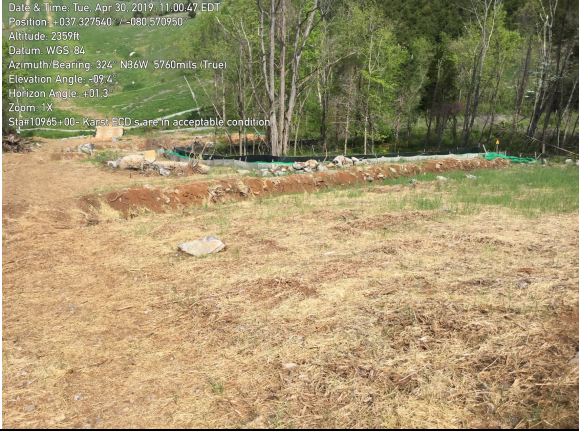
<p>Date & Time: Tue, Apr 30, 2019, 11:00:47 EDT Position: +037 327540 / -080 570950 Altitude: 2359ft Datum: WGS-84 Azimuth/Bearing: 324° N36W 5760mils (True) Elevation Angle: -09.4° Horizon Angle: +01.3° Zoom: 1X Sta#10965+00- Karst ECD's are in acceptable condition.</p>

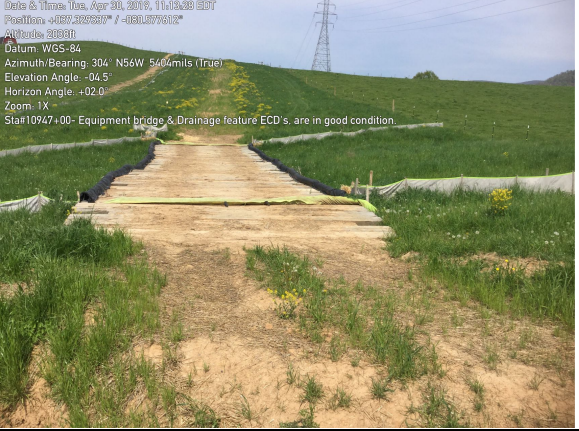
<p>Date & Time: Tue, Apr 30, 2019, 11:18:28 EDT Position: +037 326587 / -080 577612 Altitude: 2390ft Datum: WGS-84 Azimuth/Bearing: 304° N56W 5400mils (True) Elevation Angle: -04.5° Horizon Angle: +02.0° Zoom: 1X Sta#10947+00- Equipment bridge & Drainage feature ECD's are in good condition.</p>

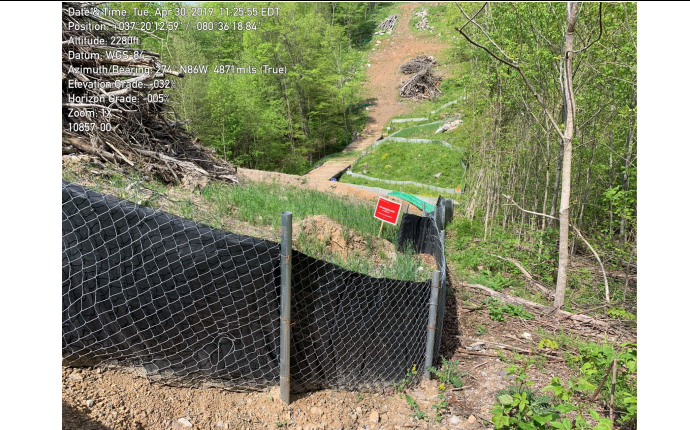
GPS Location	37.29	Field Station#	2+34	GPS Location	37.29	Field Station#	10857+00
Description	Crew replacing damaged P1 @ AR 234			Description	ECD's and ROW conditions		
<p>Date & Time: Tue, Apr 30, 2019, 12:01:59 EDT Position: +037°20'6.38" / -080°35'48.13" Altitude: 2166ft Datum: WGS-84 Azimuth/Bearing: 293° N67W 5209mils (True) Elevation Grade: -012% Horizon Grade: +004% Zoom: 1X 10883+00</p>
