Visual Site Inspection Report

| Project Name | Transco Interconnect Station | AFE | 124300113 | Spread | Transco Interconnect Station |

| Project Name | H-600 Pipeline Spread I | AFE | 124300139 | Spread | H-600 Pipeline Spread I |

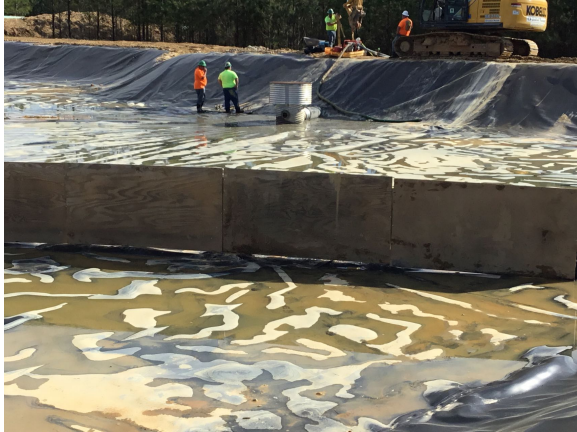
| Field Station# | | +1 | | Description | | Installed baffles | | Description | | Installed riser with concrete base | |

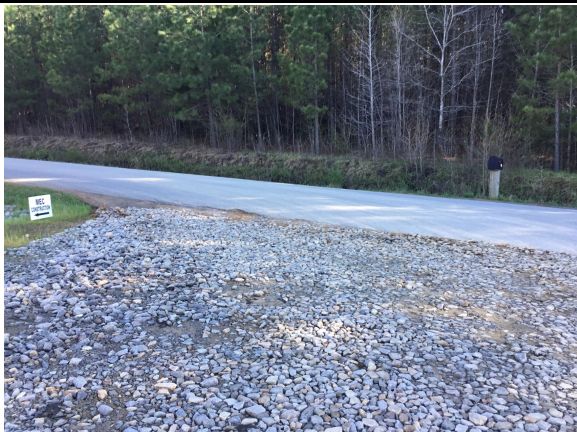
| Field Station# | | +1 | | Description | | RCE at Transco | | Description | | Containment set up for sandblasting | |

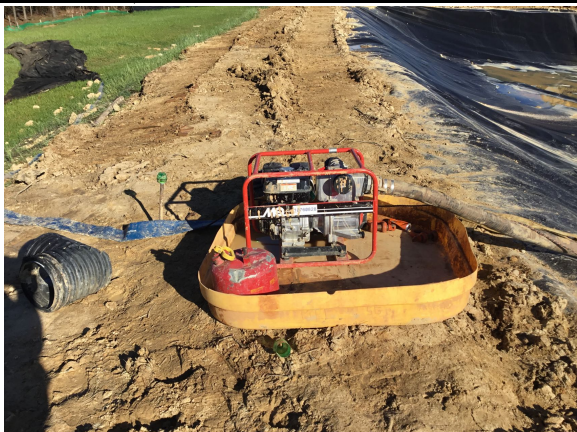
| Field Station# | | +1 | | Description | | Secondary containment | | Description | | Plunge pool and spreader for sed basin riser outfall | |

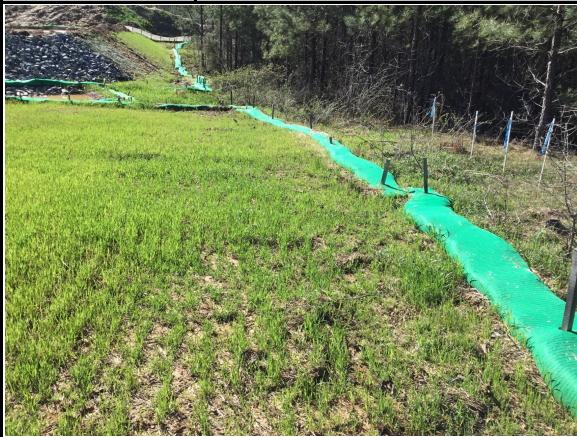
| Description | | 18 inch CFS | | | | Description | | SSF and rock filter outlet along west LOD | | | |

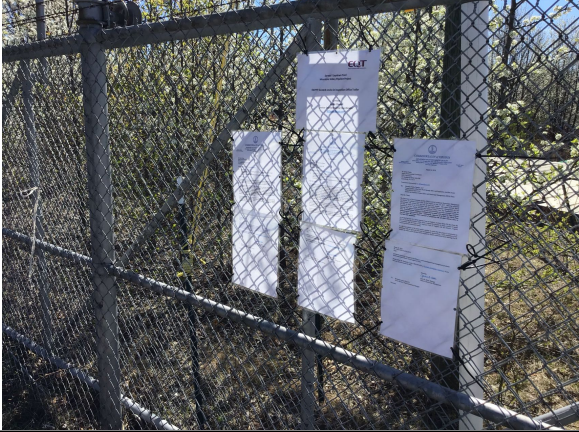
| Description | | Construction permits posted at main entrance. | | Description | |

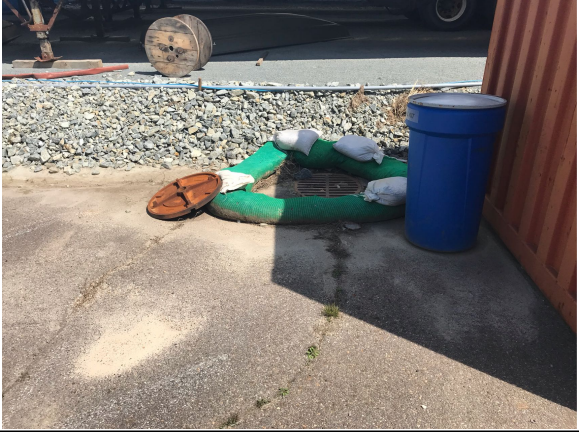
| | | | | Inlet protection for parking lot drain near tool storage building in good condition. | |

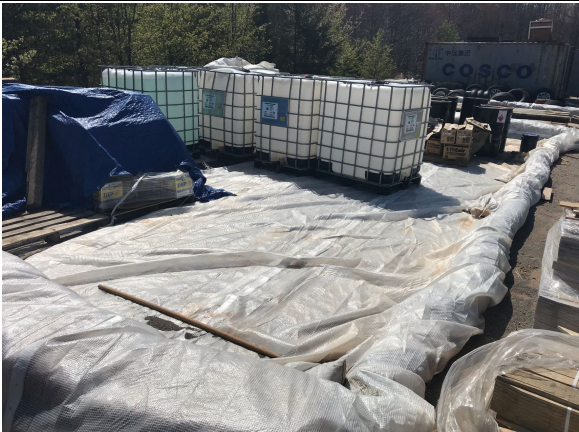
| Description | | Secondary containment structure in good condition | | Description | |

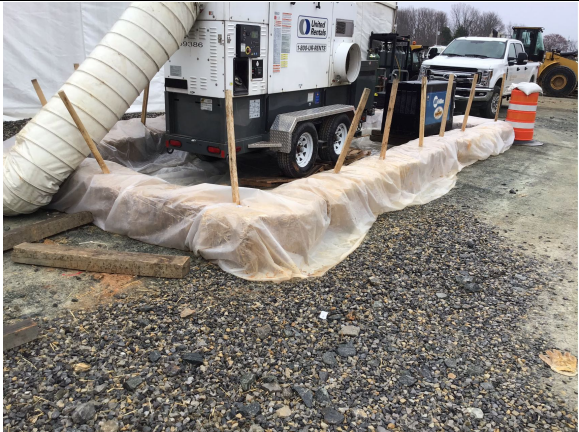
| | | | | Secondary containment structure for generator in good condition | |

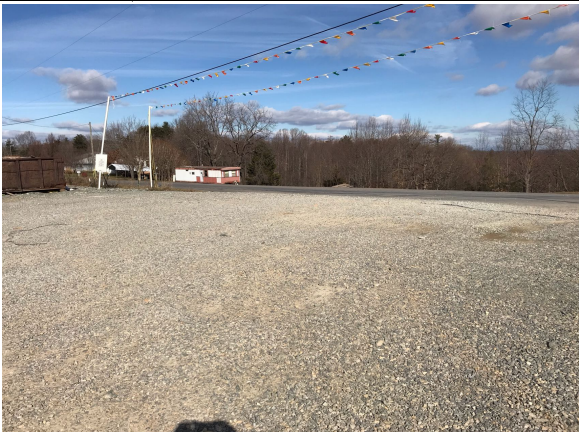
| Description | | RCE for gravel yard in compliance. | | Description | |
