Visual Site Inspection Report

Project Name	H-600 Pipeline Spread G	AFE	124300137	Spread	H-600 Pipeline Spread G
Contractor	Precision			Report #	15585
Inspector	Len Kruizenga			Date/Time	4/8/2019 7:19 AM
Permit #	TBD	Inspection Type	VA SWPP	Station Begin	11022+00
State	VA	Inspection Area	Partial	Station End	10930+00
County	Giles	Ground	Wet	Temperature (°F)	54.00
Municipality	N/A	Weather	Cloudy	Rain Gauge (in)	0.30
				Rain Accumulation Time (days)	0.30

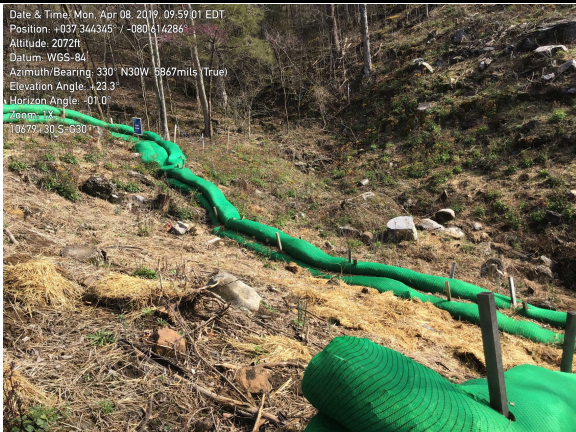
</div>				
GPS Location	37.20	Field Station#	10696+50	GPS Location	37.20	Field Station#	10679+30
Description	See photo for GPS location. RCE in place at buffalo antlklets Road.			Description	See photo for GPS location. Triple stack compost filter sock in place at stream buffer.

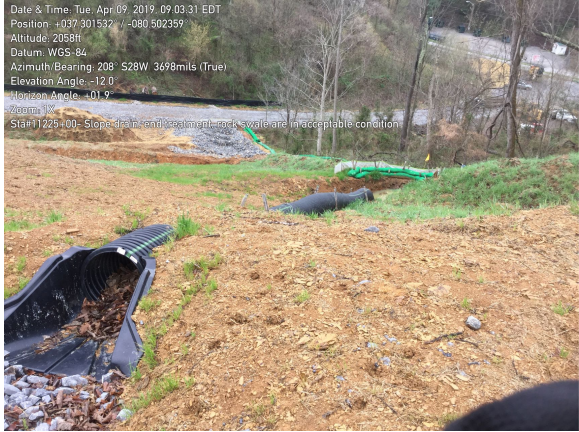
GPS Location	37.30	Field Station#	11227+55	GPS Location	37.30	Field Station#	11225+00
Description	Winding Way rain gauge reading-0.10"			Description	Slope drain, end treatment p, rock swale are in acceptable condition.		
<p>Date & Time: Tue, Apr 09, 2019, 09:14:41 EDT Position: +037.303009° / +080.506301° Altitude: 1934ft Datum: WGS-84 Azimuth/Bearing: 217° S37W 3858mils (True) Elevation Angle: -05.9° Horizon Angle: +01.3° Zoom: 1X Star11208+00- Row is stable after rain events</p>

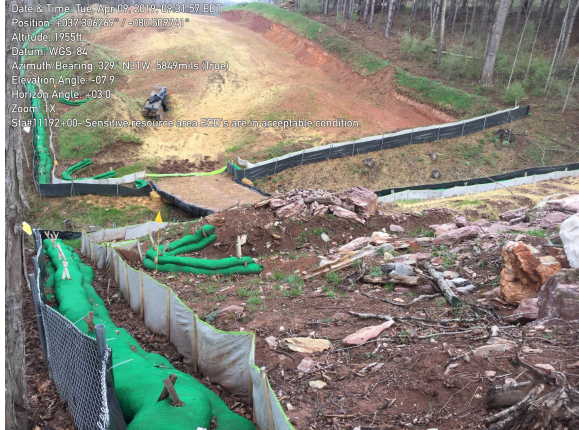
GPS Location	37.30	Field Station#	11208+00	GPS Location	37.30	Field Station#	11192+00
Description	Row stable after rain events.			Description	Sensitive resource area ECD's are in good condition		
<p>Date & Time: Tue, Apr 09, 2019, 09:43:08 EDT Position: +037.307387° / +080.510713° Altitude: 1922ft Datum: WGS-84 Azimuth/Bearing: 345° N15W 536mils (True) Elevation Angle: -09.0° Horizon Angle: +01.2° Zoom: 1X Star11184+00- CWD plunge pool rocks clean ECD's are in acceptable condition</p>

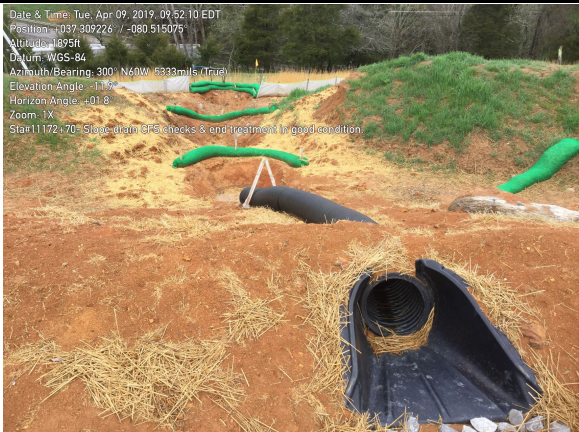
GPS Location	37.30	Field Station#	11184+00	GPS Location	37.31	Field Station#	11172+70
Description	CWD plunge pool are in good condition			Description	Slope drain CFS checks & end treatment are in good condition.

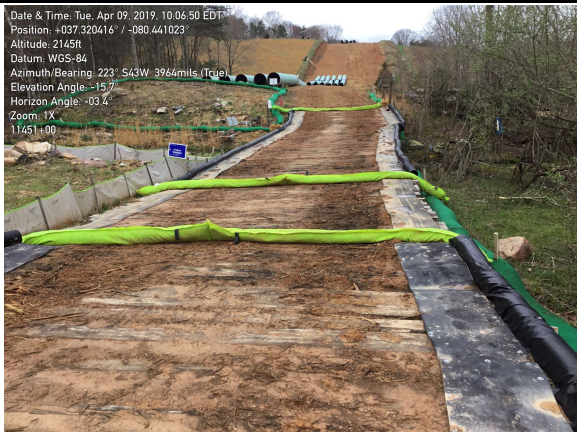
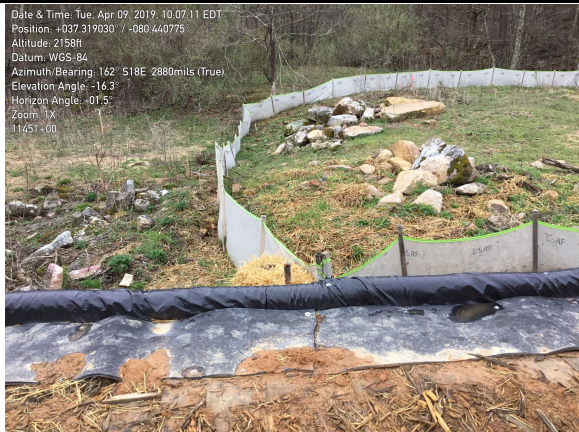
GPS Location	37.30	Field Station#	11451+00	GPS Location	37.30	Field Station#	11451+00
Description	Stream crossing all ECDs in good working condition			Description	ECDs in good condition

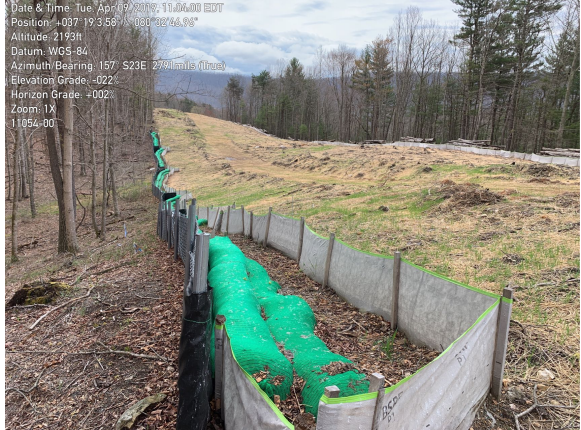
GPS Location	37.32	Field Station#	11037+00	GPS Location	37.32	Field Station#	11054+00
Description	ECD's and ROW conditions			Description	ECD's and ROW conditions

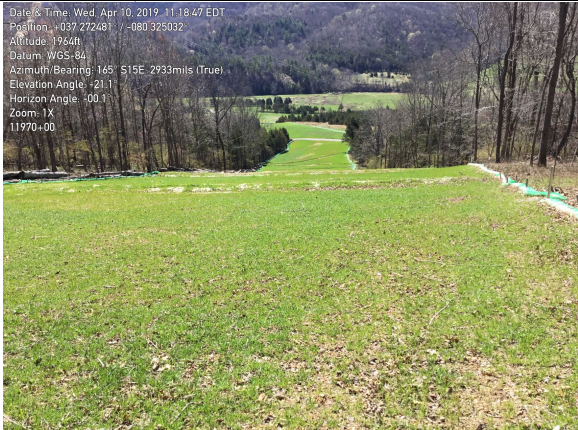
</div>					
GPS Location	37.31	Field Station#	11950+00	GPS Location	37.31	Field Station#	11970+00
Description	ECDs protecting karst			Description	Row stabilized

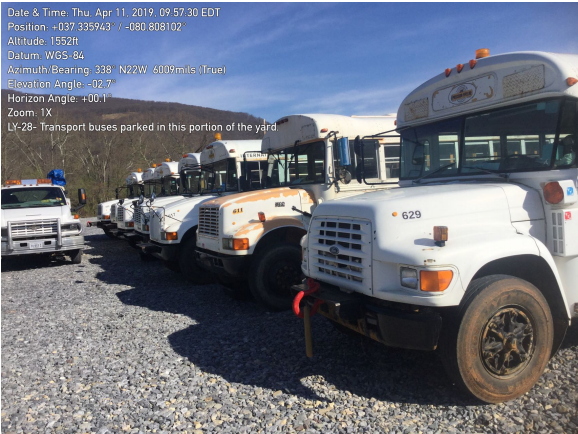
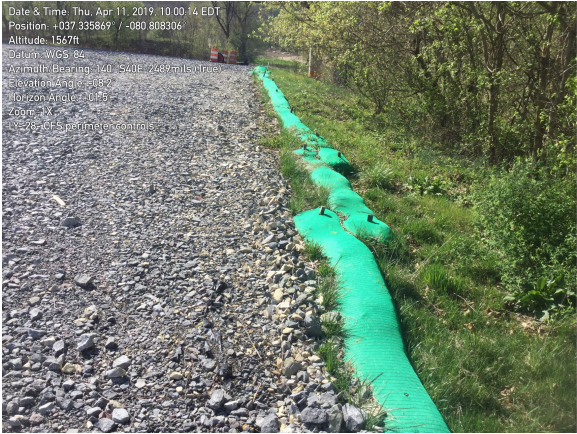
GPS Location	37.33	Field Station#	1200500-	GPS Location	37.33	Field Station#	12005+00
Description	LY-28- Transport buses parked			Description	LY- 28- CFS perimeter controls

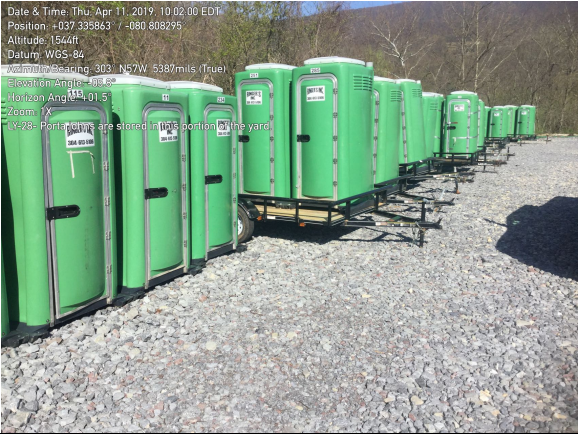
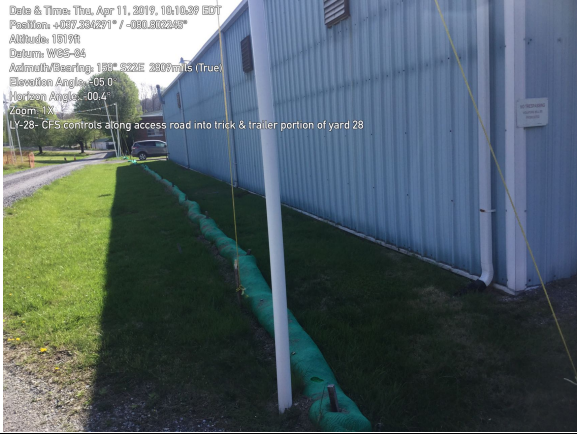
GPS Location	37.33	Field Station#	12005+00	GPS Location	37.33	Field Station#	12005+00
Description	LY- 28- Porta- Johns stored in this portion of the yard			Description	LY-28 CFS perimeter control are in acceptable condition

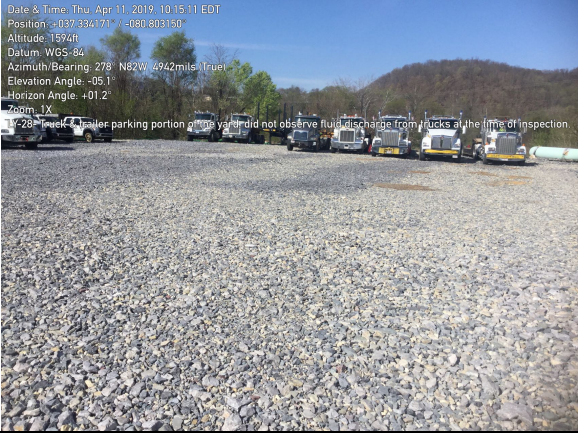
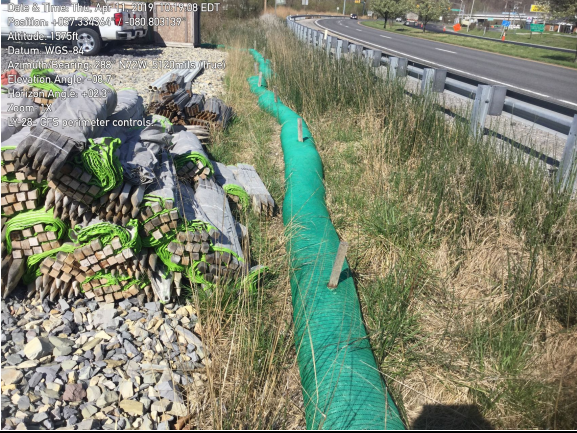
GPS Location	37.33	Field Station#	12005+00	GPS Location	37.33	Field Station#	12005+00
Description	LY-28- Truck & trailer parking portion of yard, no fluid discharge observed from equipment at time of inspection			Description	LY-28- CFS perimeter controls.

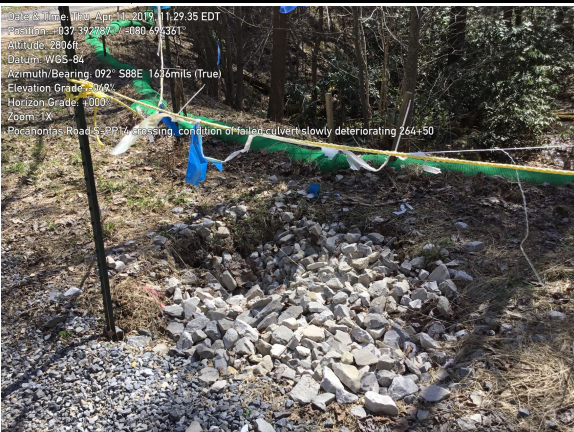
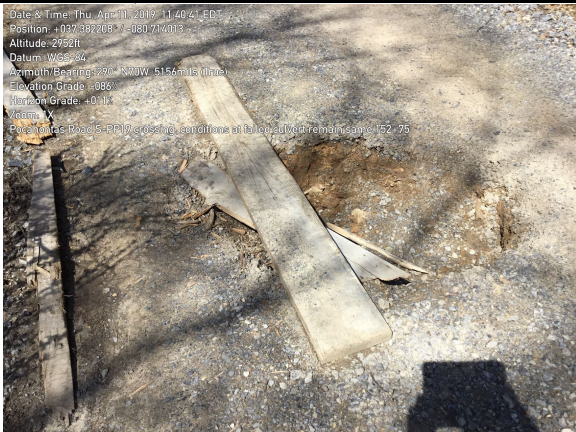
<p>Date & Time: Thu, Apr 11, 2019 11:40:47 EDT Position: +037.3972087, +080.7120013 Altitude: 2792ft Datum: WGS-84 Azimuth/Bearing: 190° S00W 515.6mils (True) Elevation Grade: +88% Horizon Grade: +01% Zoom: 1X Doehornas Road, 20' x 16" crossing, condition of failed culvert remains poor 152+75</p>

GPS Location	37.31	Field Station#	264+50	GPS Location	37.31	Field Station#	152+75
Description	Correct coordinates on photo. Failed culvert at 264+50 gradually deteriorating.			Description	Correct coordinates on photo. Hole in Road surface at failed culvert.

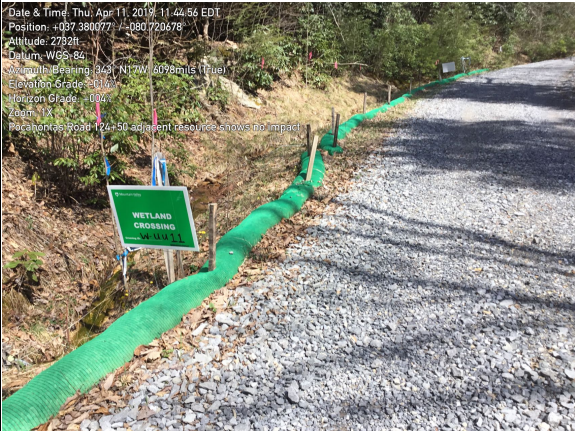
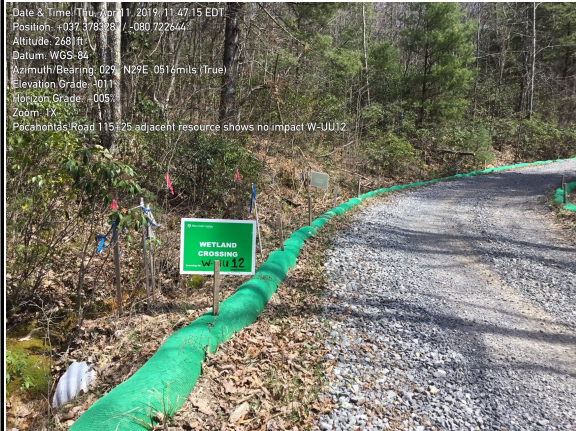
</div></div></div>				<div><div><div>Date & Time: Thu, Apr 11, 2019, 11:47:15 EDT Position: +037.978198 / -080.722644 Altitude: 2681ft Datum: WGS-84 Azimuth/Bearing: 023° N29E 0516mils (True) Elevation Grade: +011° Horizon Grade: +005° Road: 1X Pocahontas Road 115+25 adjacent resource shows no impact W-UU12</div><div>

</div></div></div>									
GPS Location		37.31	Field Station#		124+50		GPS Location		37.31	Field Station#		115+25	
Description		Correct coordinates on photo. Adjacent resource W-UU11 has not been impacted to date.				Description		Correct coordinates on photo. Adjacent resource W-UU12 has not been impacted to date.

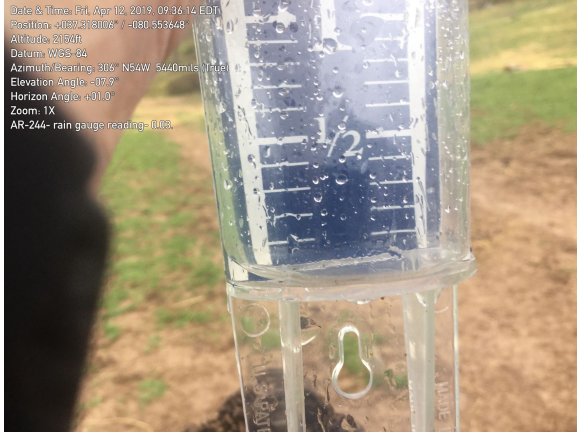
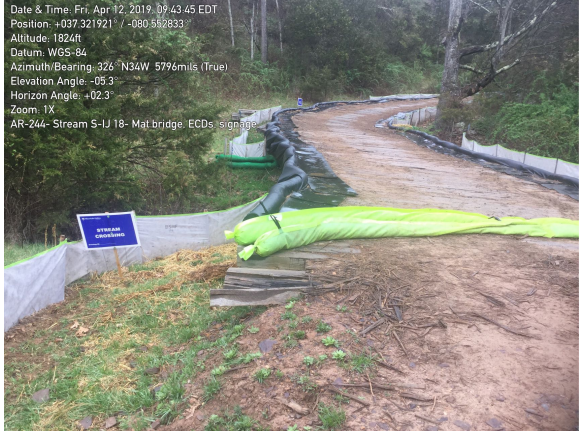
<p>Date & Time: Fri, Apr 12, 2019 09:43:45 EDT Position: +037.321921° / -080.552833° Altitude: 1824ft Datum: WGS-84 Azimuth/Bearing: 326° N34W 579mils (True) Elevation Angle: -05.3° Horizon Angle: +02.3° Zoom: 1X AR-244- Stream S-IJ 18- Mat bridge, ECD's, signage</p>

GPS Location	37.31	Field Station#	11022+00	GPS Location	37.32	Field Station#	11022+00
Description	AR-244 rain gauge readings- 0.03"			Description	AR-244- Stream S-IJ 18- Mat bridge, ECD's, Signage.		
<p>Date & Time: Fri, Apr 12, 2019 09:52:51 EDT Position: +037.323518° / -080.555027° Altitude: 2393ft Datum: WGS-84 Azimuth/Bearing: 304° N56W 540mils (True) Elevation Angle: -04.0° Horizon Angle: +02.3° Zoom: 1X Star1101017+00- Stream S-RR 5- Bridge, ECD's, signage</p>

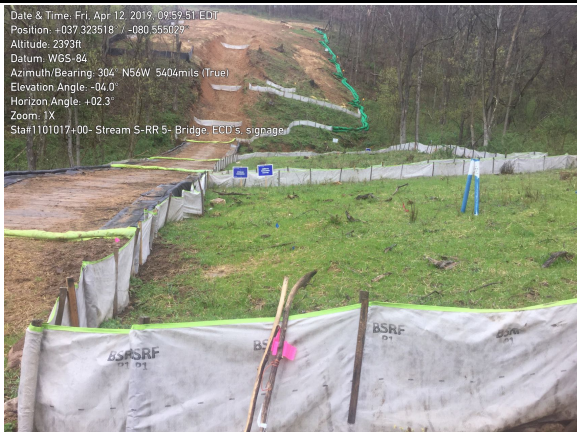
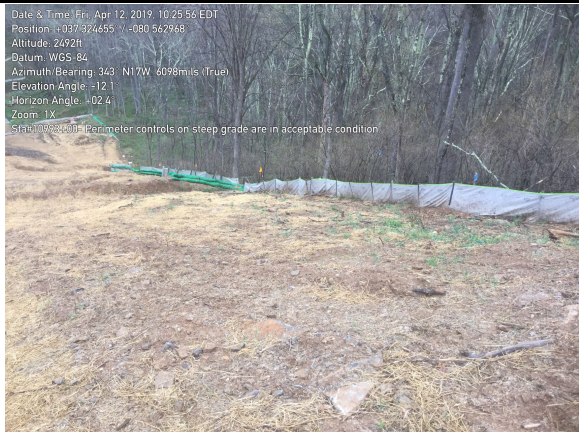
<p>Date & Time: Fri, Apr 12, 2019 10:25:56 EDT Position: +037.324655° / -080.562948° Altitude: 2492ft Datum: WGS-84 Azimuth/Bearing: 343° N17W 609mils (True) Elevation Angle: +12.1° Horizon Angle: +02.4° Zoom: 1X Star10993+00- Perimeter controls on steep grade are in acceptable condition</p>

GPS Location	37.32	Field Station#	11017+00	GPS Location	37.32	Field Station#	10993+00
Description	Stream S-RR 5- Bridge, ECD's, signage.			Description	Perimeter controls on steep grade are in acceptable condition.		
<p>Date & Time: Fri, Apr 12, 2019 10:31:24 EDT Position: +037.327138° / -080.554287° Altitude: 2397ft Datum: WGS-84 Azimuth/Bearing: 328° N22W 593mils (True) Elevation Angle: -07.2° Horizon Angle: +02.3° Zoom: 1X Star10987+00- Stream S-E24 & 25- Bridges, ECD's, Signage in acceptable condition</p>
