Visual Site Inspection Report

Project Name	H-600 Pipeline Spread I	AFE	124300139	Spread	H-600 Pipeline Spread I
Contractor	Precision			Report #	17203
Inspector	Ben Davenport			Date/Time	5/14/2019 8:10 AM
Permit #	TBD	Inspection Type	VA SWPP	Station Begin	13670+00
State	VA	Inspection Area	Full	Station End	16027+46
County	Pittsylvania	Ground	Damp	Temperature (°F)	68.00
Municipality	Chatham	Weather	Sunny	Rain Gauge (in)	0.00
				Rain Accumulation Time (days)	0.00

Project Name	Transco Interconnect Station	AFE	124300113	Spread	Transco Interconnect Station
Contractor	Kanahwa			Report #	17259
Inspector	Ben Davenport			Date/Time	5/14/2019 8:32 AM
Permit #	TBD	Inspection Type	VA SWPP	Station Begin	0+00
State	VA	Inspection Area	Full	Station End	0+00
County	Pittsylvania	Ground	Damp	Temperature (°F)	67.00
Municipality	Chatham	Weather	Sunny	Rain Gauge (in)	0.00
				Rain Accumulation Time (days)	0.00

Project Name	H-600 Pipeline Spread I	AFE	124300139	Spread	H-600 Pipeline Spread I
Contractor	Precision			Report #	17336
Inspector	Glenn Mike Renfro			Date/Time	5/14/2019 3:00 PM
Permit #	TBD	Inspection Type	VA SWPP	Station Begin	0000+00
State	VA	Inspection Area	Full	Station End	0000+00
County	Fra

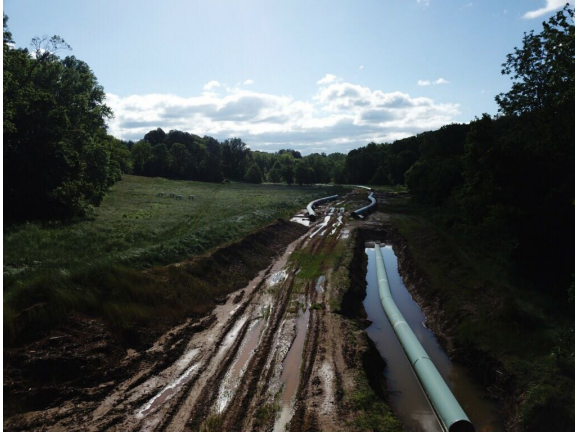
GPS Location		36.96		Field Station#		13867+22		GPS Location		36.96	
Field Station#		13867+22		Description		Saturated ROW conditions after recent rain event		Field Station#		14320+00	
Description		Saturated ROW conditions after recent rain event		Description		Corrected CFS along perimeter of ROW that had been undermining

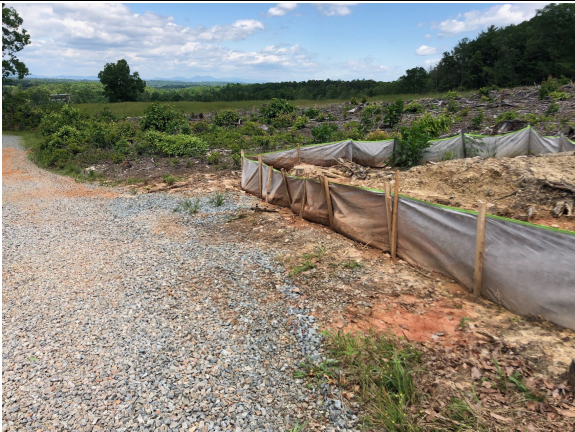
GPS Location		36.96		Field Station#		14323+00		GPS Location		36.96	
Field Station#		14323+00		Description		P1 corrected and rock added to road that had washed out during recent rain event		Field Station#		14354+00	
Description		P1 corrected and rock added to road that had washed out during recent rain event		Description		Recently stabilized ROW and functioning perimeter controls and ECD's near S-A38

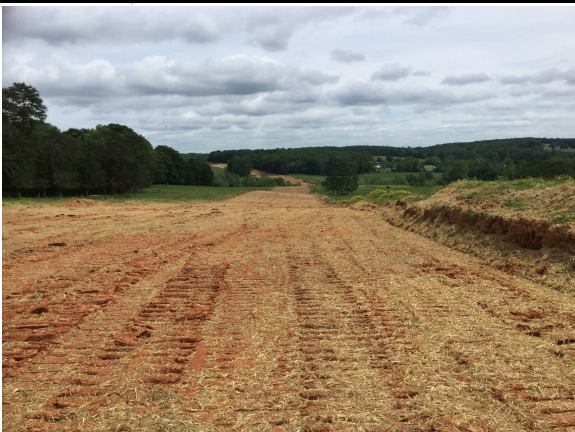
Field Station#		14375+00		Description		Area of ROW where contractor restored subsoil to pre-construction conditions		Field Station#		14331+50	
Description		Area of ROW where contractor restored subsoil to pre-construction conditions		Description		CFS, water bars, and rip rap end treatments installed

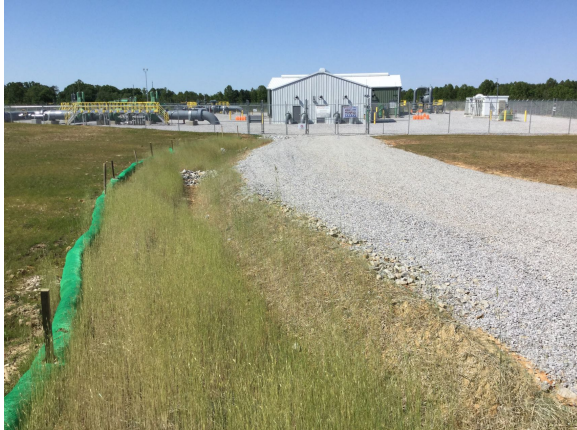
GPS Location		36.85		Field Station#		16027+46		GPS Location		36.85	
Description		RCE into Transco facility in good condition				Description		Vegetation growing on CWD berm at facility

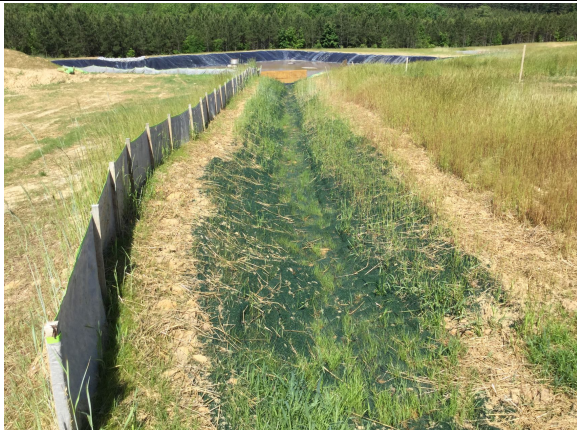
GPS Location		36.85		Field Station#		16027+46		GPS Location		36.85	
Description		P1 fence and erosion control blanket performing intended function				Description		Baffle observed during inspection

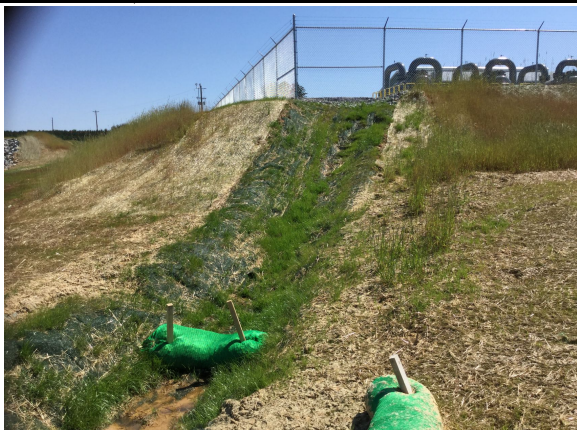
GPS Location		36.85		Field Station#		16027+46		GPS Location		36.85	
Description		Erosion control blanket and CFS check dams helping to control drainage issues				Description		Erosion control blanket performing intended function and vegetation growing around Transco facility
