Visual Site Inspection Report

Project Name	H-600 Pipeline Spread G	AFE	124300137	Spread	H-600 Pipeline Spread G
Contractor	Precision			Report #	17133
Inspector	Len Kruizenga			Date/Time	5/13/2019 8:45 AM
Permit #	TBD	Inspection Type	VA SWPP	Station Begin	11254+88
State	VA	Inspection Area	Full	Station End	11161+00
County	Giles	Ground	Muddy	Temperature (°F)	54.00
Municipality	N/A	Weather	Light Rain	Rain Gauge (in)	0.10
				Rain Accumulation Time (days)	1.00

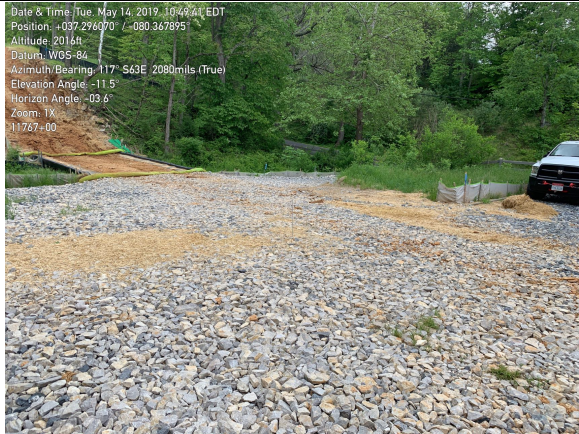
GPS Location	37.32	Field Station#	11711+00	GPS Location	37.32	Field Station#	11767+00
Description	See photo for GPS location. Undermined priority one silt fence.			Description	See photo for GPS location. RCE in place at main line valve 26.
