# Visual Site Inspection Report

<b>Project Name</b>	H-600 Pipeline Spread I	<b>AFE</b>	124300139	<b>Spread</b>	H-600 Pipeline Spread I
<b>Contractor</b>	Precision			<b>Report #</b>	17462
<b>Inspector</b>	Ben Davenport			<b>Date/Time</b>	5/20/2019 9:26 AM
<b>Permit #</b>	TBD	<b>Inspection Type</b>	VA SWPP	<b>Station Begin</b>	13670+00
<b>State</b>	VA	<b>Inspection Area</b>	Full	<b>Station End</b>	16027+46
<b>County</b>	Franklin/Pittsylvania	<b>Ground</b>	Dry	<b>Temperature (°F)</b>	82.00
<b>Municipality</b>	Chatham	<b>Weather</b>	Sunny	<b>Rain Gauge (in)</b>	0.00
				<b>Rain Accumulation Time (days)</b>	0.00

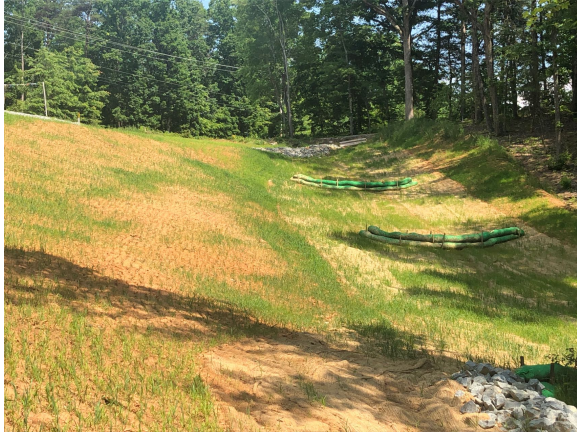
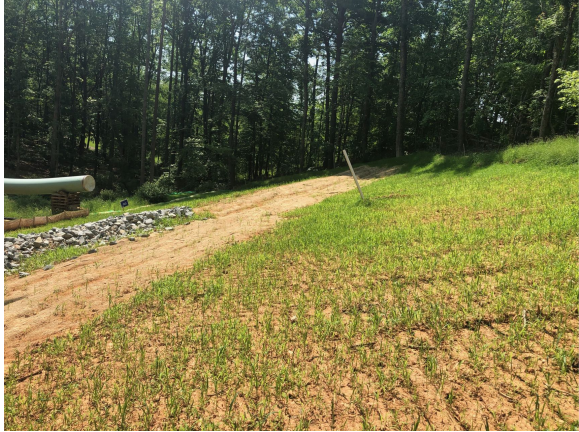
GPS Location		36.96		Field Station#		14062+50		GPS Location		36.96	
Field Station#		14066+00		Description				Description			
Vegetation growing along ROW with ECD's Installed. No erosion issues have occurred.				Vegetation growing along ROW with ECD's Installed. No erosion issues have occurred.				Vegetation growing along ROW with ECD's Installed. No erosion issues have occurred.

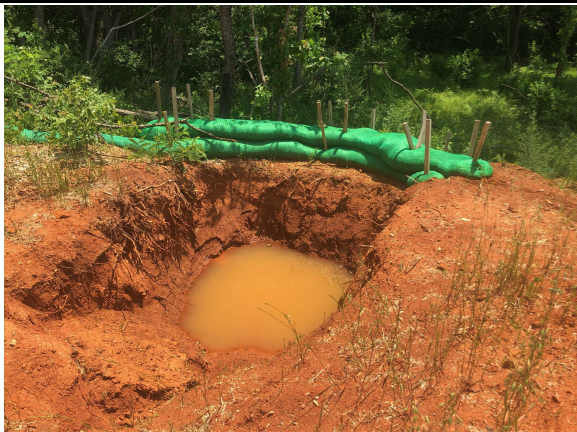
GPS Location		36.96		Field Station#		14530+00		GPS Location		36.96	
Field Station#		14551+60		Description				Description			
Sump dug to specifications with newly installed CFS triple stack.				Erosion control blanket installed to slow down water flow causing rill erosion.				Erosion control blanket installed to slow down water flow causing rill erosion.

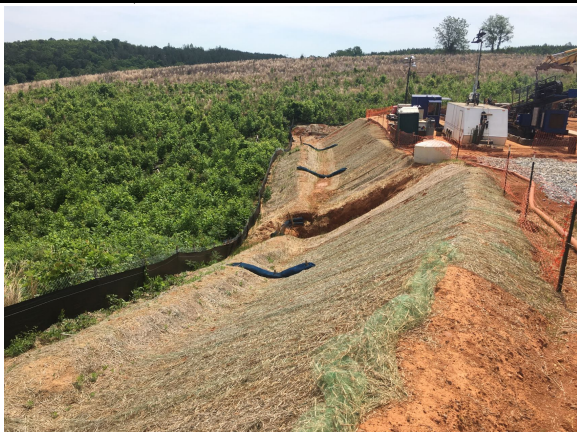
GPS Location		36.96		Field Station#		15258+50		GPS Location		36.96

Field Station#		15851+90		Description				Description			
Functioning ECD's outside of HDD exit site along perimeter of ROW.				Equipment bridge and ECD's in good condition over S-G2.				Equipment bridge and ECD's in good condition over S-G2.

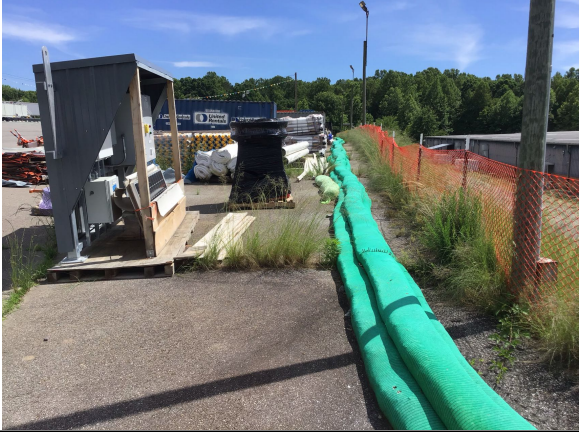
GPS Location	36.97	Field Station#	0000+00	GPS Location	36.97
Description		Perimeter ECD's in good condition on west side of paved yard		Description

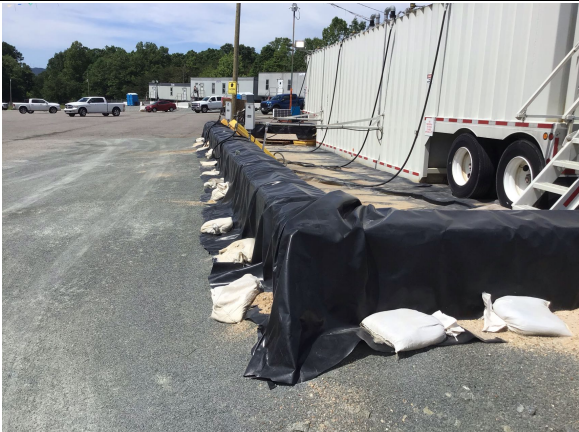
GPS Location	36.97	Field Station#	0000+00	GPS Location	36.97
Description		Secondary containment structure for fuel cell in good condition.		Description

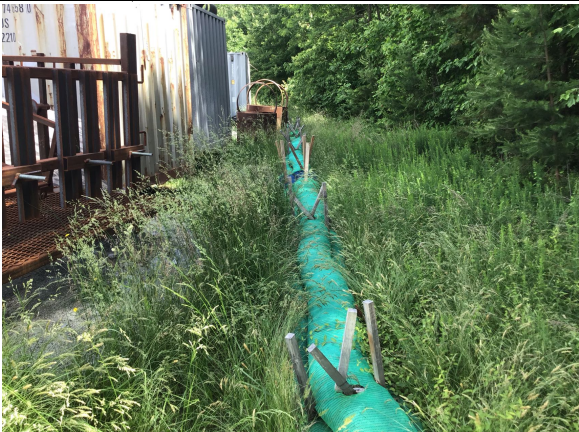
<p>Insert image here</p>		
GPS Location	36.97	Field Station#	0000+00	GPS Location	
Description		Perimeter ECD's on northwest corner of gravel yard in good condition.		Description
