Visual Site Inspection Report

Project Name	H-600 Pipeline Spread G	AFE	124300137	Spread	H-600 Pipeline Spread G
Contractor	Precision			Report #	17457
Inspector	Len Kruizenga			Date/Time	5/20/2019 7:46 AM
Permit #	TBD	Inspection Type	VA SWPP	Station Begin	11524+00
State	VA	Inspection Area	Full	Station End	11600+00
County	Giles	Ground	Damp	Temperature (°F)	65.00
Municipality	N/A	Weather	Cloudy	Rain Gauge (in)	0.10
				Rain Accumulation Time (days)	2.00

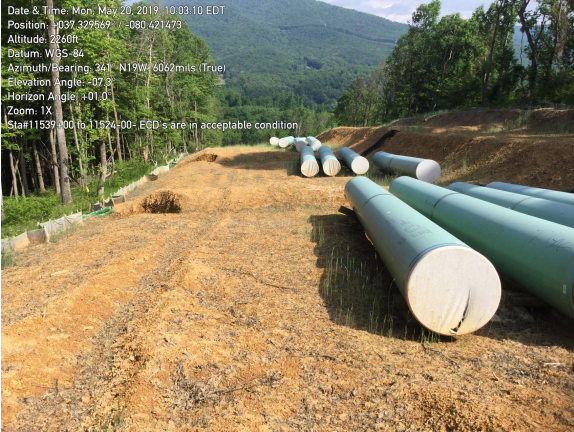
A/E	124300137	Date/Time	5/20/2019 7:46 AM	Report #	17457		
Pictures							
<p>Date & Time: Mon, May 20, 2019, 10:03:10 EDT Position: +037.329569° / -080.421473° Altitude: 2820ft Datum: WGS-84 Azimuth/Bearing: 241° N19W 60.2mils (True) Elevation Angle: -07.3° Horizon Angle: +01.0° Zoom: 1X Sta#11539+00 to 11524+00- ECD's are in acceptable condition</p>

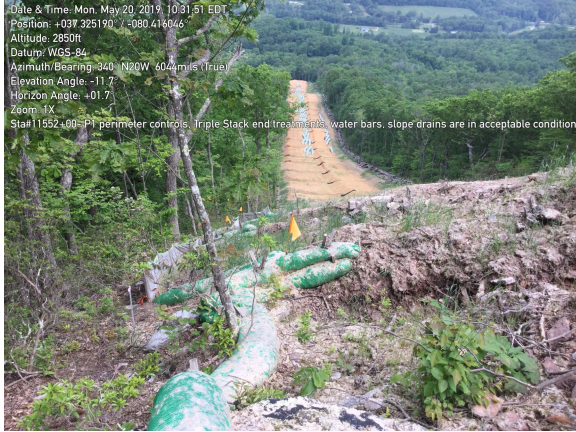
<p>Date & Time: Mon, May 20, 2019, 10:31:51 EDT Position: +037.325190° / -080.416046° Altitude: 2850ft Datum: WGS-84 Azimuth/Bearing: 340° N40W 60.4mils (True) Elevation Angle: -11.7° Horizon Angle: +01.7° Zoom: 1X Sta#11552+00-P1 perimeter controls, Triple Stack end treatment, water bars, slope drains are in acceptable condition</p>

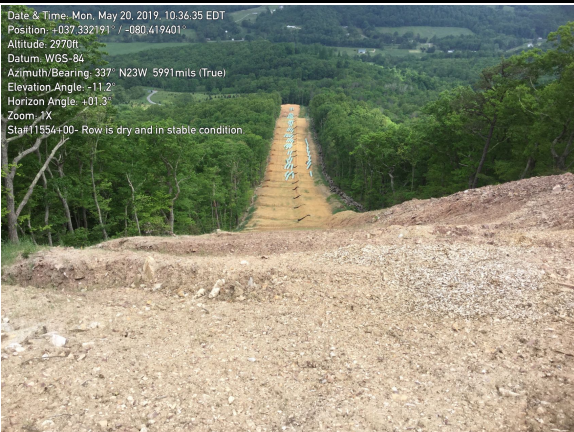
GPS Location	37.32	Field Station#	11539+00	GPS Location	37.32	Field Station#	11552+00
Description	ECD's, slope drains are in acceptable condition			Description	ECD's are in acceptable condition		
<p>Date & Time: Mon, May 20, 2019, 10:36:35 EDT Position: +037.332191° / -080.419401° Altitude: 2970ft Datum: WGS-84 Azimuth/Bearing: 337° N23W 59.1mils (True) Elevation Angle: -11.2° Horizon Angle: +01.3° Zoom: 1X Sta#11554+00- Row is dry and in stable condition</p>

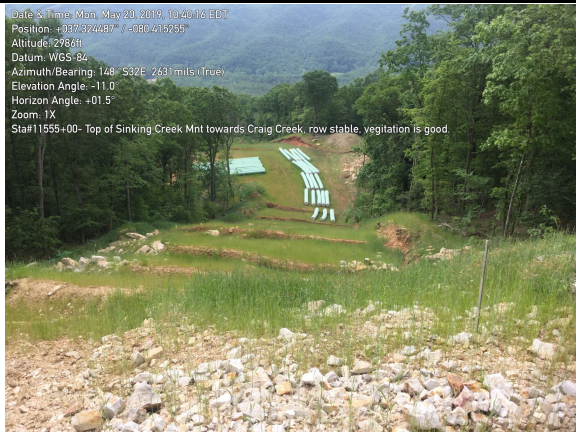
<p>Date & Time: Mon, May 20, 2019, 10:40:16 EDT Position: +037.332287° / -080.419255° Altitude: 2985ft Datum: WGS-84 Azimuth/Bearing: 148° S32E 26.1mils (True) Elevation Angle: -11.0° Horizon Angle: +01.5° Zoom: 1X Sta#11555+00- Top of Sinking Creek Mnt towards Craig Creek, row stable, vegetation is good.</p>

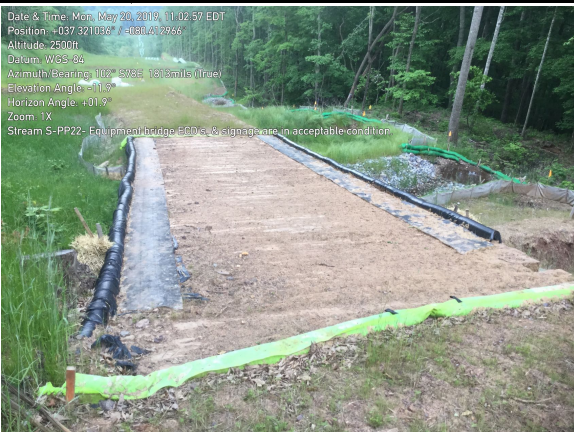
GPS Location	37.32	Field Station#	11554+00	GPS Location	37.32	Field Station#	11555+00
Description	Row is dry and in stable condition			Description	Top of Sinking Creek Mnt towards Craig Creek, JNF, row dry & stable, good vegetation		
<p>Date & Time: Mon, May 20, 2019, 11:02:57 EDT Position: +037.321036° / -080.407846° Altitude: 2900ft Datum: WGS-84 Azimuth/Bearing: 102° S89E 10.1mils (True) Elevation Angle: -01.5° Horizon Angle: +01.9° Zoom: 1X Stream S-PP22- Equipment bridge, ECD's, signage are in acceptable condition</p>

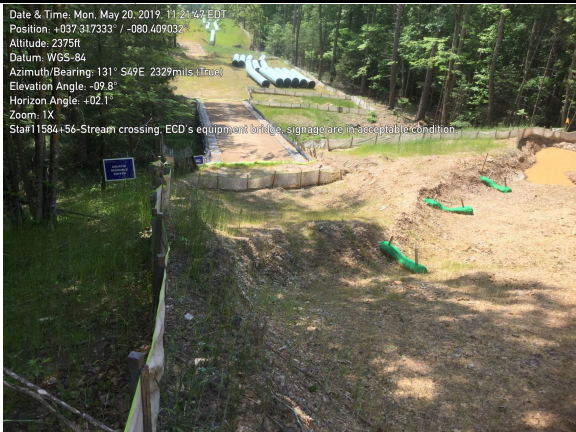
<p>Date & Time: Mon, May 20, 2019, 11:21:44 EDT Position: +037.317333° / -080.409032° Altitude: 2775ft Datum: WGS-84 Azimuth/Bearing: 131° S49E 23.2mils (True) Elevation Angle: -09.8° Horizon Angle: +02.1° Zoom: 1X Sta#11584+56-Stream crossing- ECD's equipment bridge, signage are in acceptable condition</p>

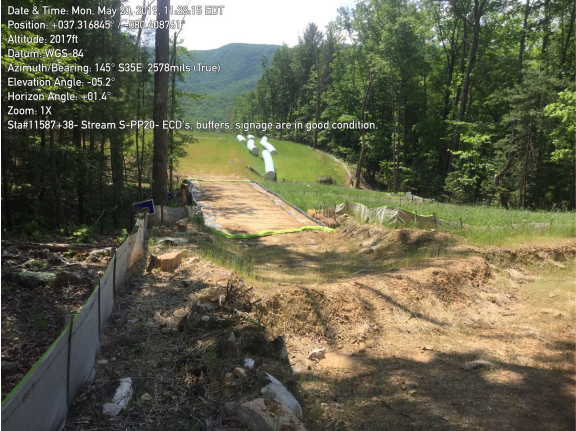
AFE	124300137	Date/Time	5/20/2019 7:46 AM	Report #	17457
Pictures					
<p><small>Date & Time: Mon, May 20, 2019, 11:58:19 EDT Position: +037.316843° / -080.435698° Altitude: 2017ft Datum: WGS-84 Azimuth/Bearing: 145° S35E 2578mils (True) Elevation Angle: -05.2° Horizon Angle: +01.4° Zoom: 1X Staff11587+38- Stream S-PP20- ECD's, buffers, signage are in good condition.</small></p>

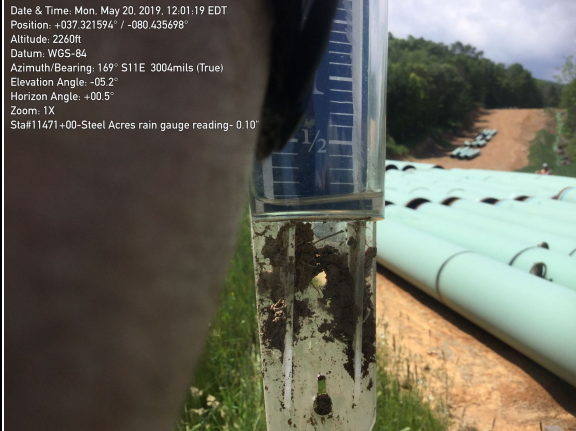
<p><small>Date & Time: Mon, May 20, 2019, 12:01:19 EDT Position: +037.321594° / -080.435698° Altitude: 2260ft Datum: WGS-84 Azimuth/Bearing: 169° S11E 3004mils (True) Elevation Angle: -05.2° Horizon Angle: +00.5° Zoom: 1X Staff11471+00-Steel Acres rain gauge reading- 0.10"</small></p>

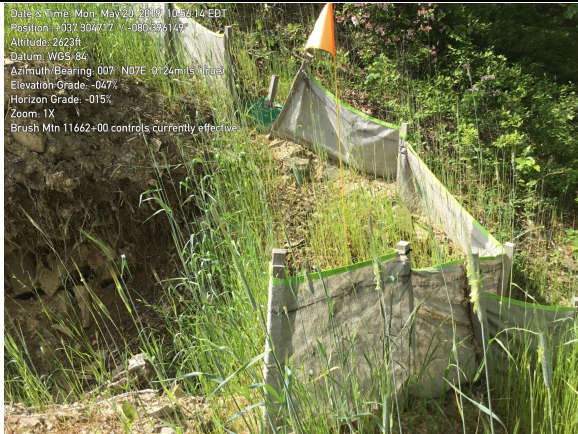
<p>Date & Time: Mon, May 20, 2019, 10:59:14 EDT Position: +037.304717 / -080.396143 Altitude: 2627ft Datum: WGS-84 Azimuth/Bearing: 007° N09E 9124mils (True) Elevation Grade: -047% Horizon Grade: -015% Zoom: 1X Brush Mtn 11662+00 controls currently effective.</p>

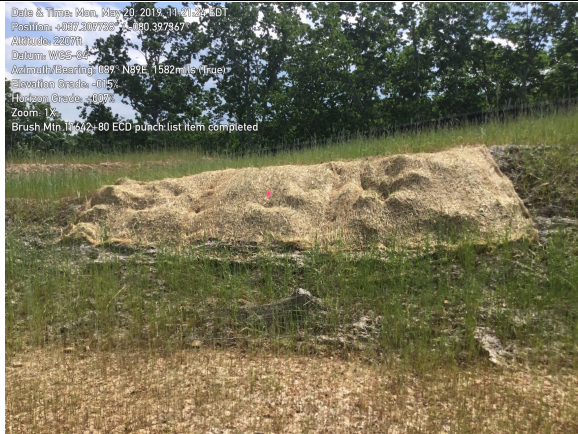
<p>Date & Time: Mon, May 20, 2019, 11:00:00 EDT Position: +037.289726 / -080.397947 Altitude: 2609ft Datum: WGS-84 Azimuth/Bearing: 089° N89E 1582mils (True) Elevation Grade: -015% Horizon Grade: -039% Zoom: 1X Brush Mtn 11642+80 ECD punch list item completed.</p>

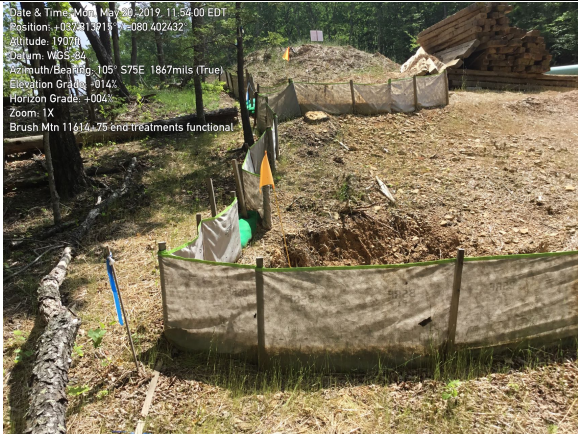
<p>Date & Time: Mon, May 20, 2019, 11:54:00 EDT Position: +037.213713 / -080.402432 Altitude: 1999ft Datum: WGS-84 Azimuth/Bearing: 105° S75E 1867mils (True) Elevation Grade: -014% Horizon Grade: -004% Zoom: 1X Brush Mtn 11614+75 end treatments functional.</p>

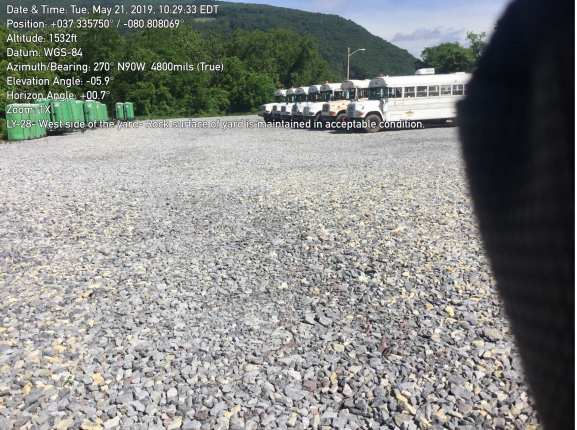
<p>Date & Time: Tue, May 21, 2019, 10:29:33 EDT Position: +037 335750° / -080 808049° Altitude: 1552ft Datum: WGS-84 Azimuth/Bearing: 270° N90W 480mils (True) Elevation Angle: -05.9° Horizon Angle: +00.7° Zoom: 1X LY-28- West side of the yard- Rock surface of yard is maintained in acceptable condition.</p>

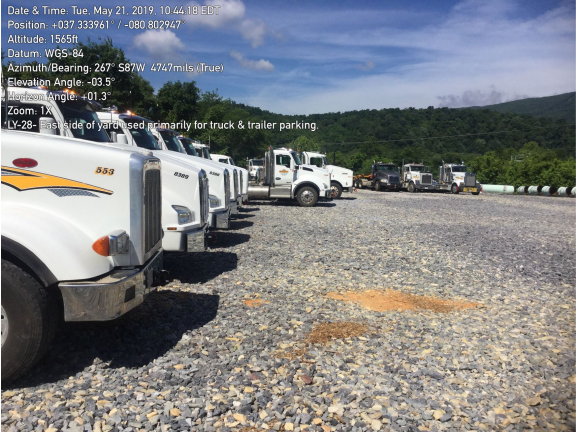
<p>Date & Time: Tue, May 21, 2019, 10:46:18 EDT Position: +037 333961° / -080 802947° Altitude: 1565ft Datum: WGS-84 Azimuth/Bearing: 267° S87W 4747mils (True) Elevation Angle: -03.5° Horizon Angle: +01.3° Zoom: 1X LY-28- East side of yard used primarily for truck & trailer parking.</p>

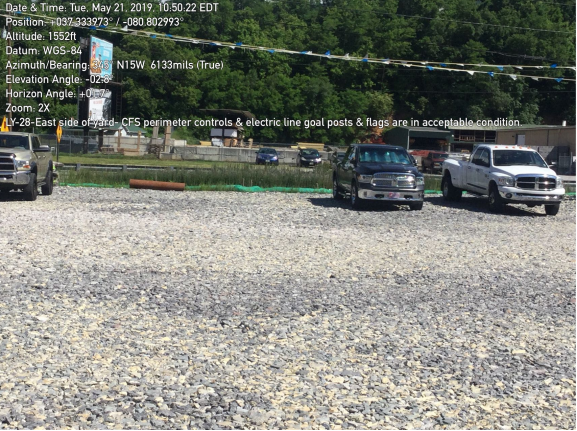
<p>Date & Time: Tue, May 21, 2019, 10:50:22 EDT Position: +037 333973° / -080 802993° Altitude: 1552ft Datum: WGS-84 Azimuth/Bearing: 315° N15W 6133mils (True) Elevation Angle: -07.3° Horizon Angle: +00.7° Zoom: 2X LY-28- East side of yard- CFS perimeter controls & electric line goal posts & flags are in acceptable condition.</p>

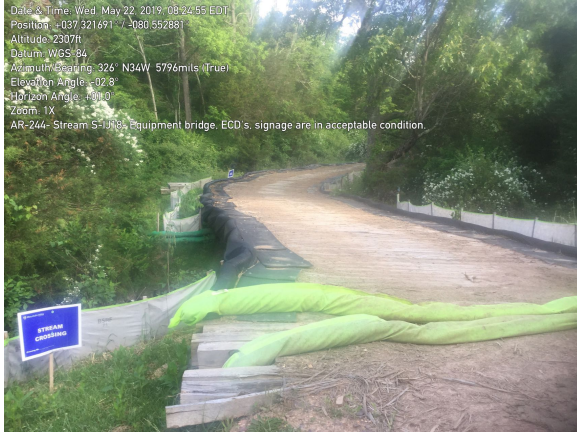
AFE	124300137	Date/Time	5/22/2019 7:32 AM	Report #	17550		
Pictures							
<p>Date & Time: Wed, May 22, 2019, 08:24:55 EDT Position: +037.321691 / -080.552881 Altitude: 2307ft Datum: WGS-84 Azimuth/Bearing: 026° N34W 5796mils (True) Elevation Angle: -02.8° Horizon Angle: +00.0° Zoom: 1X AR-244- Stream S-IJ18- Equipment bridge. ECD's, signage are in acceptable condition.</p>

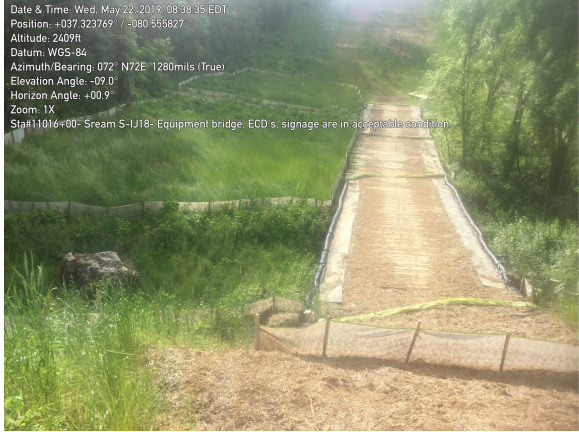
<p>Date & Time: Wed, May 22, 2019, 08:38:35 EDT Position: +037.323769 / -080.555827 Altitude: 2409ft Datum: WGS-84 Azimuth/Bearing: 072° N72E 1280mils (True) Elevation Angle: -09.0° Horizon Angle: +00.9° Zoom: 1X Sta#11016+00- Stream S-IJ18- Equipment bridge. ECD's, signage are in acceptable condition.</p>

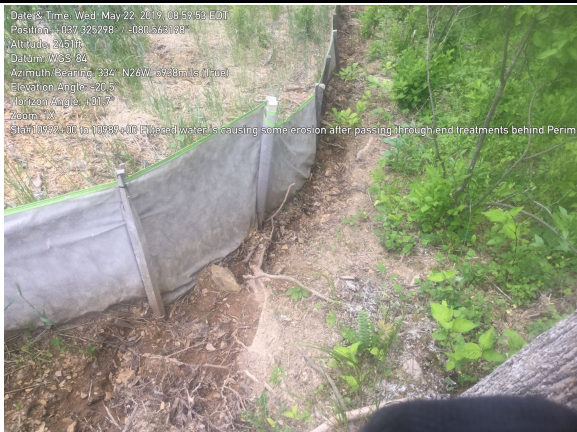
GPS Location	37.32	Field Station#	10990+00	GPS Location	37.32	Field Station#	10986+00
Description	Erosion behind perimeter controls after leaving end treatments, on steep slope. Water has been filtered.			Description	S-S-E25- Equipment bridge, ECD's, signage are in acceptable condition.

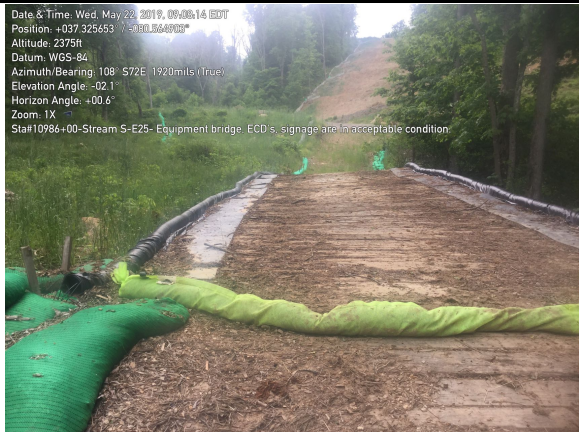
<p>Date & Time: Wed, May 22, 2019, 09:00:14 EDT Position: +037.325453 / -080.554990 Altitude: 2375ft Datum: WGS-84 Azimuth/Bearing: 108° S72E 1920mils (True) Elevation Angle: -02.1° Horizon Angle: +00.6° Zoom: 1X Sta#10986+00-Stream S-E25- Equipment bridge. ECD's, signage are in acceptable condition.</p>

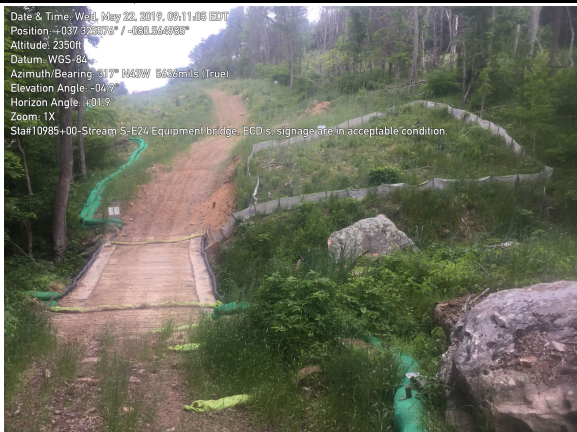
<p>Date & Time: Wed, May 22, 2019, 09:11:05 EDT Position: +037.325765 / -080.554986 Altitude: 2350ft Datum: WGS-84 Azimuth/Bearing: 017° N65W 5436mils (True) Elevation Angle: -04.9° Horizon Angle: +01.9° Zoom: 1X Sta#10985+00-Stream S-E24- Equipment bridge, ECD's, signage are in acceptable condition.</p>

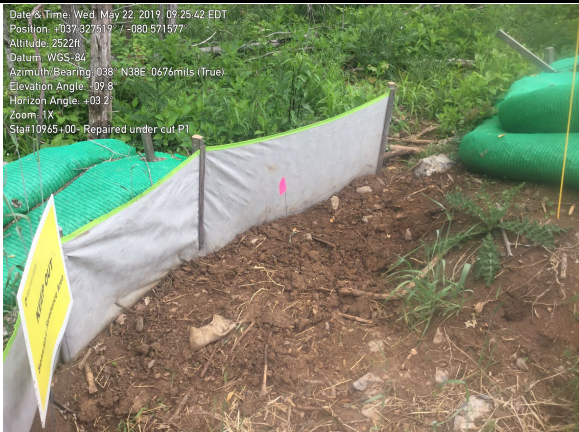
<p>Date & Time: Wed, May 22, 2019, 09:25:42 EDT Position: +037.327519 / -080.571577 Altitude: 2322ft Datum: WGS-84 Azimuth/Bearing: 038° N38E 0676mils (True) Elevation Angle: -09.8° Horizon Angle: +03.2° Zoom: 1X Sta#10965+00- Repaired under cut P1.</p>

GPS Location	37.32	Field Station#	10985+00	GPS Location	37.32	Field Station#	10965+00
Description	Stream S-E24- Equipment bridge, ECD's, signage are in acceptable condition.			Description	Repaired Under cut P1.

7. Identify all remedial measures that have been taken since the previous inspection was conducted. Sta#10965+00- P1 silt fence under cut has been repaired. Sta#10964+00- P1 end treatment under cut has been repaired.					
Comments (Reference above questions as appropriate.) SWPPP inspection: Sta#11022+00 to 10930+00. MP- 208.6 to 206.2 Streams S-IJ18, S-RR5, S-E24, S-E25– Buffers, ECD's, sensitive resource signage are in acceptable condition. P1 silt fence and CFS perimeter controls are in acceptable condition. Row is dry and in stable condition. Water bars are in acceptable condition. Water bar end treatments are in acceptable condition. SSF is in acceptable condition. Sta#10992+00 to 10990+00- There is some erosion occurring outside P1 perimeter controls from treated water coming from end treatments. This is a steep slope. Doe Creek Farms has opened cattle crossing gate to allow cattle to graze row, cattle have damaged P1 silt fence at drainage feature at sta#10947+50. Doe Creek RCE is in acceptable condition. AR-244 is in acceptable condition.

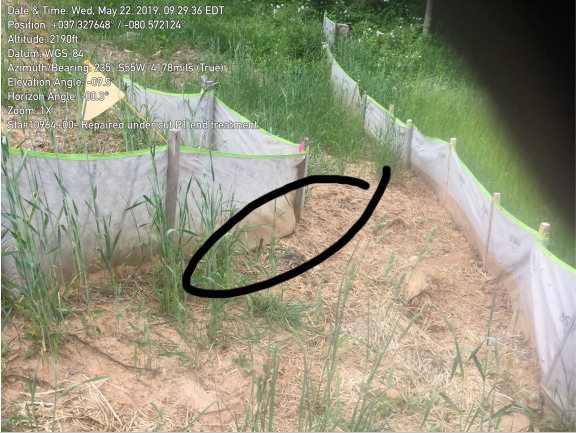
<p>Insert image here</p>			
GPS Location	37.32	Field Station#	10964+00	GPS Location	
Description	Repaired under cut P1 end treatment.		Description

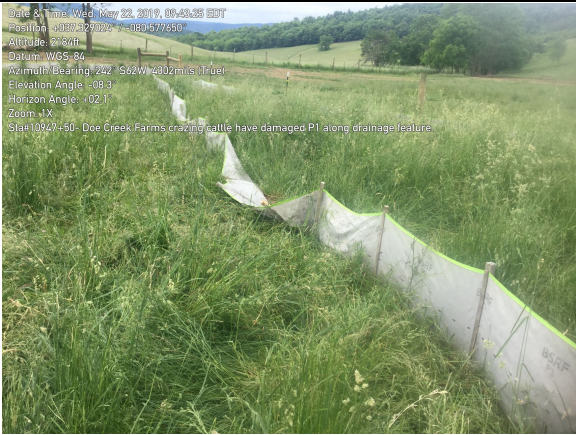
<p>Insert image here</p>			
GPS Location	37.32	Field Station#	10947+50	GPS Location	
Description	Doe Creek Farms Cattle damaged P1 along drainage feature.		Description		
<p>Insert image here</p>		<p>Insert image here</p>			
GPS Location		Field Station#		GPS Location	
Description			Description
