# Visual Site Inspection Report

<b>Project Name</b>	H-600 Pipeline Spread H	<b>AFE</b>	124300138	<b>Spread</b>	H-600 Pipeline Spread H	
<b>Contractor</b>	Precision			<b>Report #</b>	16855	
<b>Inspector</b>	Pat Davis			<b>Date/Time</b>	5/7/2019 6:30 PM	
<b>Permit #</b>	TBD	<b>Inspection Type</b>	VA SWPP	<b>Station Begin</b>	+0	
<b>State</b>	VA	<b>Inspection Area</b>	Partial	<b>Station End</b>	+0	
<b>County</b>	Montgomery	<b>Ground</b>	Dry	<b>Temperature (°F)</b>	75.00	
<b>Municipality</b>	N/A	<b>Weather</b>	Sunny	<b>Rain Gauge (in)</b>	0.00	
				<b>Rain Accumulation Time (days)</b>	0.00

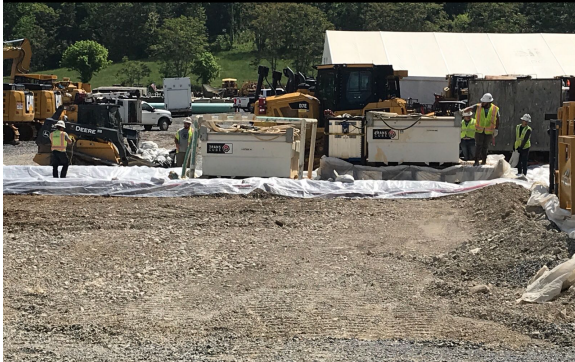
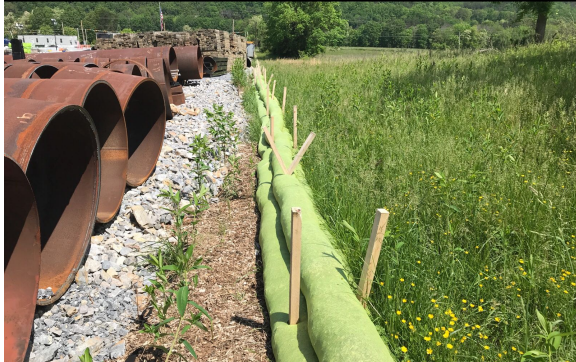
<div>2019-05-07 11:28:13-04:00</div></div>											
GPS Location		37.23		Field Station#		+0		GPS Location		37.23		Field Station#		+0	
Description		MVP-PY-006_050719 crew constructing seamless containment for portable fuel tanks. Looking SE. See photo for gps data.						Description		MVP-PY-006_050719_ condition of triple stack compost filter sock on east boundary. Looking N. See photo for gps data.					
<div><div>DIRECTION S (T)</div><div>+37.23470° -080.22579°</div><div>ACCURACY 16 ft DATUM WGS84</div>

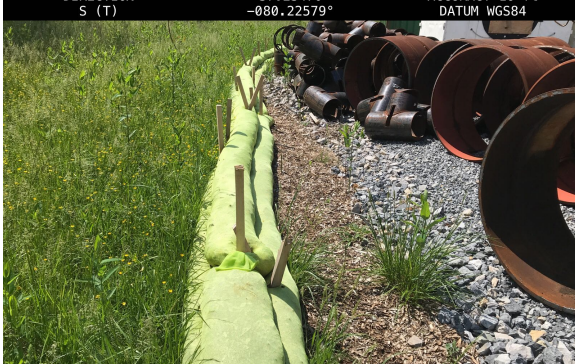
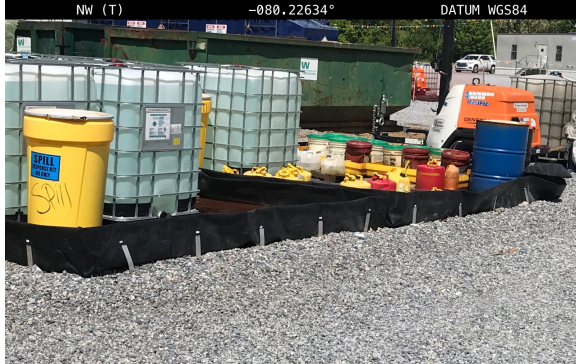
GPS Location		37.23		Field Station#		+0		GPS Location		37.23		Field Station#		+0	
Description		MVP-PY-006_050719_ condition of triple stack compost filter sock on east boundary. Looking S. See photo for gps data.						Description		MVP-PY-006_050719_ condition of containment under supplies. Looking NW. See photo for gps data.					
<div><div>DIRECTION W (T)</div><div>+37.23558° -080.22665°</div><div>ACCURACY 16 ft DATUM WGS84</div>

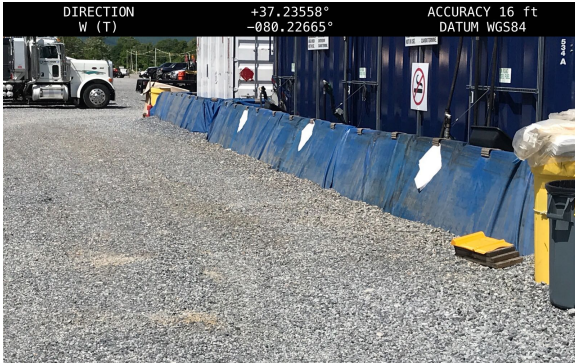
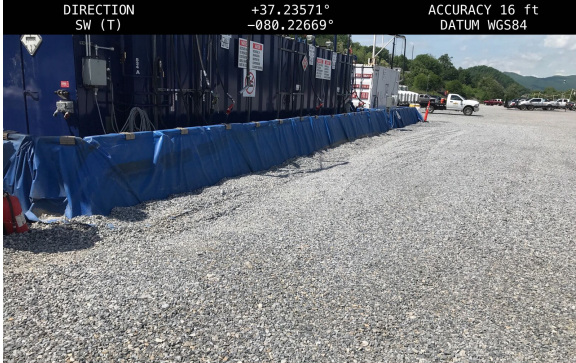
<div>2019-05-07 11:30:27-04:00</div></div>											
GPS Location		37.23		Field Station#		+0		GPS Location		37.23		Field Station#		+0	
Description		MVP-PY-006_050719 no fluid deposits on the south side of the bulk fuel tanks. Looking W. See photo for gps data.						Description		MVP-PY-006_050719 no fluid deposits on the north side of the bulk fuel tanks. Looking SW. See photo for gps data.

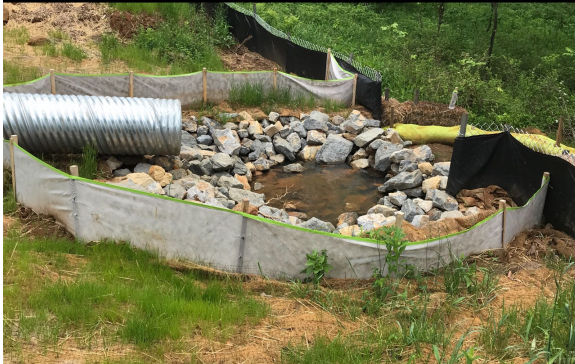
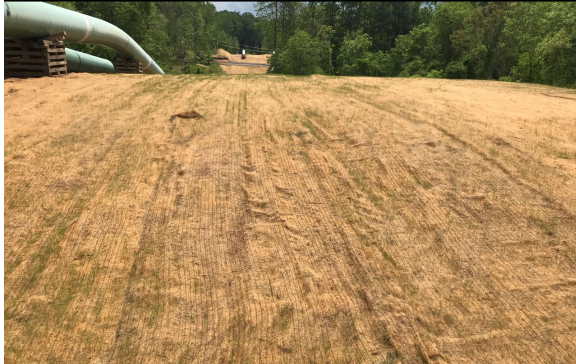
<div>2019-05-07 13:30:22-04:00</div>					
GPS Location 37.10		Field Station# 13345+00		GPS Location 37.10		Field Station# 13350+00	
Description		13345+00_050719_ condition of plunge pool. Looking S. See photo for gps data.		Description		13350+00_050719_ vegetation showing growth on travel lane. Looking S. See photo for gps data.	
<div>DIRECTION S (T)</div> <div>+37.10288° -080.04149°</div> <div>ACCURACY 0.28 mi DATUM WGS84</div>

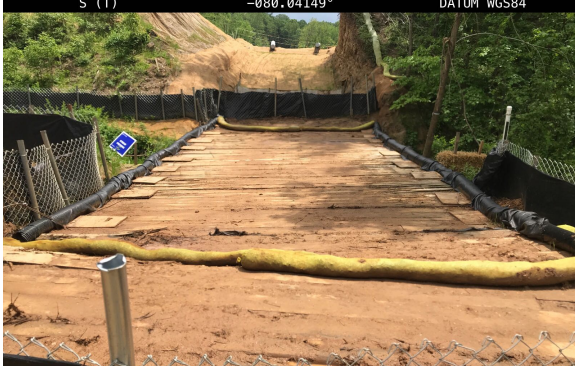
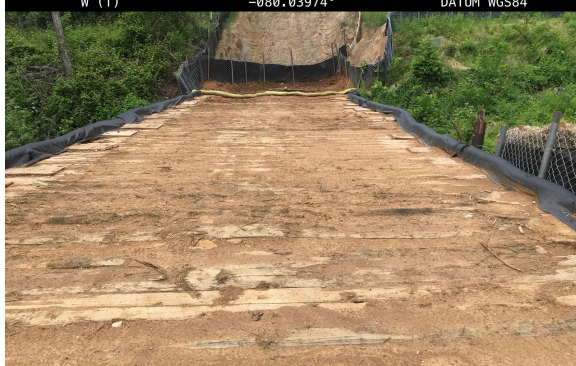
GPS Location 37.10		Field Station# 13352+23		GPS Location 37.10		Field Station# 13358+64	
Description		13352+23_050719_ S-RR09 mat bridge clean and closed. Looking S. See photo for gps data.		Description		13358+64_050719_ S-RR11 mat bridge closed. Looking W. See photo for gps data.	
<div>DIRECTION SE (T)</div> <div>+37.06691° -079.91836°</div> <div>ACCURACY 1.51 mi DATUM WGS84</div>

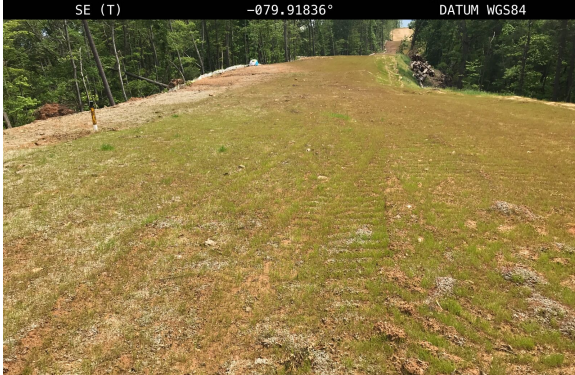
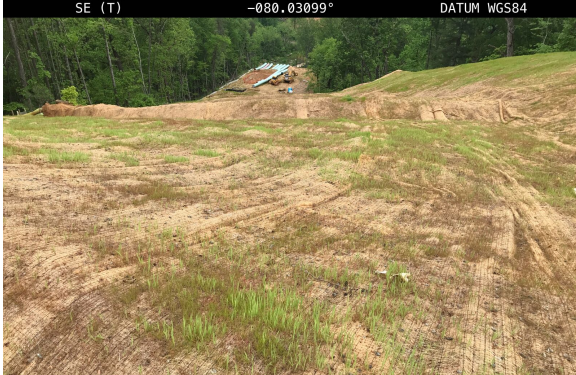
<div>2019-05-07 14:50:08-04:00</div>					
GPS Location 37.10		Field Station# 13385+00		GPS Location 37.10		Field Station# 13403+08	
Description		13385+00_050719_ vegetation growth on ROW and travel lane. Looking SE. See photo for gps data.		Description		13403+08_050719_ vegetation growth on travel lane. Looking SE. See photo for gps data.

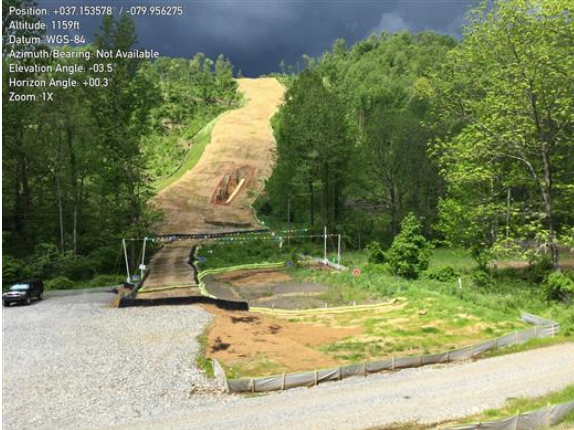
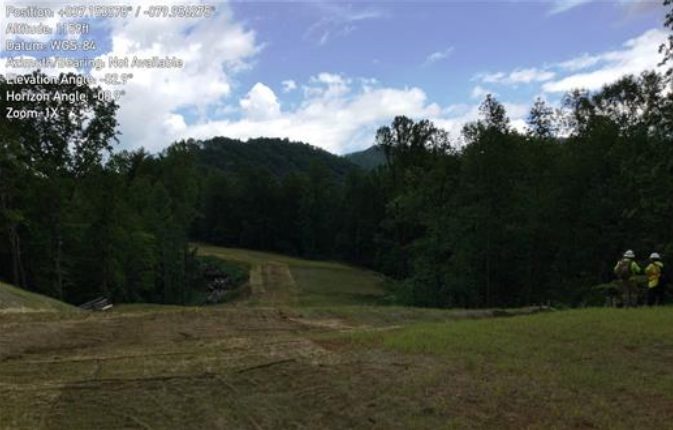
GPS Location	37.23	Field Station#	13262+62	GPS Location	37.23	Field Station#	13290+00
Description	Looking down upon the CIS of Wade's Gap Road from the GAS. View: West from center of LOD, see photo for GPS data.			Description	Personnel from the environmental crew conducting a walk-through. View: North from center of LOD, see photo for GPS data.

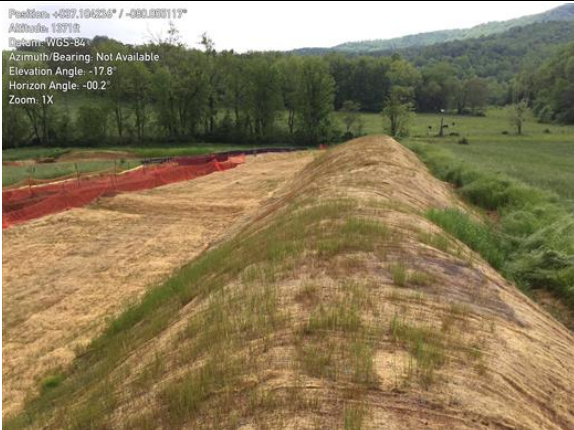
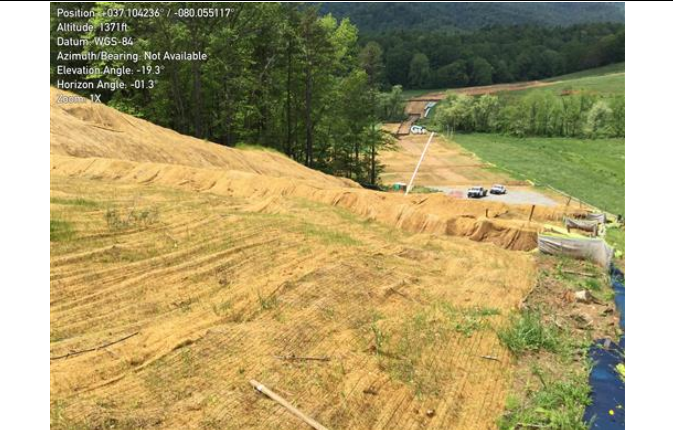
GPS Location	37.23	Field Station#	13305+00	GPS Location	37.23	Field Station#	13317+50
Description	Looking upon spoil-piles along the perimeter of the ROW. View: South from western edge of LOD, see photo for GPS data.			Description	Looking down upon Wade's Gap road from the GAS. View: West from northern edge of LOD, see photo for GPS data.

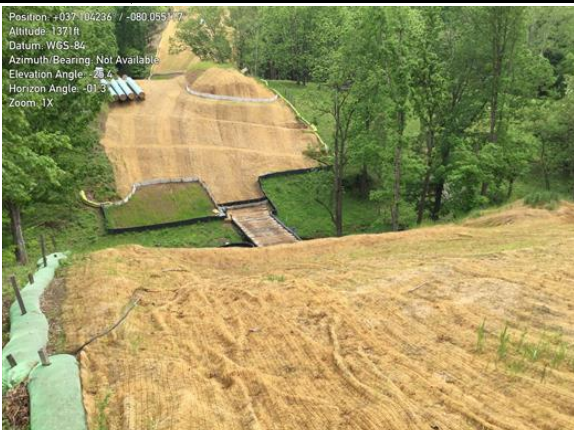
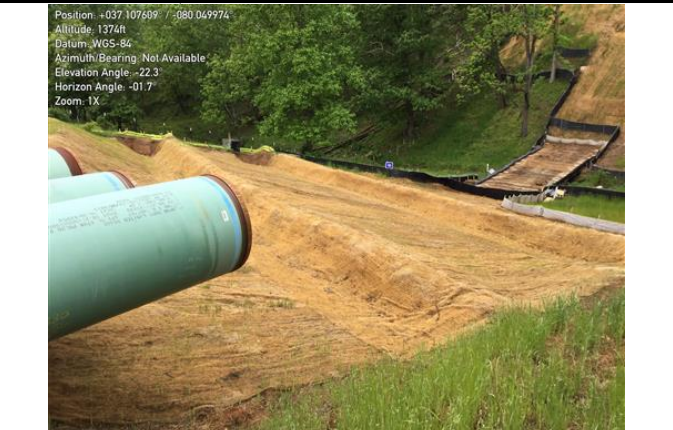
GPS Location	37.23	Field Station#	13322+50	GPS Location	37.23	Field Station#	13323+43
Description	Looking down upon waterway S-GH15 from the hillside at the CIS. View: East from northern edge of LOD, see photo for GPS data.			Description	Looking down upon waterway S-GH15 from the hillside at the GAS. View: Southwest from northern edge of LOD, see photo for GPS data.

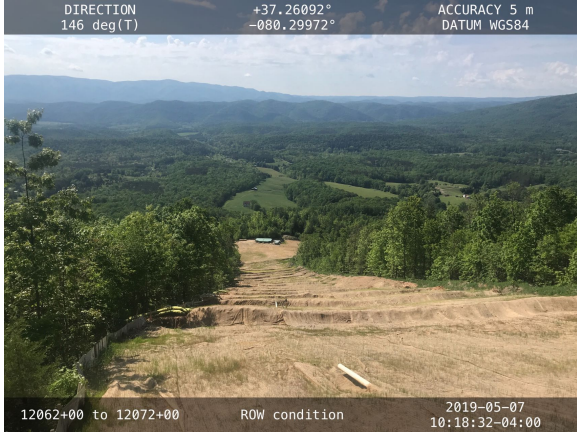
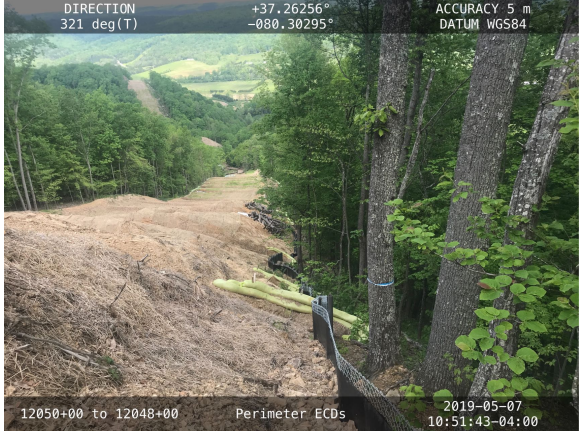
GPS Location	37.26	Field Station#	12062+00	GPS Location	37.26	Field Station#	12050+00
Description	See photo for gps data. Photo shows the ROW condition from about 12062+00 to 12072+00.			Description	See photo for gps data. Photo shows the perimeter ECDs from about 12050+00 to 12048+00.

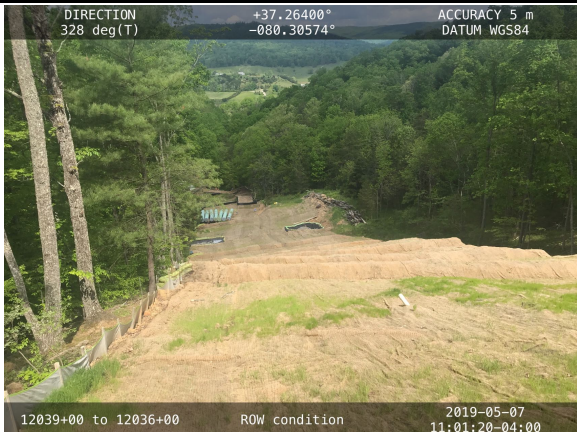
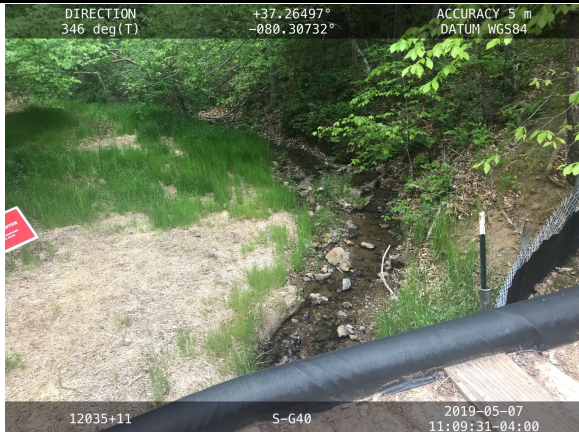
GPS Location	37.26	Field Station#	12039+00	GPS Location	37.26	Field Station#	12035+11
Description	See photo for gps data. Photo shows the ROW condition from about 12039+00 to 12036+00.			Description	See photo for gps data. photo shows stream S-G40 downstream from the ROW.

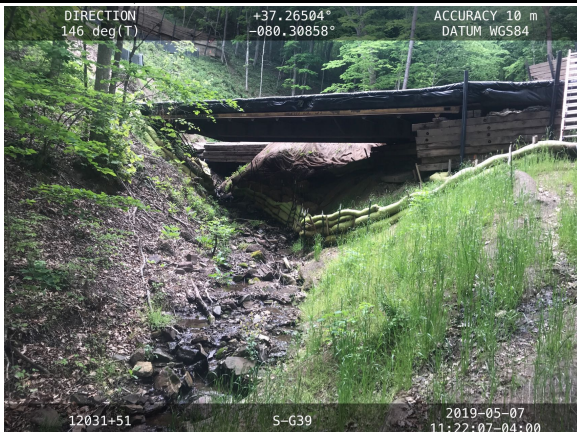
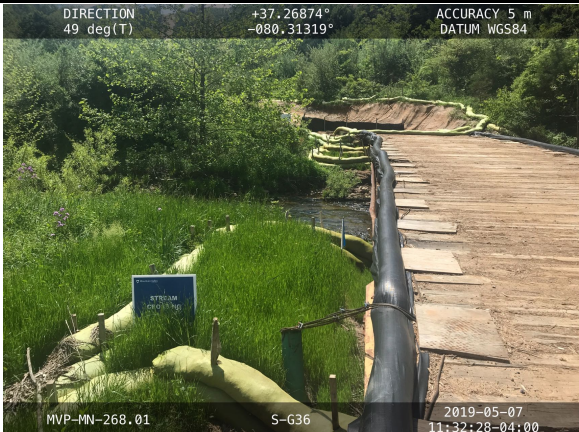
GPS Location	37.26	Field Station#	12031+51	GPS Location	37.26	Field Station#	12013+97
Description	See photo for gps data. Photo shows stream S-G39 at about 12031+51.			Description	See photo for gps data. Photo shows the ECDs along S-G36 along access road MVP-MN-268.01.

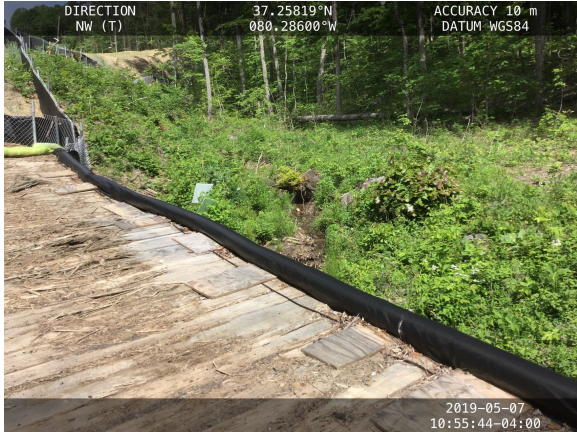
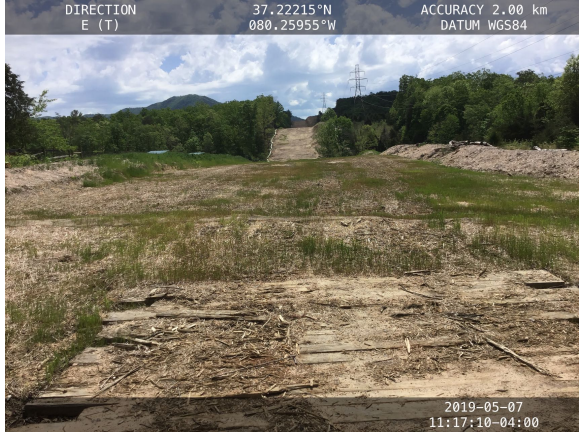
GPS Location	37.25	Field Station#	12108+41	GPS Location	37.25	Field Station#	12126+00
Description	Stream S-F15, facing northwest, upstream.			Description	This stretch of ROW from station 12126+00 to 12132+00 has grown significantly more vegetation in recent weeks.

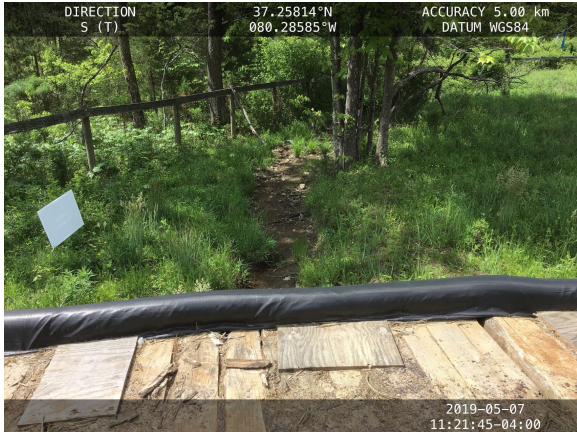
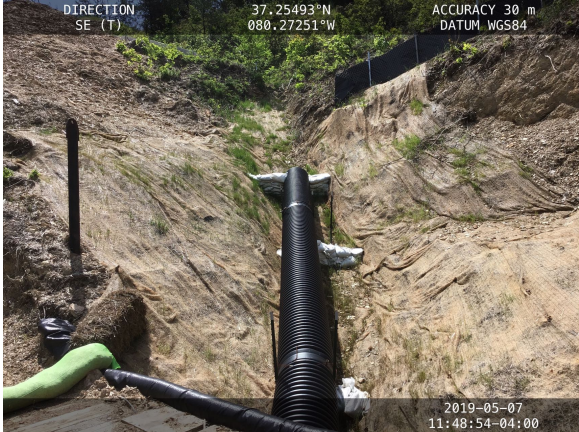
GPS Location	37.25	Field Station#	12132+73	GPS Location	37.25	Field Station#	12148+00
Description	Stream S-C29, facing south, downstream.			Description	Clean water diversion pipe is in satisfactory condition and functioning properly.

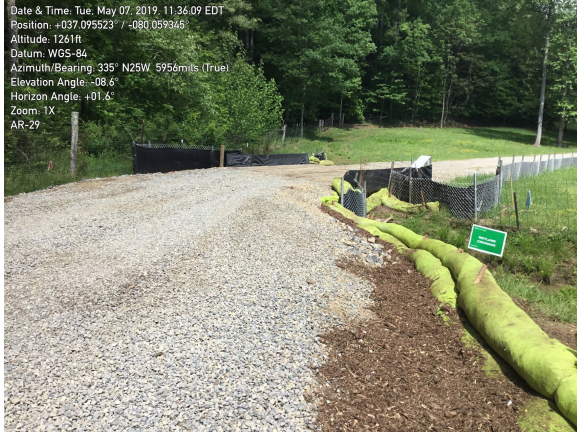
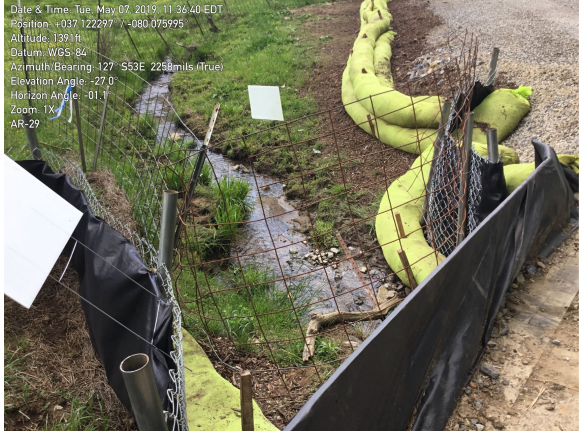
GPS Location	37.32	Field Station#	13188+66	GPS Location	37.32	Field Station#	13188+66
Description	Please see photo for accurate coordinates. MVP-MLV-AR-29, access road maintained, no environmental issues noted.			Description	Please see photo for accurate coordinates. S-D10, ECDs functioning acceptably along stream banks.		
<p>Date &amp; Time: Tue, May 07, 2019, 12:24:31 EDT Position: +037 124076° / -080 072697° Altitude: 1620ft Datum: WGS-84 Azimuth/Bearing: 208° N82W 4927mils (True) Elevation Angle: -28.7° Horizon Angle: +01.8° Zoom: 1X S-D8</p>

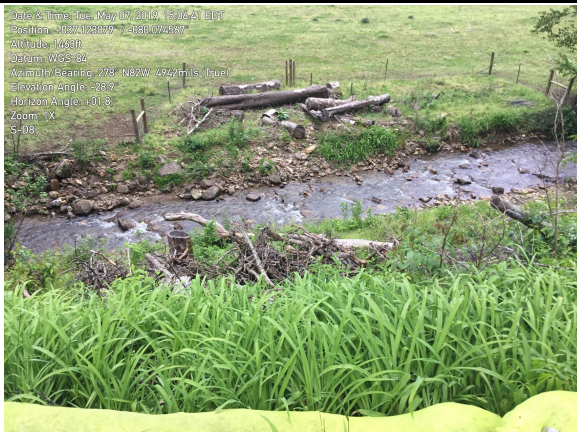
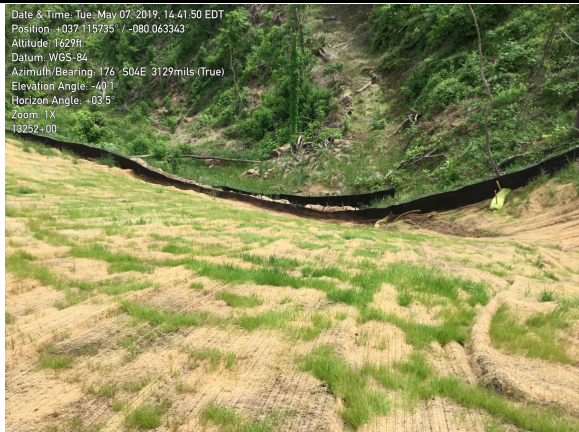
GPS Location	37.32	Field Station#	13196+90	GPS Location	37.32	Field Station#	13262+00
Description	Please see photo for accurate coordinates. S-D10, no environmental concerns noted at stream.			Description	Please see photo for accurate coordinates. ROW, old soil migration area, sediment build up noted at SSF, no at 50 percent.		
<p>Date &amp; Time: Tue, May 07, 2019, 14:30:31 EDT Position: +037 115702° / -080 060471° Altitude: 1419ft Datum: WGS-84 Azimuth/Bearing: 010° N10E 0178mils (True) Elevation Angle: -15.5° Horizon Angle: -00.2° Zoom: 1X S-114</p>

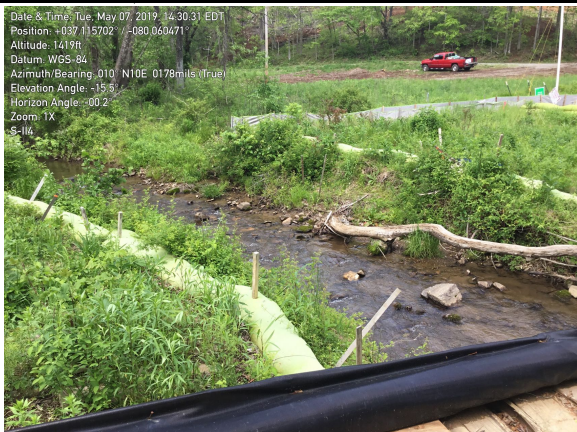
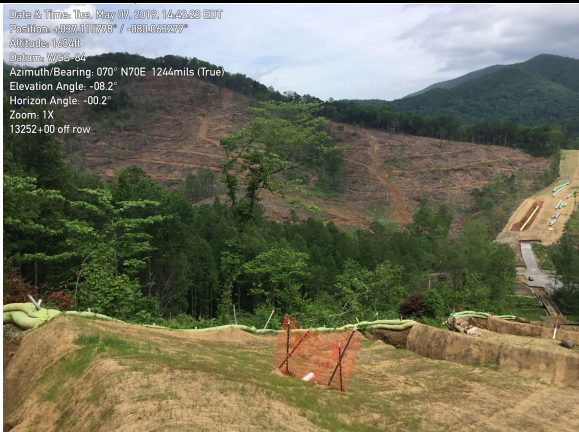
GPS Location	37.32	Field Station#	13260+60	GPS Location	37.32	Field Station#	13251+00
Description	Please see photo for accurate coordinates. S-114, ECDs functioning acceptably at stream crossing, bridge maintained.			Description	Please see photo for accurate coordinates. Off ROW, extensive logging activity adjacent to ROW.

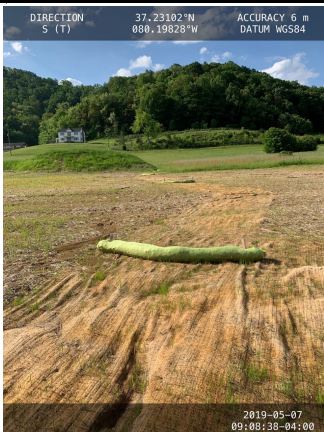
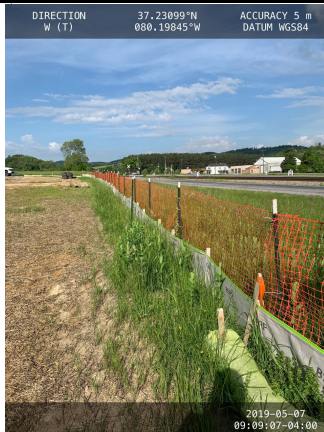
<div>2019-05-07 09:09:07-04:00</div>										
GPS Location		37.33	Field Station#		12445+86		GPS Location		37.33	Field Station#		12447+00	
Description		Curlexed channel crossing the ROW. Looking S. See picture for GPS data.				Description		P1silt fence perimeter controls. Looking W. See picture for GPS data.

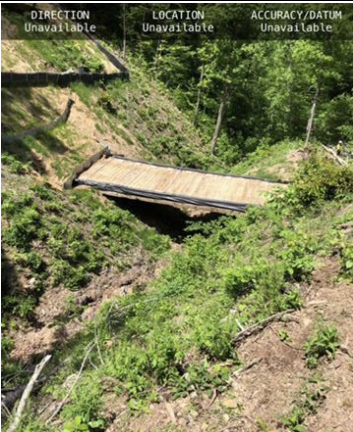
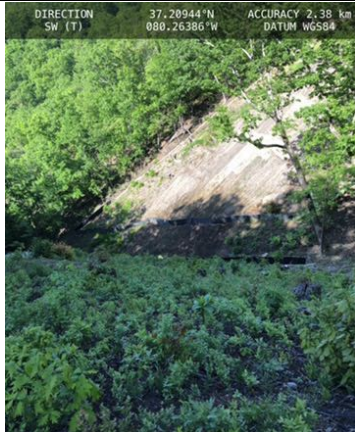
GPS Location	37.23	Field Station#	12211+21	GPS Location	37.23	Field Station#	12295+00
Description	Bridge crossing drainage feature.			Description	Stabilized undisturbed ROW. Looking SW. See picture for GPS data.
