Visual Site Inspection Report

Project Name	H-600 Pipeline Spread G	AFE	124300137	Spread	H-600 Pipeline Spread G
Contractor	Precision			Report #	16808
Inspector	Len Kruizenga			Date/Time	5/6/2019 8:43 AM
Permit #	TBD	Inspection Type	VA SWPP	Station Begin	11022+00
State	VA	Inspection Area	Full	Station End	10930+00
County	Giles	Ground	Muddy	Temperature (°F)	63.00
Municipality	N/A	Weather	Sunny	Rain Gauge (in)	0.60
				Rain Accumulation Time (days)	2.00

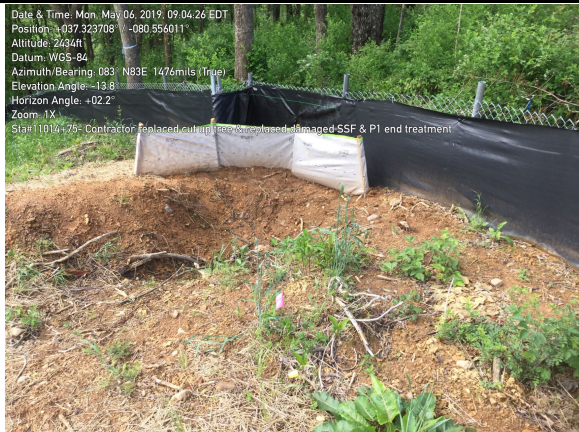
<p>Date & Time: Mon, May 06, 2019, 09:04:26 EDT Position: +037.323708° / -080.556011° Altitude: 2434ft Datum: WGS-84 Azimuth/Bearing: 083° N83E 1476mils (True) Elevation Angle: -13.8° Horizon Angle: +02.2° Zoom: 1X Sta#11014+75- Contractor replaced culvert section and replaced damaged SSF & P1 end treatment</p>

GPS Location	37.32	Field Station#	11016+00	GPS Location	37.32	Field Station#	11014+75
Description	Stream S-RR5- Bridge, ECD's, Signage are in acceptable condition			Description	Contractor has addressed crushed SSF & P1 end treatment		
<p>Date & Time: Mon, May 06, 2019, 09:28:20 EDT Position: +037.327604° / -080.571189° Altitude: 2341ft Datum: WGS-84 Azimuth/Bearing: 270° S90W 4800mils (True) Elevation Angle: -07.2° Horizon Angle: -00.3° Zoom: 1X Sta#10986+00- S-E24, S-E25, Replacement bridge, ECD's, Signage are in acceptable condition</p>

7. Identify all remedial measures that have been taken since the previous inspection was conducted. Sta#11014+75- Tree has been removed from SSF & P1 end treatment, repairs made.					
Comments (Reference above questions as appropriate.) SWPPP inspection: Sta#11022+00 to 10930+00. MP- 208.6 to 206.2 The row is muddy from recent rain events, but in stable condition. SSF & P1 perimeter controls are in acceptable condition. P1 & Triple stack end treatment's are in acceptable condition, there is some erosion on the backside of triple stack end treatments from water going through end treatments but no under cutting. Water bars & sump pits are in acceptable condition. Streams equipment bridges, ECD's & signage are in acceptable condition. RCE and access road are in acceptable condition. Attending environmental class from 11:30 to 4:30					
Note: It is a condition of National Pollutant Discharge Elimination System and Erosion and Sediment permits that a maintenance program be conducted to provide for the operation and maintenance of all BMPs to be inspected on a weekly basis and after each stormwater event. Please list in the space provided comments to note if repairs or replacement are needed or have been made for BMPs as a result of the inspection. Failure to conduct the required inspection may result in permit suspension or the imposition of civil penalties. If supplemental monitoring is required as part of a permit condition this form may be used to meet those monitoring requirements.

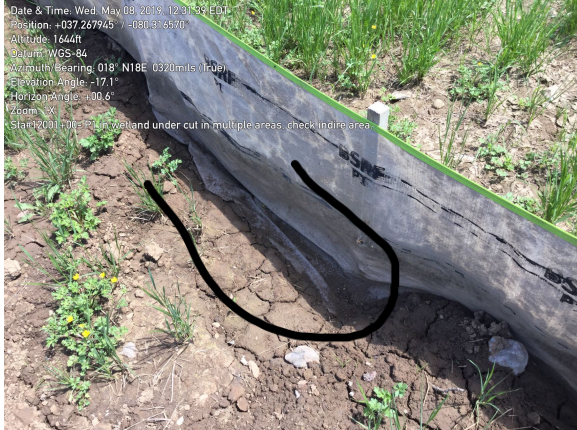
GPS Location	37.13	Field Station#	12001+00	GPS Location	37.13	Field Station#	11997+00
Description	P1 is under cut in several areas at wetland area.			Description	12" CFS perimeter control is damaged.

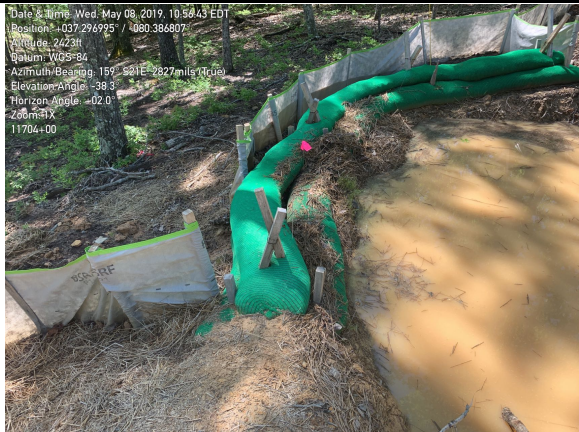
GPS Location	37.20	Field Station#	11686+81	GPS Location	37.20	Field Station#	11704+00
Description	See photo for GPS location. Undermined end treatment resulting in sediment off ROW.			Description	See photo for GPS location. Undermined end treatment resulting in sediment off ROW.		
<p>Date & Time: Wed, May 08, 2019, 13:12:35 EDT Position: +037.295703 / +080.368394 Altitude: 2028ft Datum: WGS-84 Azimuth/Bearing: +053°-0942mils Elevation Angle: +39.5° Horizon Angle: -81.0° Zoom: 1X 11765+00</p>

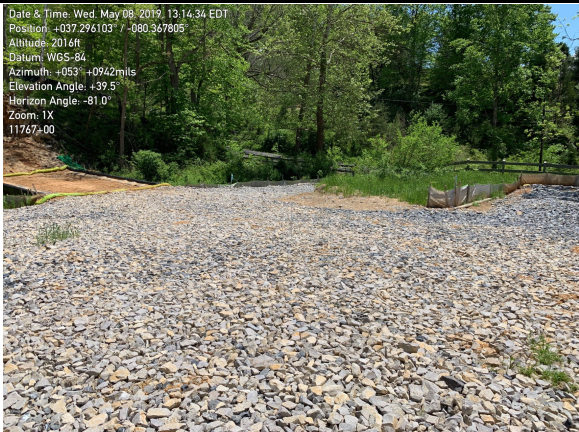
GPS Location	37.20	Field Station#	11765+00	GPS Location	37.20	Field Station#	11767+00
Description	See photo for GPS location. Undermined end treatment.			Description	See photo for GPS location. RCE at main line valve 26.

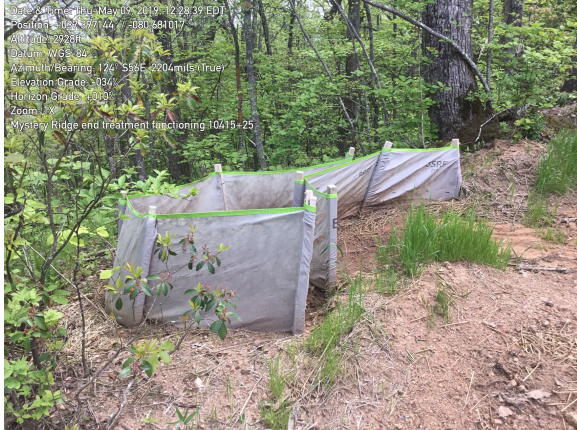
<p>Date & Time: Thu, May 09, 2019, 12:28:39 EDT Position: +037 397144 / -080 681017 Altitude: 3227ft Datum: WGS 84 Azimuth/Bearing: 126 / S85E 204mils (True) Elevation Grade: +036 Horizon Grade: +010 Zoom: 1X Mystery Ridge end treatment functioning 10415+25</p>			  <p>Date & Time: Thu, May 09, 2019, 12:30:19 EDT Position: +037 397405 / -080 681491 Altitude: 3168ft Datum: WGS 84 Azimuth/Bearing: 308 / N82W 54mils (True) Elevation Grade: -036 Horizon Grade: -002 Zoom: 1X Mystery Ridge end treatment had been overwhelmed. Repairs were completed 10412+25</p>				
GPS Location	37.31	Field Station#	10415+25	GPS Location	37.31	Field Station#	10412+25
Description	Correct coordinates on photo. This end treatment is operational			Description	Correct coordinates on photo. Maintenance needed on ECDs		
  <p>Date & Time: Thu, May 09, 2019, 13:21:00 EDT Position: +037 391091 / -080 679314 Altitude: 3227ft Datum: WGS 84 Azimuth/Bearing: 041 / N41E 029mils (True) Elevation Grade: +028 Horizon Grade: +001 Zoom: 1X Mystery Ridge end treatment in need of maintenance 10440+05</p>
