Visual Site Inspection Report

Project Name	H-600 Pipeline Spread G	AFE	124300137	Spread	H-600 Pipeline Spread G
Contractor	Precision			Report #	11078
Inspector	Clinton Banks			Date/Time	11/19/2018 4:18 AM
Permit #	TBD	Inspection Type	VA SWPP	Station Begin	+28
State	VA	Inspection Area	Full	Station End	+28
County	Giles	Ground	Damp	Temperature (°F)	58.00
Municipality	N/A	Weather	Sunny	Rain Gauge (in)	0.00
GPS Location	37.3338975292047, -80.803012987674			Rain Accumulation Time (days)	0.00

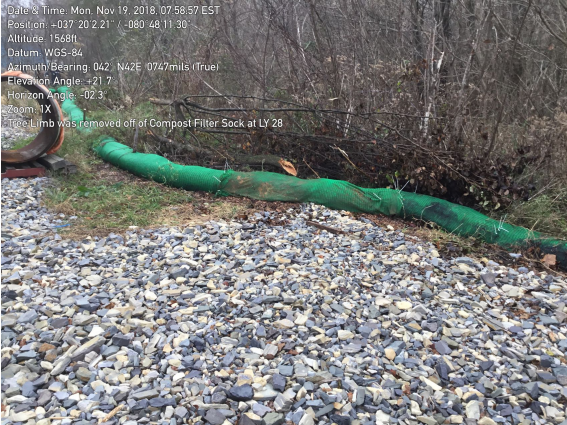
<p>Date & Time: Mon, Nov 19, 2018 07:58:57 EST Position: -037.20221° / -080.481130° Altitude: 1568ft Datum: WGS-84 Azimuth/Heading: 042° N42E 0747mils (True) Bearing Angle: +21.7° Horizon Angle: -02.3° Zoom: 1X Tree Limb was removed off of Compost Filter Sock at LY 28</p>

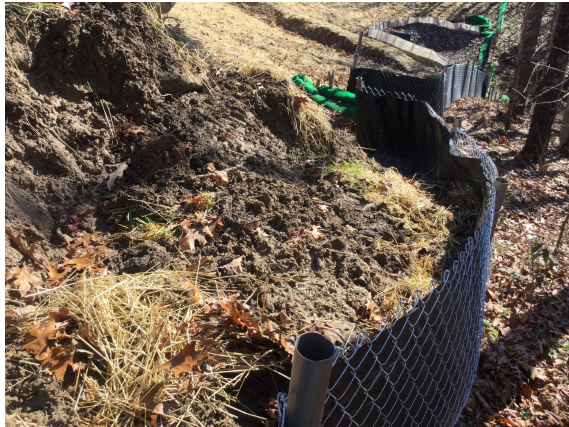
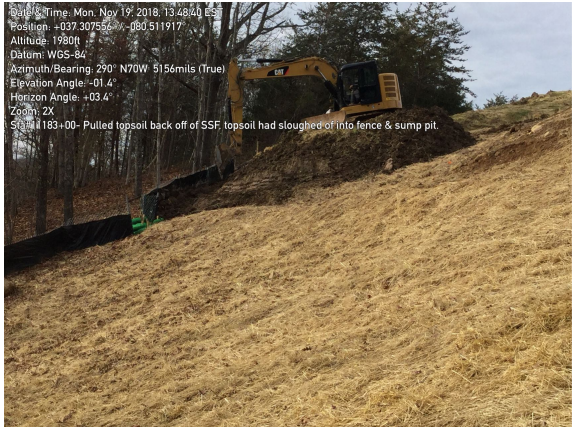
<p>Date & Time: Mon, Nov 19, 2018, 13:48:40 EST Position: +037.307554°N, -080.511917°W Altitude: 1980ft Datum: WGS-84 Azimuth/Bearing: 290° N70W 515mils (True) Elevation Angle: -01.4° Horizon Angle: +03.4° Zoom: 2X Sta#1183+00- Pulled topsoil back off of SSF, topsoil had sloughed off into fence & sump pit.</p>			
GPS Location	37.3124077124869, -80.5187684857105	GPS Location	37.30746088808731, -80.512131024227		
Description	Sta#11183+00- topsoil stockpile has sloughed off into SSF.	Description	Sta#11183+00- Contractor pulled back topsoil that had sloughed off into SSF. Picture to the left shows before it was addressed.

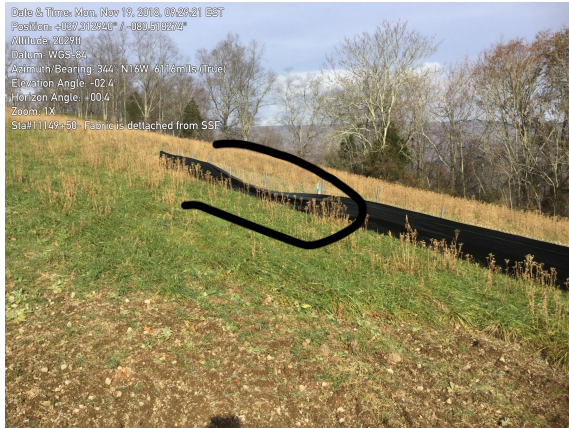
<p>Date & Time: Mon, Nov 19, 2018, 08:28:21 EST Position: +037.3130369838675°N, -080.5187487882381°W Altitude: 2024ft Datum: WGS-84 Azimuth/Bearing: 344° N16W 613mils (True) Elevation Angle: -02.4° Horizon Angle: +00.4° Zoom: 1X Sta#11149+50- Fabric is detached from SSF</p>

GPS Location	37.3130369838675, -80.5187487882381	GPS Location	37.3151392490019, -80.5428076163684		
Description	Sta#11149+50- Fabric detached from SSF.	Description	Sta#11068+00 to 11062+00- row reseeded & mulched, crimping has not been done.

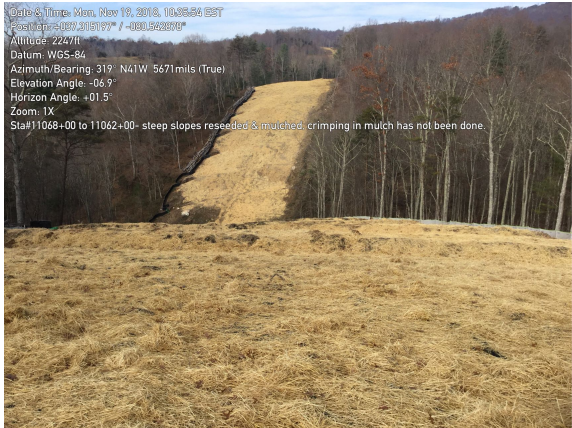
<p>Date & Time: Mon, Nov 19, 2018, 10:06:46 EST Position: +037.3151392490019°N, -080.5428076163684°W Altitude: 2227ft Datum: WGS-84 Azimuth/Bearing: 319° N41W 5471mils (True) Elevation Angle: -06.9° Horizon Angle: +01.5° Zoom: 1X Sta#11068+00 to 11062+00- steep slopes reseeded & mulched, crimping in mulch has not been done.</p>

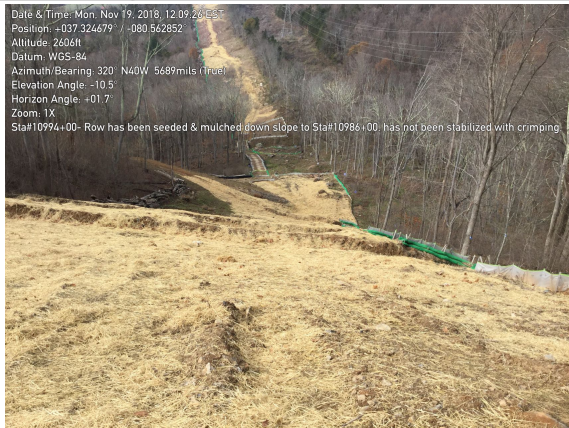
<p>Date & Time: Mon, Nov 19, 2018, 12:09:20 EST Position: +037.324679°N, -080.562852°W Altitude: 2606ft Datum: WGS-84 Azimuth/Bearing: 320° N40W 5689mils (True) Elevation Angle: -10.5° Horizon Angle: +01.7° Zoom: 1X Sta#10994+00- Row has been seeded & mulched down slope to Sta#10986+00, has not been stabilized with crimping.</p>

Description	Sta#10994+00 to 10986+00- slope has been seeded & mulched, not crimped.	Description	Sta#10969+00 to 10965+00- slope has been seeded & mulched but hasn't been crimped.

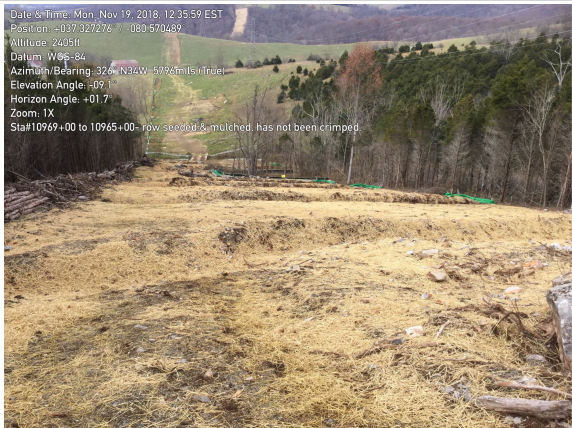
<p>Date & Time: Mon, Nov 19, 2018, 12:35:59 EST Position: +037.327276°N, -080.570439°W Altitude: 2425ft Datum: WGS-84 Azimuth/Bearing: 324° N36W 5936mils (True) Elevation Angle: -09.1° Horizon Angle: +01.7° Zoom: 1X Sta#10969+00 to 10965+00- row seeded & mulched, has not been crimped.</p>			
GPS Location	37.3074431112384, -80.5118351430451	GPS Location	37.307537323283, -80.511816451401

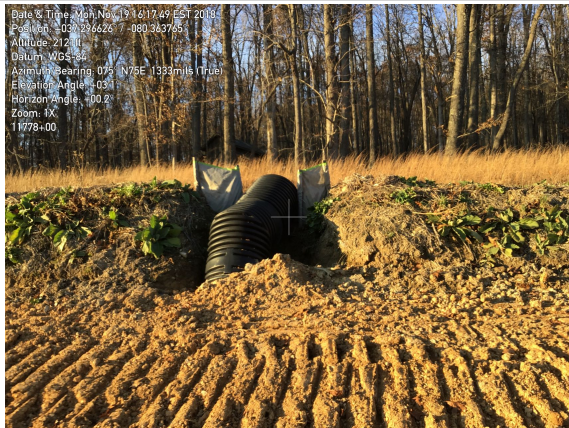
<p>Date & Time: Mon Nov 19 16:18:03 EST 2018 Position: +037.2059751861144 / -80.3938835766915 Altitude: 2118ft Datum: WGS-84 Azimuth/Bearing: 065° N65E 1156mils (True) Elevation Angle: -00.7° Horizon Angle: -03.6° Zoom: 1X 11779+00</p>  			
GPS Location	37.2060225857768, -80.3938909527663	GPS Location	37.2059751861144, -80.3938835766915

Description	See photo for GPS location and station number. Clean water diversion pipe and berm in place.	Description	See photo for GPS location and station number. Clean water diversion berm that needs to be repaired.

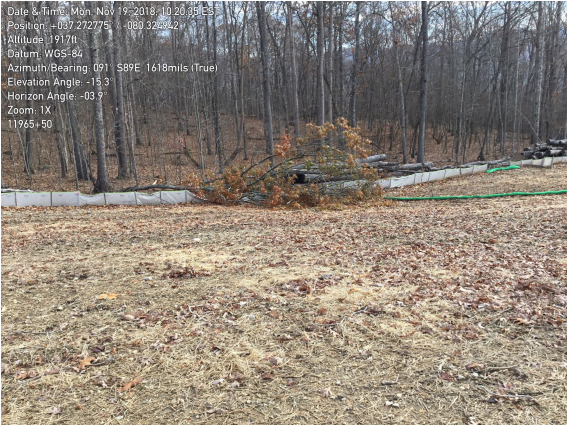
GPS Location	37.3337484324408, -80.7502608373936	GPS Location	37.3337773360963, -80.7502458532392		
Description	Wetland 12002+00	Description	Tree overtopped P1 silt fence 11965+50

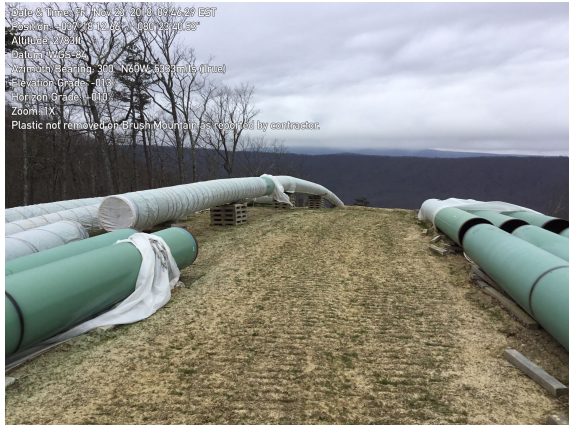
A/E	124300137	Date/Time	11/23/2018 4:47 PM	Report #	11268
Pictures					
<p>Date & Time: Fri, Nov 23, 2018, 09:44:36 EST Position: +037° 18' 17.40" N -080° 23' 46.74" W Altitude: 2586ft Datum: WGS-84 Azimuth Bearing: 247° 58' 56" W 4231mils (True) Elevation Grade: +005% Horizon Grade: +005% Zoom: 1X Plastic not removed on Brush Mountain perimeter by contractor.</p>

<p>GPS Location 37.1331561869356, -80.3944878280912</p> <p>Description Correct coordinates on photo. Plastic sheeting left on top of Brush Mountain.</p>	
<p>GPS Location 37.1331561869356, -80.3944878280912</p> <p>Description Correct coordinates on photo. End treatments in place with no maintenance needs noted.</p>		<p>GPS Location 37.1331561869356, -80.3944878280912</p> <p>Description Correct coordinates on photo. End treatments in place with no maintenance needs noted.</p>		<p>GPS Location 37.1331561869356, -80.3944878280912</p> <p>Description Correct coordinates on photo. End treatments in place with no maintenance needs noted.</p>

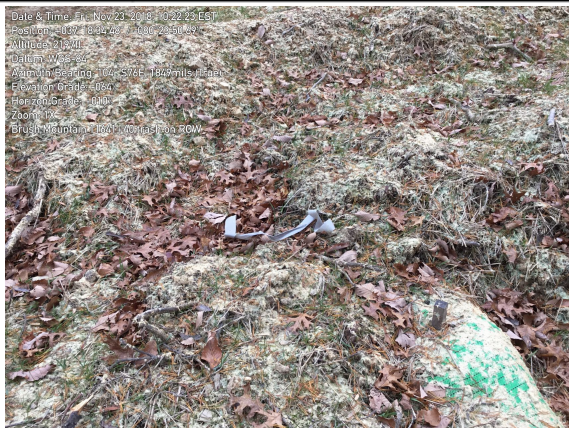
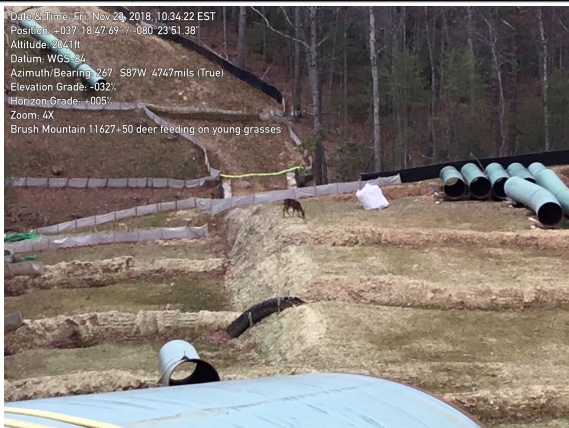
<p>GPS Location 37.1331812488261, -80.3944247123603</p> <p>Description Correct coordinates on photo. Tape and trash found scattered about ROW. Crew arrived after inspection to remove.</p>	
<p>GPS Location 37.1331812488261, -80.3944247123603</p> <p>Description Correct coordinates on photo. Tape and trash found scattered about ROW. Crew arrived after inspection to remove.</p>		<p>GPS Location 37.1331812488261, -80.3944247123603</p> <p>Description Correct coordinates on photo. Deer feeding on new growth. S-HH18 crossing stable.</p>		<p>GPS Location 37.1331812488261, -80.3944247123603</p> <p>Description Correct coordinates on photo. Deer feeding on new growth. S-HH18 crossing stable.</p>
