Visual Site Inspection Report

Project Name	H-600 Pipeline Spread G	AFE	124300137	Spread	H-600 Pipeline Spread G
Contractor	Precision			Report #	11978
Inspector	Rob Robertson			Date/Time	12/11/2018 4:34 PM
Permit #	TBD	Inspection Type	VA SWPP	Station Begin	11618+91
State	VA	Inspection Area	Full	Station End	11669+87
County	Montgomery	Ground	Muddy	Temperature (°F)	36.00
Municipality	N/A	Weather	Sunny	Rain Gauge (in)	0.00
GPS Location	37.13304644, -80.39505926			Rain Accumulation Time (days)	0.00

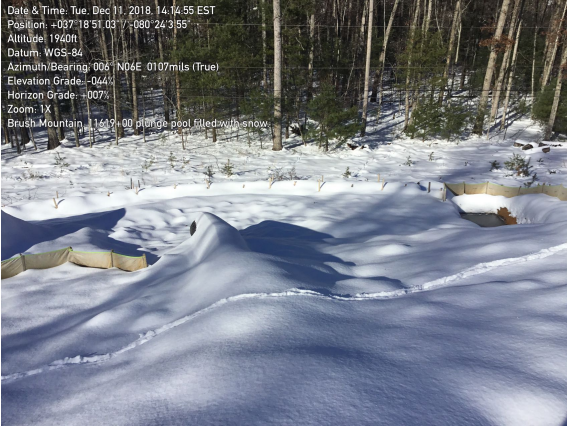
A/E	124300137	Date/Time	12/11/2018 4:34 PM	Report #	11978
Pictures					
<p>Date & Time: Tue, Dec 11, 2018, 13:58:43 EST Position: +037°16'51.46" / -080°24'44.1" Altitude: 1873ft Datum: WGS-84 Azimuth/Bearing: 356° N04W 6929mils (True) Elevation Grade: +00% Horizon Grade: +011% Zoom: 1X Brush Mountain 11619+00 Near JNF property line ROW blanketed with snow.</p>  		<p>Date & Time: Tue, Dec 11, 2018, 14:14:55 EST Position: +037°18'51.03" / -080°24'31.55" Altitude: 1940ft Datum: WGS-84 Azimuth/Bearing: 006° N04E 0107mils (True) Elevation Grade: +044% Horizon Grade: +007% Zoom: 1X Brush Mountain 11619+00 plunge pool filled with snow.</p>

GPS Location	37.1331839310351, -80.3944885824624	GPS Location	37.1331839310351, -80.3944885824624		
Description	Correct coordinates on photo. A recent winter storm dumped 12"-14" of snow on ROW in this area.	Description	Correct coordinates on photo. A plunge pool near 11619+00 is barley visible under the snow.

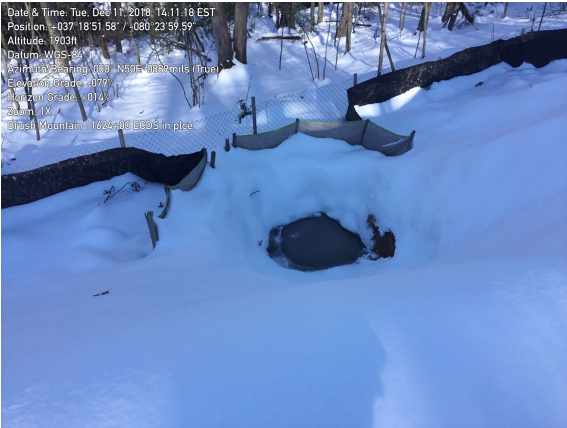
<p>Date & Time: Tue, Dec 11, 2018, 14:11:18 EST Position: +037°18'51.58" / -080°23'59.59" Altitude: 1903ft Datum: WGS-84 Azimuth/Bearing: 010° N10E 0088mils (True) Elevation Grade: +072% Horizon Grade: +014% Zoom: 1X Brush Mountain 11624+00 ECDS in place.</p>

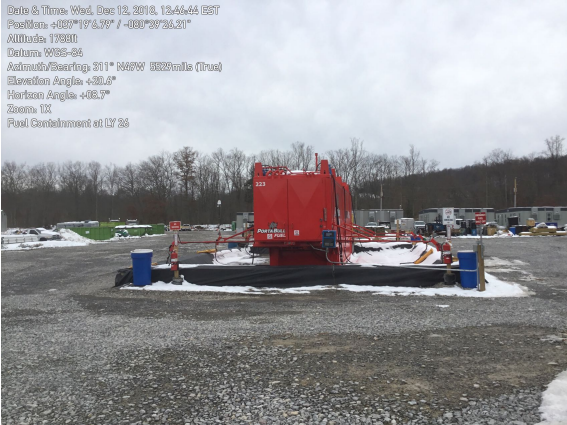
<p>Date & Time: Wed, Dec 12, 2018, 13:44:44 EST Position: +089°19'4.97" / -080°37'34.31" Altitude: 1777ft Datum: WGS-84 Azimuth/Heading: 311° 84°W 002mils (True) Elevation Angle: +30.4° Horizon Angle: +08.7° Zoom: 1X Fuel Containment at LY 26</p>

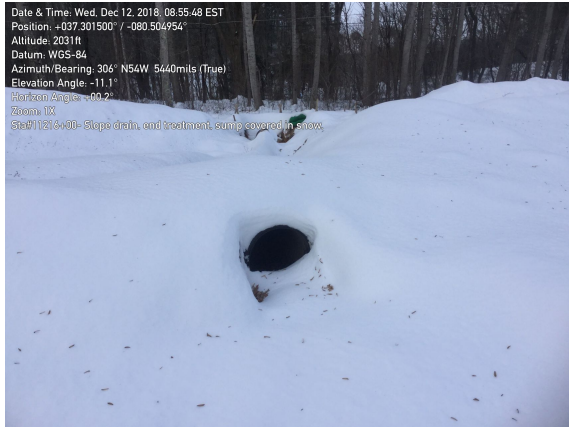
A/E	124300137	Date/Time	12/12/2018 6:21 AM	Report #	11998
Pictures					
<p>Date & Time: Wed, Dec 12, 2018, 08:55:48 EST Position: +037.301500° / -080.504954° Altitude: 2031ft Datum: WGS-84 Azimuth/Bearing: 306° N54W 5440mils (True) Elevation Angle: -11.1° Horizon Angle: -00.2° Zoom: 1X Sta#11216+00- Slope drain, end treatment, sump covered in snow.</p>

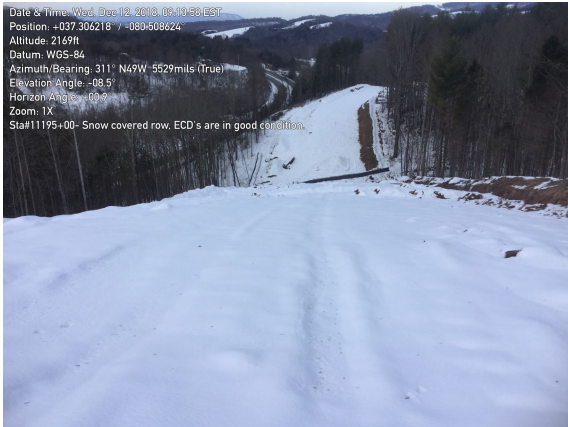
<p>Date & Time: Wed, Dec 12, 2018, 08:19:38 EST Position: +037.306218° / -080.508624° Altitude: 2169ft Datum: WGS-84 Azimuth/Bearing: 311° N49W 5529mils (True) Elevation Angle: -08.5° Horizon Angle: -00.9° Zoom: 1X Sta#11195+00- Snow covered row, ECD's are in good condition.</p>

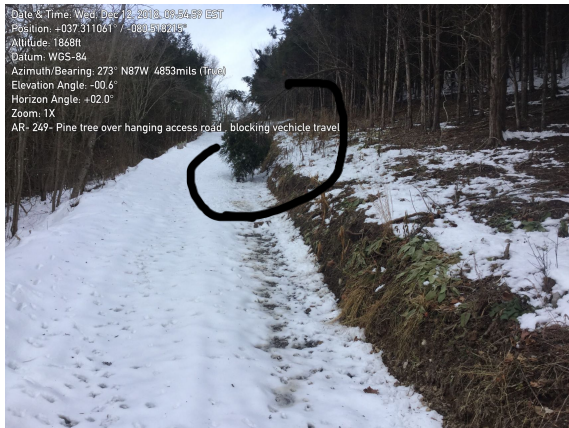
GPS Location	37.3015963565906, -80.504868356586	GPS Location	37.3062438704421, -80.5085706432168		
Description	Sta#11216+00- Slope drain, end treatment, sump covered in snow.	Description	Sta#11195+00- Row snow covered, ECD's in good condition.		
<p>Date & Time: Wed, Dec 12, 2018, 09:44:19 EST Position: +037.311061° / -080.518271° Altitude: 1868ft Datum: WGS-84 Azimuth/Bearing: 273° N87W 4853mils (True) Elevation Angle: -00.6° Horizon Angle: +02.0° Zoom: 1X AR-249- Pine tree over hanging access road, blocking vehicle travel</p>

GPS Location	37.3110713856642, -80.5182716064905	GPS Location	37.3151630116974, -80.5431886576866		
Description	AR-249- pine tree over hanging access rd, blocking vehicle access.	Description	Sta#11069+00 to 11062+00- SSF on slopes in good condition.		
<p>Date & Time: Wed, Dec 12, 2018, 13:00:25 EST Position: +037.323387° / -080.554125° Altitude: 2434ft Datum: WGS-84 Azimuth/Bearing: 296° N64W 5262mils (True) Elevation Angle: -06.1° Horizon Angle: +01.8° Zoom: 1X Sta#11015+00- stream R- 55. ECD's are in good condition. Stream is flowing.</p>

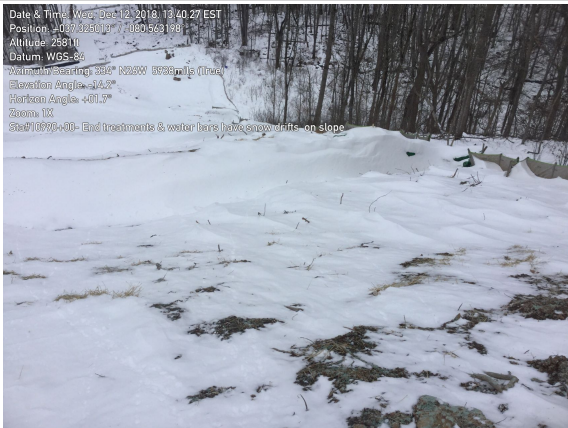
<p>Date & Time: Wed, Dec 12, 2018, 13:40:27 EST Position: +037.329055° / -080.485093° Altitude: 2591ft Datum: WGS-84 Azimuth/Bearing: 308° N63W 5033mils (True) Elevation Angle: -12.5° Horizon Angle: +01.5° Zoom: 1X Sta#10990+00- Red treatments & water here have snow drifts on slope</p>

Description	Sta#11015+00, stream RR-5	Description	Sta#10990+00- Snow drifts on this slope are over the top of end treatments & P1 perimeter controls.

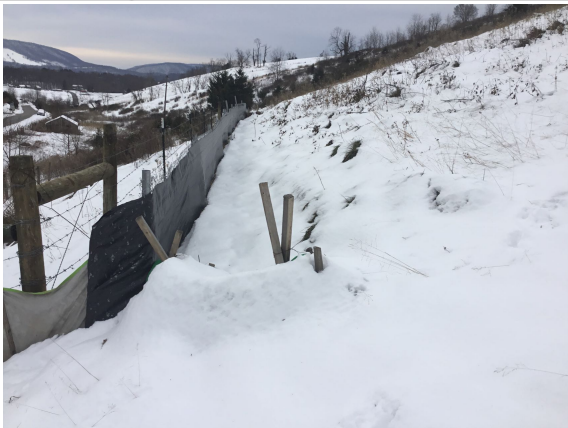
<p>Date & Time: Wed, Dec 12, 2018, 11:22:10 EST Position: +037.337355° / -080.604335° Altitude: 2237ft Datum: WGS-84 Azimuth/Bearing: 200° N69W 5533mils (True) Elevation Angle: +04.8° Horizon Angle: -05.8° Zoom: 2X Kow camp 1</p>

GPS Location	37.3007383430724, -80.5037151743476	GPS Location	37.3373555671771, -80.6043354795133		
Description	Kow camp 2 heavy snow but end treatments still up 10858+00	Description	Kow camp 1 super silt fence ok 10880+50

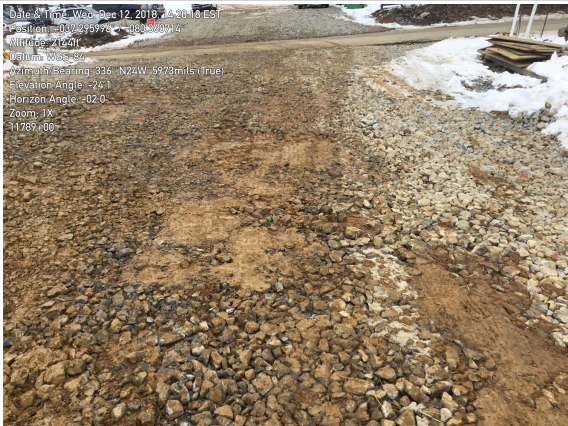
GPS Location	37.2958781384279, -80.3604815249148		GPS Location	37.2960730176766, -80.3607422021035	
Description	CFS in good condition 11991+00		Description	RCE in need of refreshing 11789+00

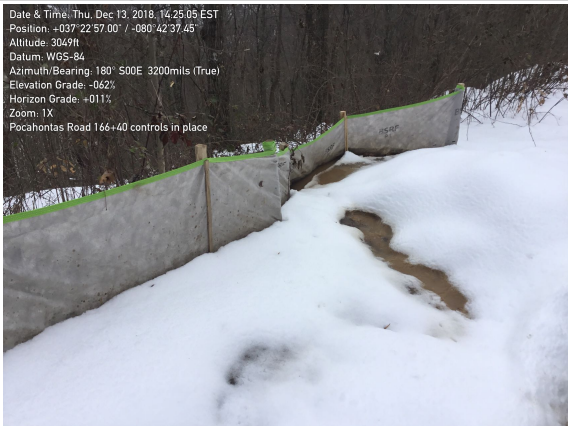
<p>Date & Time: Thu, Dec 13, 2018, 14:25:05 EST Position: +037° 22' 57.00" / -080° 42' 37.45" Altitude: 3049ft Datum: WGS-84 Azimuth/Bearing: 180° S00E 3200mils (True) Elevation Grade: -042% Horizon Grade: +011% Zoom: 1X Pocahontas Road 166+40 controls in place</p>

GPS Location	37.1333730686802, -80.3945695516471	GPS Location	37.1333730686802, -80.3945695516471		
Description	Correct coordinates on photo. Stream flowing clear.	Description	Correct coordinates on photo. Controls are in place. Too much snow to determine effectiveness.
