Visual Site Inspection Report

Project Name	H-600 Pipeline Spread G	AFE	124300137	Spread	H-600 Pipeline Spread G
Contractor	Precision			Report #	12246
Inspector	Rob Robertson			Date/Time	12/17/2018 4:18 PM
Permit #	TBD	Inspection Type	VA SWPP	Station Begin	11669+87
State	VA	Inspection Area	Full	Station End	11618+91
County	Montgomery	Ground	Damp	Temperature (°F)	47.00
Municipality	N/A	Weather	Sunny	Rain Gauge (in)	0.20
GPS Location	37.1328725561528, -80.3944302947873			Rain Accumulation Time (days)	1.00

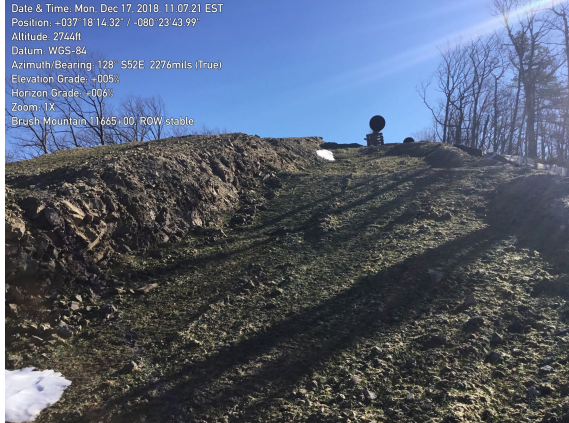
A/E	124300137	Date/Time	12/17/2018 4:18 PM	Report #	12246
Pictures					
<p>Date & Time: Mon Dec 17, 2018 11:07:21 EST Position: +037 18 14.32 / -080 23 43.99 Altitude: 2744ft Datum: WGS-84 Azimuth/Bearing: 128 S52E 2276mils (True) Elevation Grade: +00% Horizon Grade: +00% Zoom: 1X Brush Mountain 11655+00 ROW stable</p>

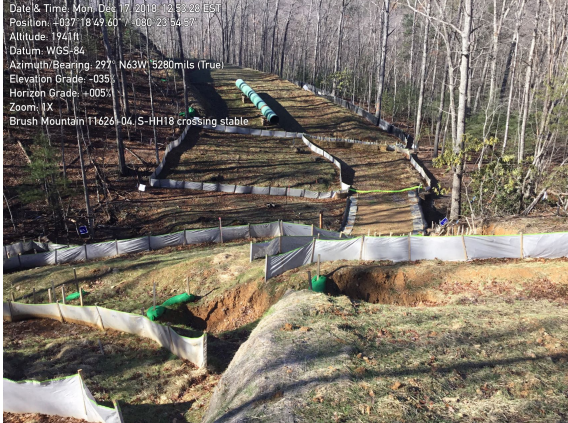
<p>Date & Time: Mon Dec 17, 2018 12:53:20 EST Position: +037 18 49.60 / -080 23 54.50 Altitude: 1941ft Datum: WGS-84 Azimuth/Bearing: 271 N43W 5280mils (True) Elevation Grade: +03% Horizon Grade: +00% Zoom: 1X Brush Mountain 11626+04 S-HH18 crossing stable</p>

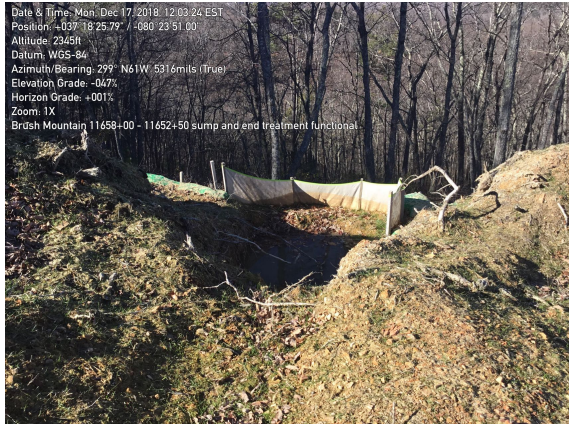
GPS Location	37.1331059793356, -80.3943902627382	GPS Location	37.1333420556384, -80.3945263010267		
Description	Brush Mountain coordinates on photo. 2-tone area stable	Description	Brush Mountain coordinates on photo. S-HH18 crossing stable.		
<p>Date & Time: Mon Dec 17, 2018 12:03:24 EST Position: +037 18 25.79 / -080 23 51.00 Altitude: 2345ft Datum: WGS-84 Azimuth/Bearing: 299 N61W 5316mils (True) Elevation Grade: -047% Horizon Grade: +001% Zoom: 1X Brush Mountain 11658+00 - 11652+50 sump and end treatment functional</p>

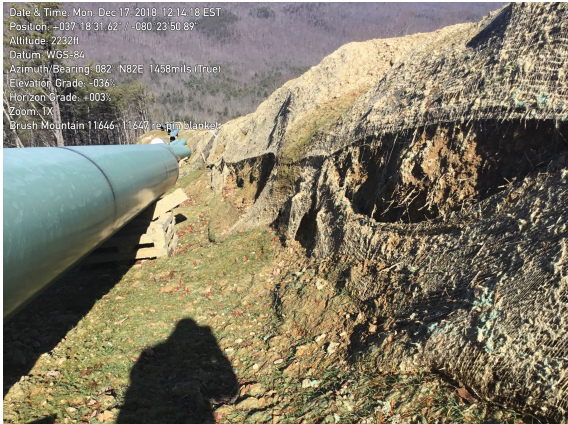
<p>Date & Time: Mon Dec 17, 2018 12:12:18 EST Position: +037 18 31.62 / -080 23 50.89 Altitude: 2231ft Datum: WGS-84 Azimuth/Bearing: 082 N82E 1458mils (True) Elevation Grade: +03% Horizon Grade: +00% Zoom: 1X Brush Mountain 11646+11640 re-rim blanket</p>

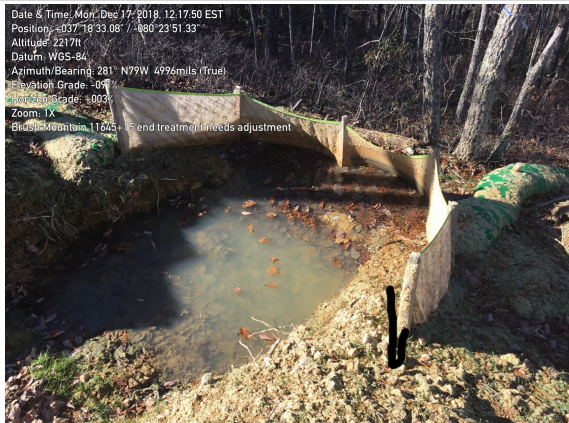
GPS Location	37.1332190512094, -80.3944119718675	GPS Location	37.1332190512094, -80.3944119718675		
Description	Brush Mountain coordinates on photo. Slope breakers and end treatments functional.	Description	Brush Mountain coordinates on photo. Minor erosion blanket maintenance needed.		
<p>Date & Time: Mon Dec 17, 2018 12:17:50 EST Position: +037 18 33.08 / -080 23 51.33 Altitude: 2217ft Datum: WGS-84 Azimuth/Bearing: 281 N79W 4996mils (True) Elevation Grade: +0% Horizon Grade: +00% Zoom: 1X Brush Mountain 11655+00 end treatment needs adjustment</p>

Description	Brush Mountain coordinates on photo. End treatment needs adjustment.	Description	Brush Mountain coordinates on photo. ROW stable with perimeter controls in place.

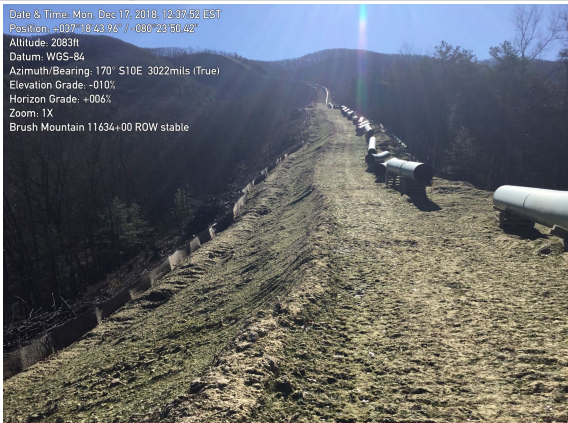
<p>Date & Time: Mon Dec 17, 2018 12:07:52 EST Position: +037 18 43.96 / -080 23 50.42 Altitude: 2083ft Datum: WGS-84 Azimuth/Bearing: 170 S10E 3022mils (True) Elevation Grade: +00% Horizon Grade: +00% Zoom: 1X Brush Mountain 11634+00 ROW stable</p>

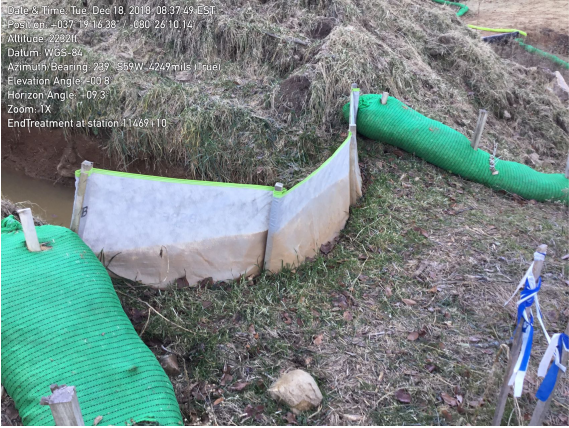
A/E	124300137	Date/Time	12/18/2018 3:57 AM	Report #	12266
Pictures					
<p>Date & Time: Tue, Dec 18, 2018, 08:37:49 EST Position: +037°19'16.38" / -080°26'10.14" Altitude: 2225ft Datum: WGS-84 Azimuth/Bearing: 003° N03E 0053mils (True) Elevation Angle: +08.6° Horizon Angle: +09.3° Zoom: 1X EndTreatment at station 11469+10</p>

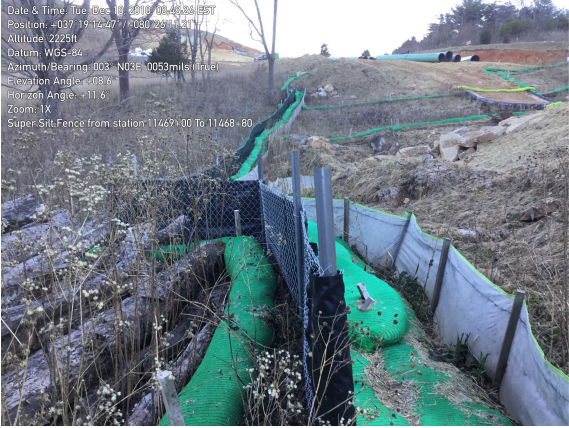
<p>Date & Time: Tue, Dec 18, 2018, 08:44:38 EST Position: +037°19'12.47" / -080°26'11.01" Altitude: 2225ft Datum: WGS-84 Azimuth/Bearing: 003° N03E 0053mils (True) Elevation Angle: +08.6° Horizon Angle: +11.6° Zoom: 1X Super Silt Fence from station 11469+00 To 11468+80</p>

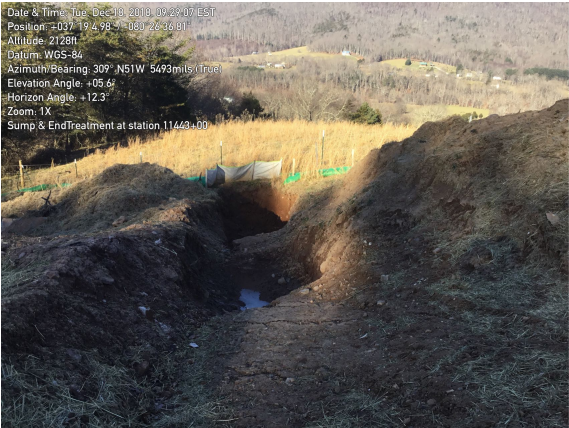
<p>Date & Time: Tue, Dec 18, 2018, 09:27:07 EST Position: +037°19'4'98.3" / -080°26'46.01" Altitude: 2128ft Datum: WGS-84 Azimuth/Bearing: 309° N51W 5493mils (True) Elevation Angle: +05.6° Horizon Angle: +12.3° Zoom: 1X Sump & EndTreatment at station 11443+00</p>

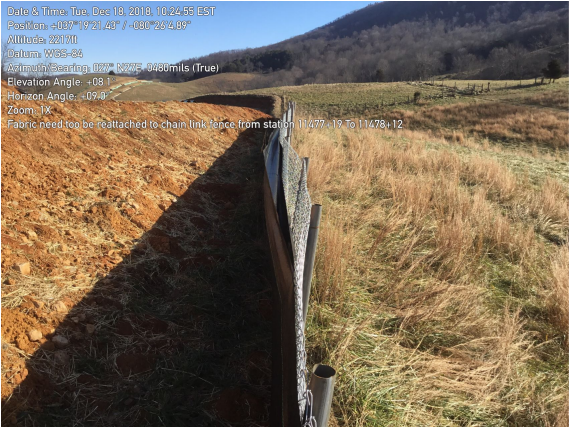
<p>Date & Time: Tue, Dec 18, 2018, 10:24:55 EST Position: +037°19'21.48" / -080°26'44.89" Altitude: 2217ft Datum: WGS-84 Azimuth/Bearing: 077° N07E 0480mils (True) Elevation Angle: +08.1° Horizon Angle: +07.4° Zoom: 1X Fabric need too be reattached to chain link fence from station 11477+19 To 11478+12</p>

GPS Location	37.3170424858456, -80.445338320062
Description		Description		GPS Location	37.3225959157919, -80.4346565064792
Sump & EndTreatment at station 11436+00		Fabric need too be reattached to chain link fence from station 11477+19 To 11478+12

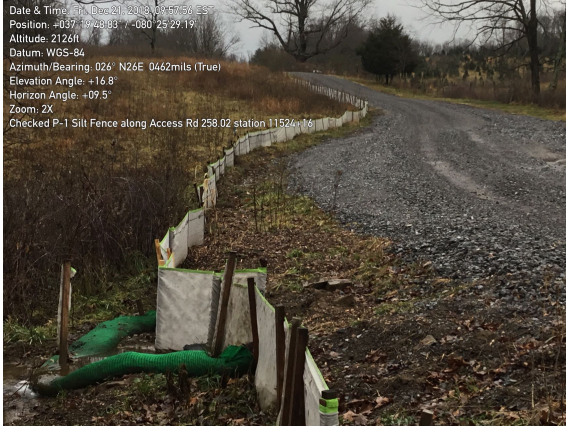
<p>Date & Time: Fri, Dec 21, 2018, 09:55:56 EST Position: +037°19'48.83" / -080°25'29.19" Altitude: 2126ft Datum: WGS-84 Azimuth/Bearing: 025° N26E 0462mils (True) Elevation Angle: +16.8° Horizon Angle: +09.5° Zoom: 2X Checked P-1 Silt Fence along Access Rd 258.02 station 11524+16</p>

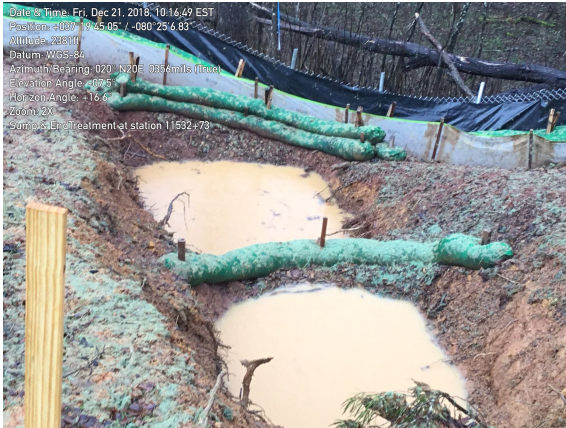
<p>Date & Time: Fri, Dec 21, 2018, 10:16:49 EST Position: +037°19'45.05" / -080°25'6.83" Altitude: 2234ft Datum: WGS-84 Azimuth/Bearing: 020° N20E 0866mils (True) Elevation Angle: +07.5° Horizon Angle: +16.6° Zoom: 2X Sump & EndTreatment at station 11532+73</p>

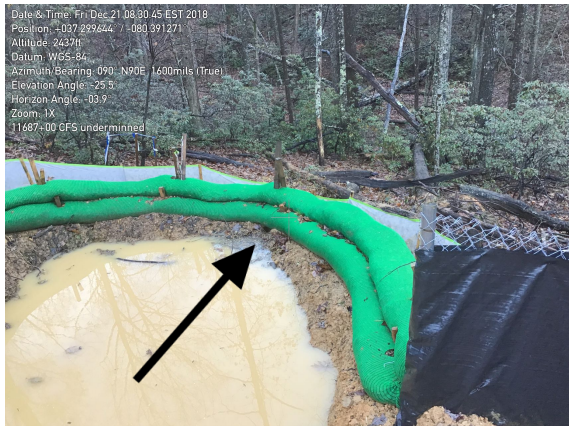
GPS Location	37.2058968446754, -80.3946620857456	GPS Location	37.2060338258825, -80.3945354622571		
Description	See photo for GPS location and station number. ROW stabilized and water bars in place.	Description	See photo for GPS location and station number. Rock filter over two tone section to minimize erosion.		
<p>Date & Time: Fri Dec 21 08:30:45 EST 2018 Position: -037.299644° / -080.391271° Altitude: 2432ft Datum: WGS-84 Azimuth/Bearing: 090° N90E 1400mils (True) Elevation Angle: -25.3° Horizon Angle: -03.9° Zoom: 1X 11687+00 CFS undermined</p>

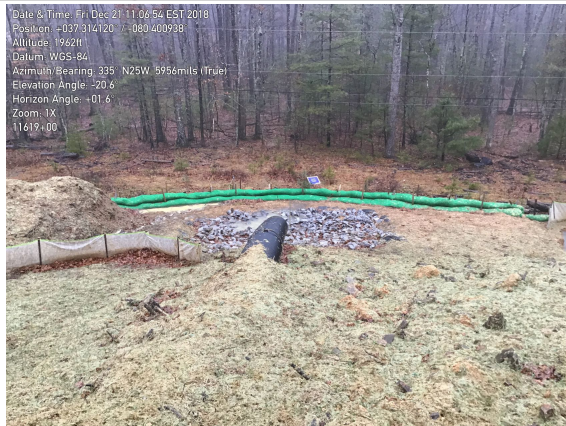
GPS Location	37.2060335336053, -80.3945400931449	GPS Location	37.2060335336053, -80.3945400931449		
Description	See photo for GPS location and station number. Channel next to bridge created when bridge slide over.	Description	See photo for GPS location and station number. Plunge pool in place.

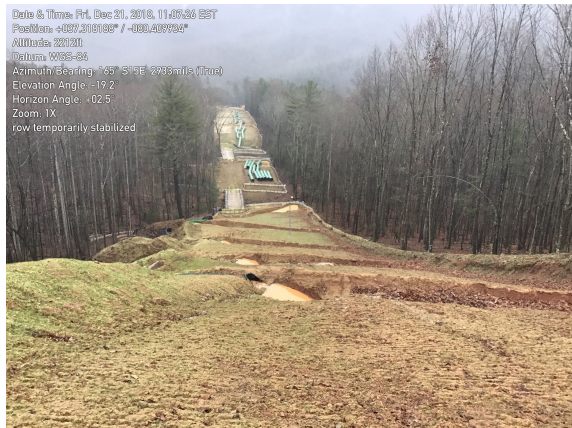
GPS Location	37.1360158827502, -80.3940331098441	GPS Location	37.1360210376206, -80.3940319363776		
Description	Stream s-pp21 flowing clear during rain event.	Description	Stabilized ROW conditions along sinking creek mountain.		
<p>Date & Time: Fri, Dec 21, 2018, 11:06:22 EST Position: +037.313834° / -088.415425° Altitude: 2020ft Datum: WGS-84 Azimuth/Bearing: 141° N41W 3529mils (True) Elevation Angle: -08.1° Horizon Angle: -01.2° Zoom: 1X installed super silt fence in good working condition</p>
