Visual Site Inspection Report

Project Name	H-600 Pipeline Spread G		AFE	124300137	Spread	H-600 Pipeline Spread G	
Contractor	Precision				Report #	12491	
Inspector	Jared Saunders				Date/Time	12/26/2018 6:44 PM	
Permit #	TBD	Inspection Type	VA SWPP		Station Begin	0+00	
State	VA	Inspection Area	Partial		Station End	0+00	
County	Giles	Ground	Muddy		Temperature (°F)	50.00	
Municipality	N/A	Weather	Cloudy		Rain Gauge (in)	0.00	
GPS Location	37.206002562847, -80.3943528542494				Rain Accumulation Time (days)	1.00

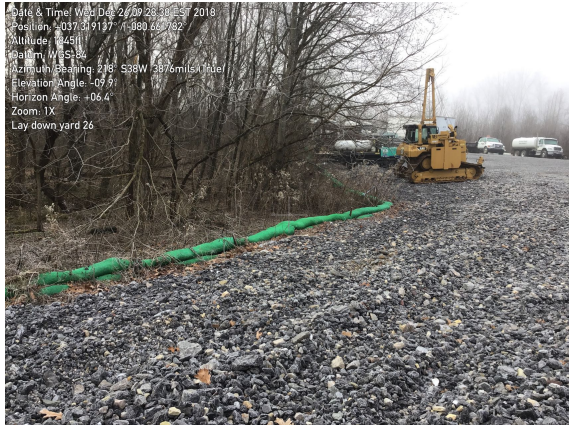
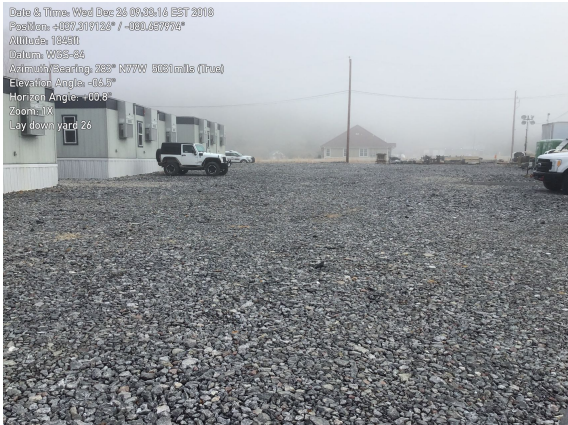
GPS Location	37.2060041160983, -80.3944017313558	GPS Location	37.2060038787813, -80.3944027628613		
Description	See photo for GPS location and station number. Triple stack compost filter sock in place.	Description	See photo for GPS location and station number. RCE at yard 26 eliminating track out.		
<p>Date & Time: Wed Dec 26 10:05:37 EST 2018 Position: +037.362761° / -080.677089° Altitude: 1922ft Datum: WGS-84 Azimuth/Bearing: 178° S02E 3124mils (True) Elevation Angle: -12.5° Horizon Angle: -00.4° Zoom: 1X Lay down yard 28</p>

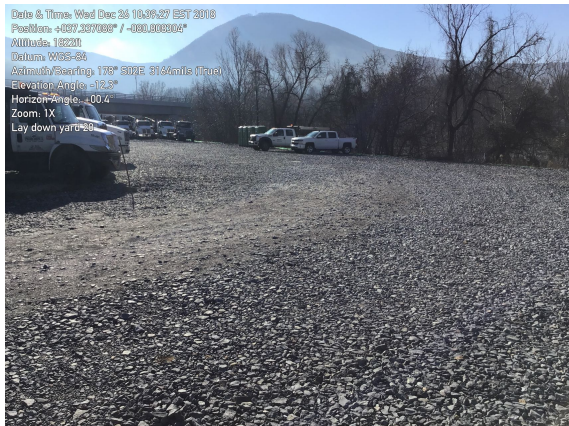
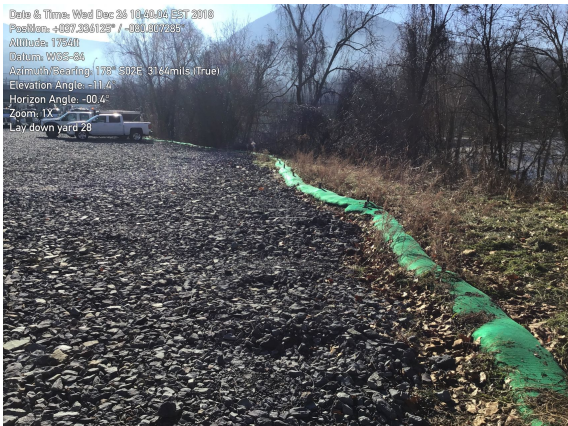
GPS Location	37.2060035869564, -80.3944062755614	GPS Location	37.2060255478438, -80.394261481275		
Description	See photo for GPS location and station number. Yard 28. RCE in place.	Description	See photo for GPS location and station number. Compost filter sock in place.		
<p>Date & Time: Wed Dec 26 14:33:41 EST 2018 Position: +037.362761° / -080.677089° Altitude: 1922ft Datum: WGS-84 Azimuth/Bearing: 204° S24W 3627mils (True) Elevation Angle: -09.0° Horizon Angle: -01.9° Zoom: 1X Lay Down Yard 29</p>

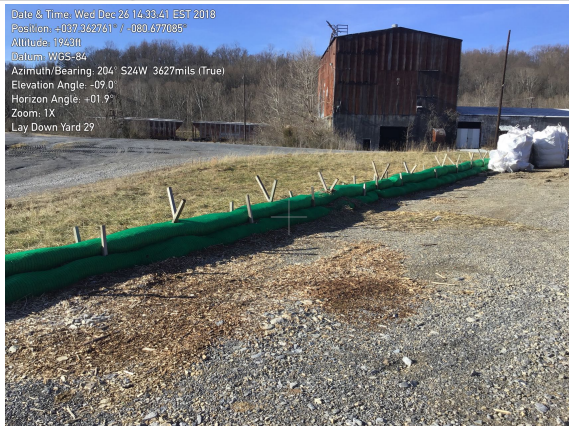
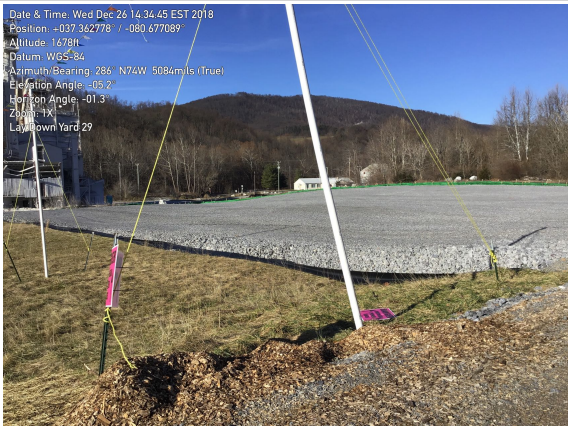
GPS Location	37.2060661912233, -80.3944166873649	GPS Location	37.2060661912233, -80.3944166873649		
Description	See photo for GPS location and station number. Triple stack compost filter sock in place.	Description	See photo for GPS location and station number. Yard 29 rock in place to prevent track out.

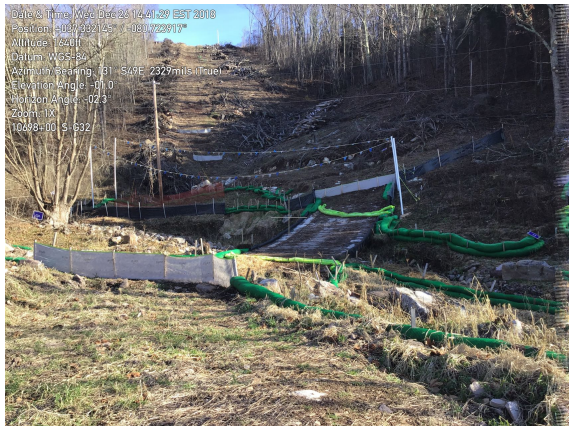
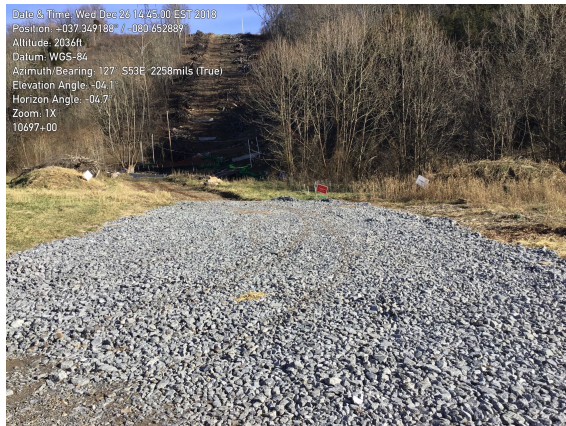
GPS Location	37.2060296329132, -80.3943675209578		GPS Location	37.2060202940759, -80.3944107525591	
Description	See photo for GPS location and station number. ECDs and sensitive resource buffer in place at stream crossing.		Description	See photo for GPS location and station number. RCE in place at buffalo anklets road.

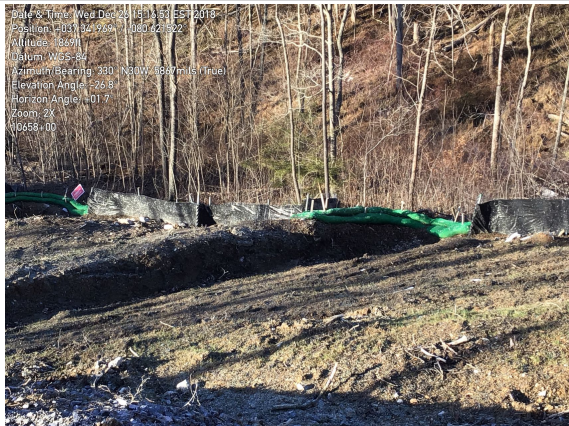
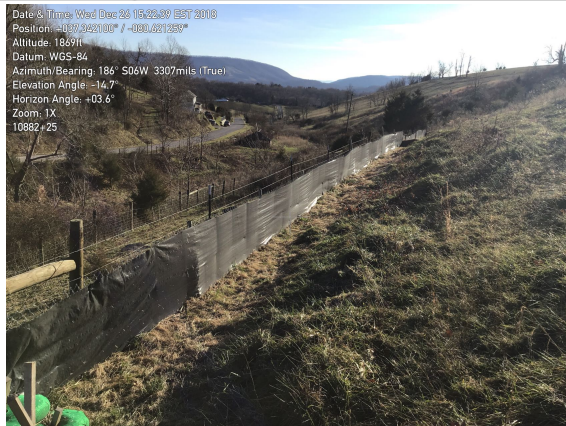
<p>Date & Time: Wed Dec 26 15:22:39 EST 2018 Position: -037.425100 / -80.021259 Altitude: 1869ft Datum: WGS-84 Azimuth/Bearing: 186° S06W 3307mils (True) Elevation Angle: -14.7 Horizon Angle: -03.6 Zoom: 1X 10882-25</p>			
GPS Location	37.2060417604019, -80.3943613469048		GPS Location	37.2060200350177, -80.3943872467333	
Description	See photo for GPS location and station number. Water bar with sump pit and end treatment in place.		Description	See photo for GPS location and station number. Reinforced silt fence in place per E&S sheets.

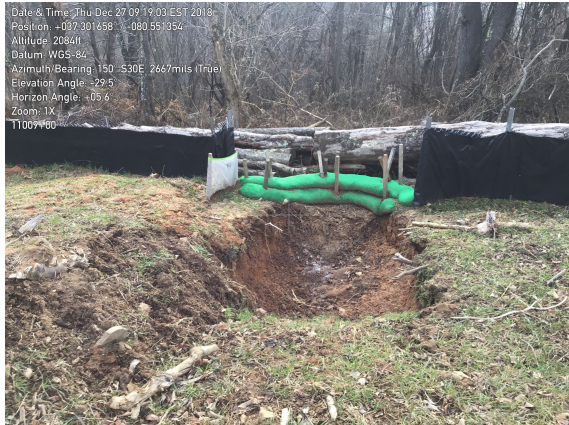
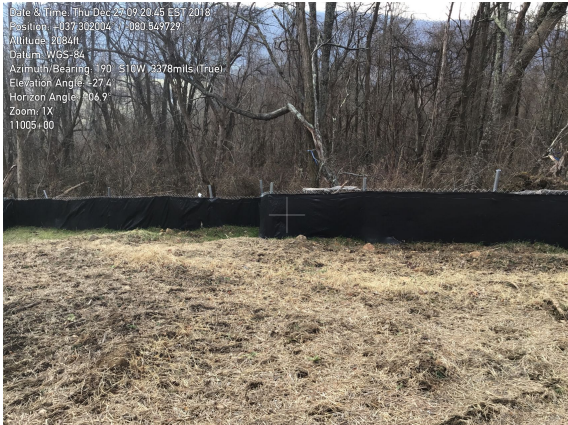
GPS Location	37.2060456084297, -80.394159071272	GPS Location	37.2060286536141, -80.3942807215563		
Description	See photo for GPS location and station number. Water bar with sump pit and end treatment.	Description	See photo for GPS location and station number. Reinforced silt fence in place.		
<p>Date & Time: Thu Dec 27 09:35:55 EST 2018 Position: +037.262586° / -080.5537179° Altitude: 2086ft Datum: WGS-84 Azimuth/Bearing: 242° S62W 4302mils (True) Elevation Angle: -13.7° Horizon Angle: +06.4° Zoom: 1X 10983+00</p>

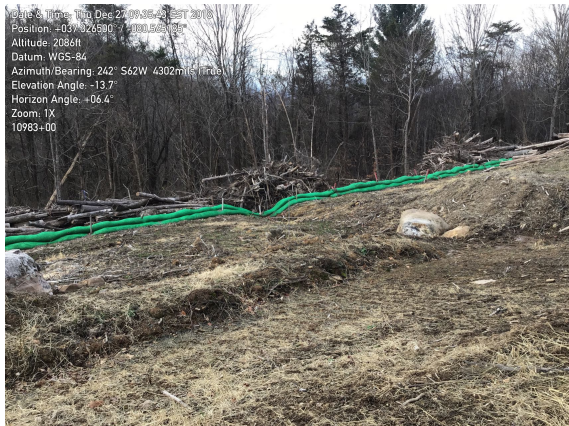
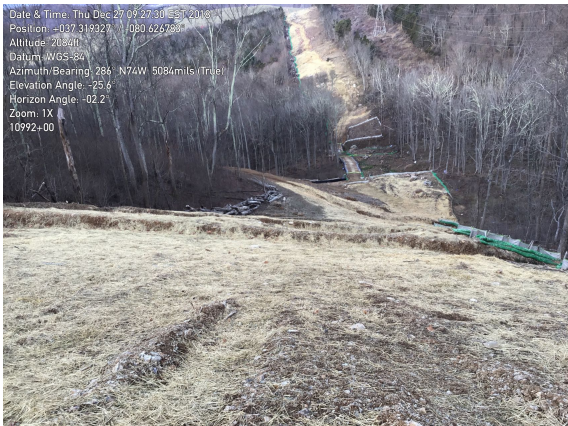
GPS Location	37.2060365333628, -80.3942651756756	GPS Location	37.2059703638588, -80.3943779163376		
Description	See photo for GPS location and station number. Triple stack 18 inch compost filter sock in place.	Description	See photo for GPS location and station number. Water bars in place.		
<p>Date & Time: Thu Dec 27 09:51:49 EST 2018 Position: +037.330457° / -080.5731179° Altitude: 2139ft Datum: WGS-84 Azimuth/Bearing: 300° N67W 5450mils (True) Elevation Angle: -09.4° Horizon Angle: -08.4° Zoom: 1X 10985+92 = +026</p>

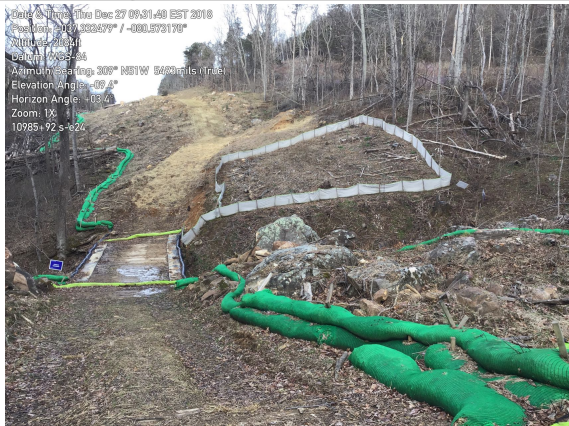
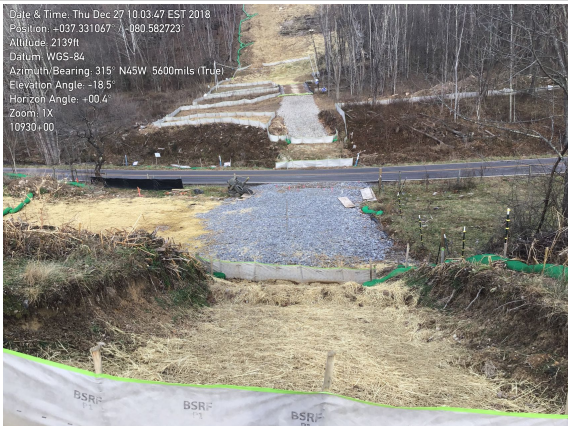
GPS Location	37.2059686262378, -80.3943810417744	GPS Location	37.2059685601915, -80.3943811601033		
Description	See photo for GPS location and station number. Stream S-E24 with ECD in place and sensitive resource buffer.	Description	See photo for GPS location and station number. RCE in place at Doe Creek Road.

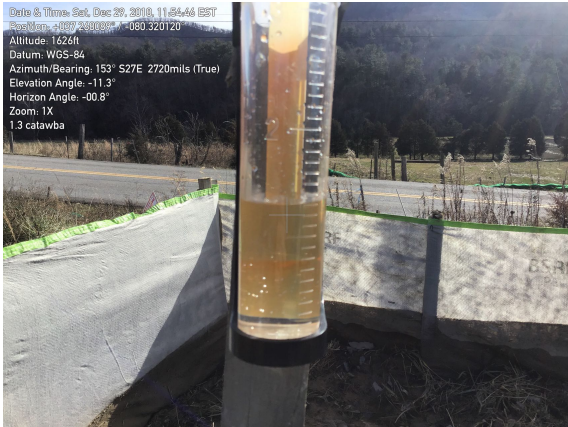
GPS Location	37.1360719995919, -80.3938969039176	GPS Location	37.1360585885468, -80.3941197787229		
Description	1.2 inches Craig creek rain gauge.	Description	1.3 inches Catawba rain gauge		
<p>Date & Time: Fri, Dec 28, 2018, 12:25:26 EST Position: +037.293644° / -080.422115° Altitude: 2044ft Datum: WGS-84 Azimuth/Bearing: 232° S52W 4720mils (True) Elevation Angle: -19.0° Horizon Angle: -02.3° Zoom: 1X s-pp20</p>  		<p>Date & Time: Fri, Dec 28, 2018, 12:27:09 EST Position: +037.293698° / -080.413409° Altitude: 2054ft Datum: WGS-84 Azimuth/Bearing: 249° S69W 4427mils (True) Elevation Angle: -19.2° Horizon Angle: -01.5° Zoom: 1X s-pp21</p>

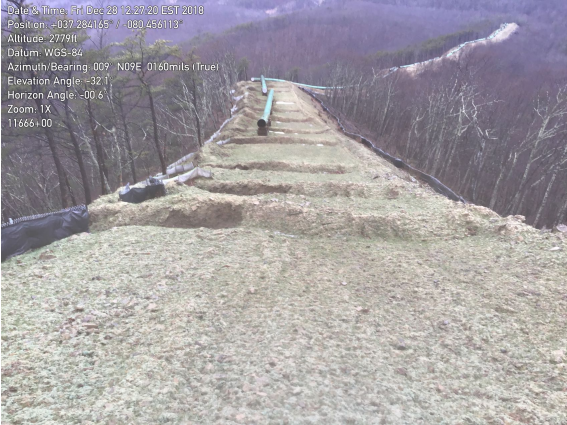
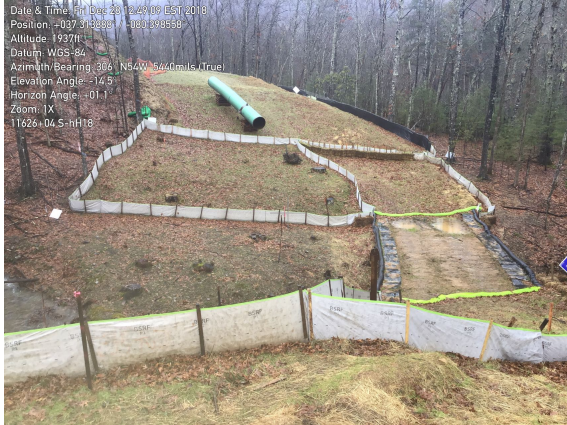
GPS Location	37.2060511433077, -80.3943338569952	GPS Location	37.2060564562462, -80.3940730007694		
Description	See photo for GPS location and station number. Water bars in place.	Description	See photo for GPS location and station number. ECDs and sensitive resource buffer in place at stream S-HH18.

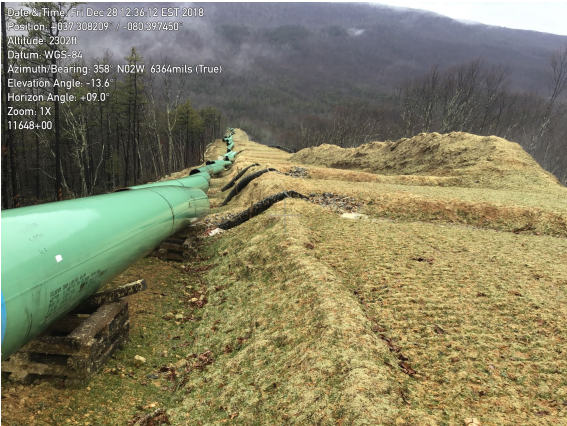
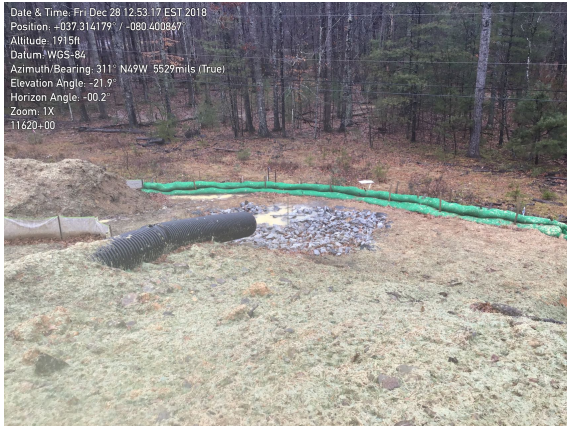
GPS Location	37.2060140025276, -80.3943854561844	GPS Location	37.2060089796269, -80.3943693258734		
Description	See photo for GPS location and station number. Slope drains over two-tone section with rock inlet and outlet filters.	Description	See photo for GPS location and station number. Plunge pool in place for clean water drainage pipe.

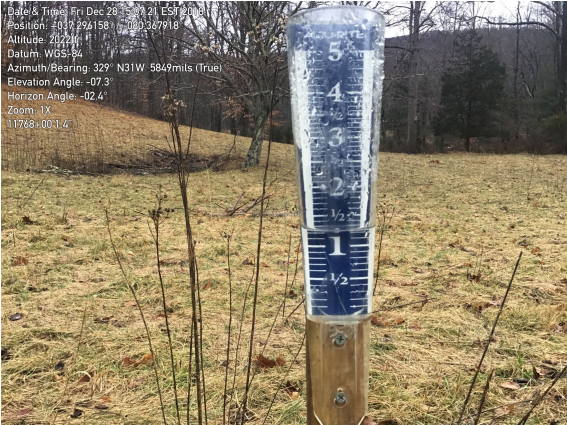
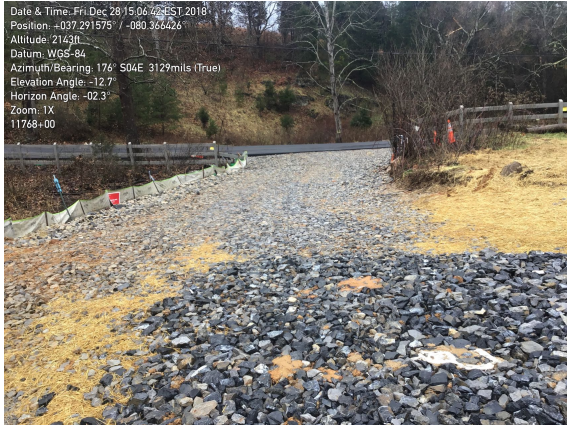
GPS Location	37.206021993449, -80.3943469741383	GPS Location	37.206023274277, -80.3943400283562		
Description	See photo for GPS location and station number. 1.4 inches of rain fall at Mount Tabor road.	Description	See photo for GPS location and station number. RCE in place and functional at main line valve 26.
