# Visual Site Inspection Report

<b>Project Name</b>	H-600 Pipeline Spread G	<b>AFE</b>	124300137	<b>Spread</b>	H-600 Pipeline Spread G
<b>Contractor</b>	Precision			<b>Report #</b>	12685
<b>Inspector</b>	Rob Robertson			<b>Date/Time</b>	1/4/2019 3:02 PM
<b>Permit #</b>	TBD	<b>Inspection Type</b>	VA SWPP	<b>Station Begin</b>	11669+87
<b>State</b>	VA	<b>Inspection Area</b>	Full	<b>Station End</b>	11600+12
<b>County</b>	Montgomery	<b>Ground</b>	Damp	<b>Temperature (°F)</b>	39.00
<b>Municipality</b>	N/A	<b>Weather</b>	Light Rain	<b>Rain Gauge (in)</b>	0.00
<b>GPS Location</b>	37.1330981003466, -80.3944576532397			<b>Rain Accumulation Time (days)</b>	1.00

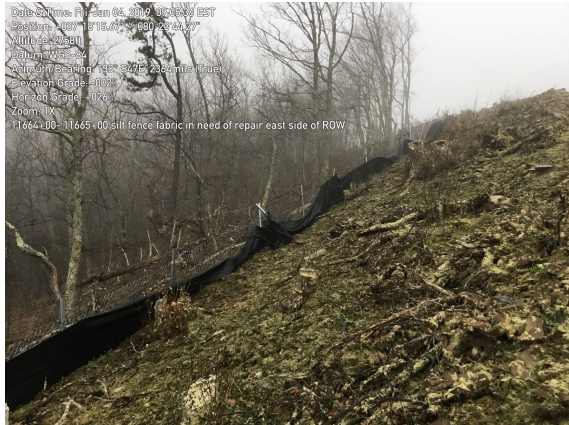
<p>Date &amp; Time: Fri, Jan 04, 2019, 09:23:30 EST Position: +037°18'49.97" N -080°23'54.29" W Altitude: 2509ft Datum: WGS-84 Azimuth/Bearing: 172° S04E 3093mils (True) Elevation Grade: -031 Horizon Grade: -000 Zoom: 1X 11664+00 - 11665+00 silt fence fabric in need of repair east side of ROW</p>

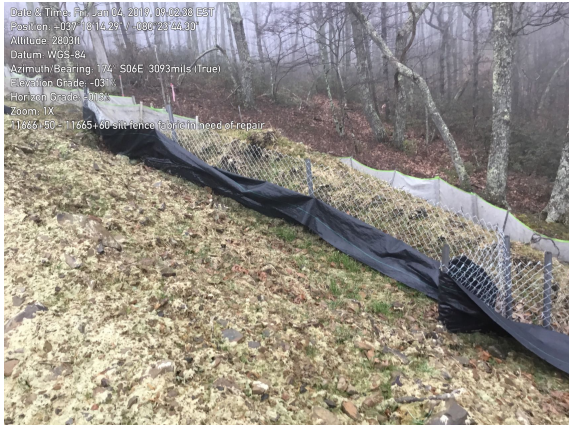
<p>Date &amp; Time: Fri, Jan 04, 2019, 09:23:30 EST Position: +037°18'49.97" N -080°23'54.29" W Altitude: 2509ft Datum: WGS-84 Azimuth/Bearing: 172° S04E 3093mils (True) Elevation Grade: -031 Horizon Grade: -000 Zoom: 1X 11664+00 - 11665+00 silt fence fabric in need of repair</p>			
GPS Location	37.1331446618188, -80.3944698069993		GPS Location	37.1331446618188, -80.3944698069993	
Description	Correct coordinates on photo. Wind has blown fabric off chain link. Will be re-attached.		Description	Correct coordinates on photo. Wind has blown fabric off chain link. Will be re-attached.

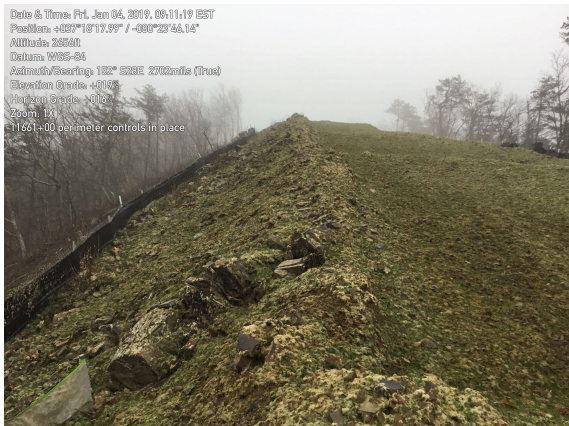
<p>Date &amp; Time: Fri, Jan 04, 2019, 09:11:19 EST Position: +037°18'49.97" N -080°23'54.14" W Altitude: 2554ft Datum: WGS-84 Azimuth/Bearing: 182° S32E 2702mils (True) Elevation Grade: -074 Horizon Grade: -000 Zoom: 1X 11661+00 perimeter controls in place</p>			
GPS Location	37.1331446618188, -80.3944698069993		GPS Location	37.1331311669546, -80.394455725402	
Description	Correct coordinates on photo. Perimeter controls functional. Topsoil piles stable.		Description	Correct coordinates on photo. Perimeter controls are functional.

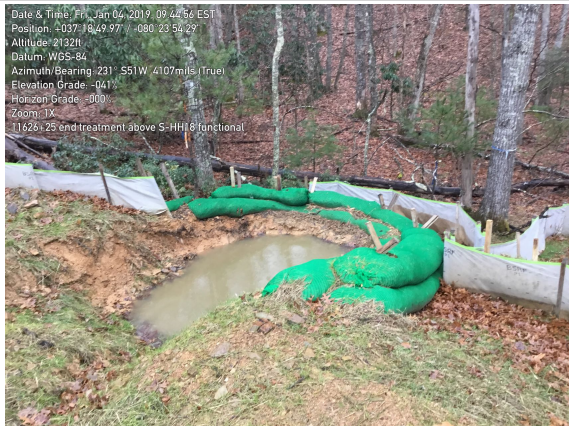
<p>Date &amp; Time: Fri, Jan 04, 2019, 09:44:56 EST Position: +037°18'49.97" N -080°23'54.29" W Altitude: 2132ft Datum: WGS-84 Azimuth/Bearing: 231° S51W 4107mils (True) Elevation Grade: -041 Horizon Grade: -000 Zoom: 1X 11626+25 end treatment above S-HH18 functional</p>

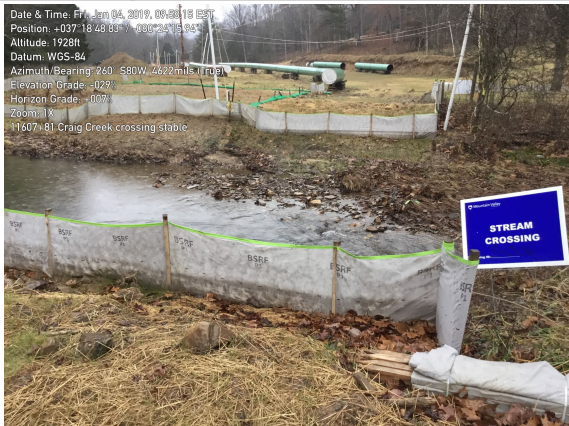
<p>Date &amp; Time: Fri, Jan 04, 2019, 09:54:19 EST Position: +037°18'48.83" N -080°24'13.94" W Altitude: 1928ft Datum: WGS-84 Azimuth/Bearing: 240° S80W 2422mils (True) Elevation Grade: -023 Horizon Grade: -000 Zoom: 1X 11607+81 Craig Creek crossing stable</p>

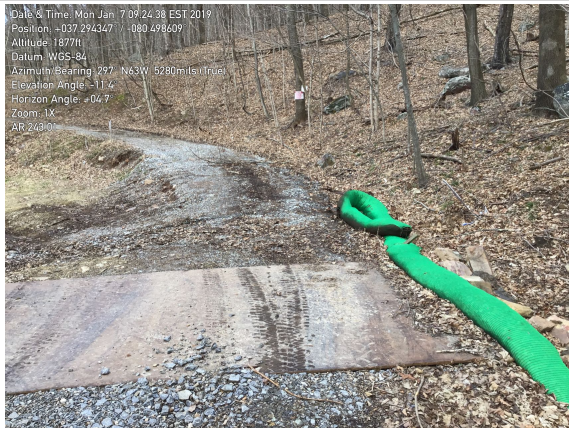
<b>A/E</b>	124300137	<b>Date/Time</b>	1/7/2019 4:12 PM	<b>Report #</b>	12744
<b>6. PCSM BMPs</b> (List BMPs and note if installed and maintained as per the plan. If corrective action is needed, a picture is required.)					
<b>PCSM BMPs</b>	<b>Compliance Level</b>	<b>Corrective Action</b>	<b>Corrective Time Frame</b>	<b>Date Repaired</b>	
<b>7. Identify all remedial measures that have been taken since the previous inspection was conducted.</b>					
<b>Comments</b> (Reference above questions as appropriate.)					
Conducted VA SWPPP inspection of Lay down Yard 29. Yard has no been used since last inspection due to winter shut down. All ECDs observed were functional.  Checked rain gauges from AR 234 to Buffalo Anklets Road. AR 234 had .7 inches and buffalo anklets road had .4 inches of rain fall.  Observed access roads 243.01 and 242.01. On access road 243.01 located damaged CFS. Communicated to the contractor via punchlist.

<p>Date &amp; Time: Mon Jan 7 09:24:38 EST 2019 Position: +037 292427° / -080 498609° Altitude: 1877ft Datum: WGS-84 Azimuth/Bearing: 292° N63W 5280mils (True) Elevation Angle: -11.6° Horizon Angle: -04.7° Zoom: 1X AR 243.01</p>		Insert image here			
GPS Location	37.2060643978189, -80.3943058844151	GPS Location			
Description	See photo for GPS location and station number. CFS damaged along AR 243.01.	Description

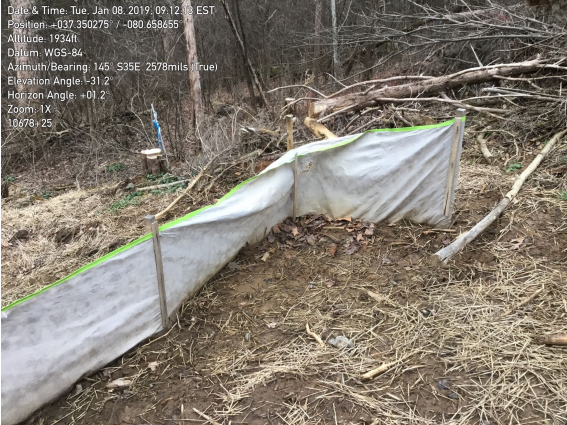
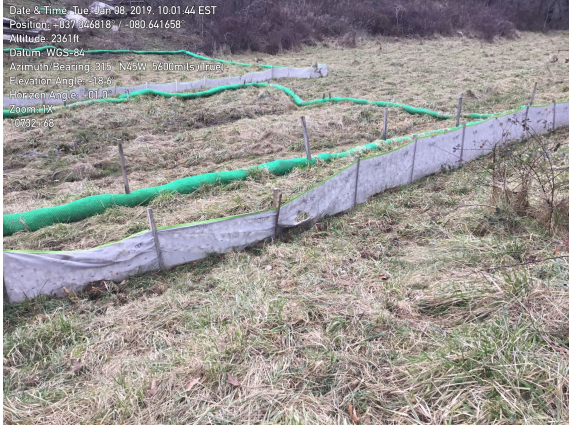
<b>GPS Location</b>	37.3328732187276, -80.7506047189988	<b>GPS Location</b>	37.3328714585279, -80.7505998574949		
<b>Description</b>	ECDs in need of maintenance 10678+25	<b>Description</b>	ECDs in need of maintenance 10732+68

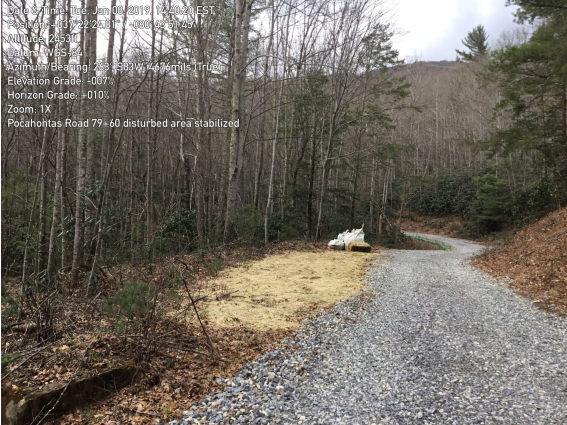
<p><b>GPS Location</b> 37.1331436140809, -80.3944389615957</p> <p><b>Description</b> Correct coordinates on photo. Disturbed area along edge of road stabilized.</p>	
<p>Date &amp; Time: Tue, Jan 08 2019 13:53:18 EST  Position: +087° 23' 25.00" W -080° 42' 37.75" N  Altitude: 2027ft  Datum: WGS-84  Azimuth/Bearing: 172° 503E 3147mils (True)  Elevation Grade: +052%  Horizon Grade: +008%  Zoom: 1X  Pocahontas Road 166+70 ECD trapping sediment</p>
