Visual Site Inspection Report

Project Name	H-600 Pipeline Spread G	AFE	124300137	Spread	H-600 Pipeline Spread G
Contractor	Precision			Report #	13199
Inspector	Len Kruizenga			Date/Time	1/21/2019 8:19 AM
Permit #	TBD	Inspection Type	VA SWPP	Station Begin	11254+88
State	WV	Inspection Area	Partial	Station End	11162+00
County	Monroe	Ground	Frozen	Temperature (°F)	4.00
Municipality	N/A	Weather	Sunny	Rain Gauge (in)	0.00
GPS Location	37.3275867800037, -80.4861710299966			Rain Accumulation Time (days)	1.00

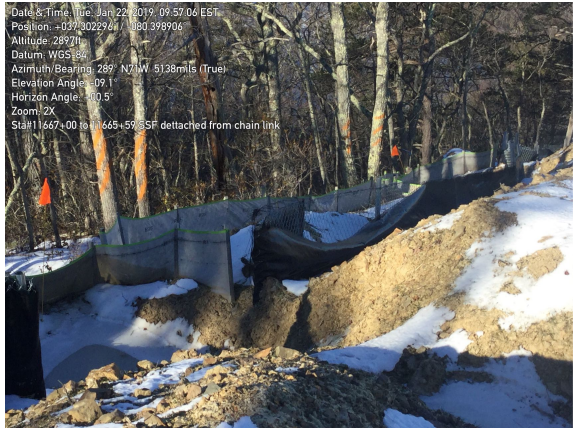
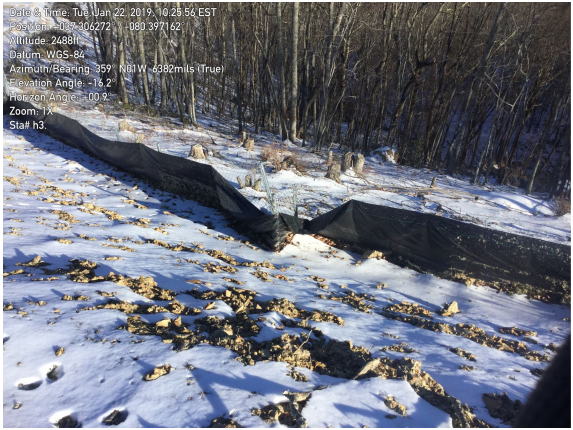
GPS Location	37.3039183952262, -80.3955716919903		GPS Location	37.3062276514595, -80.397370699868	
Description	Sta#11667+00 to 11665+00- Fabric detached from SSF chain link.		Description	Sta#11656+00- SSF fabric detached from chain link

4. E&S BMPs (List BMPs and note if installed and maintained as per the plan. If corrective action is needed, a picture is required.)					
E&S BMPs	Compliance Level	Corrective Action		Corrective Time Frame	Date Repaired
Compost Filter Sock	Acceptable				
Housekeeping	Acceptable				
Rock Construction Entrance	Acceptable				
Sensitive Resource Buffer	Acceptable				
Sensitive Resource Signage	Acceptable				
Silt Fence (Filter Fabric Fence)	Acceptable				
Silt Fence (Reinforced Filter Fabric Fence)	Problem Area	Attach fabric to chain link		24 Hours	
Straw Bale Barrier	Acceptable				
Waterbar	Acceptable

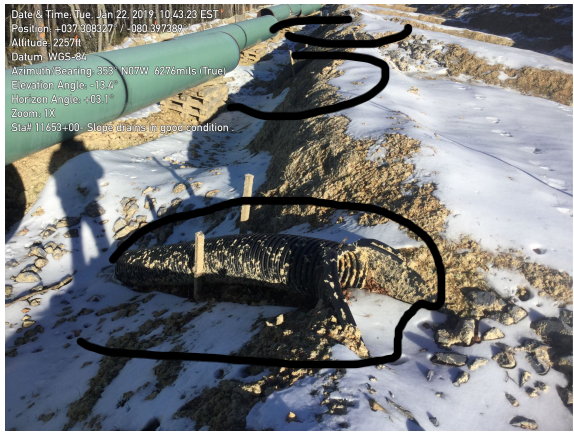
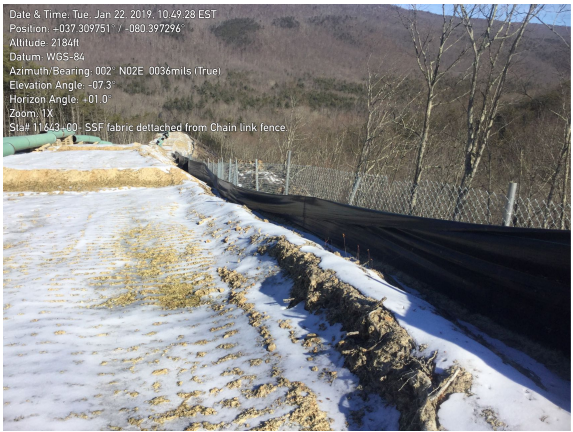
GPS Location	37.3083057348033, -80.3973927442733		GPS Location	37.3097621323888, -80.3972422052924	
Description	Sta#11653+00- Slope drains are in good condition.		Description	Sta#11643+00- Fabric loose on SSF chain link

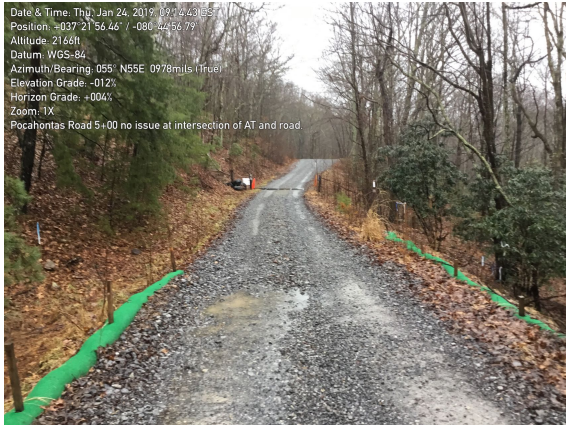
GPS Location	37.133117528162, -80.3944800568839	GPS Location	37.1330777857424, -80.394454186457		
Description	Correct coordinates on photo. Patches of ice are now melting.	Description	Correct coordinates on photo. No issues near intersection of Appalachian Trail and Pocahontas Road.

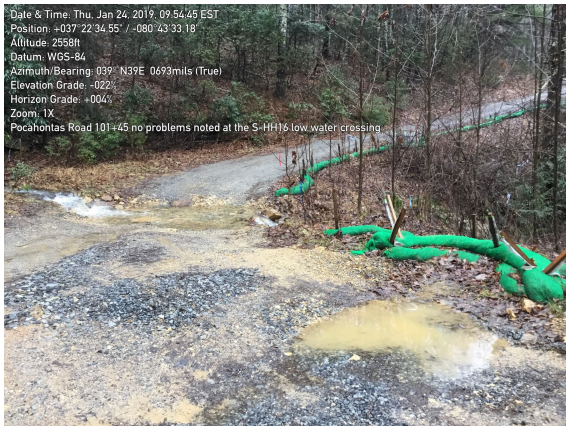
GPS Location	37.1330701466996, -80.3943931964044	GPS Location	37.1330162929717, -80.3944052663449		
Description	Correct coordinates on photo. Resources crossed by the road show no signs of impact.	Description	Correct coordinates on photo. Resources crossed by the road show no sign of impact.		
<p>Date & Time: Thu, Jan 24, 2019, 10:57:27 EST Position: +037°23'48.86" / -080°41'39.22" Altitude: 2836ft Datum: WGS-84 Azimuth/Bearing: 078° N78E 1387mils (True) Elevation Grade: +044% Horizon Grade: +004% Zoom: 1X Pocahontas Road 125+00 impact apparent to adjacent resource W-UU11</p>

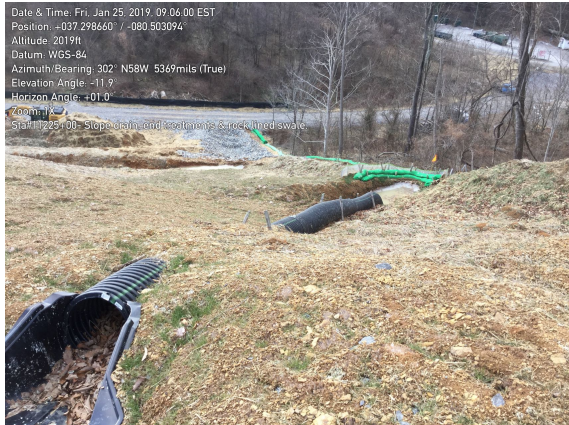
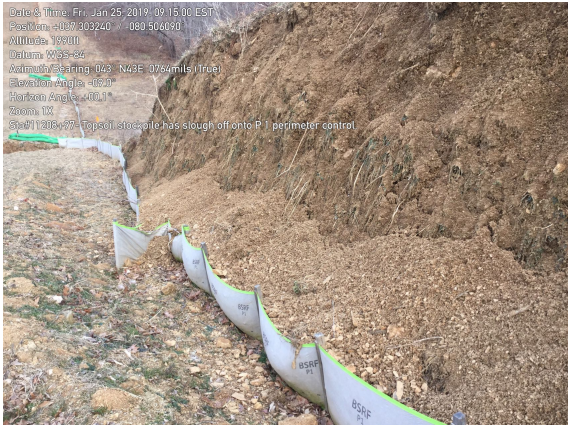
<p>Date & Time: Fri, Jan 25, 2019, 09:15:00 EST Position: +037.303240 / -080.506020 Altitude: 1920ft Datum: WGS-84 Azimuth/Bearing: 032° N36E 0780mils (True) Elevation Angle: -04.0° Horizon Angle: -00.1° Zoom: 1X Sta#11208+97- Topsoil stockpile has slough off onto P 1 perimeter control</p>

GPS Location	37.3015344562356, -80.5025731400405	GPS Location	37.3032880341982, -80.5060930364584		
Description	Sta#11225+00- Slope drain , end treatments, rock lined swale.	Description	Sta#11208+97- Topsoil stockpile has slough off onto p 1 perimeter controls.

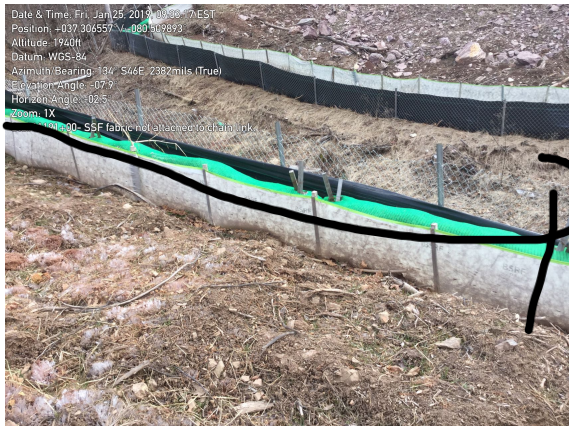
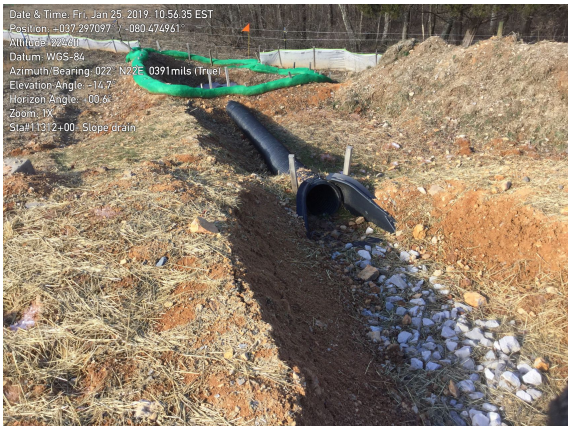
<p>Date & Time: Fri, Jan 25, 2019, 10:56:35 EST Position: +037.297097 / -080.474961 Altitude: 1930ft Datum: WGS-84 Azimuth/Bearing: 022° N72E 0391mils (True) Elevation Angle: -14.7° Horizon Angle: -00.6° Zoom: 1X Sta#11312+00- Slope drain</p>

GPS Location	37.3103246000012, -80.5146305915718	GPS Location	37.2970929695641, -80.4752358143036		
Description	Sta#11191+00- SSF fabric has blown loose from chain link fence.	Description	Sta#11312+00- Slope drain.		
<p>Date & Time: Fri, Jan 25, 2019, 11:00:23 EST Position: +037.298275 / -080.474537 Altitude: 2027ft Datum: WGS-84 Azimuth/Bearing: 032° N40W 5590mils (True) Elevation Angle: -14.1° Horizon Angle: -01.8° Zoom: 1X Sta#11315+50- P 1 perimeter control wooden fence snapped off fence down</p>

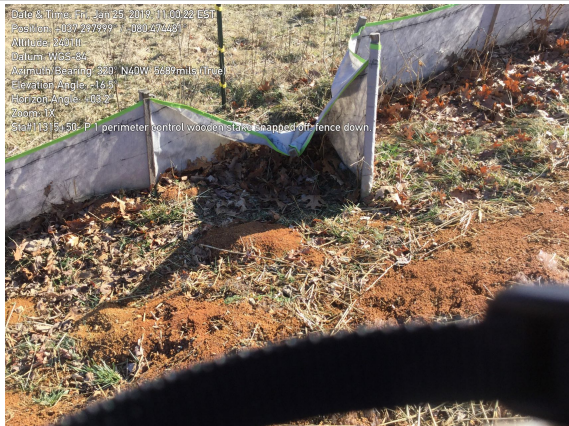
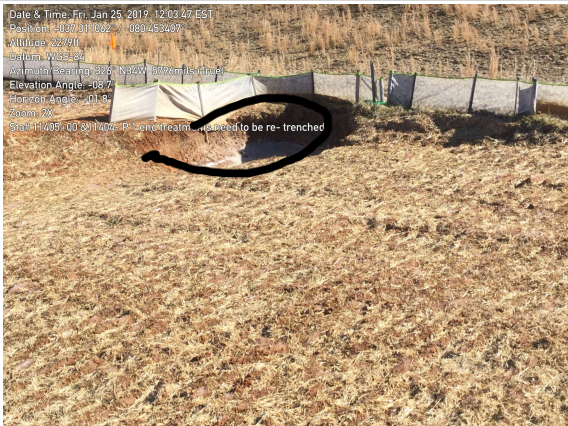
<p>Date & Time: Fri, Jan 25, 2019, 12:03:47 EST Position: +037.311022 / -080.453647 Altitude: 2229ft Datum: WGS-84 Azimuth/Bearing: 022° N36W 6080mils (True) Elevation Angle: -08.9° Horizon Angle: -01.8° Zoom: 1X Sta#11405+00 & 11404+00- P 1 end treatment, appeared to be re- trenched</p>

GPS Location	37.298275530373, -80.4744536150996	GPS Location	37.3110552505006, -80.4531782493744		
Description	Sta#11315+50- P 1 stake snapped off fence down.	Description	Sta#'s 11405+00 & 11404+00- P 1 end treatments need to be re- trenched.

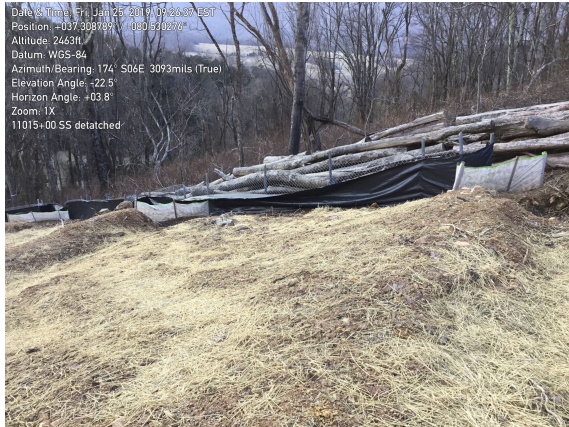
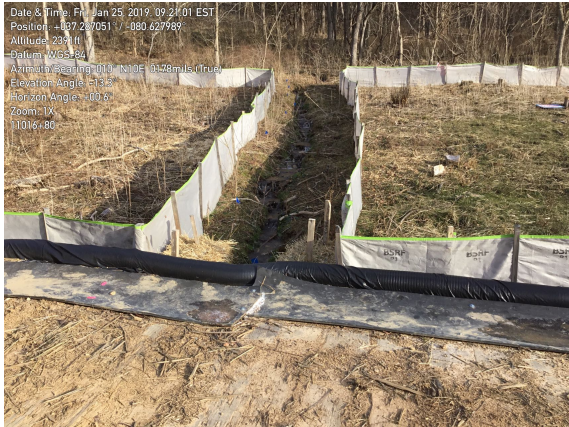
GPS Location	37.3339188446492, -80.7501643378975	GPS Location	37.334013742583, -80.7500948309994		
Description	11015+00 silt fence detached	Description	Stream with functional ECDs 11016+80		
<p>Date & Time: Fri, Jan 25, 2019, 09:21:50 EST Position: +037.023501 / -080.555516 Altitude: 2400ft Datum: WGS-84 Azimuth/Bearing: 322 N38W 322mils (True) Elevation Angle: -05.7 Horizon Angle: -02.1 Zoom: 1X 11016+80</p>
