# Visual Site Inspection Report

<b>Project Name</b>	H-600 Pipeline Spread G	<b>AFE</b>	124300137	<b>Spread</b>	H-600 Pipeline Spread G	
<b>Contractor</b>	Precision			<b>Report #</b>	13628	
<b>Inspector</b>	Len Kruizenga			<b>Date/Time</b>	2/4/2019 7:02 AM	
<b>Permit #</b>	TBD	<b>Inspection Type</b>	VA SWPP	<b>Station Begin</b>	+0	
<b>State</b>	WV	<b>Inspection Area</b>	Full	<b>Station End</b>	+0	
<b>County</b>	Monroe	<b>Ground</b>	Frozen	<b>Temperature (°F)</b>	55.00	
<b>Municipality</b>	N/A	<b>Weather</b>	Sunny	<b>Rain Gauge (in)</b>	0.00	
<b>GPS Location</b>	37.4164080201065, -80.7403622009612			<b>Rain Accumulation Time (days)</b>	1.00

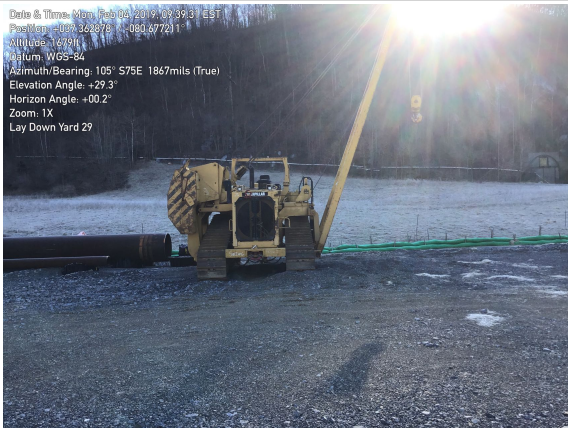
Description	See photo for GPS location. Lay down yard 29 covered is crushed lime stone per spec.		Description	See photo for GPS location. Staged equipment at lay down yard 29. No leaks observed.

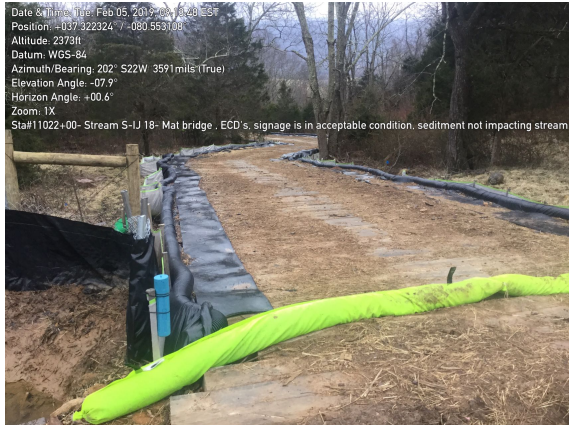
<b>A/E</b>	124300137	<b>Date/Time</b>	2/5/2019 6:59 AM	<b>Report #</b>	13663
<b>Pictures</b>					
<p>Date &amp; Time: Tue, Feb 05, 2019, 10:26:39 EST Position: +037.322324 / -080.553109 Altitude: 2373ft Datum: WGS-84 Azimuth/Bearing: 202° S22W 3591mils (True) Elevation Angle: -07.9° Horizon Angle: +00.6° Zoom: 1X Sta#11022+00- Stream S-IJ 18- Mat bridge, ECD's, signage is in acceptable condition, sediment not impacting stream.</p>

<b>GPS Location</b>	37.3223051056613, -80.55308701478	<b>GPS Location</b>	37.3232393106793, -80.5541462358837		
<b>Description</b>	Sta#11022+00- Stream S- IJ 18, bridge & ECD's are in good condition.	<b>Description</b>	Sta#11015+00- Stream S-RR 5- Bridge, ECD's, signage in good condition.

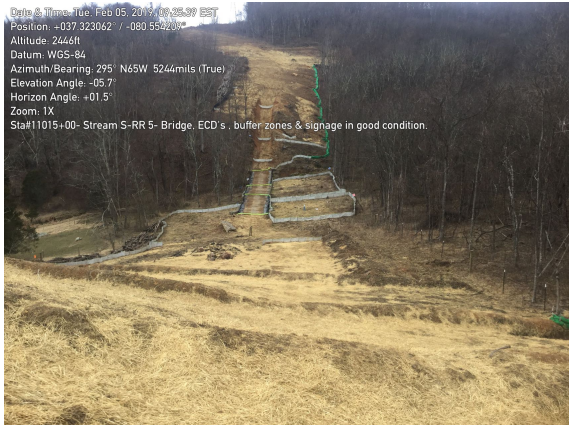
<p>Date &amp; Time: Tue, Feb 05, 2019, 10:26:39 EST Position: +037.323062 / -080.553220 Altitude: 2446ft Datum: WGS-84 Azimuth/Bearing: 295° N65W 5244mils (True) Elevation Angle: -05.7° Horizon Angle: +01.5° Zoom: 1X Sta#11015+00- Stream S-RR 5- Bridge, ECD's, buffer zones &amp; signage in good condition.</p>

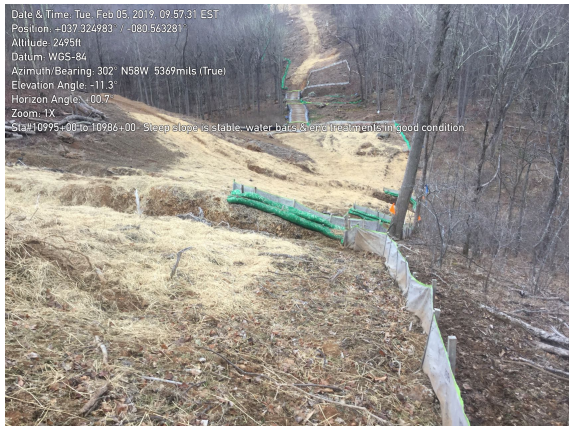
<p>Date &amp; Time: Tue, Feb 05, 2019, 09:57:31 EST Position: +037.324983 / -080.563281 Altitude: 2495ft Datum: WGS-84 Azimuth/Bearing: 302° N58W 5369mils (True) Elevation Angle: -11.3° Horizon Angle: -00.7° Zoom: 1X Sta#10995+00 to 10986+00- Steep slope is stable, water bars &amp; end treatments in good condition.</p>

<b>GPS Location</b>	37.3249825369914, -80.5632809177791	<b>GPS Location</b>	37.3252673540612, -80.563566070125		
<b>Description</b>	Sta#10995+00 to 10986+00- Steep slope & water bars & end treatments are in good condition.	<b>Description</b>	Sta#10991+00- Triple stack end treatment undermined, also P1 undermined.

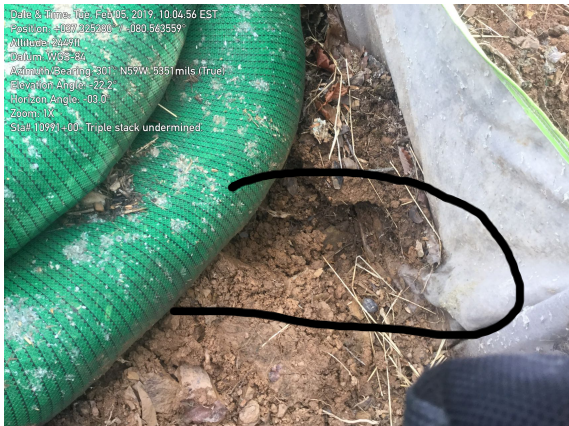
<p>Date &amp; Time: Tue, Feb 05, 2019, 10:04:56 EST Position: +037.325267 / -080.563559 Altitude: 2527ft Datum: WGS-84 Azimuth/Bearing: 301° N59W 5351mils (True) Elevation Angle: -22.2° Horizon Angle: -03.0° Zoom: 1X Sta#10991+00- Triple stack undermined.</p>

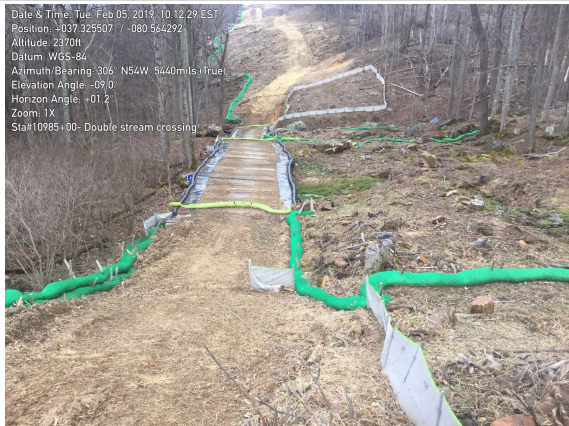
<p>Date &amp; Time: Tue, Feb 05, 2019, 10:12:29 EST Position: +037.325507 / -080.564292 Altitude: 2370ft Datum: WGS-84 Azimuth/Bearing: 306° N54W 5440mils (True) Elevation Angle: -09.0° Horizon Angle: +01.2° Zoom: 1X Sta#10985+00- Double stream crossing.</p>

<b>GPS Location</b>	37.3255008738836, -80.5643521250045	<b>GPS Location</b>	37.3274284601559, -80.5715535209333		
<b>Description</b>	Sta#10985+00- Double stream crossings.	<b>Description</b>	Sta#10966+00- SSF fabric detached from chain link

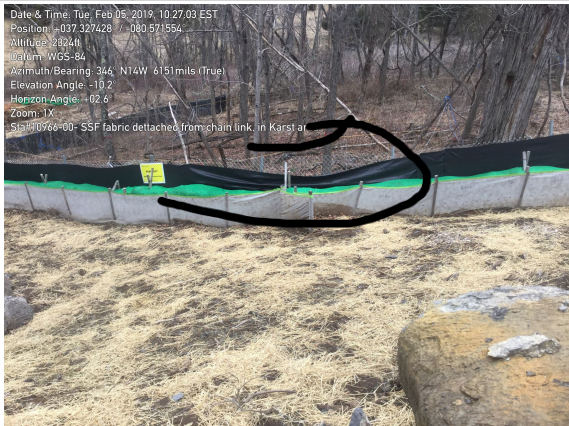
<p>Date &amp; Time: Tue, Feb 05, 2019, 10:27:03 EST Position: +037.327428 / -080.571554 Altitude: 2324ft Datum: WGS-84 Azimuth/Bearing: 344° N14W 6151mils (True) Elevation Angle: -10.2° Horizon Angle: +02.6° Zoom: 1X Sta#10966+00- SSF fabric detached from chain link, in Karst area.</p>

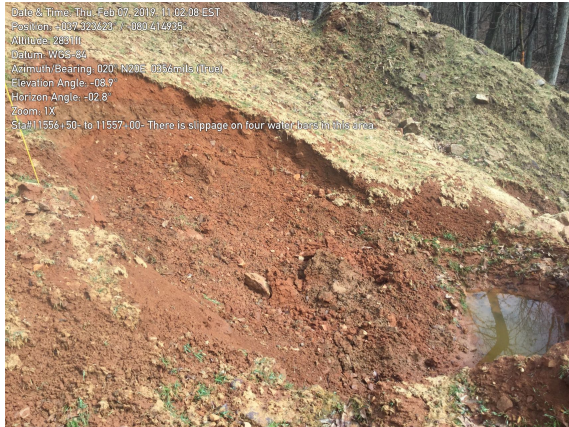
A/E	124300137	Date/Time	2/7/2019 7:24 AM	Report #	13746
Pictures					
<p>Date &amp; Time: Thu, Feb 07, 2019, 11:02:08 EST Position: +037.3275277 / -080.412288 Altitude: 2231ft Datum: WGS-84 Azimuth/Bearing: 020° N33W 483mils (True) Elevation Angle: -03.0° Horizon Angle: -02.8° Zoom: 1X Sta#11556+50 to 11557+00- There is slippage on four water bars in this area</p>

GPS Location	37.32759277, -80.48617247	GPS Location	37.32759277, -80.48617247		
Description	Sta#11556+50 to 11557+00- There are four water bars where soils are sloughing off above the water bars.	Description	Sta#11570+00 to 11570+97- Two tone bank is sloughing off.

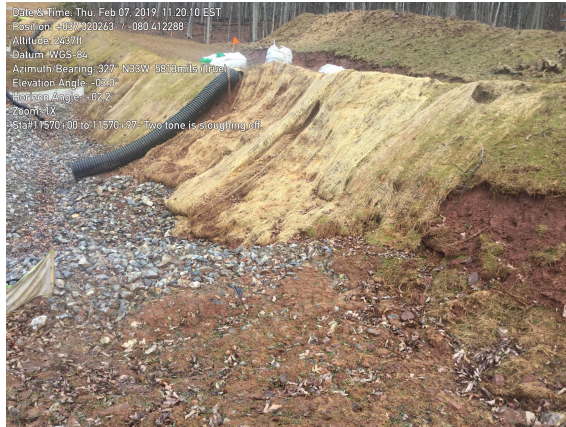
<p>Date &amp; Time: Thu, Feb 07, 2019, 11:20:10 EST Position: +037.3275277 / -080.412288 Altitude: 2231ft Datum: WGS-84 Azimuth/Bearing: 322° N33W 483mils (True) Elevation Angle: -03.0° Horizon Angle: -03.2° Zoom: 1X Sta#11570+00 to 11570+97- Two tone bank is sloughing off</p>
