Visual Site Inspection Report

Project Name	H-600 Pipeline Spread G	AFE	124300137	Spread	H-600 Pipeline Spread G	
Contractor	Precision			Report #	13873	
Inspector	Len Kruizenga			Date/Time	2/11/2019 8:37 AM	
Permit #	TBD	Inspection Type	VA SWPP	Station Begin	0+00	
State	WV	Inspection Area	Full	Station End	0+00	
County	Monroe	Ground	Muddy	Temperature (°F)	36.00	
Municipality	N/A	Weather	Light Rain	Rain Gauge (in)	0.50	
GPS Location	37.4166912446147, -80.7412810251869			Rain Accumulation Time (days)	1.00

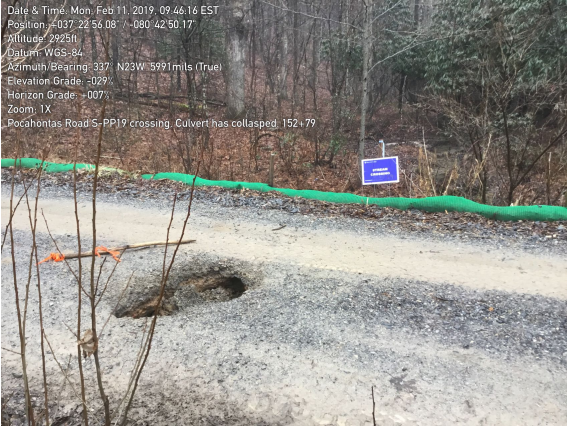
<p>Date & Time: Mon, Feb 11, 2019, 10:59:41 EST Position: +037° 22' 56.49" / -080° 43' 5.52" Altitude: 2958ft Datum: WGS-84 Azimuth/Bearing: 061° N61E 1084mils (True) Elevation Grade: -010% Horizon Grade: +005% Zoom: 1X Pocahontas Road small dozer staged near 309+50 trees - leaks</p>

GPS Location	37.13305196, -80.39505864	GPS Location	37.13305196, -80.39505864		
Description	Correct coordinates on photo. Failed culvert resulting in hole on road surface at S-PP19 crossing near 152+79.	Description	Correct coordinates on photo. Equipment staged on road is free of leaks.

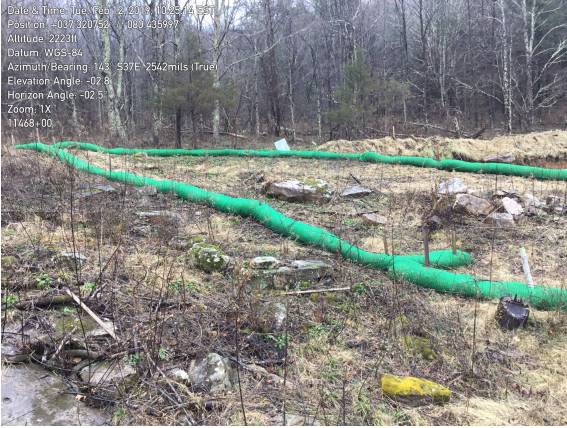
<p>Date & Time: Tue, Feb 12, 2019, 10:53:08 EST Position: +037.318466° / -080.442380° Altitude: 2154ft Datum: WGS-84 Azimuth/Bearing: 337° N23W 5591mils (True) Elevation Angle: -02.6° Horizon Angle: -02.5° Zoom: 1X 11468+00</p>

GPS Location	37.3193083657299, -80.65788108863	GPS Location	37.3193083657299, -80.65788108863		
Description	CFS needing additional stakes 11468+00	Description	SSF fabric loose 11436+00		
<p>Date & Time: Tue, Feb 12, 2019, 11:27:19 EST Position: +037.300936° / -080.580856° Altitude: 2339ft Datum: WGS-84 Azimuth/Bearing: 330° N30W 5857mils (True) Elevation Angle: -01.1° Horizon Angle: -02.2° Zoom: 1X 11405+00</p>

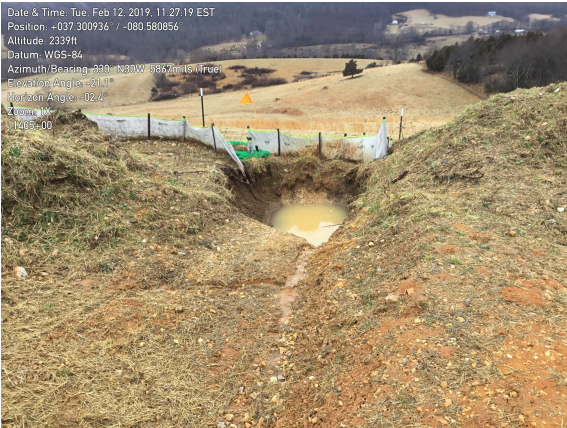
GPS Location	37.3193083657299, -80.65788108863	GPS Location	37.3193986807366, -80.6579033006734		
Description	SF falling into sump 11405+00	Description	SF undermined 11419+90		
<p>Date & Time: Tue, Feb 12, 2019, 11:04:00 EST Position: +037.329502° / -080.502932° Altitude: 2090ft Datum: WGS-84 Azimuth/Bearing: 019° N19E 0388mils (True) Elevation Angle: -20.6° Horizon Angle: -01.5° Zoom: 1X 11402+00</p>

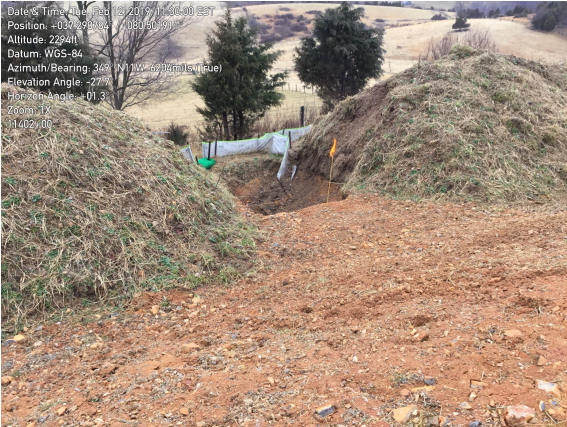
GPS Location	37.3193820122888, -80.6577721685391	GPS Location	37.3193789340816, -80.6577841074189		
Description	SF falling into sump 11402+00	Description	Sediment on bridge 11360+00

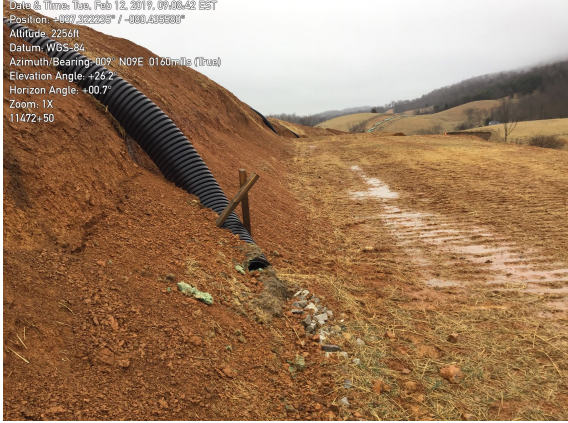
GPS Location	37.2060983356815, -80.3941397077804	GPS Location	37.2061560186442, -80.3941603864417		
Description	See photo for station number and GPS location. Triple stack CFS, priority one silt fence, and reinforced silt fence in place.	Description	See photo for station number and GPS location. Two-tone sloughed off and covered up pipe outlet and rock outlet.

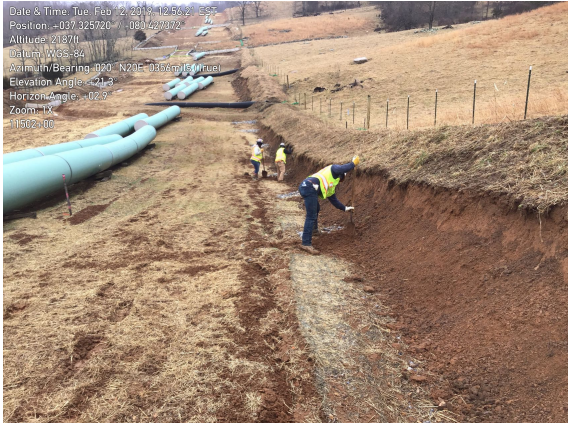
GPS Location	37.2061428241778, -80.393877038807	GPS Location	37.2061428241778, -80.393877038807		
Description	See photo for station number and GPS location. Rocked lined channel.	Description	See photo for station number and GPS location. Environmental crew removing sediment from rock checks.
