# Visual Site Inspection Report

<b>Project Name</b>	H-600 Pipeline Spread G	<b>AFE</b>	124300137	<b>Spread</b>	H-600 Pipeline Spread G
<b>Contractor</b>	Precision			<b>Report #</b>	14132
<b>Inspector</b>	Len Kruizenga			<b>Date/Time</b>	2/18/2019 8:58 AM
<b>Permit #</b>	TBD	<b>Inspection Type</b>	VA SWPP	<b>Station Begin</b>	11254+88
<b>State</b>	VA	<b>Inspection Area</b>	Partial	<b>Station End</b>	11161+00
<b>County</b>	Giles	<b>Ground</b>	Muddy	<b>Temperature (°F)</b>	43.00
<b>Municipality</b>	N/A	<b>Weather</b>	Cloudy	<b>Rain Gauge (in)</b>	1.00
<b>GPS Location</b>	37.3275343655025, -80.4861149378871			<b>Rain Accumulation Time (days)</b>	2.00

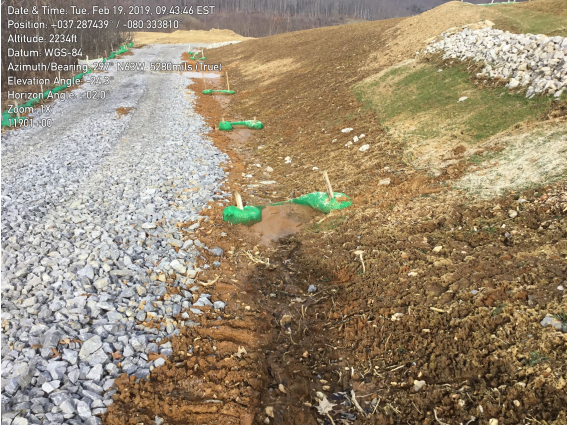
<b>GPS Location</b>	37.319371002384, -80.6577529692918	<b>GPS Location</b>	37.3197013726401, -80.6574341263483		
<b>Description</b>	Ditch check with sediment build up 11901+00	<b>Description</b>	ECDs protecting karst 11942+00

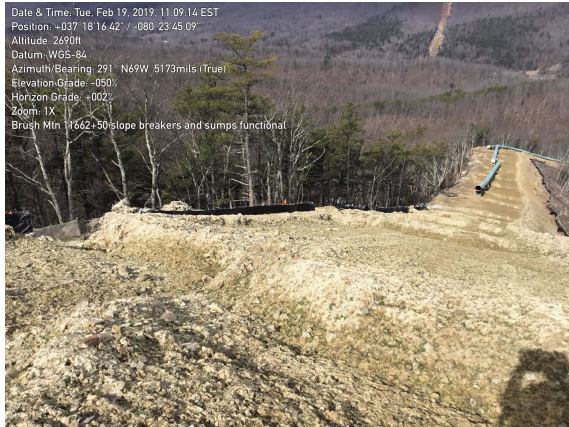
<p>Date &amp; Time: Tue, Feb 19, 2019, 11:17:56 EST Position: +037° 18' 18.98" / -080° 23' 48.22" Altitude: 2570ft Datum: WGS-84 Azimuth/Bearing: 305° N65W 5422mils (True) Elevation Grade: +072% Horizon Grade: +012% Zoom: 1X Brush Mtn 11659+00 end treatments functional</p>  			
GPS Location	37.1331260539937, -80.3945369460437	GPS Location	37.1329057775784, -80.3944510315362		
Description	Correct coordinates on photo. Slope breakers in place and working properly.	Description	Correct coordinates on photo. Sumps have end treatments in place.

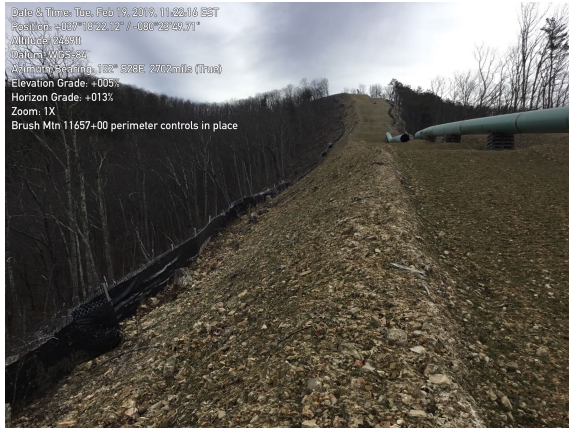
<p>Date &amp; Time: Tue, Feb 19, 2019, 11:58:57 EST Position: +037° 18' 48.16" / -080° 23' 51.24" Altitude: 1887ft Datum: WGS-84 Azimuth/Bearing: 325° N35W 5778mils (True) Elevation Grade: +048% Horizon Grade: +010% Zoom: 1X Brush Mtn 11638+00 perimeter controls functioning</p>  			
GPS Location	37.1330837672922, -80.3944158275429	GPS Location	37.1331382496628, -80.3943970520798		
Description	Correct coordinates on photo. Perimeter controls are in place and functioning.	Description	Correct coordinates on photo. Perimeter controls are functional.		
<p>Date &amp; Time: Tue, Feb 19, 2019, 12:16:30 EST Position: +037° 18' 48.80" / -080° 24' 8.85" Altitude: 1920ft Datum: WGS-84 Azimuth/Bearing: 311° N49W 5529mils (True) Elevation Grade: +026% Horizon Grade: +002% Zoom: 1X Brush Mtn S-006 crossing stable</p>

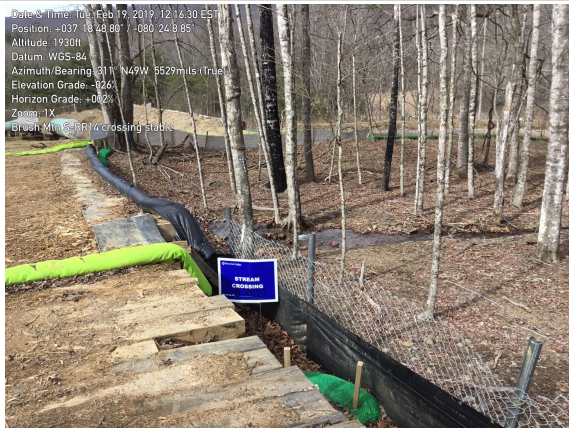
<p>Date &amp; Time: Tue, Feb 19, 2019, 12:44:48 EST Position: +037° 18' 53.26" / -080° 24' 16.52" Altitude: 1907ft Datum: WGS-84 Azimuth/Bearing: 071° N01E 1222mils (True) Elevation Grade: +019% Horizon Grade: +004% Zoom: 1X Brush Mtn S-006 crossing stable</p>

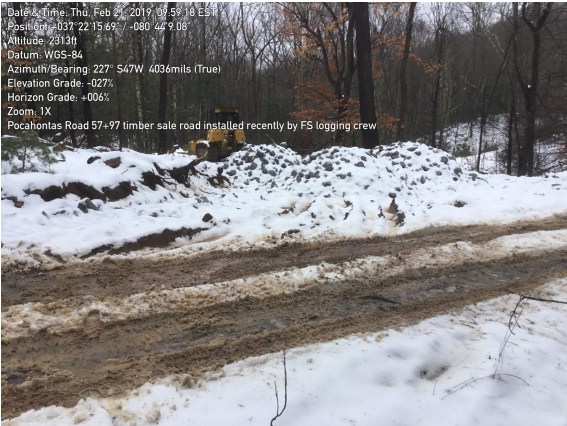
<p>Date &amp; Time: Thu, Feb 21, 2019, 10:00:11 EST  Position: +037° 22' 15.49" / -080° 44' 20.19"  Altitude: 2281ft  Datum: WGS-84  Azimuth/Bearing: 249° S50W 4027mils (True)  Elevation Grade: -007%  Horizon Grade: +012%  Zoom: 2X  Pocahontas Road 40+00 no problems identified from runoff</p>

<b>GPS Location</b>	37.3192325095062, -80.6578655821091	<b>GPS Location</b>	37.3192325095062, -80.6578655821091		
<b>Description</b>	Correct coordinates on photo. No logging activity or traffic on Pocahontas Road today.	<b>Description</b>	Correct coordinates on photo. Road should be crowned to prevent runoff traveling downslope.

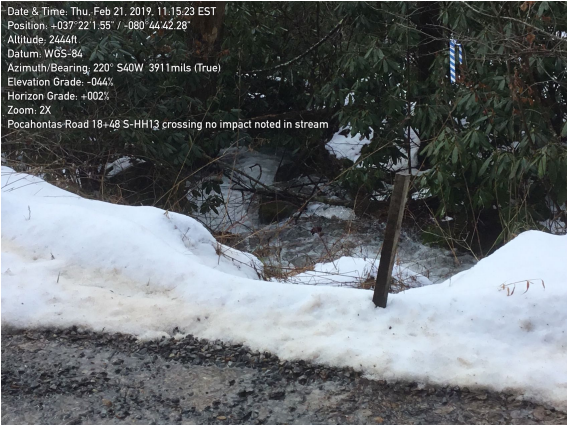
<p>Date &amp; Time: Thu, Feb 21, 2019, 11:18:43 EST  Position: +037° 21' 56.88" / -080° 44' 57.14"  Altitude: 2238ft  Datum: WGS-84  Azimuth/Bearing: 117° S43E 2080mils (True)  Elevation Grade: -052%  Horizon Grade: +006%  Zoom: 1X  Pocahontas Road 00 S-SS2 crossing no impact noted</p>

<b>GPS Location</b>	37.3192325095062, -80.6578655821091	<b>GPS Location</b>	37.3192325095062, -80.6578655821091		
<b>Description</b>	Correct coordinates on photo. No impact found at the S-HH13 crossing.	<b>Description</b>	Correct coordinates on photo. No impact noted at the S-SS2 crossing.

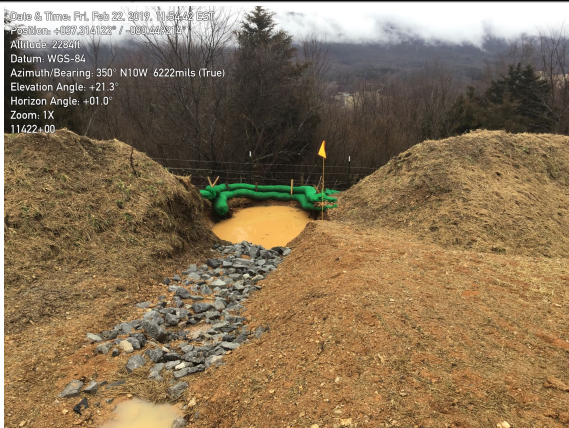
GPS Location	37.2061367053885, -80.3938339558247	GPS Location	37.2061367053885, -80.3938339558247		
Description	See photo for station number and GPS location. Plunge pool in place.	Description	See photo for station number and GPS location. CFS end treatment starting to fall into sump pit.
