Visual Site Inspection Report

Project Name	H-600 Pipeline Spread G	AFE	124300137	Spread	H-600 Pipeline Spread G
Contractor	Precision			Report #	14528
Inspector	Trey Ingram			Date/Time	3/2/2019 11:47 AM
Permit #	TBD	Inspection Type	Daily	Station Begin	10300+00
State	VA	Inspection Area	Full	Station End	11300+00
County	Montgomery	Ground	Muddy	Temperature (°F)	45.00
Municipality	N/A	Weather	Cloudy	Rain Gauge (in)	0.50
GPS Location	37.3338476515141, -80.7502208090308			Rain Accumulation Time (days)	1.00

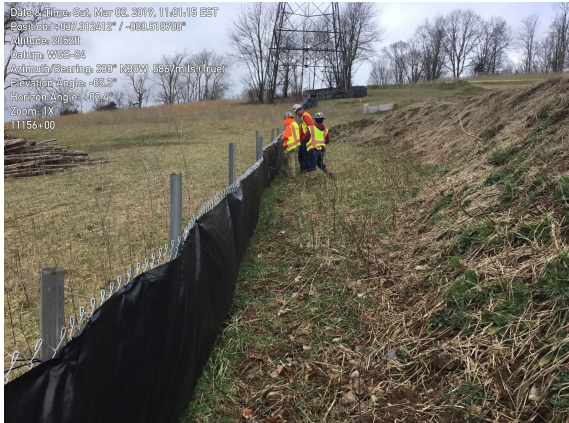
GPS Location	37.3338624939511, -80.7501798021893		GPS Location	37.3329892242675, -80.7503910642869	
Description	Paperwork		Description	Crew repairing Super silt fence 11156+00	
<p>Date & Time: Sat, Mar 02, 2019, 07:50:26 EST Position: -037.414700 / -88.741191 Altitude: 1828ft Datum: WGS-84 Azimuth/Bearing: 044° N44E 0782mils (True) Elevation Angle: -04.1° Horizon Angle: -00.3° Zoom: 1X yc37</p>

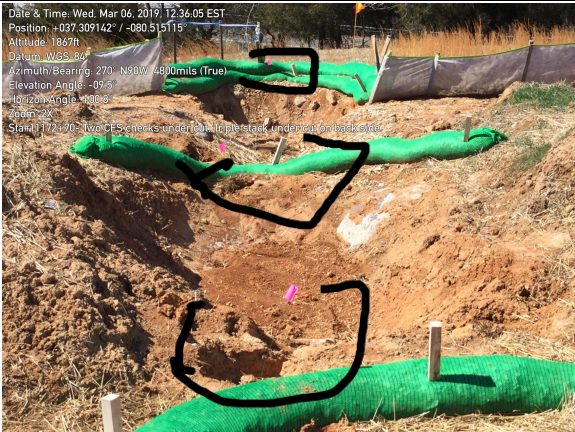
</div></div>			<div><div><div>Date & Time: Wed, Mar 06, 2019, 11:49:09 EST Position: +037.322452° / -080.439268° Altitude: 2278ft Datum: WGS-84 Azimuth/Bearing: 016° N16E 0284mils (Error) Elevation Angle: -36.4 Horizon Angle: -00.8 Zoom: 1X Sta#11475+00- Two tone slope sloughed off covering the end of slope drain pipe & outlet rock</div>

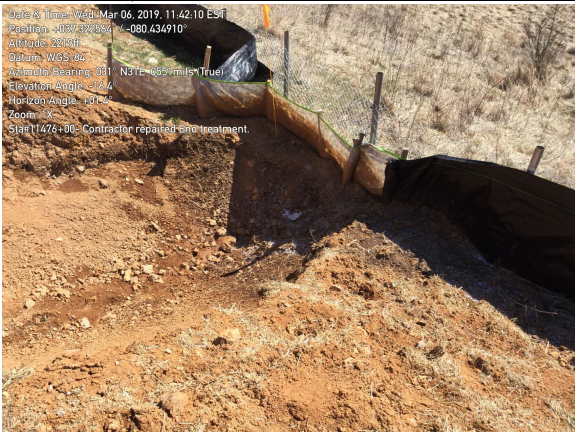
</div></div>			Insert image here				
GPS Location	37.31	Field Station#	11476+00	GPS Location		Field Station#	
Description	P1 end treatment that was a punch List item has been repaired.			Description

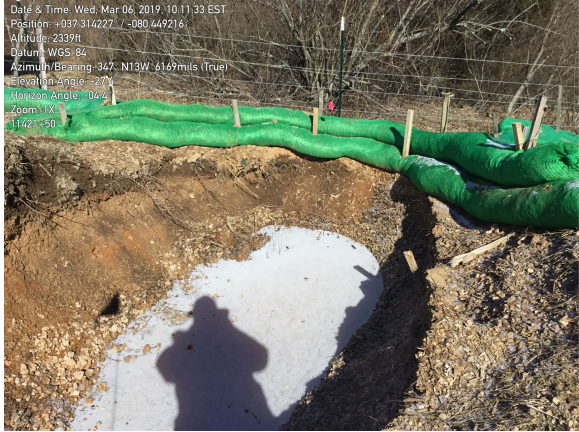
</div>				
GPS Location	37.31	Field Station#	11456+50	GPS Location	37.31	Field Station#	11421+50
Description	Broke stake on P1			Description	CFS starting to undermine		
<div><div>Date & Time: Wed, Mar 06, 2019, 10:45:53 EST Position: +037.307661° / -080.466772° Altitude: 1886ft Datum: WGS-84 Azimuth/Bearing: 217° S37W 3858mils (True) Elevation Angle: -26.7° Horizon Angle: -01.6° Zoom: 1X 11361+75 undermined cfs</div> </div>			<div><div>Date & Time: Wed, Mar 06, 2019, 10:38:27 EST Position: +037.296321° / -080.500313° Altitude: 2144ft Datum: WGS-84 Azimuth/Bearing: 165° S15E 2933mils (True) Elevation Angle: -25.9° Horizon Angle: -01.6° Zoom: 1X 11368+00</div> </div>

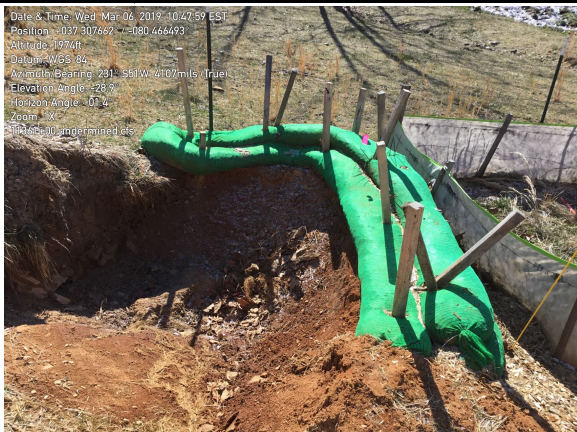
</div>			<div><div>Date & Time: Wed, Mar 06, 2019, 10:49:06 EST Position: +037.307566° / -080.466731° Altitude: 1991ft Datum: WGS-84 Azimuth/Bearing: 19° S16W 3684mils (True) Elevation Angle: -18.8° Horizon Angle: -0.2° Zoom: 1X 11361+00 KL43</div> </div>				
GPS Location	37.31	Field Station#	11361+00	GPS Location	37.31	Field Station#	11361+00
Description	Undermined CFS			Description	KL43 stream running clear

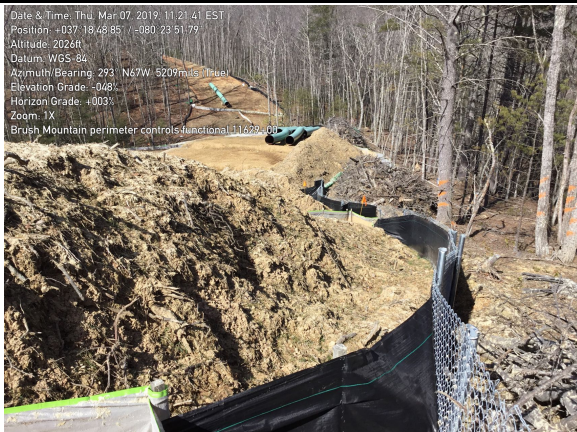
</div></div>				<div><div><div>Date & Time: Thu, Mar 07, 2019, 11:41:19 EST Position: +037.184601 / -080.247002 Altitude: 1947ft Datum: WGS-84 Azimuth/Bearing: 054.134E 10960mils (True) Elevation Grade: -018% Horizon Grade: +007% Zoom: 1X Brush Mountain tree has fallen on Sensitive Resource fencing at 11616+75</div> </div></div>				
GPS Location	37.13	Field Station#	11629+00		GPS Location	37.13	Field Station#	11616+75
Description	Correct coordinates on photo. Perimeter controls are in place and functioning properly.			Description	Correct coordinates on photo. Downed tree caused damage to orange barricade fence.
