Visual Site Inspection Report

Project Name	H-600 Pipeline Spread G	AFE	124300137	Spread	H-600 Pipeline Spread G
Contractor	Precision			Report #	14740
Inspector	Len Kruizenga			Date/Time	3/11/2019 7:12 AM
Permit #	TBD	Inspection Type	VA SWPP	Station Begin	11022+00
State	VA	Inspection Area	Partial	Station End	10930+00
County	Giles	Ground	Muddy	Temperature (°F)	51.00
Municipality	N/A	Weather	Cloudy	Rain Gauge (in)	0.60
				Rain Accumulation Time (days)	0.60

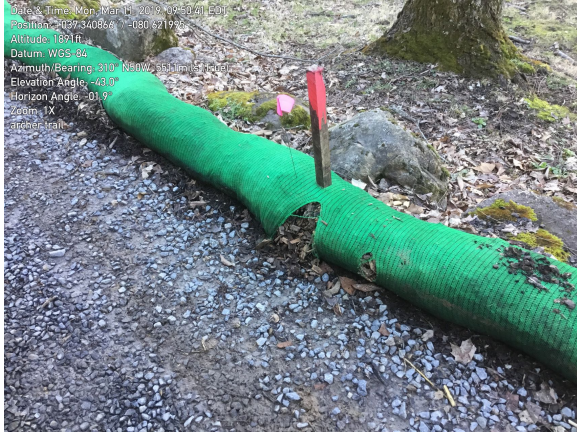
GPS Location		37.31	Field Station#		+0		
Description		Sock with minor damages. Archer trail					
GPS Location		37.31	Field Station#		10733+00		
Description		Wetland

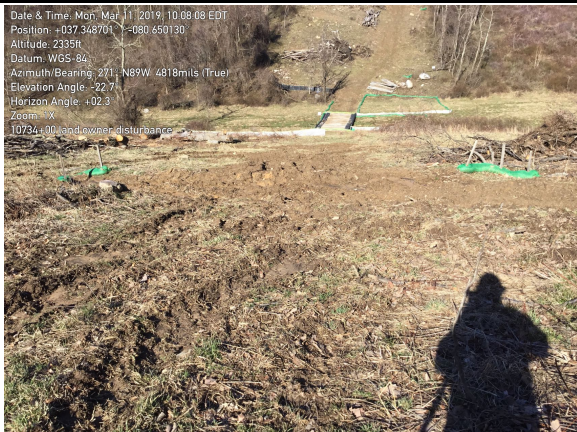
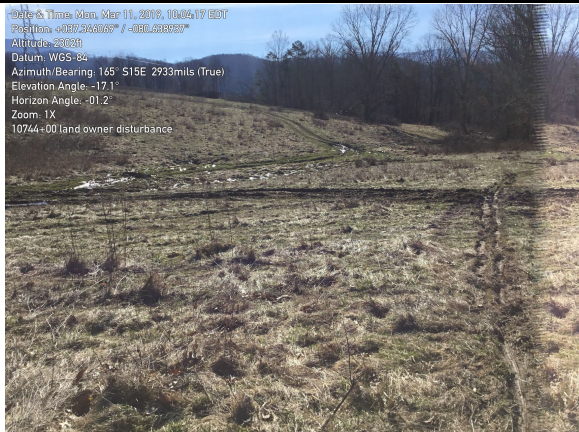
GPS Location		37.31	Field Station#		10734+00		
Description		Land owner disturbance					
GPS Location		37.31	Field Station#		10744+00		
Description		Land owner disturbance

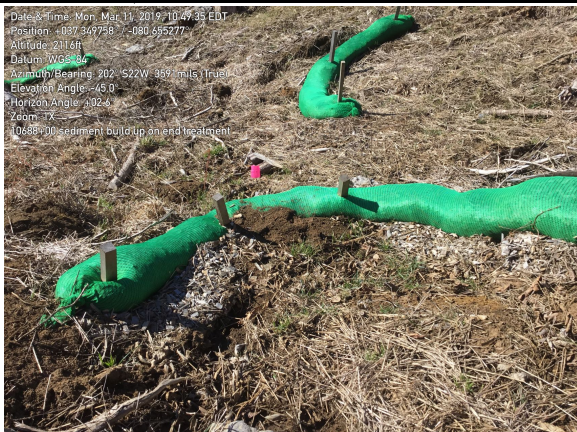
GPS Location		37.31	Field Station#		10688+00		
Description		Sediment build up on sock					
GPS Location		37.31	Field Station#		+1		
Description		.5" rainfall

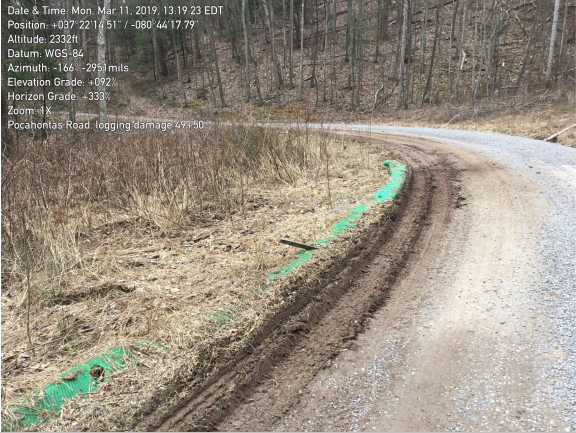
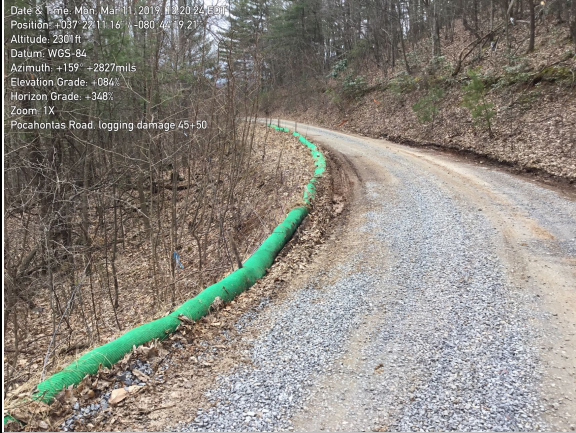
GPS Location	37.31	Field Station#	49+50	GPS Location	37.31	Field Station#	45+50
Description	Correct coordinates on photo. Logging damages to ECDs.			Description	Correct coordinates on photo. Logging damages to ECDs.		
<small>Date & Time: Mon, Mar 11, 2019 13:20:18 EDT Position: +037° 21' 08.21" / -080° 44' 51.21" Altitude: 2291ft Datum: WGS-84 Azimuth: +111° -2403mits Elevation Grade: +109% Horizon Grade: +298% Zoom: 1X Pocahontas Road, logging damage 9+45</small>

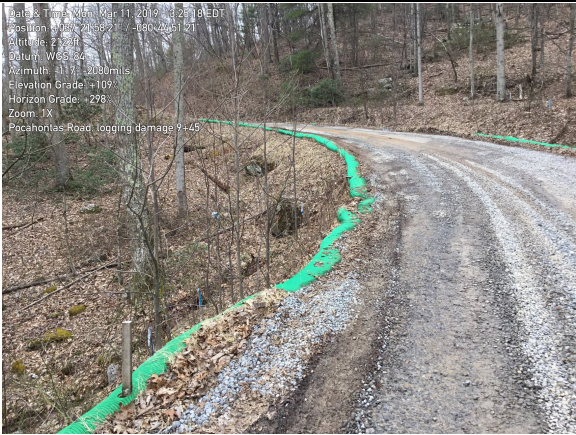
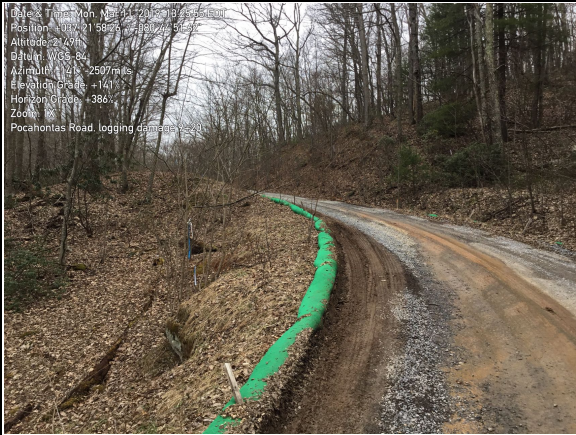
GPS Location	37.31	Field Station#	9+45	GPS Location	37.31	Field Station#	9+20
Description	Correct coordinates on photo. Logging damages to ECDs.			Description	Correct coordinates on photo. Logging damages to ECDs.		
<small>Date & Time: Mon, Mar 11, 2019 13:22:41 EDT Position: +037° 21' 58.70" / -080° 44' 42.34" Altitude: 2076ft Datum: WGS-84 Azimuth: +040° -0711mits Elevation Grade: +101% Horizon Grade: +288% Zoom: 1X Pocahontas Road, logging damage 18+00</small>

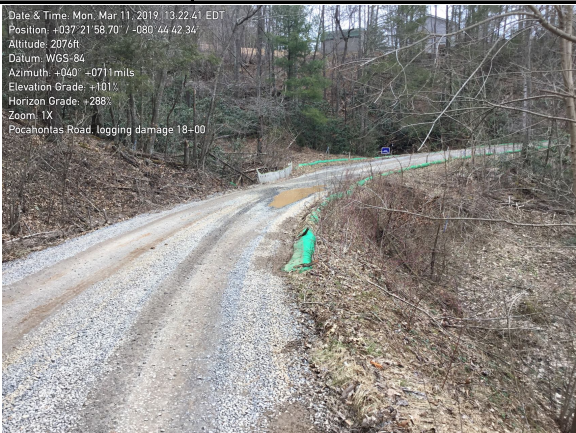
<div style="text-align: center; height: 150px;">Insert image here</div>				
GPS Location	37.31	Field Station#	18+00	GPS Location		Field Station#	
Description	Correct coordinates on photo. Logging damages to ECDs.			Description

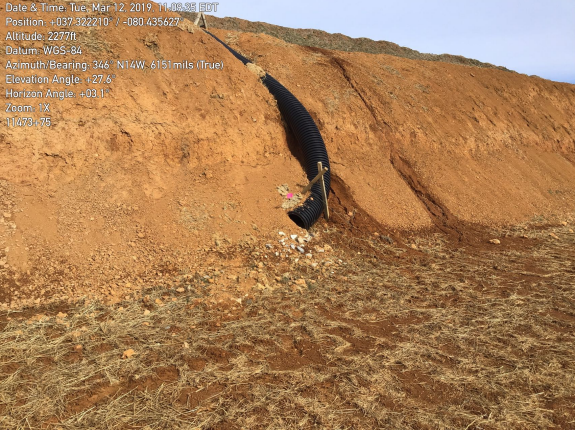
<p>Date & Time: Tue, Mar 12, 2019, 11:03:38 EDT Position: +037.322210° / -080.435622° Altitude: 2277ft Datum: WGS-84 Azimuth/Bearing: 344° N14W 6151mils (True) Elevation Angle: +27.6° Horizon Angle: +03.1° Zoom: 1X 11473+75</p>				
GPS Location	37.20	Field Station#	11437+00	GPS Location	37.20	Field Station#	11473+75
Description	See photo for GPS location. Top soil pile sloughed off into sump pit.			Description	See photo for GPS location. Two tone sloughed off cover slope drain pipe and rock outlet.

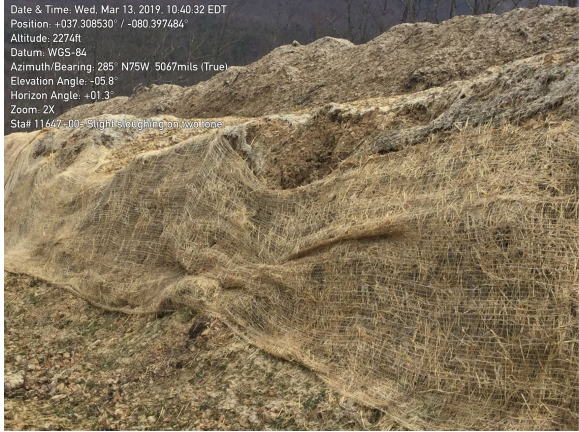
GPS Location	37.32	Field Station#	11665+00	GPS Location	37.32	Field Station#	11647+00
Description	Row is stable and dry.			Description	Slight sloughing on two tone.		
<p>Date & Time: Wed, Mar 13, 2019, 10:59:13 EDT Position: +037.313350° / -080.397414° Altitude: 1996ft Datum: WGS-84 Azimuth/Bearing: 072° N72E 1280mils (True) Elevation Angle: -10.6° Horizon Angle: +00.4° Zoom: 1X Sta# 11630+00 - SSF fabric is loose at wooden stake at sump pit, still functional.</p>

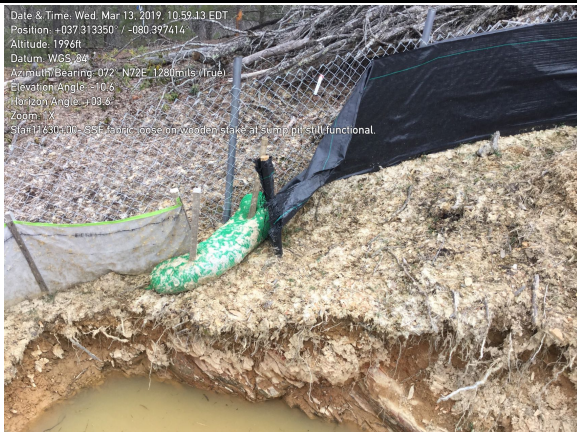
GPS Location	37.32	Field Station#	11630+00	GPS Location	37.32	Field Station#	11626+00
Description	SSF fabric is loose at wooden stake at sump pit, still diverting water into sump pit to be treated.			Description	Stream, buffers, ECD's are in good condition		
<p>Date & Time: Wed, Mar 13, 2019, 11:26:41 EDT Position: +037.313487° / -080.404497° Altitude: 1924ft Datum: WGS-84 Azimuth/Bearing: 242° N18W 6133mils (True) Elevation Angle: -06.5° Horizon Angle: +01.5° Zoom: 1X Sta# 11608+62 - Craig Creek ECD's</p>

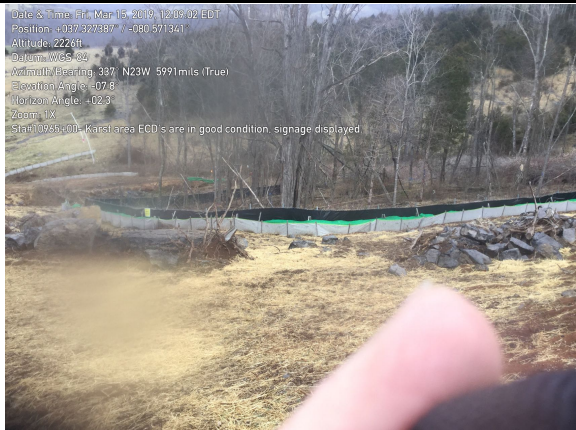
</div></div></div>				
GPS Location	37.32	Field Station#	10984+00	GPS Location	37.32	Field Station#	10965+00
Description	Tracks left by contractor side by side.			Description	Karst ECD's are in acceptable condition.		
<div><div><div>Date & Time: Fri, Mar 15, 2019, 12:14:04 EDT Position: +037.276314° / -080.526557° Altitude: 2120ft Datum: WGS-84 Azimuth/Bearing: 011.162W 5120mils (True) Elevation Angle: -08.3° Horizon Angle: -01.0° Zoom: 1X Doe Creek Farms- Straw bales have been replaced at mat bridge at drain feature, too survey station 10956</div><div>

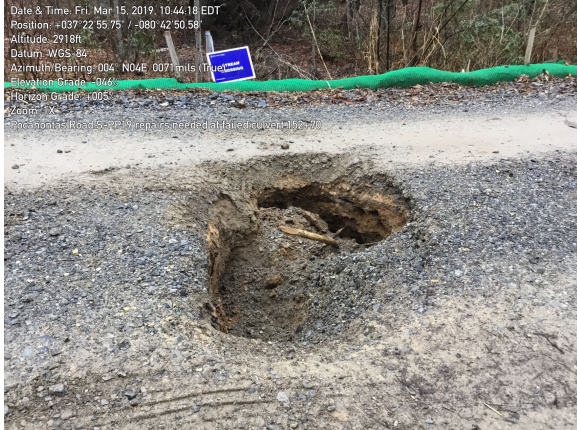
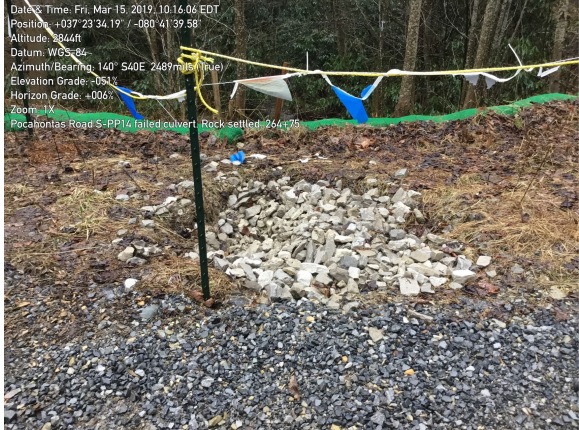
</div>			<div><div>Date & Time: Fri, Mar 15, 2019, 10:16:06 EDT Position: +037 23 34.19 / -080 41 39.58 Altitude: 2648ft Datum: WGS-84 Azimuth/Bearing: 140° S40E 2489mils (True) Elevation Grade: -0.5% Horizon Grade: +006% Zoom: 1X Pocahontas Road S-PP14 failed culvert. Rock settled 264+75</div>

</div>			
GPS Location	37.36	Field Station#	152+70	GPS Location	37.36	
Description	Failed culvert at S-PP19 crossing on Pocahontas Road.			Description	Failed culvert at S-PP14 crossing on Pocahontas Road.	
<div><div>Date & Time: Fri, Mar 15, 2019, 10:50:06 EDT Position: +037 22 48.43 / -080 43 14.48 Altitude: 2740ft Datum: WGS-84 Azimuth/Bearing: 337° N23W 5991mils (True) Elevation Grade: -0.2% Horizon Grade: +010% Zoom: 1X Pocahontas Road W-UU11 shows no impact 124+50</div>
