Visual Site Inspection Report

Project Name	H-600 Pipeline Spread G	AFE	124300137	Spread	H-600 Pipeline Spread G
Contractor	Precision			Report #	14761
Inspector	Garrett Barclay			Date/Time	3/18/2019 2:19 PM
Permit #	TBD	Inspection Type	VA SWPP	Station Begin	11020+00
State	VA	Inspection Area	Partial	Station End	11150+00
County	Craig	Ground	Dry	Temperature (°F)	42.00
Municipality	N/A	Weather	Sunny	Rain Gauge (in)	0.00
				Rain Accumulation Time (days)	1.00

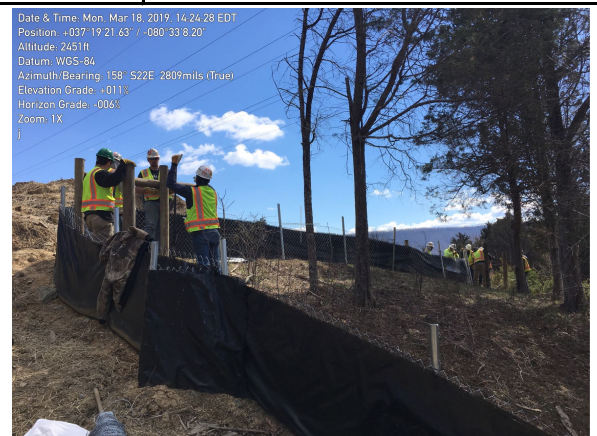
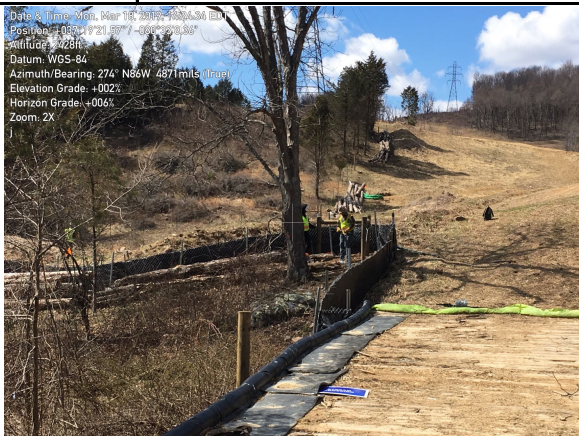
GPS Location	37.32	Field Station#	11023+80	GPS Location	37.32	Field Station#	11023+80
Description	Crews building perimeter fence			Description	Crews building perimeter fenceq

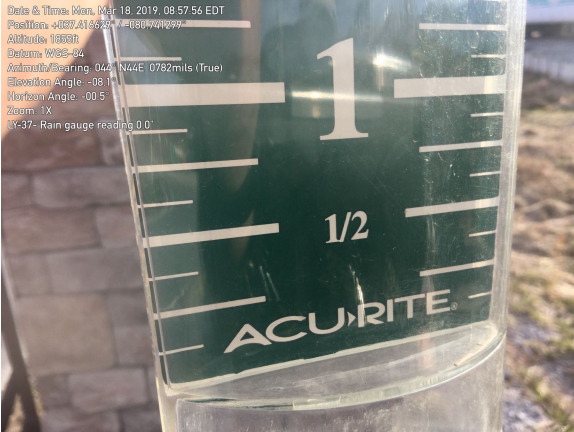
<p>Date & Time: Mon, Mar 18, 2019, 08:57:56 EDT Position: +037.416641° / -080.743855° Altitude: 1865ft Datum: WGS-84 Azimuth/Bearing: 042° N44E 0782mils (True) Elevation Angle: -08.1° Horizon Angle: -00.5° Zoom: 1X LY-37- Rain gauge reading- 0.00"</p>

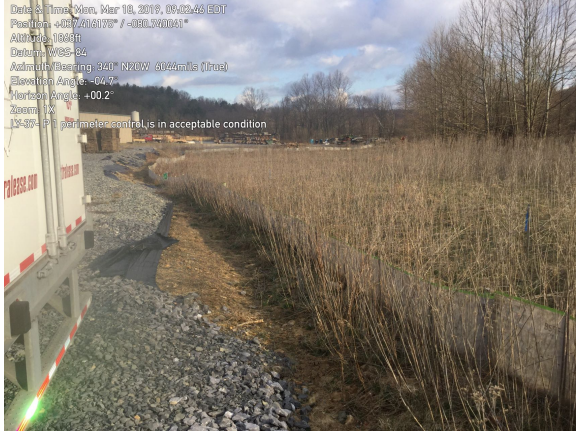
<p>Date & Time: Mon, Mar 18, 2019, 09:42:48 EDT Position: +037.416871° / -080.741691° Altitude: 1869ft Datum: WGS-84 Azimuth/Bearing: 140° N40W 0024mils (True) Elevation Angle: -64.7° Horizon Angle: -00.2° Zoom: 1X LY-37- P1 perimeter controls in acceptable condition</p>				
GPS Location	37.41	Field Station#	+0	GPS Location	37.41	Field Station#	+0
Description	LY-37- Rain gauge reading- 0.00"			Description	LY-37- Wetlands P1 perimeter controls in acceptable condition.

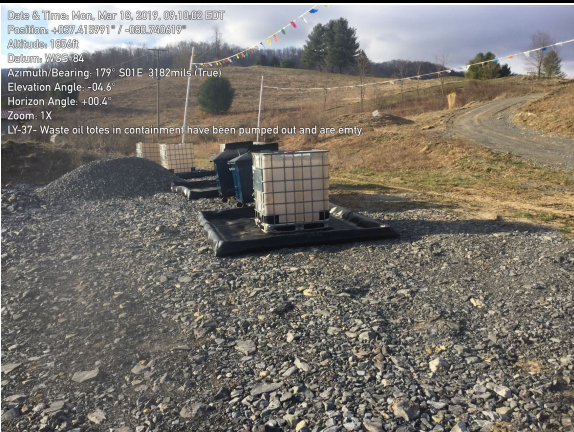
<p>Date & Time: Mon, Mar 18, 2019, 09:16:04 EDT Position: +037.416991° / -080.740499° Altitude: 1865ft Datum: WGS-84 Azimuth/Bearing: 179° S01E 3182mils (True) Elevation Angle: -04.6° Horizon Angle: -00.4° Zoom: 1X LY-37- Waste oil totes in containment have been pumped out and are empty</p>

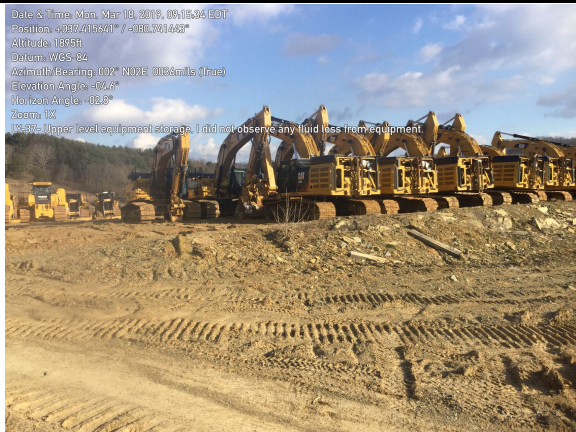
<p>Date & Time: Mon, Mar 18, 2019, 09:16:04 EDT Position: +037.416991° / -080.740499° Altitude: 1865ft Datum: WGS-84 Azimuth/Bearing: 002° N02E 0164mils (True) Elevation Angle: -04.6° Horizon Angle: -02.6° Zoom: 1X LY-37- Upper level equipment storage. I did not observe any fluid loss from equipment</p>

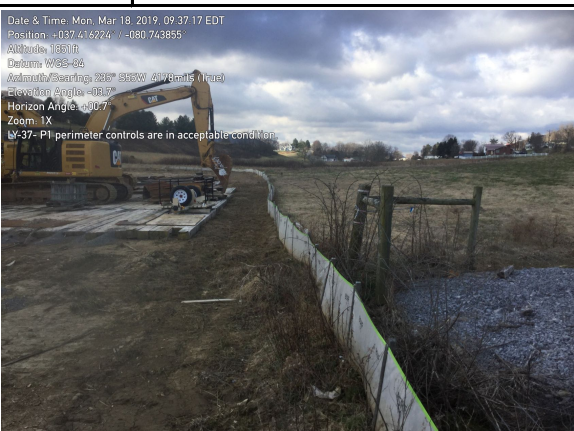
<p>Date & Time: Mon, Mar 18, 2019, 09:37:17 EDT Position: +037.416724° / -080.743855° Altitude: 1869ft Datum: WGS-84 Azimuth/Bearing: 026° S36W 4376mils (True) Elevation Angle: -08.7° Horizon Angle: -00.7° Zoom: 1X LY-37- P1 perimeter controls are in acceptable condition</p>

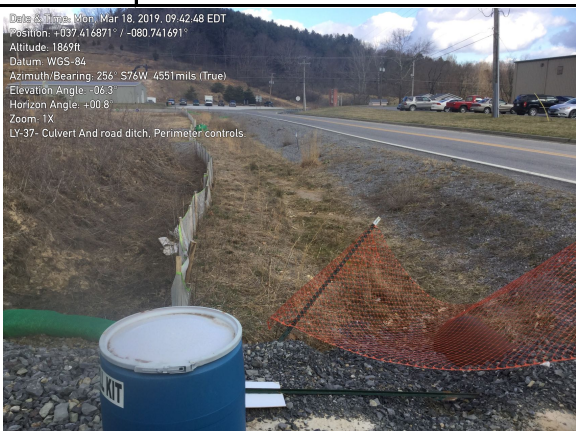
<p>Date & Time: Mon, Mar 18, 2019, 09:42:48 EDT Position: +037.416871° / -080.741691° Altitude: 1869ft Datum: WGS-84 Azimuth/Bearing: 255° S76W 4551mils (True) Elevation Angle: -05.3° Horizon Angle: -00.8° Zoom: 1X LY-37- Culvert And road ditch. Perimeter controls</p>				
GPS Location	37.41	Field Station#	+0	GPS Location	37.41	Field Station#	+0
Description	LY-37- P1 perimeter controls are in acceptable condition.			Description	LY-37- Culvert, road ditch and perimeter controls.

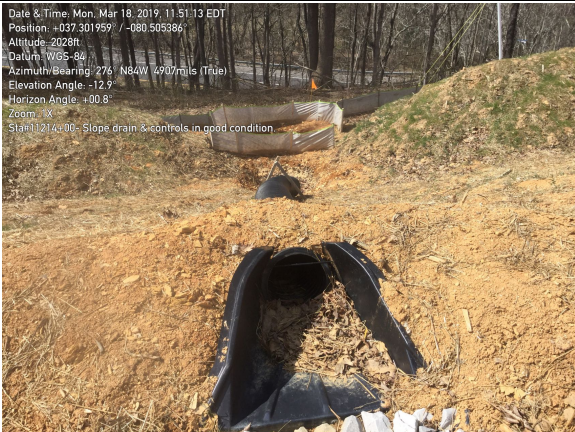
</div></div></div>			<div><div><div>Date & Time: Mon, Mar 18, 2019, 12:12:50 EDT Position: +037.306711° / -080.507569° Altitude: 1975ft Datum: WGS-84 Azimuth/Bearing: 290° N70W 616mils (True) Elevation Angle: -13.1° Horizon Angle: +00.2° Zoom: 1X Sta#11191+00: SSF fabric blown loose from chain link</div><div>

GPS Location	37.32	Field Station#	11214+00	GPS Location	37.32	Field Station#	11191+00
Description	Slope drain & controls are in acceptable condition.			Description	SSF fabric blown loose, environmental crew addressed the issue.		
<div><div><div>Date & Time: Mon, Mar 18, 2019, 12:28:01 EDT Position: +037.305230° / -080.515111° Altitude: 1929ft Datum: WGS-84 Azimuth/Bearing: 327° N33W 481mils (True) Elevation Angle: -16.1° Horizon Angle: +00.9° Zoom: 1X Sta#11184+00: CWD inlet</div><div>

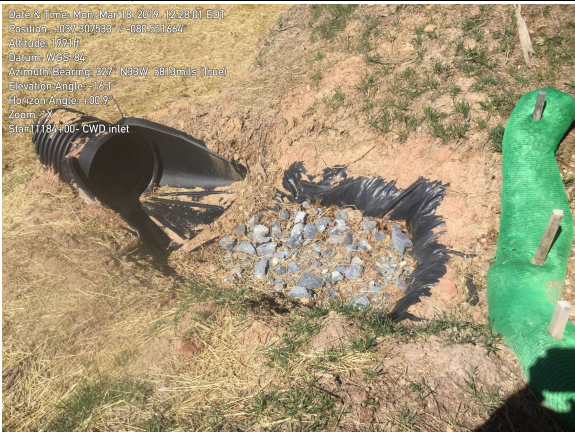
</div></div></div>			<div><div><div>Date & Time: Mon, Mar 18, 2019, 12:36:38 EDT Position: +037.305230° / -080.515111° Altitude: 1885ft Datum: WGS-84 Azimuth/Bearing: 302° N58W 536mils (True) Elevation Angle: -11.4° Horizon Angle: +01.2° Zoom: 1X Sta#11172+70: Contractor repaired under cut controls</div><div>

7. Identify all remedial measures that have been taken since the previous inspection was conducted. Sta#11172+70- Under cut controls have been repaired.					
Comments (Reference above questions as appropriate.) SWPPP inspection: Sta#11254+88 to 11161+00. MP- 213 to 211 There have been no rain events so the row is dry and in stable condition, no sediment movement. Water bars are stable and in good condition. End treatments are in acceptable condition. P1 silt fence perimeter controls are in acceptable condition. CFS perimeter controls are acceptable condition. Slope drains are in good condition. CWD pipe and plunge pool are in good condition. SSF is in good condition, fabric was loose at sta#11191+00, Environmental crew addressed it. Rain gauge readings- 0.0"					
Note: It is a condition of National Pollutant Discharge Elimination System and Erosion and Sediment permits that a maintenance program be conducted to provide for the operation and maintenance of all BMPs to be inspected on a weekly basis and after each stormwater event. Please list in the space provided comments to note if repairs or replacement are needed or have been made for BMPs as a result of the inspection. Failure to conduct the required inspection may result in permit suspension or the imposition of civil penalties. If supplemental monitoring is required as part of a permit condition this form may be used to meet those monitoring requirements.

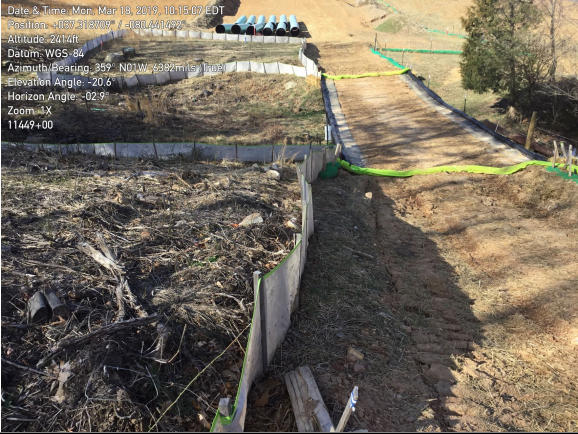
GPS Location	37.31	Field Station#	11449+00	GPS Location	37.31	Field Station#	11379+00
Description	ECDs in good condition			Description	ECDs in good condition

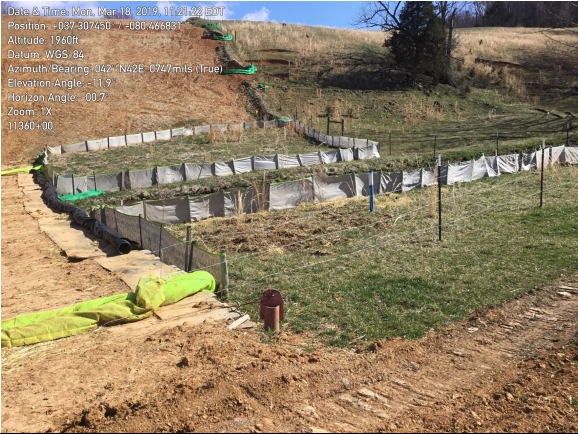
GPS Location	37.31	Field Station#	11360+00	GPS Location	37.31	Field Station#	11363+00
Description	ECDs protecting stream			Description	End treatment in good condition		
Insert image here

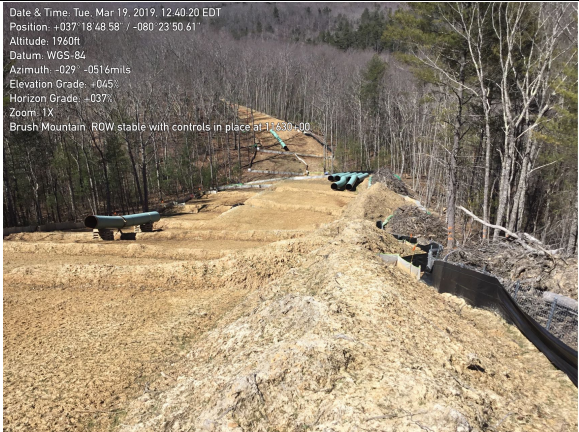
<p> GPS Location 37.13 Field Station# 11631+00 </p> <p> Description Correct coordinates on photo. Controls in place and functional. Surface is stable. </p>

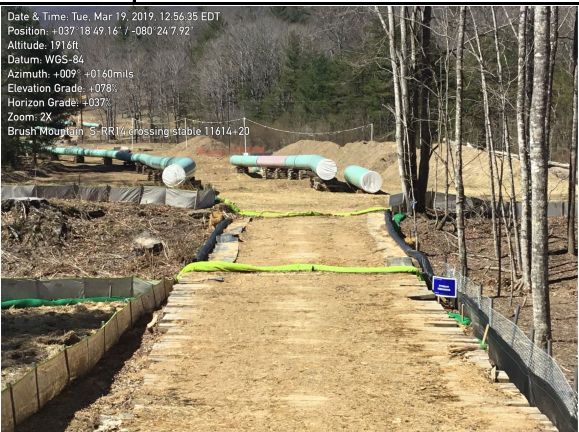
<p> GPS Location 37.13 Field Station# 11614+20 </p> <p> Description Correct coordinates on photo. Resource crossings are stable. </p>

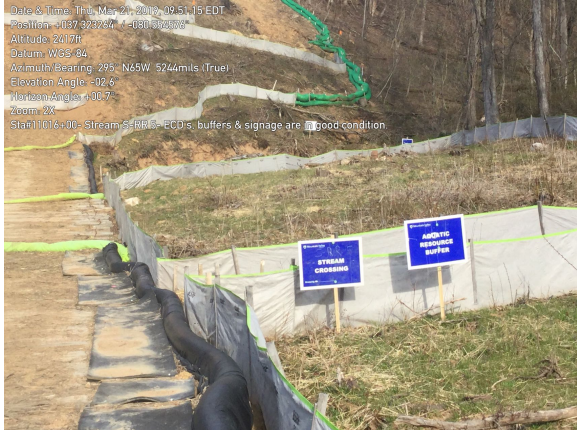
<p>Date & Time: Thu, Mar 21, 2019, 09:51:15 EDT Position: +037 327627, +388056295 Altitude: 2217ft Datum: WGS 84 Azimuth Bearing: 295° N45W 5244mils (True) Elevation Angle: -02.4° Horizon Angle: +00.7° Zoom: 2X Station 11016+00- Stream S-RR-5 ECD's, buffers & signage are in good condition</p>

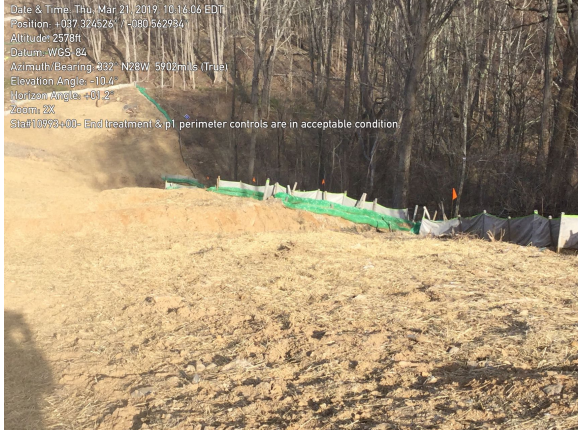
<p>Date & Time: Thu, Mar 21, 2019, 10:16:06 EDT Position: +037 327625, +388056295 Altitude: 2217ft Datum: WGS 84 Azimuth Bearing: 432° N28W 5009mils (True) Elevation Angle: -10.4° Horizon Angle: +01.2° Zoom: 2X Station 10993+00- Rad treatment & p1 perimeter controls are in acceptable condition</p>							
GPS Location		37.30	Field Station#		11016+00	GPS Location		37.30	Field Station#		10993+00
Description		Stream S- RR-5 buffers & signage				Description		Perimeter controls and P1 perimeter controls

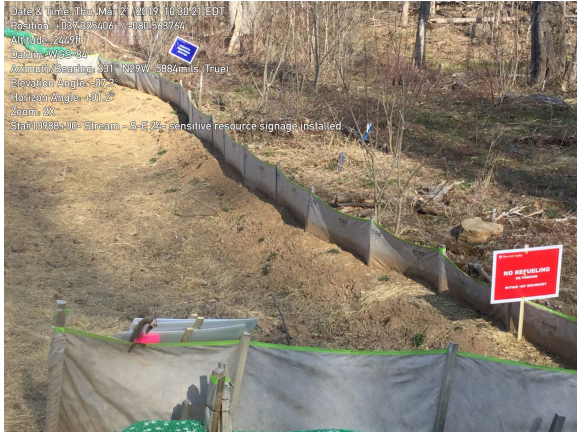
<p>Date & Time: Thu, Mar 21, 2019, 10:08:15 EDT Position: +037 327666, +388057152 Altitude: 2235ft Datum: WGS 84 Azimuth Bearing: 201° N29W 5884mils (True) Elevation Angle: -01.2° Horizon Angle: +01.2° Zoom: 2X Station 10988+00- Stream S-E 24- sensitive resource signage installed</p>

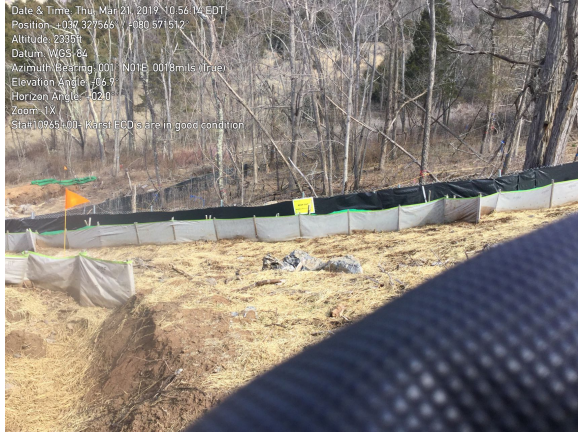
<p>Date & Time: Thu, Mar 21, 2019, 10:56:12 EDT Position: +037 327666, +388057152 Altitude: 2235ft Datum: WGS 84 Azimuth Bearing: 001° N01E 0018mils (True) Elevation Angle: +06.9° Horizon Angle: +02.0° Zoom: 1X Station 10965+00- Karst ECD's are in good condition</p>
