Visual Site Inspection Report

Project Name	H-600 Pipeline Spread G	AFE	124300137	Spread	H-600 Pipeline Spread G
Contractor	Precision			Report #	15140
Inspector	Garrett Barclay			Date/Time	3/25/2019 12:10 PM
Permit #	TBD	Inspection Type	VA SWPP	Station Begin	11530+00
State	VA	Inspection Area	Partial	Station End	11560+00
County	Giles	Ground	Dry	Temperature (°F)	55.00
Municipality	N/A	Weather	Cloudy	Rain Gauge (in)	0.00
				Rain Accumulation Time (days)	1.00

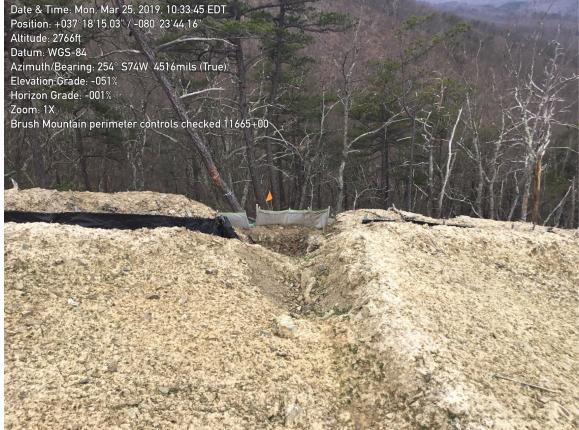
GPS Location	37.32	Field Station#	11666+00	GPS Location	37.31	Field Station#	11665+00
Description	Correct coordinates on photo. Perimeter controls are in place with no maintenance needs identified.			Description	Correct coordinates on photo. Slope breakers and end treatments are in place and functional.

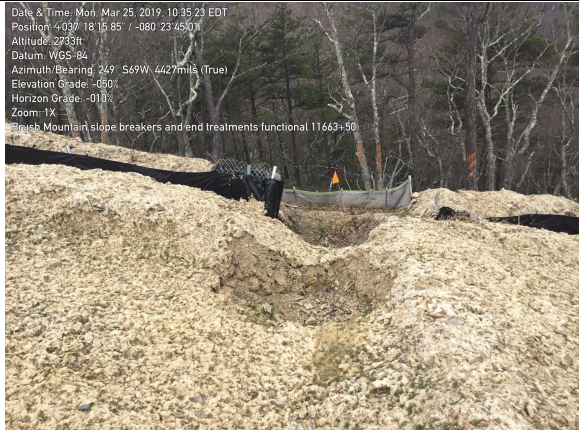
GPS Location	37.31	Field Station#	11664+50	GPS Location	37.31	Field Station#	11663+50
Description	Correct coordinates on photo. ROW is stable although grasses are sparse.			Description	Correct coordinates on photo. Sumps and end treatments are in place and functioning.		
<p>Date & Time: Mon, Mar 25, 2019, 10:35:10 EDT Position: +037° 18' 25.71" / -080° 23' 51.19" Altitude: 2808ft Datum: WGS-84 Azimuth/Bearing: 119° S65E 2006mils (True) Elevation Grade: +004% Horizon Grade: +003% Zoom: 1X Brush Mountain surface conditions stable 11649+00</p>

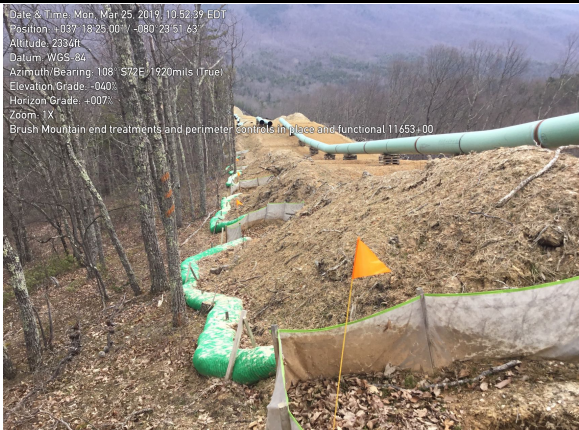
GPS Location	37.31	Field Station#	11649+00	GPS Location	37.31	Field Station#	11653+00
Description	Correct coordinates on photo. ROW surface is stable with no erosion located.			Description	Correct coordinates on photo. Perimeter controls are in place and functional.

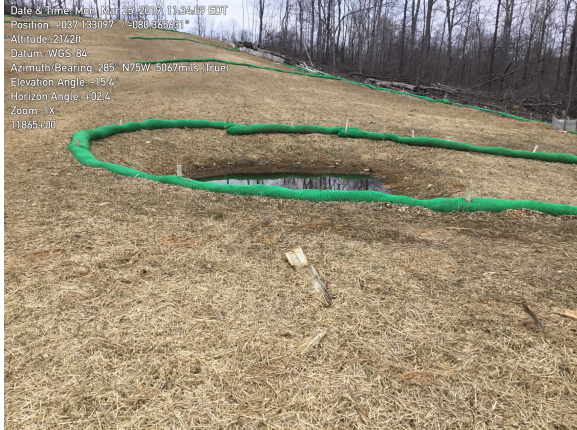
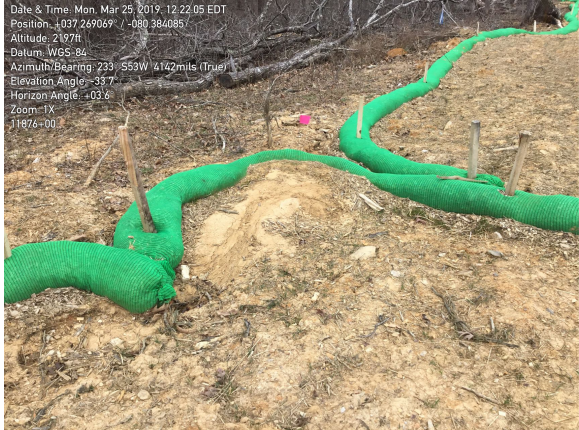
Date & Time: Mon, Mar 25, 2019, 11:35:19 EDT Position: +037.133097 / -080.686381* Altitude: 2122ft Datum: WGS-84 Azimuth/Bearing: 285° N75W 5967mils (True) Elevation Angle: -15.4° Horizon Angle: +02.4° Zoom: 1X 11865+00			Date & Time: Mon, Mar 25, 2019, 12:22:05 EDT Position: +037.269069 / -080.384085* Altitude: 2197ft Datum: WGS-84 Azimuth/Bearing: 233° S59W 4142mils (True) Elevation Angle: -31.7° Horizon Angle: +03.6° Zoom: 1X 11876+00				
GPS Location	37.31	Field Station#	11865+00	GPS Location	37.31	Field Station#	11876+00
Description	Wetland with ECD surrounding			Description	Sediment build up on CFS

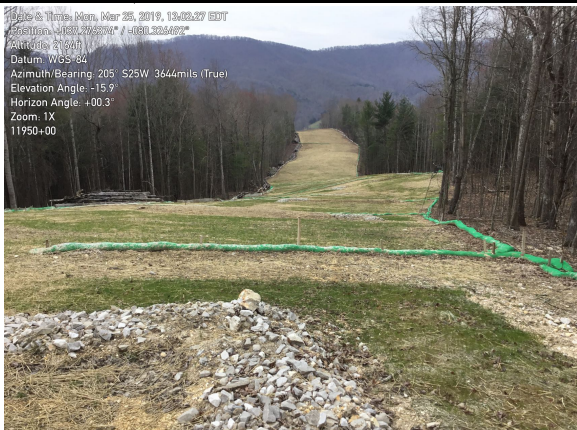
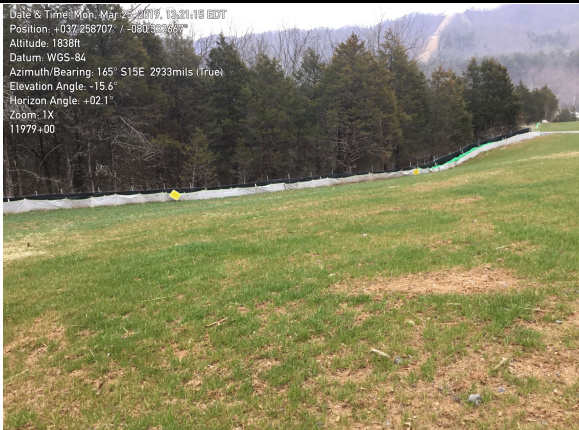
Date & Time: Mon, Mar 25, 2019, 13:46:37 EDT Position: +037.295374 / -080.326497* Altitude: 1944ft Datum: WGS-84 Azimuth/Bearing: 205° S25W 3644mils (True) Elevation Angle: -15.9° Horizon Angle: +00.3° Zoom: 1X 11950+00			Date & Time: Mon, Mar 25, 2019, 13:51:18 EDT Position: +037.258707 / -080.326357* Altitude: 1938ft Datum: WGS-84 Azimuth/Bearing: 165° S15E 2933mils (True) Elevation Angle: -15.6° Horizon Angle: +02.1° Zoom: 1X 11979+00				
GPS Location	37.31	Field Station#	11950+00	GPS Location	37.31	Field Station#	11979+00
Description	Row level spreader			Description	ECDs protecting karst.

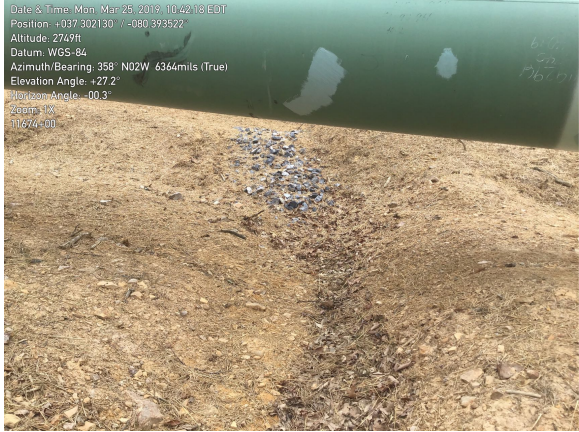
<p>Date & Time: Mon, Mar 25, 2019, 10:42:18 EDT Position: +037 302130 / -080 393522° Altitude: 2749ft Datum: WGS-84 Azimuth/Bearing: 358° N02W 6364mils (True) Elevation Angle: +27.2° Horizon Angle: -00.3° Zoom: 1X 11674+00</p>				
GPS Location	37.21	Field Station#	11670+00	GPS Location	37.21	Field Station#	11674+00
Description	See photo for GPS location. Water breaks in place. TOW has been stabilized using seed and mulch.			Description	See photo for GPS location. Rock lined channel over two tone in place.

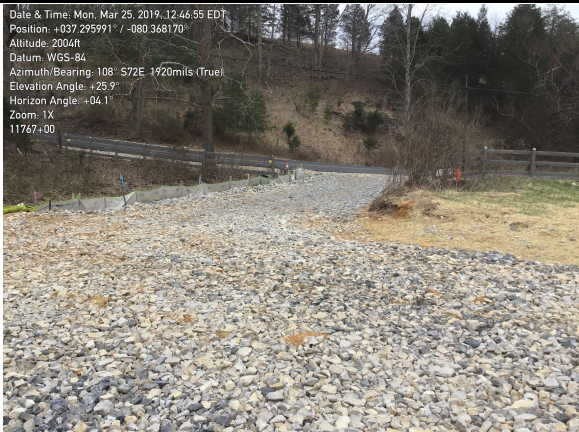
<p>Date & Time: Mon, Mar 25, 2019, 12:46:55 EDT Position: +037 295591 / -080 368170° Altitude: 2004ft Datum: WGS-84 Azimuth/Bearing: 108° S72E 1920mils (True) Elevation Angle: +25.9° Horizon Angle: +04.1° Zoom: 1X 11767+00</p>				
GPS Location	37.20	Field Station#	11764+00	GPS Location	37.20	Field Station#	11767+00
Description	See photo for GPS location. Reinforced super silt fence in place.			Description	See photo for GPS location. RCE in place at main line valve 26.

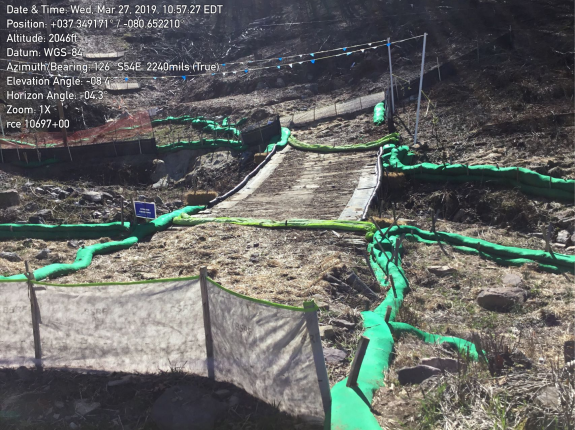
</div>			
GPS Location		37.31	Field Station#		10696+00		
Description		RCE buffalo anklets					
<div><div>Date & Time: Wed, Mar 27, 2019, 11:12:39 EDT Position: +037.337289° / -080.425830° Altitude: 2297ft Datum: WGS-84 Azimuth/Bearing: 122° 558E 2169mils (True) Elevation Angle: -14.2° Horizon Angle: -00.8° Zoom: 1X rce 10712+00</div>

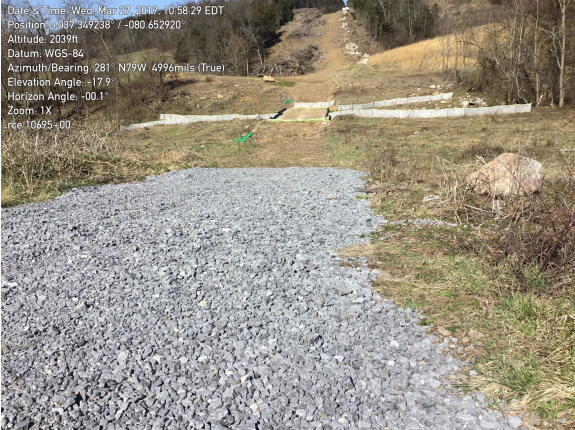
GPS Location		37.31	Field Station#		10712+00		
Description		Timber mat crossing, ECDs in good condition					
GPS Location		37.31	Field Station#		10695+00		
Description		RCE off buffalo anklets					
Insert image here				<div><div>Date & Time: Wed, Mar 27, 2019, 11:13:17 EDT Position: +037.348593° / -080.447804° Altitude: 2280ft Datum: WGS-84 Azimuth/Bearing: 182° S02W 3236mils (True) Elevation Angle: -26.6° Horizon Angle: +02.4° Zoom: 1X rce 10712+00</div>

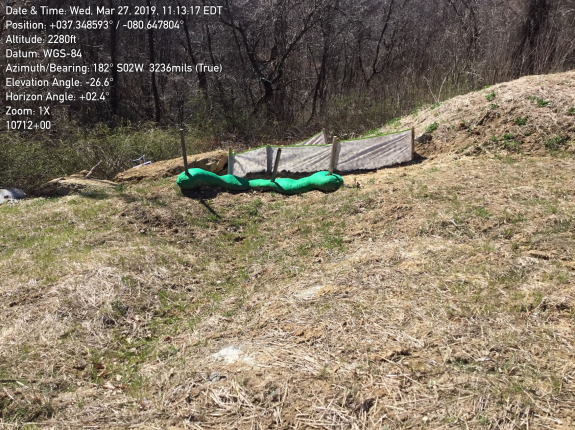
</div>			
GPS Location			Field Station#				
Description		ECDs in good condition					
GPS Location		37.31	Field Station#		10712+00		
Description		ECDs in good condition

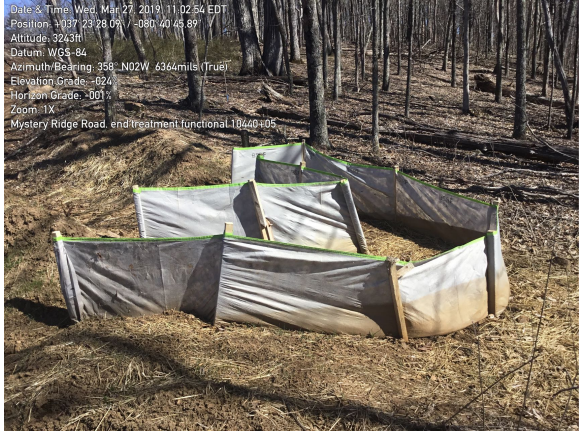
GPS Location	37.31	Field Station#	10413+25	GPS Location	37.31	Field Station#	10440+05
Description	Correct coordinates on photo. ECDs in place and working correctly on Mystery Ridge Road.			Description	Correct coordinates on photo. ECDs are filtering runoff and retaining loose sediment on Mystery Ridge Road.

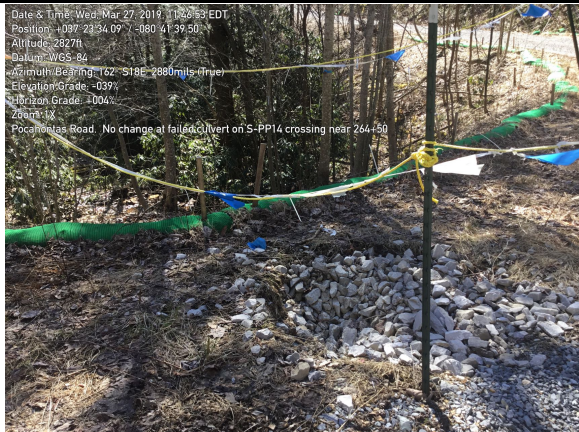
GPS Location	37.31	Field Station#	152+70	GPS Location	37.31	Field Station#	264+50
Description	Correct coordinates on photo. Hole in Pocahontas Road can barely be straddled with a pickup.			Description	Correct coordinates on photo. No change noted at failed culvert on Pocahontas Road.		
<p>Date & Time: Wed, Mar 27, 2019, 12:39:29 EDT Position: +037° 22' 42.32" / -080° 43' 21.24" Altitude: 2886ft Datum: WGS-84 Azimuth/Bearing: 277° N83W 4924mils (True) Elevation Grade: -023° Horizon Grade: -010° Zoom: 1X Pocahontas Road W-0012 shows no signs of impact 115+25</p>

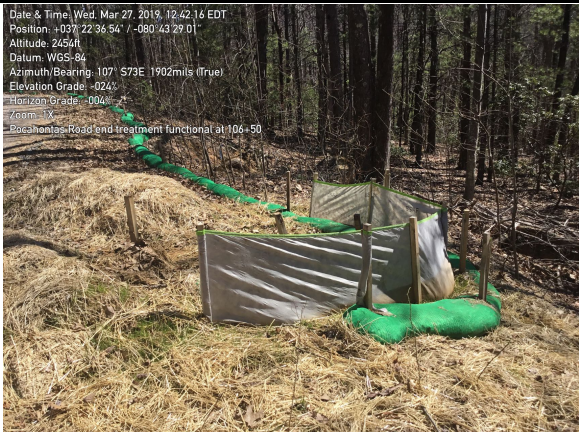
GPS Location	37.31	Field Station#	115+25	GPS Location	37.31	Field Station#	106+50
Description	Correct coordinates on photo. Resources show no impact.			Description	Correct coordinates on photo. ECDs in place and functioning on Pocahontas Road.

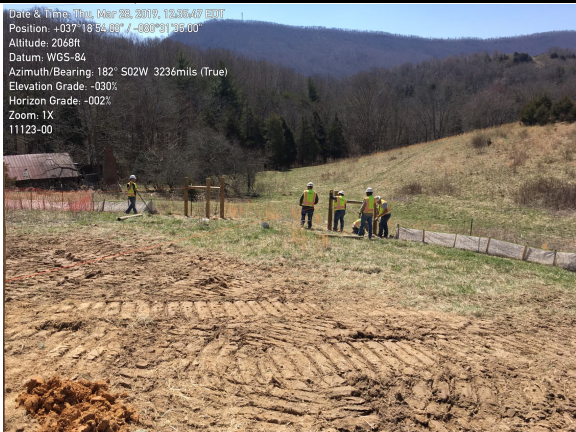
</div></div></div>				
GPS Location	37.24	Field Station#	11124+00	GPS Location	37.24	Field Station#	11124+00
Description	Crew installing cattle crossing with fence gaps @ 11124+00			Description	Crew installing cattle crossing with fence gaps @ 11124+00

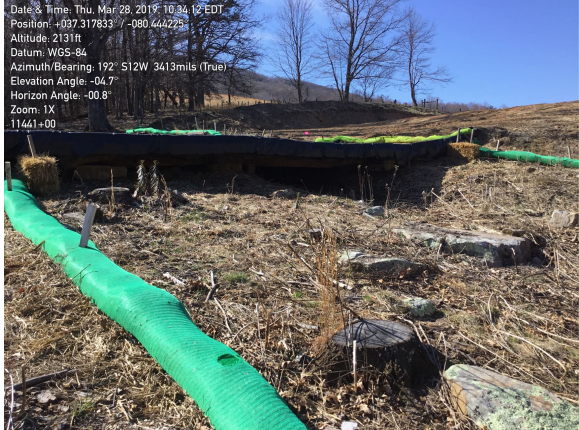
</div></div>					
GPS Location		37.31		Field Station#		11441+00		GPS Location		37.31	
Description				ECDs in good condition				Description		ECDs in good condition	
<div><div><div>Date & Time: Thu, Mar 28, 2019, 10:40:25 EDT Position: +037 306617 / -080 573886 Altitude: 2141ft Datum: WGS-84 Azimuth/Bearing: 302° N50W 5387mils (True) Elevation Angle: -27.1° Horizon Angle: -00.2° Zoom: 1X 11435+00</div>

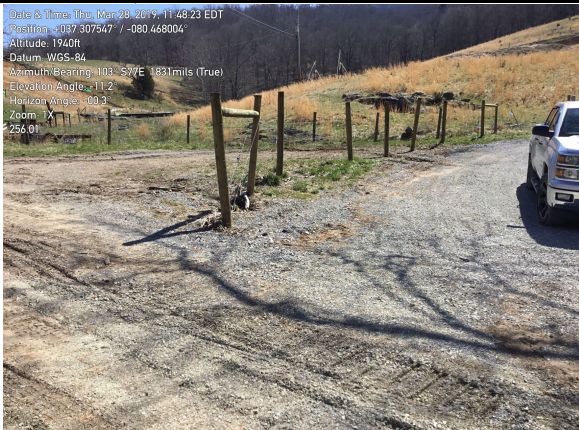
</div></div>					
GPS Location		37.31		Field Station#		11354+00		GPS Location		37.31	
Description				Top soil pile				Description		AR 256.01

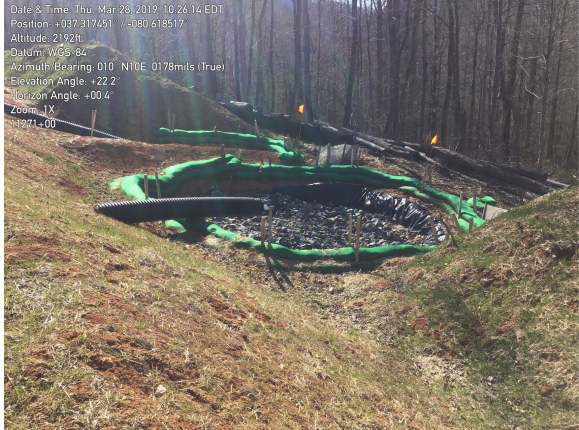
GPS Location	37.20	Field Station#	11262+00	GPS Location	37.20	Field Station#	11271+00
Description	See photo for GPS location. Slope drain pipe in place with rock filter outlet.			Description	See photo for GPS location. Plunge pool in place.		
<p>Date & Time: Thu, Mar 28, 2019, 10:39:14 EDT Position: +037.293821, +080.559721 Altitude: 2060ft Datum: WGS-84 Azimuth/Bearing: 011° N11E 0196mils (True) Elevation Angle: +24.4° Horizon Angle: +00.1° Zoom: 1X 11275+00</p>

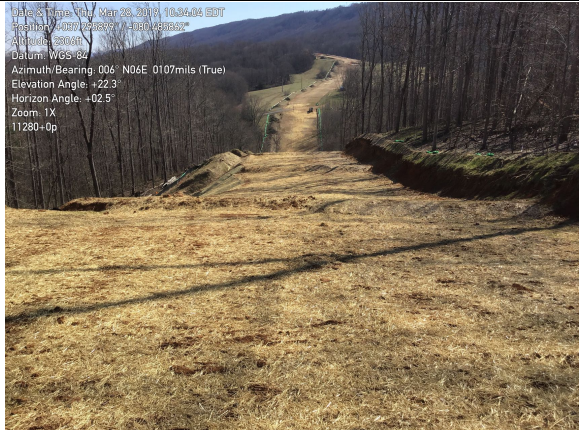
GPS Location	37.20	Field Station#	11275+00	GPS Location	37.20	Field Station#	11280+00
Description	See photo for GPS location. Reinforced super silt fence in place.			Description	See photo for GPS location. Water bars in place. ROW stabilized with seed and mulch.		
<p>Date & Time: Thu, Mar 28, 2019, 11:01:21 EDT Position: +037.310054, +080.471588 Altitude: 2270ft Datum: WGS-84 Azimuth/Bearing: 014° N14E 0249mils (True) Elevation Angle: +26.8° Horizon Angle: +01.4° Zoom: 1X 11332+00</p>

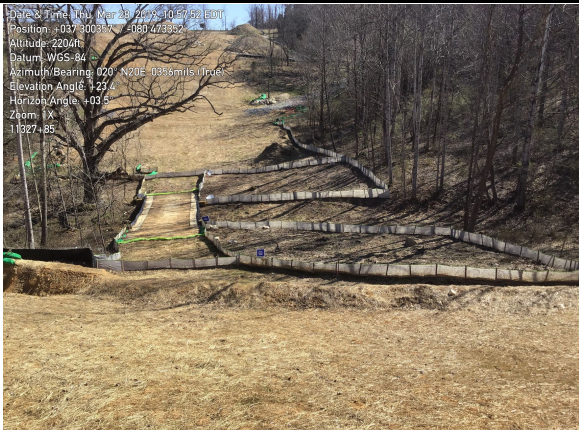
GPS Location	37.20	Field Station#	11332+00	GPS Location	37.20	Field Station#	11327+85
Description	See photo for GPS location. Rock lined channel in place.			Description	See photo for GPS location. Sensitive resource buffer in place at stream S-MM18.

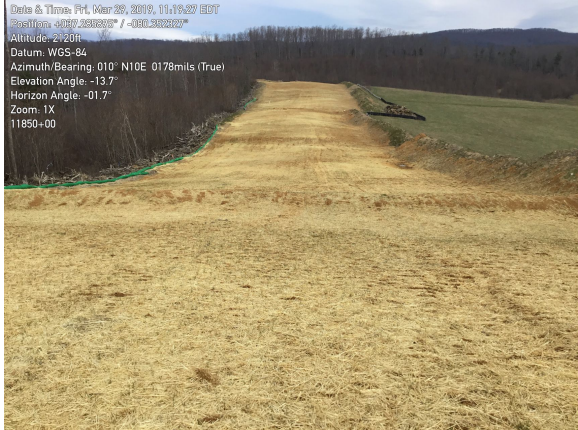
<p>Date & Time: Fri, Mar 29, 2019, 11:16:27 EDT Position: +037 288222° / -080 332222° Altitude: 2170ft Datum: WGS-84 Azimuth/Bearing: 010° N10E 0178mils (True) Elevation Angle: -13.7° Horizon Angle: -01.7° Zoom: 1X 11850+00</p>				
GPS Location	37.31	Field Station#	11848+00	GPS Location	37.31	Field Station#	11850+00
Description	ECDs in good condition			Description	Row with temporary stabilization

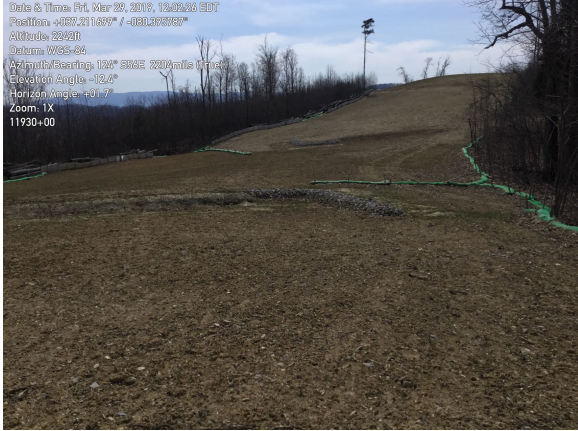
<p>Date & Time: Fri, Mar 29, 2019, 12:06:26 EDT Position: +037 211457° / -080 377837° Altitude: 3349ft Datum: WGS-84 Azimuth/Bearing: 104° S86E 2207mils (True) Elevation Angle: -12.4° Horizon Angle: -01.7° Zoom: 1X 11930+00</p>				
GPS Location	37.31	Field Station#	2+66	GPS Location	37.31	Field Station#	11930+00
Description	Ar 266 end treatment			Description	Final restoration row
