Visual Site Inspection Report

Project Name	H-600 Pipeline Spread H	AFE	124300138	Spread	H-600 Pipeline Spread H
Contractor	Precision			Report #	12504
Inspector	Glenn Mike Renfro			Date/Time	12/27/2018 12:43 PM
Permit #	TBD	Inspection Type	VA SWPP	Station Begin	13415+00
State	VA	Inspection Area	Full	Station End	13670+00
County	Franklin	Ground	Damp	Temperature (°F)	41.00
Municipality	N/A	Weather	Cloudy	Rain Gauge (in)	5.50
GPS Location	36.9719798583882, -79.8700180650501			Rain Accumulation Time (days)	6.00

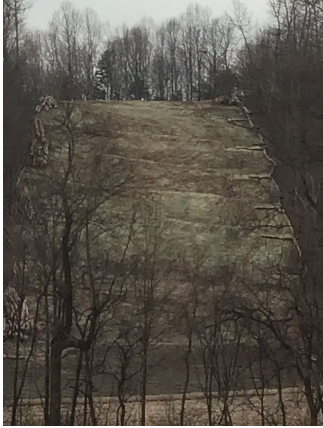
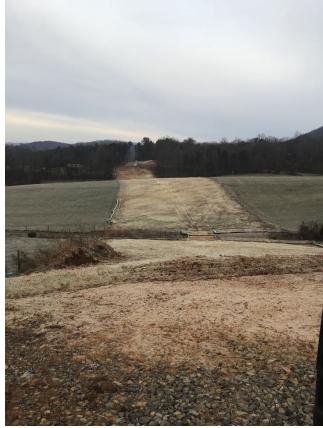
GPS Location	36.9717683489146, -79.8700051503054	GPS Location	36.9719231967227, -79.8700173106788		
Description	Permanent stabilization and waterbars in good condition at 13630+00	Description	Stabilization in acceptable on the CIS of Monty Rd.

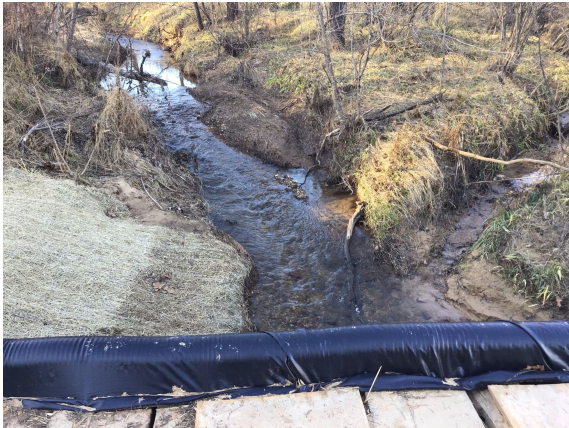
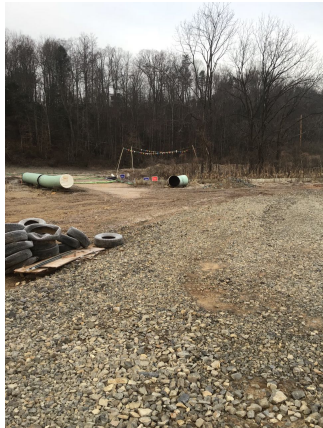
GPS Location	36.9719163654716, -79.8700265307723	GPS Location	36.9719095342206, -79.8699531053005		
Description	Stream crossing S-E28 flowing free and clear of sediment.	Description	RCE on the CIS on Leaning Oak in good condition.

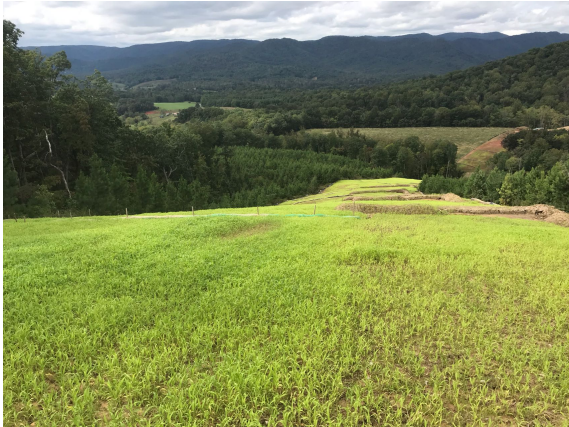
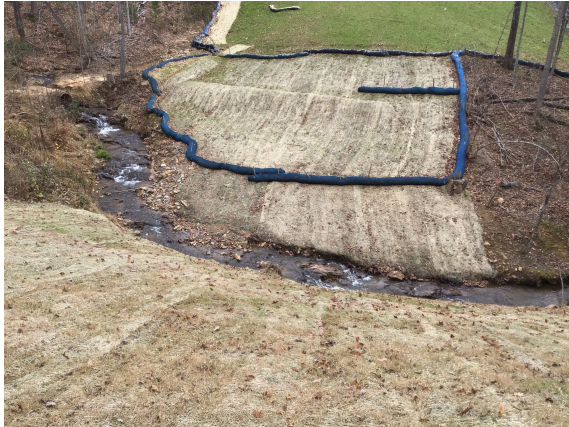
GPS Location	36.9720544992359, -79.8700003792344	GPS Location	36.9718687562616, -79.8697661050408		
Description	Grow-in on the CIS of 13437+00.	Description	Stabilization in good condition and stream S-IJ4 flowing clear of any sediment.

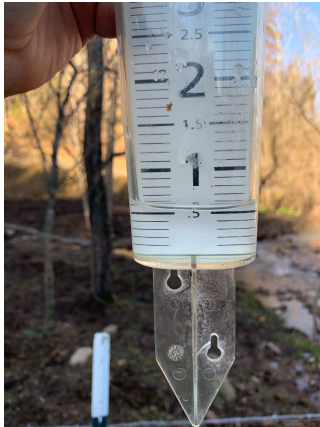
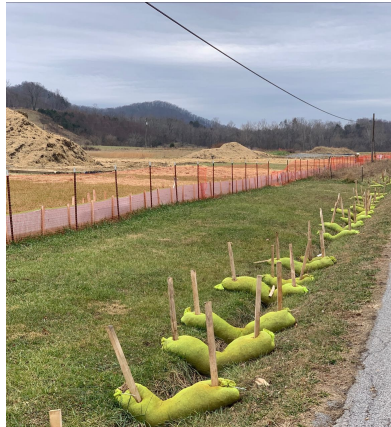
GPS Location	37.2356545760861, -80.2295528246516		GPS Location	37.2356545760861, -80.2295528246516	
Description	Yellow Finch_122918 Rain gauge (.6")		Description	12451+00_122918 Checks in the road ditch to filter any possible sediment.

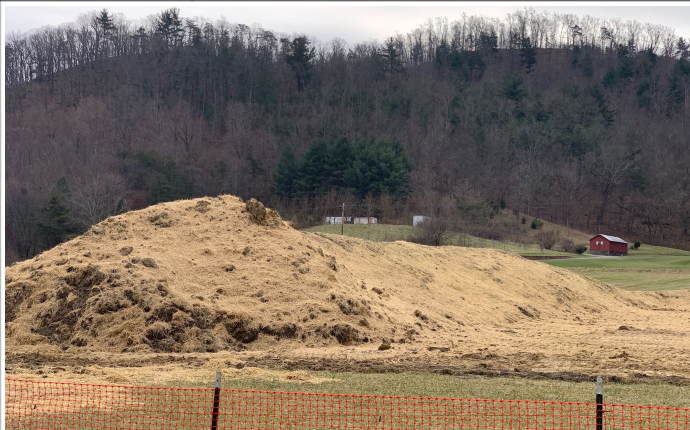
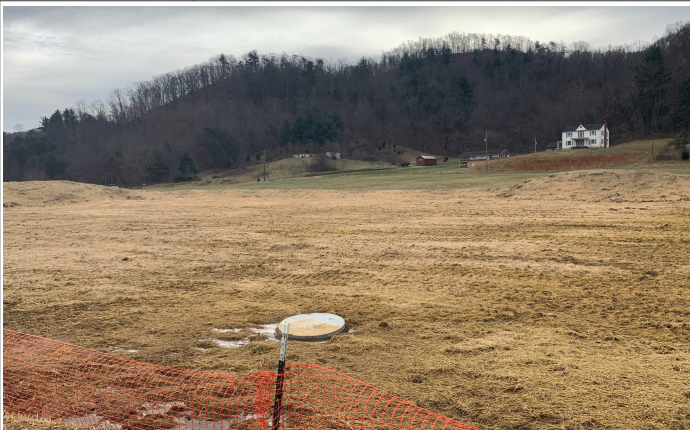
GPS Location	37.2356545760861, -80.2295528246516		GPS Location	37.2356545760861, -80.2295528246516	
Description	12451+00_122918 Stabilized topsoil pile.		Description	12451+00_122918 Stabilized ROW.

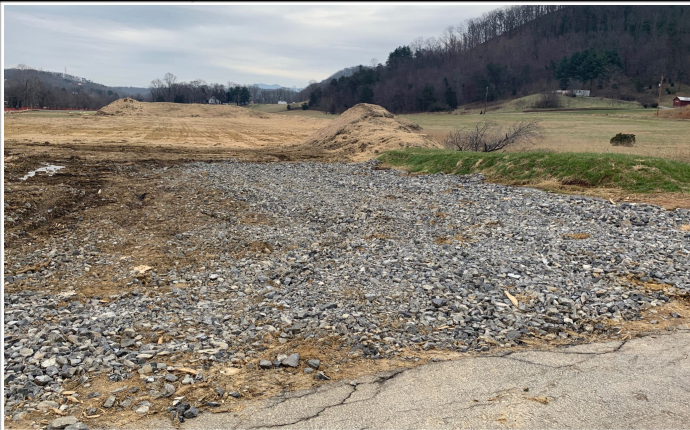
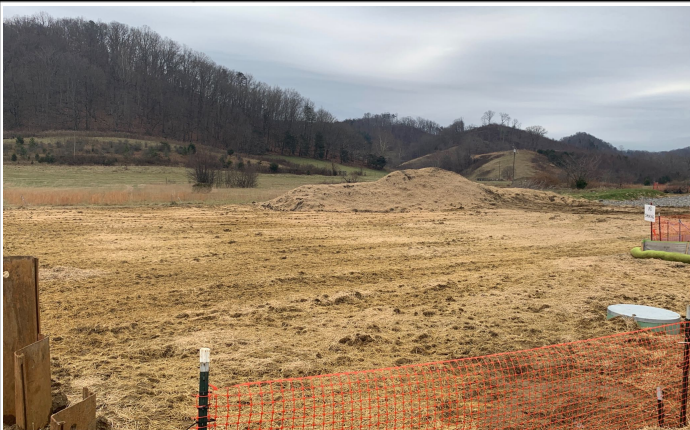
GPS Location	37.2356545760861, -80.2295528246516		GPS Location	37.2356545760861, -80.2295528246516	
Description	12451+00_122918 RCE.		Description	12451+00_122918 Stabilized ROW.

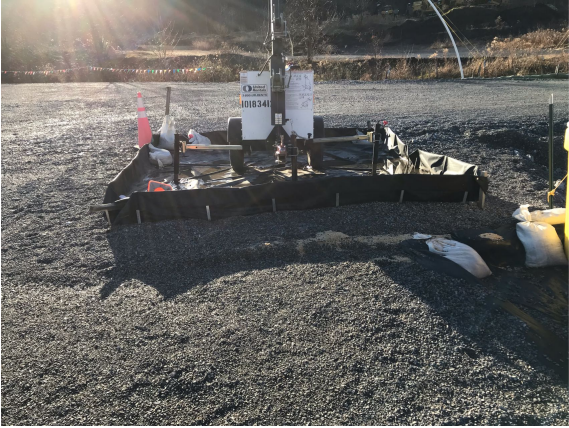
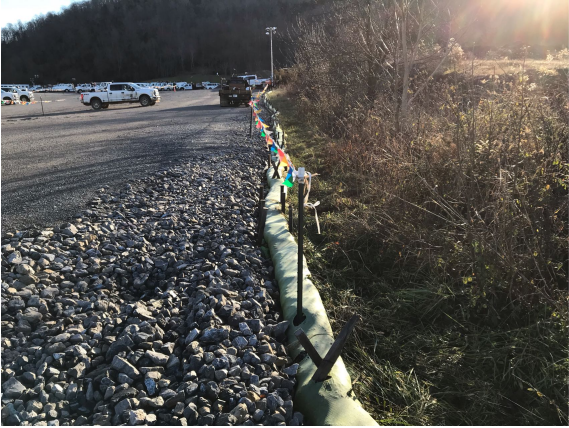
GPS Location	37.2354980511938, -80.2295339015128	GPS Location	37.2355142081448, -80.2294460964635		
Description	MVP-PY-006_122918 condition of containment under under light plant. Looking SW.	Description	MVP-PY-006_122918 condition of compost filter sock on the south boundary. Looking SE.

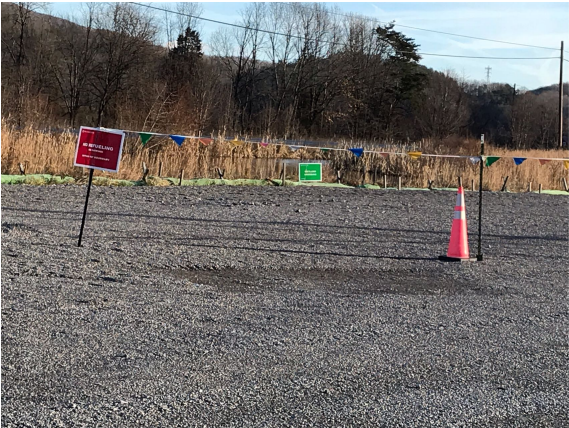
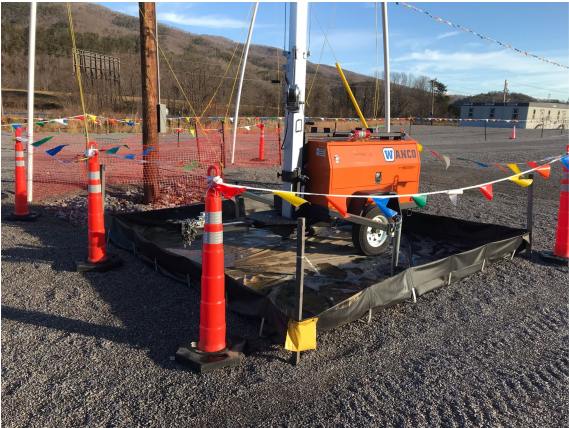
GPS Location	37.2358347160075, -80.2277042816938	GPS Location	37.2355006914933, -80.2295314707609		
Description	MVP-PY-006_122918 boundary flagging and signage for feature in good condition. Looking NE.	Description	MVP-PY-006_122918 condition of containment under light plant. Looking NE.

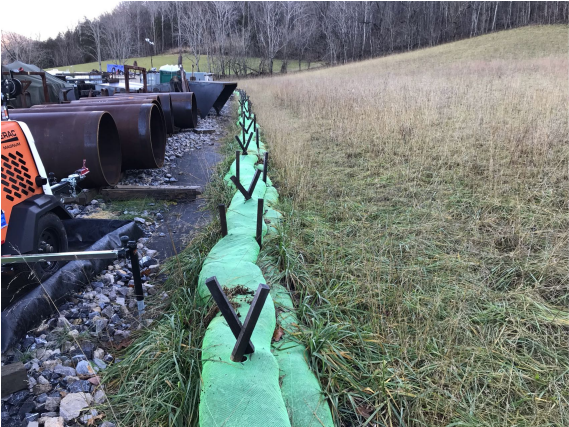
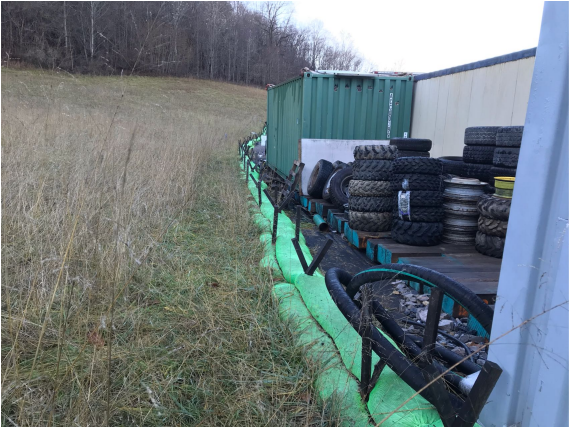
GPS Location	37.2355006914933, -80.2295314707609	GPS Location	37.2355006914933, -80.2295314707609		
Description	MVP-PY-006_122918 condition of compost filter sock along south boundary. Looking E.	Description	MVP-PY-006_122918 condition of compost filter sock along south boundary. Looking W.
