# Visual Site Inspection Report

<b>Project Name</b>	H-600 Pipeline Spread H	<b>AFE</b>	124300138	<b>Spread</b>	H-600 Pipeline Spread H
<b>Contractor</b>	Precision			<b>Report #</b>	12818
<b>Inspector</b>	Dawn McCullough			<b>Date/Time</b>	1/9/2019 6:54 PM
<b>Permit #</b>	TBD	<b>Inspection Type</b>	VA SWPP	<b>Station Begin</b>	13262+58
<b>State</b>	VA	<b>Inspection Area</b>	Partial	<b>Station End</b>	13315+70
<b>County</b>	Franklin	<b>Ground</b>	Damp	<b>Temperature (°F)</b>	35.00
<b>Municipality</b>	N/A	<b>Weather</b>	Sunny	<b>Rain Gauge (in)</b>	0.00
<b>GPS Location</b>	37.3255903271319, -80.0287939060433			<b>Rain Accumulation Time (days)</b>	1.00

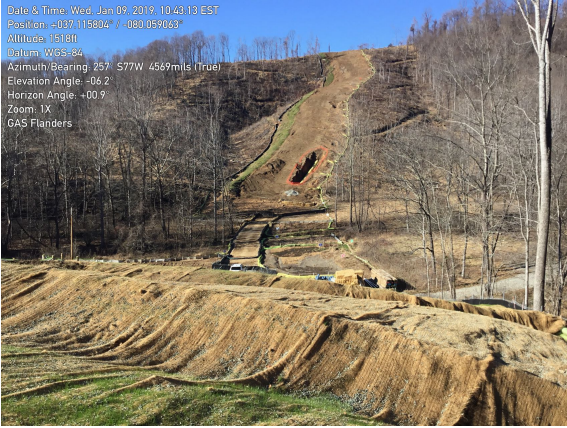
<p>Date &amp; Time: Wed Jan 09, 2019, 10:43:13 EST Position: +037.115804 / -080.057043 Altitude: 1518ft Datum: WGS-84 Azimuth/Bearing: 259.577W 4569mils (True) Elevation Angle: -06.2 Horizon Angle: +00.9 Zoom: 1X GAS Flanders</p>		<b>GPS Location</b> 37.3256837251012, -80.028649102971	
<b>Description</b>		<b>Description</b>		Please see photo for coordinates. ~Sta. No. 13265+00, germination noted in areas that have been hand seeded.

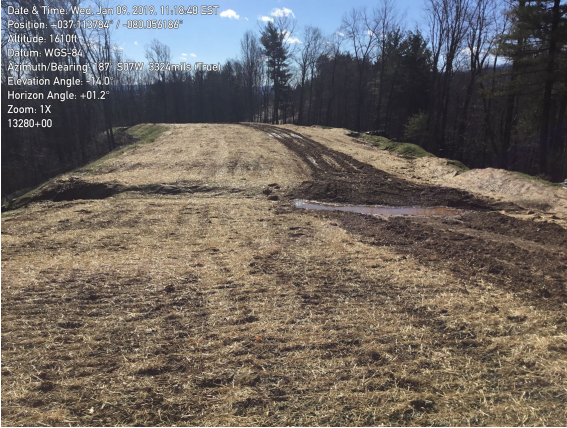
<p>Date &amp; Time: Wed Jan 09, 2019, 11:04:49 EST Position: +037.109765 / -080.056109 Altitude: 1610ft Datum: WGS-84 Azimuth/Bearing: 187.507W 8327mils (True) Elevation Angle: -14.0 Horizon Angle: +01.2 Zoom: 1X 13280+00</p>		<b>GPS Location</b> 37.3255818850768, -80.0288088934138

<b>Description</b>		<b>Description</b>		Please see photo for coordinates. ~Sta. No. 13268+50, sump needed cleaned, added as punch list item.

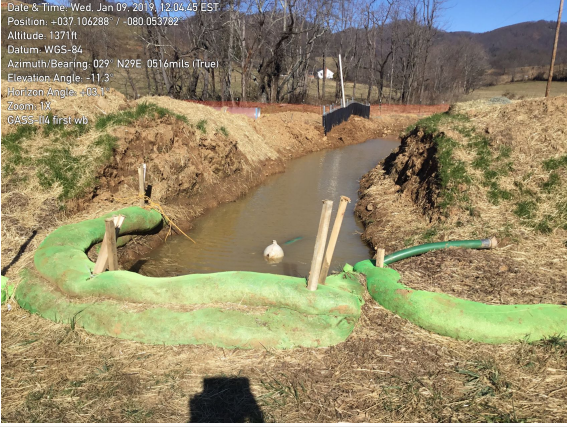
<p>Date &amp; Time: Wed Jan 09, 2019, 12:04:45 EST Position: +037.106288 / -080.053782 Altitude: 1371ft Datum: WGS-84 Azimuth/Bearing: 023.229E 0516mils (True) Elevation Angle: -11.3 Horizon Angle: +05.1 Zoom: 1X GAS 13311+00</p>		<b>GPS Location</b> 37.3256542208021, -80.0287185889483	
<b>Description</b>		<b>Description</b>		Please see photo for coordinates. ~Sta. No. 13294+00, no seed in travel lane, curlex not secure along edge.

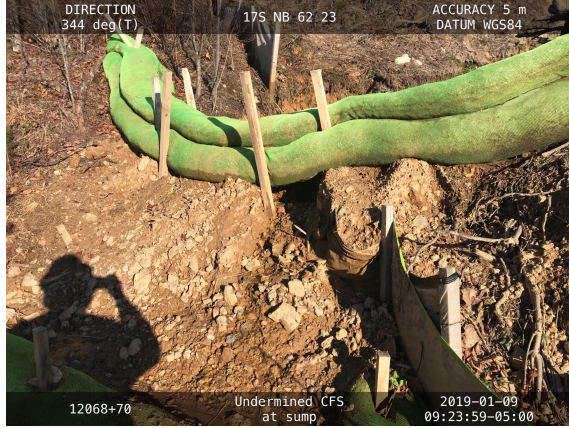
<p>DIRECTION 344 deg(T) 17S NB 62 23 ACCURACY 5 m DATUM WGS84 12068+70 Undermined CFS at sump 2019-01-09 09:23:59-05:00</p>		<b>GPS Location</b>	37.256209356745, -80.2760734968635
<b>Description</b>		Photo shows the repaired undermined CFS at 12073+65 (punch list item 1795).		<b>Description</b>	Photo shows the undermined CFS at 12068+70.

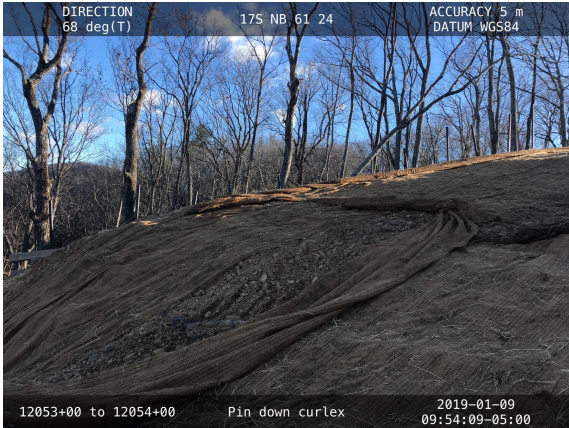
<p>DIRECTION 68 deg(T) 17S NB 61 24 ACCURACY 5 m DATUM WGS84 12053+00 to 12054+00 Pin down curlax 2019-01-09 09:54:09-05:00</p>

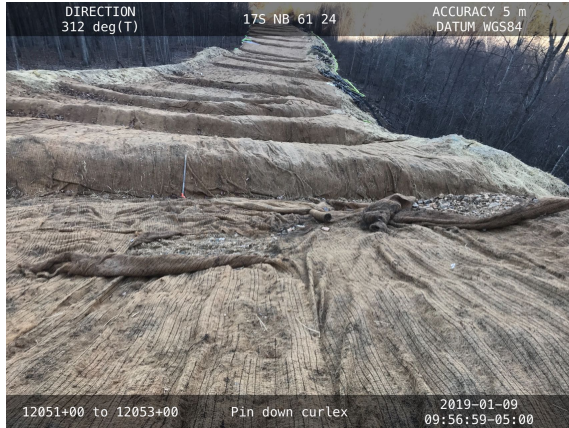
<p>DIRECTION 312 deg(T) 17S NB 61 24 ACCURACY 5 m DATUM WGS84 12051+00 to 12053+00 Pin down curlax 2019-01-09 09:56:59-05:00</p>		<b>GPS Location</b>	37.2562465723951, -80.2760337666425
<b>Description</b>		Photo shows the erosion control blanket that was blown off the ground surface between 12053+00 and 12054+00.		<b>Description</b>	Photo shows section of erosion control blanket that was blown off the ground surface between 12051+00 and 12053+00.

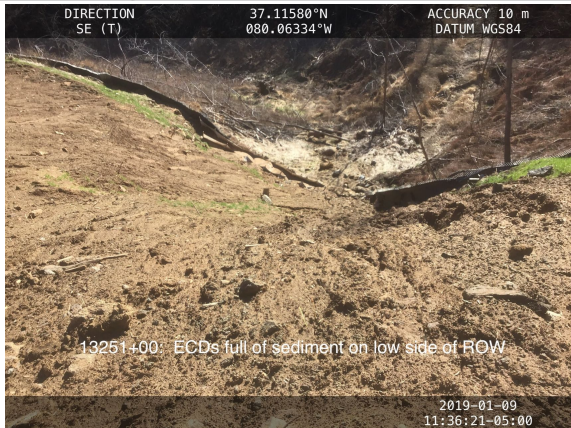
<div>13251+00: ECDs full of sediment on low side of ROW</div> <div>2019-01-09 11:36:21-05:00</div>			<div>DIRECTION W (T)</div> <div>37.11568°N 080.05999°W</div> <div>ACCURACY 5 m DATUM WGS84</div>
