Visual Site Inspection Report

Project Name	H-600 Pipeline Spread H	AFE	124300138	Spread	H-600 Pipeline Spread H
Contractor	Precision			Report #	12960
Inspector	Dustin Lyons			Date/Time	1/14/2019 10:02 AM
Permit #	TBD	Inspection Type	VA SWPP	Station Begin	12005+00
State	VA	Inspection Area	Partial	Station End	12072+00
County	Montgomery	Ground	Frozen	Temperature (°F)	31.00
Municipality	N/A	Weather	Cloudy	Rain Gauge (in)	0.60
GPS Location	37.2706981888388, -80.3142796364429			Rain Accumulation Time (days)	2.00

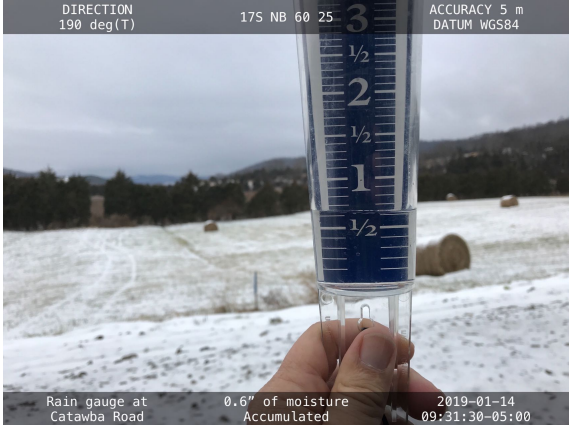
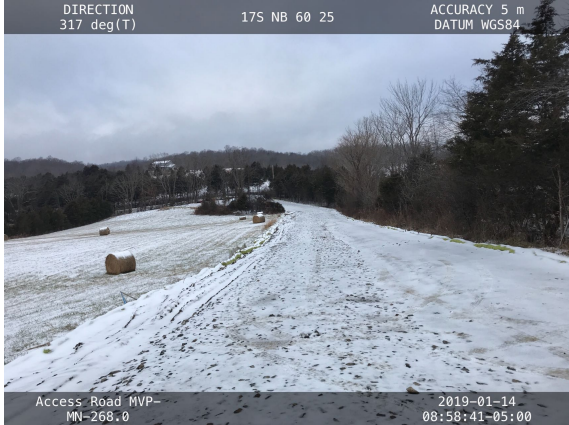
GPS Location	37.2705985699196, -80.3142267466339	GPS Location	37.270562527736, -80.314129097462		
Description	Photo shows the moisture accumulation from the snow/sleet event on 1-12 and 1-13-2019.	Description	Photo shows the condition of access road MVP-MN-268.0.

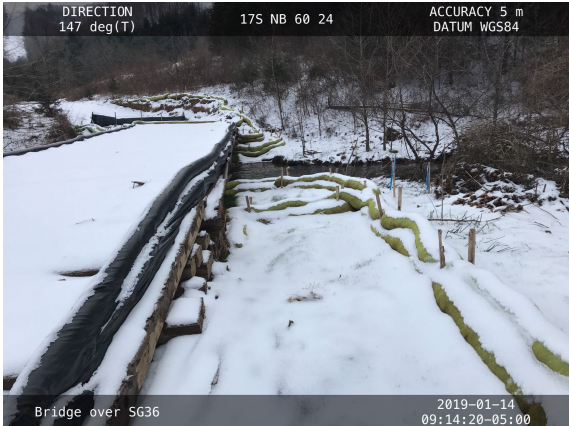
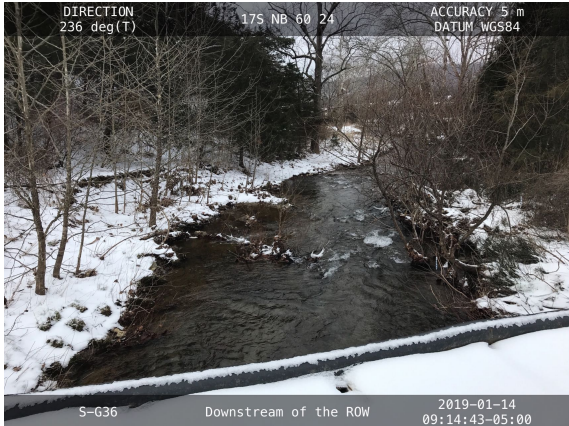
GPS Location	37.2704215022151, -80.3140964080396	GPS Location	37.2705286229376, -80.314184585661		
Description	Photo shows the bridge over SG36.	Description	Photo shows SG36 downstream of MVP-MN-268.01.

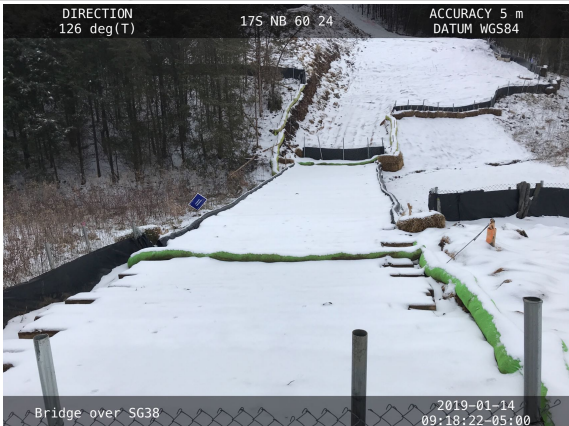
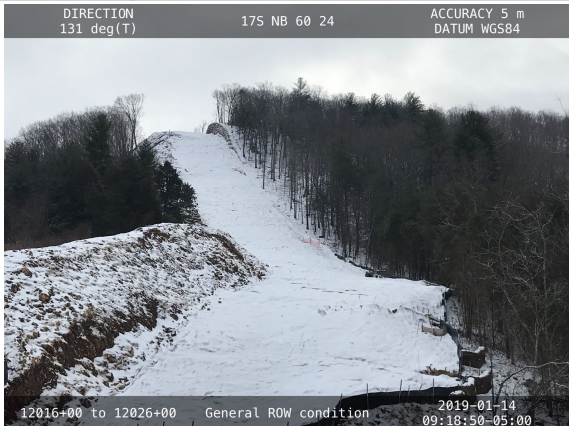
GPS Location	37.2705286229376, -80.314184585661	GPS Location	37.2706981888388, -80.3142796364429		
Description	Photo shows the bridge over SG38.	Description	Photo shows the ROW condition from about 12016+00 to 12026+00.

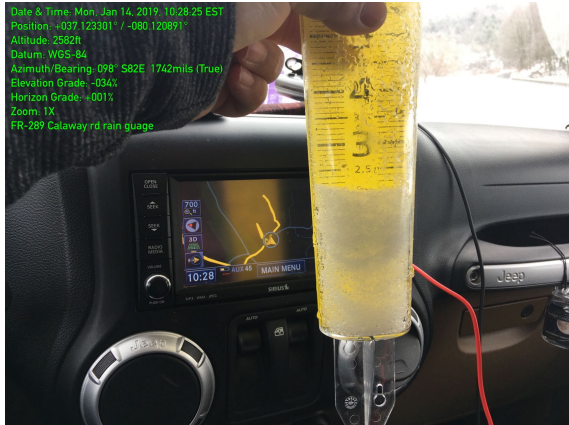
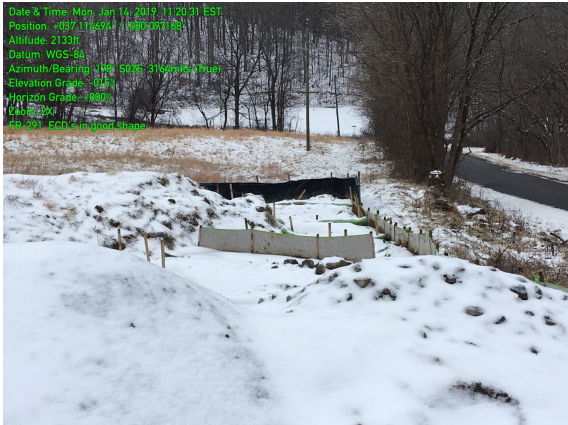
GPS Location	37.2939969438705, -80.0226855041393		GPS Location	37.2938656015669, -80.0228241831809	
Description	Total precipitation after melting was 0.7" total since Saturday morning.		Description	ECD's and surrounding area remained frozen throughout the day.

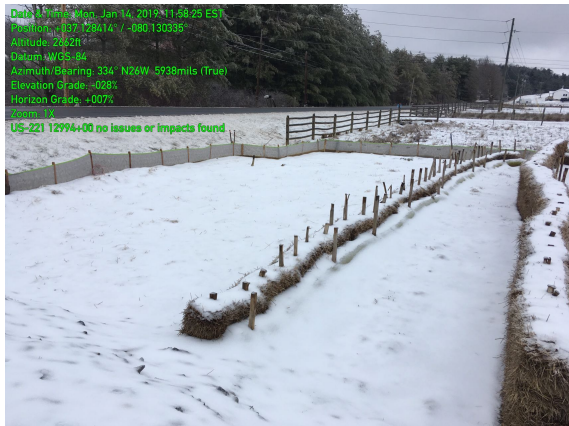
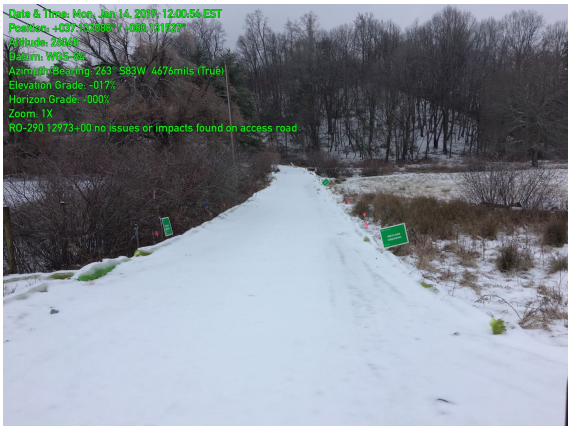
GPS Location	37.2938922141095, -80.0227032323182		GPS Location	37.2937531164263, -80.0227852911502	
Description	No issues or impacts found near US-221.		Description	No issues or impacts found along RO-288.

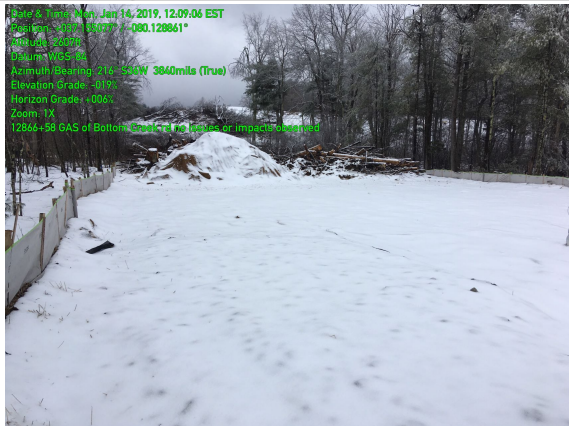
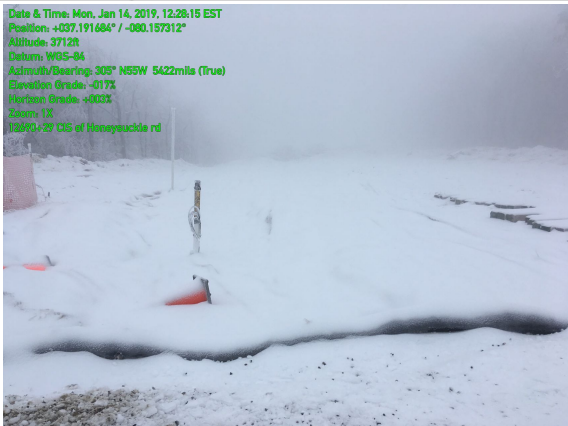
GPS Location	37.293692724814, -80.0229567010701		GPS Location	37.2936747456317, -80.0227118656784	
Description	No issues or impacts found at Bottom Creek rd.		Description	No issues or impacts found at Honeysuckle rd.

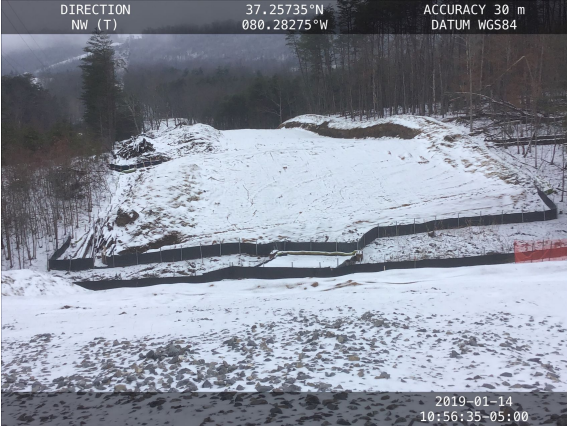
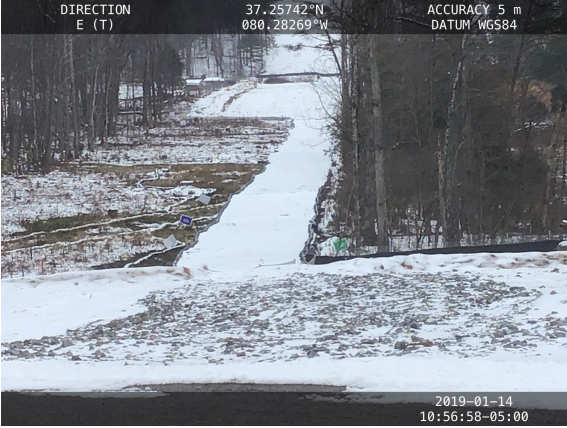
GPS Location	37.308639118277, -80.0101657719348	GPS Location	37.3086551763465, -80.010157199651		
Description	Station 12119+00, facing northwest. See photo for location.	Description	Station 12120+00, facing east. See photo for location.

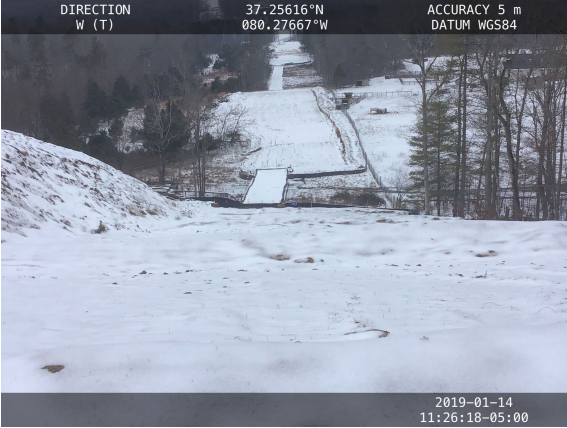
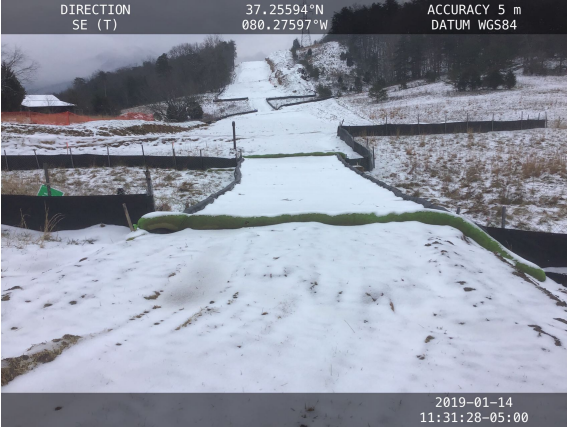
GPS Location	37.3085941980009, -80.0102336426079	GPS Location	37.3086002329712, -80.0102186390013		
Description	Station 12137+00, facing west. See photo for location.	Description	Wetland W-C6, facing southeast, station 12140+00. See photo for location.

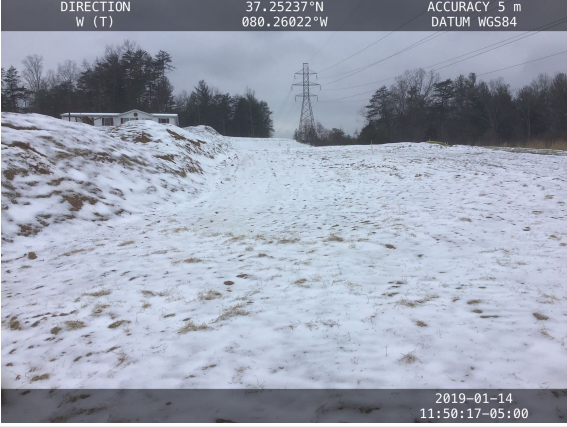
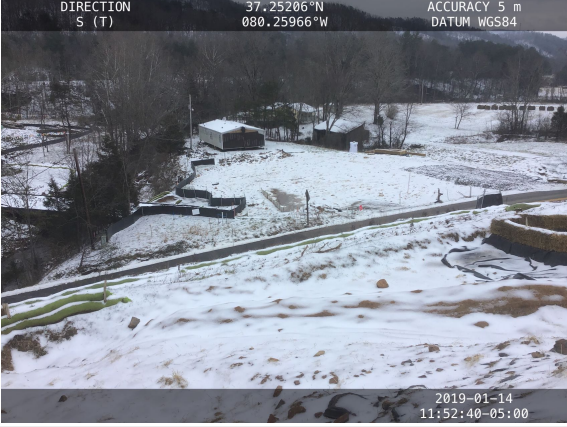
GPS Location	37.3086891230543, -80.0102621410787	GPS Location	37.3086681263869, -80.0101675932109		
Description	Station 12187+00, facing west. See photo for location.	Description	Station 12190+00, facing south, overlooking the Bradshaw Road crossing. See photo for location.

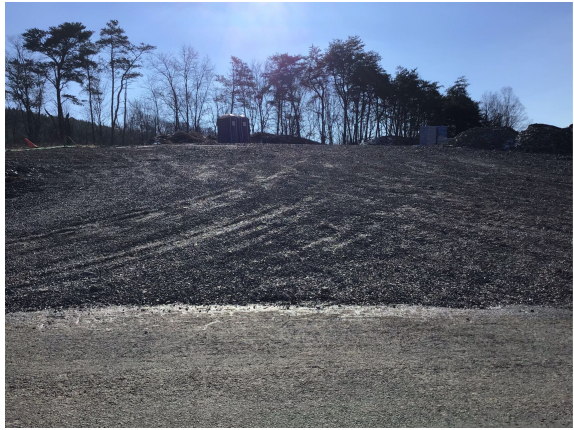
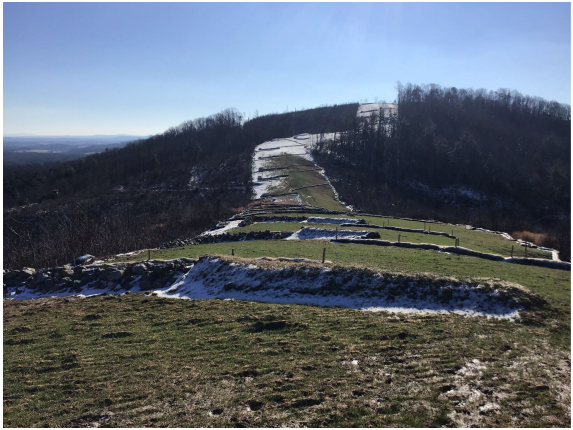
GPS Location	36.9716689214467, -79.8697943578875		GPS Location	36.9718457479374, -79.8699089326708	
Description	RCE at Cahas Mt#1 in good condition.		Description	Permanent stabilization of RoW in compliance.

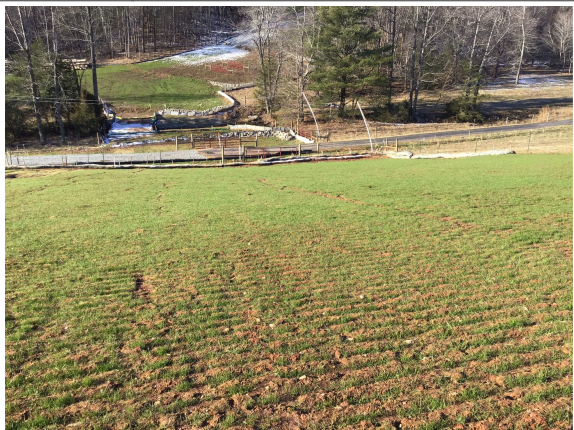
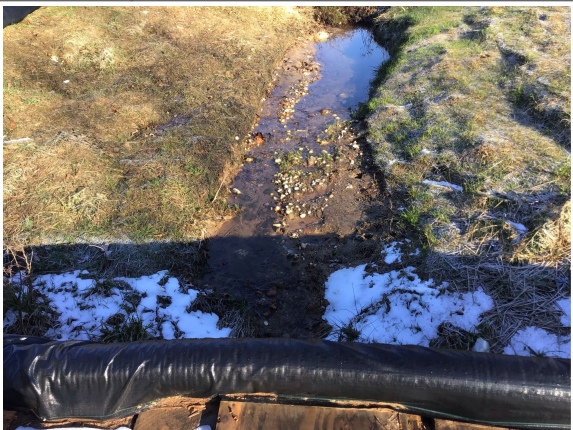
GPS Location	36.9721126277344, -79.869832657352		GPS Location	36.9721107418062, -79.8699564580618	
Description	Permanent stabilization near private drive and stream S-KL2 at 13525+08		Description	Stream S-II8 flowing free and clear of any sediment.

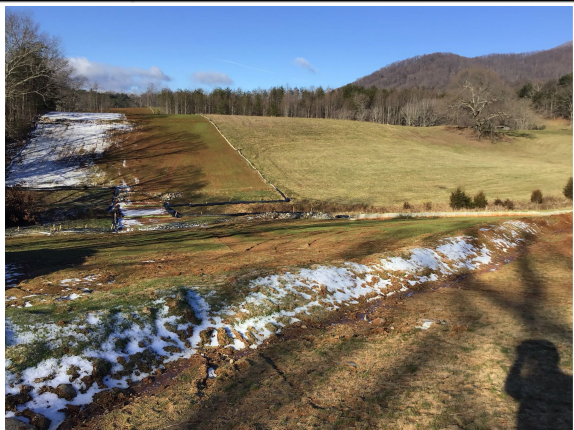
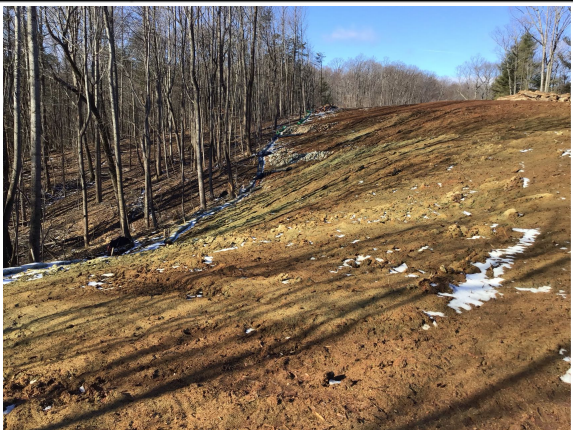
GPS Location	36.9717861945154, -79.8698979523777		GPS Location	36.9718263019221, -79.869919912964	
Description	Stabilization and ECD's in compliance on CIS of House Rock Rd.		Description	Perimeter ECD's in good condition near 13635+00

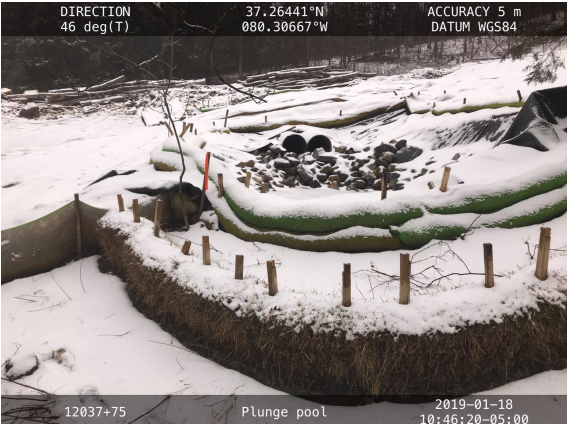
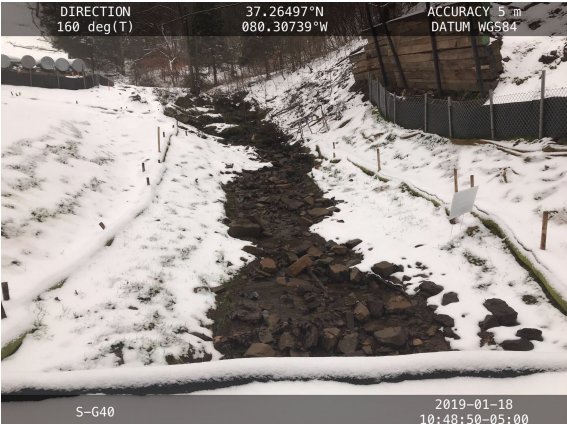
Description	Photo shows the condition of the plunge pool at 12037+75. GPS data is included on Photo.		Description	Photo shows the general condition of stream S-G40. GPS data is included on Photo.	
DIRECTION 4 deg(T) 37.26491°N 080.30860°W ACCURACY 5 m DATUM WGS84

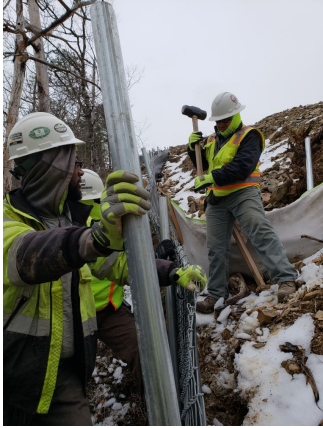
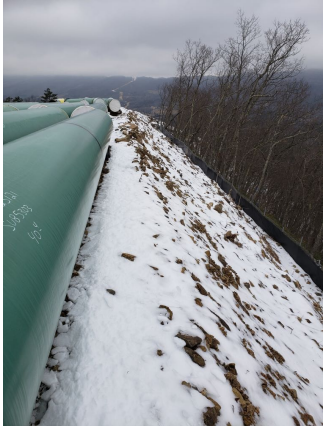
GPS Location	37.3313797308565, -79.9582126206378	GPS Location	37.3313749218199, -79.9582170706013		
Description	12218+00_011819 Crew performing maintenance to SSF.	Description	12229+00_011819 SSF perimeter controls.

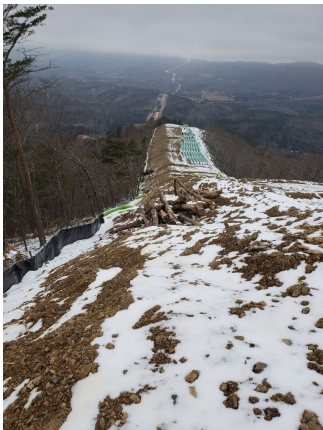
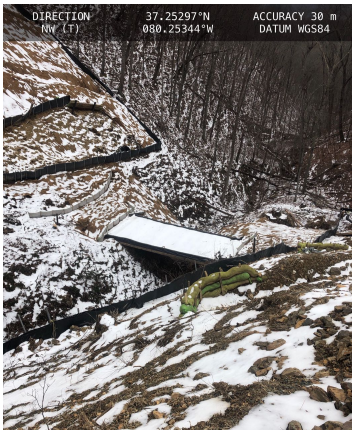
GPS Location	37.3313414155066, -79.958218307917	GPS Location	37.3313352759007, -79.958260736213		
Description	12234+00_011819 Stabilized snow covered ROW.	Description	12211+21_011819 Bridge crossing drainage feature. Looking NW. See picture for GPS data.

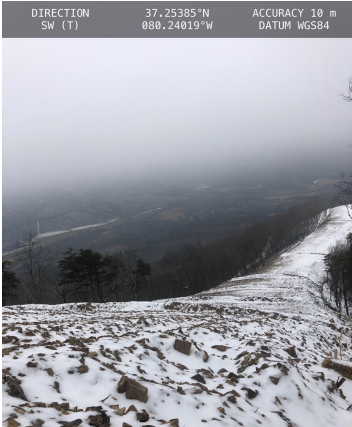
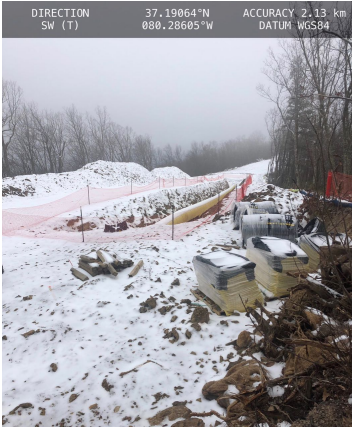
GPS Location	37.3313054016406, -79.9581424997725	GPS Location	37.3314138535317, -79.9585108104517		
Description	12269+00_011819 Snow covered stabilized ROW. Looking SE. See picture for GPS data.	Description	12281+85_011819 Safety fence around open ditch. Looking SW. See picture for GPS data.

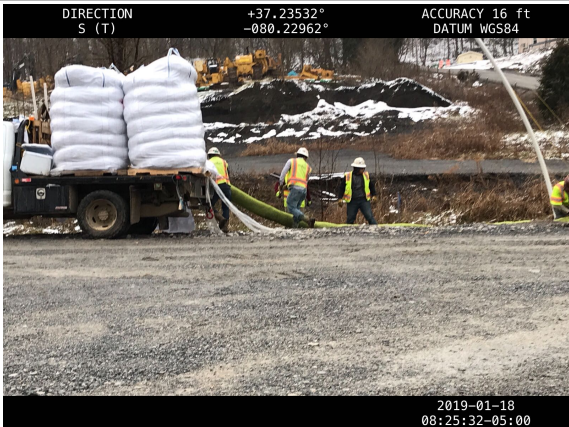
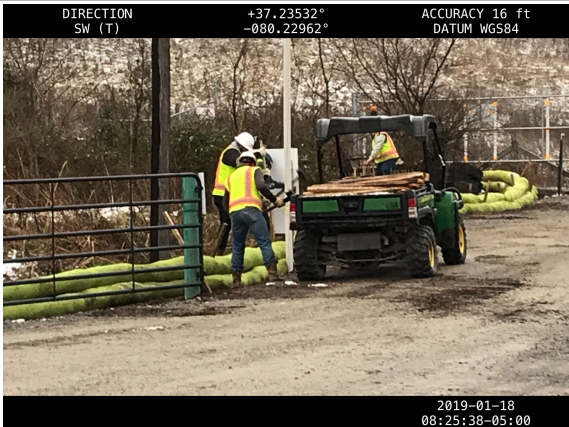
GPS Location	37.2354882024575, -80.229177419171		GPS Location	37.2354900045667, -80.2291639243068	
Description	MVP-PY-006_011819 crew refreshing compost filter sock along boundary. Looking S. See photo for gps data.		Description	MVP-PY-006_011819 crew refreshing compost filter sock along boundary. Looking SW. See photo for gps data.

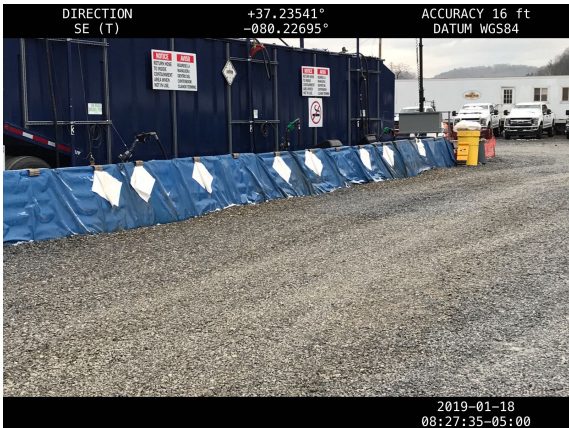
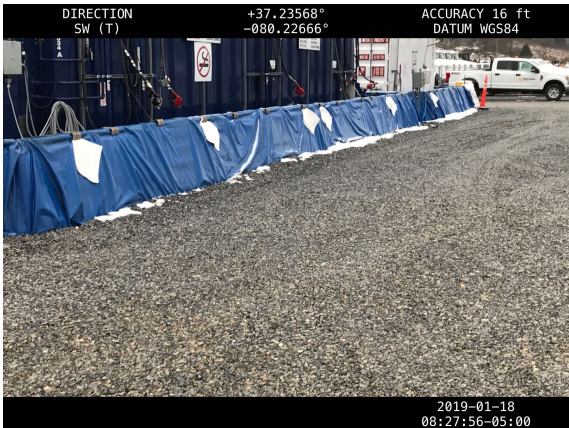
GPS Location	37.2354900045667, -80.2291639243068		GPS Location	37.2354900045667, -80.2291639243068	
Description	MVP-PY-006_011819 no fluid on the south side of the bulk fuel tanks. Looking SE. See photo for gps data.		Description	MVP-PY-006_011819 no fluid deposits on the north side of the bulk fuel tanks. Looking SW. See photo for gps data.

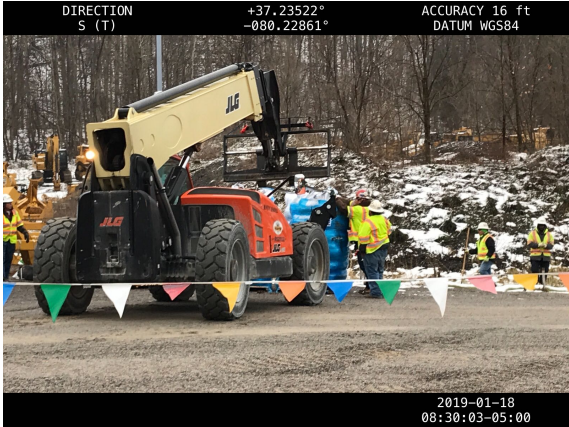
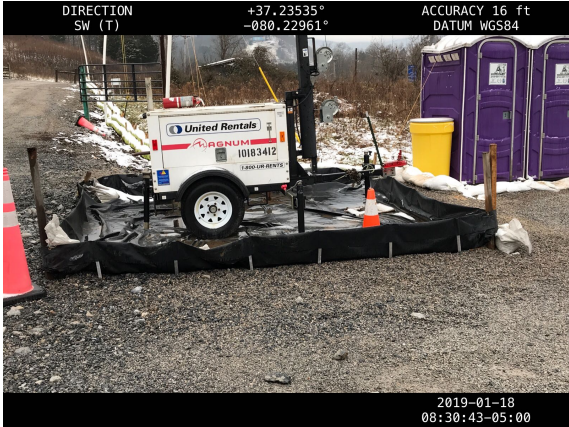
GPS Location	37.235495955718, -80.2291666903349		GPS Location	37.235495955718, -80.2291666903349	
Description	MVP-PY-006_011819 crew moving compost filter sock to be installed. Looking S. See photo for gps data.		Description	MVP-PY-006_011819 condition of containment under light plant. Looking SW. See photo for gps data.
