Visual Site Inspection Report

Project Name	H-600 Pipeline Spread H	AFE	124300138	Spread	H-600 Pipeline Spread H
Contractor	Precision			Report #	13424
Inspector	Glenn Mike Renfro			Date/Time	1/28/2019 12:16 PM
Permit #	TBD	Inspection Type	VA SWPP	Station Begin	13415+00
State	VA	Inspection Area	Full	Station End	13670+00
County	Franklin	Ground	Damp	Temperature (°F)	39.00
Municipality	N/A	Weather	Sunny	Rain Gauge (in)	1.10
GPS Location	36.9717959332242, -79.8699327097349			Rain Accumulation Time (days)	6.00

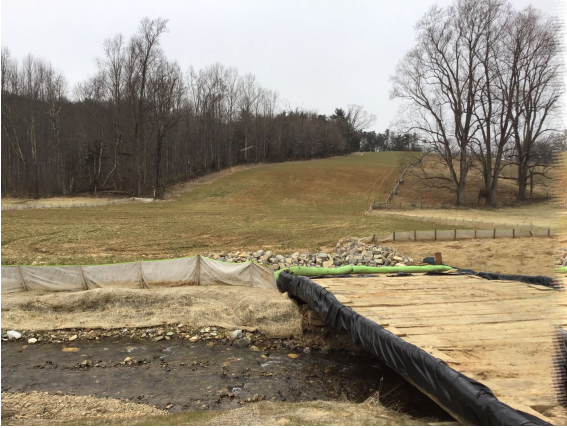
GPS Location	36.9719022836872, -79.8702204271838	GPS Location	36.9720829138877, -79.8700583820044		
Description	All E&S controls in place and functioning properly at kickoff near 13415+00.	Description	E&S controls in place and in compliance on GAS of stream S-IJ10 at 13498+00.

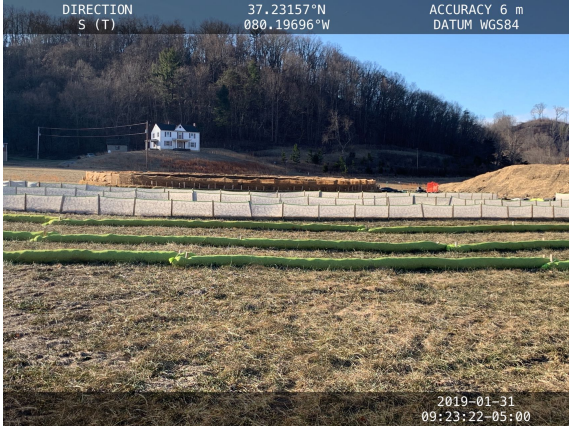
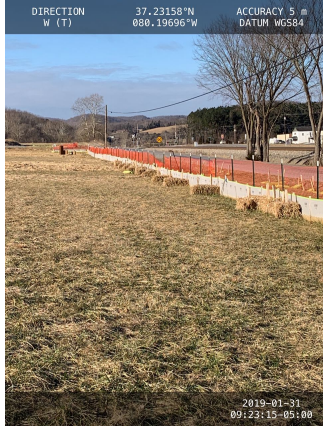
GPS Location	37.3313225492298, -79.9582654433467	GPS Location	37.3316078339053, -79.9583237823364		
Description	12451+00_013119 Dewatering structure with layers of filtration. looking S. See picture for GPS data.	Description	12451+00_013119 P1 slide fence perimeter controls with straw bale Checks. Looking W. See picture for GPS data.

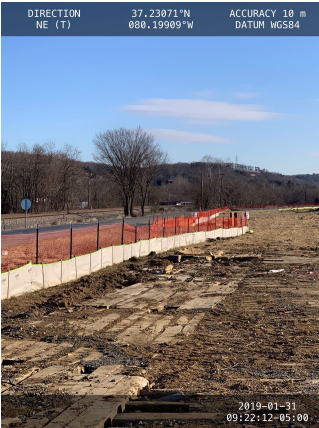
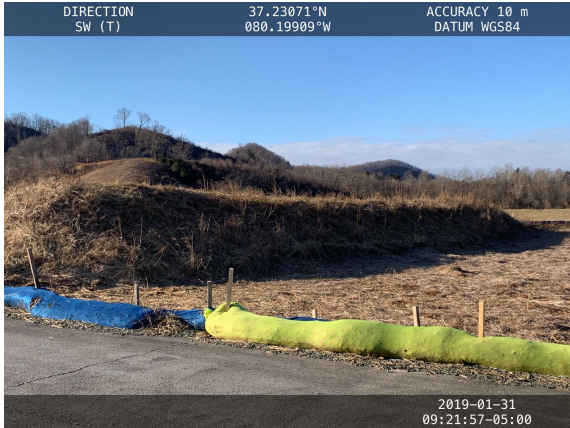
GPS Location	37.331429587161, -79.958199725307	GPS Location	37.331429587161, -79.958199725307		
Description	12452+70_013119 P1 silt fence perimeter controls. Looking NE. See picture for GPS data	Description	12453+00_013119 Stabilized topsoil pile. Looking SW. See picture for GPS data.

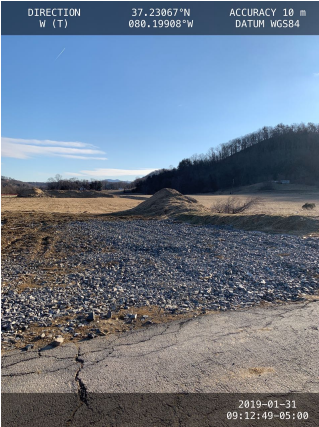
GPS Location	37.331429587161, -79.958199725307	GPS Location	37.331429587161, -79.958199725307		
Description	12452+70_013119 RCE. Looking W. See picture for GPS data.	Description	YellowFinchRoad_013119 Rain gauge. Looking NW. See picture for GPS data.

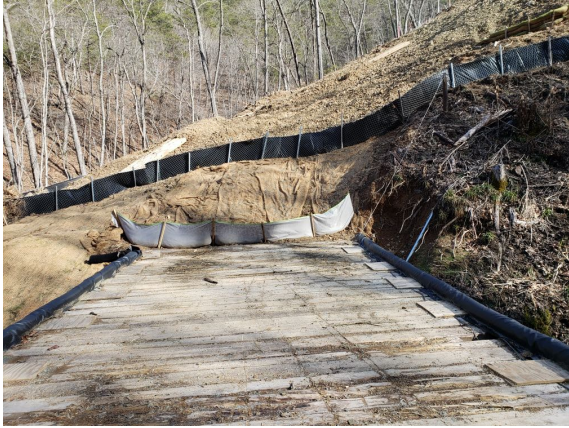
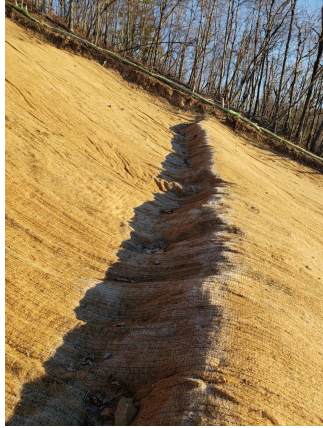
GPS Location	37.331492951862, -79.9583258358707	GPS Location	37.3313495290323, -79.9583544012173		
Description	12211+21_013119 Bridge crossing drainage feature.	Description	12269+68_013118 Water bar crossing ROW.

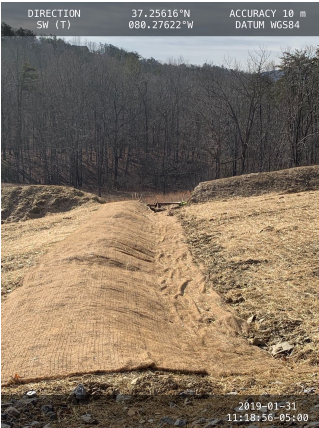
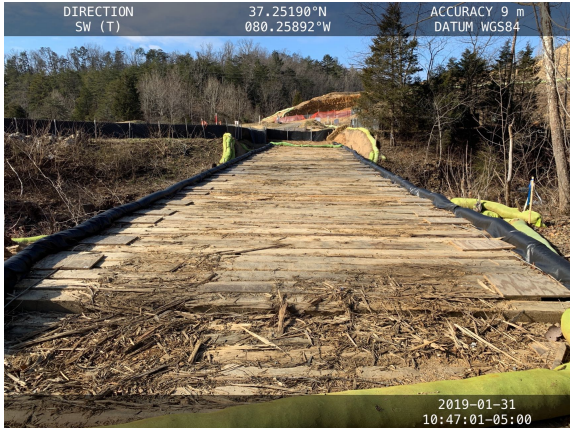
GPS Location	37.3315457899421, -79.9583062290775	GPS Location	37.3314433233192, -79.958456413248		
Description	12140+00_013119 Water bar Looking SW. See picture for GPS data.	Description	12192+36_013119 Bridge crossing S-C21. Looking SW. See picture for GPS data.

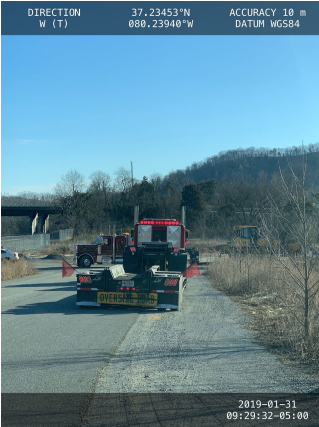
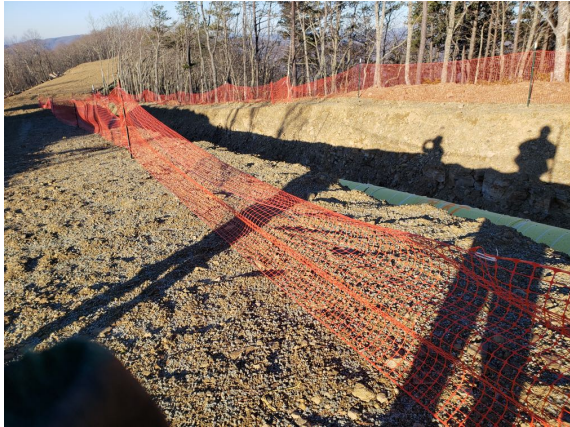
GPS Location	37.3316328381508, -79.9582350396589	GPS Location	37.3313371160793, -79.9583897146035		
Description	MVP-MN-276.03 crew removing equipment from ROW. Looking W. See picture for GPS data.	Description	12281+00_013119 Open ditch on ROW.

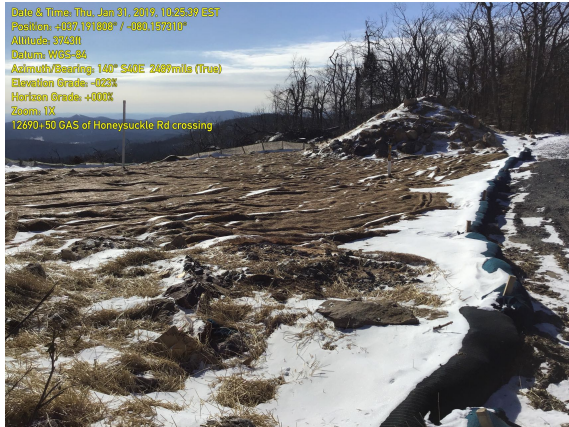
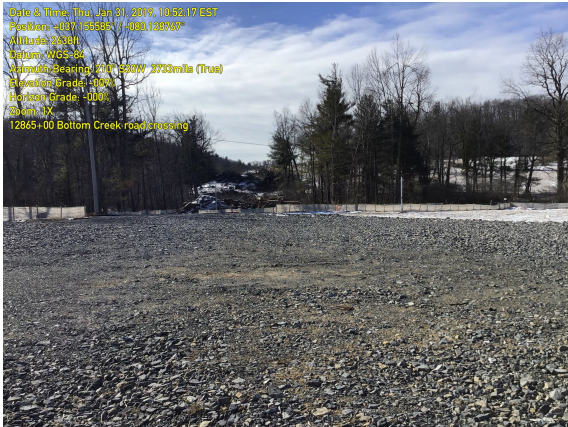
GPS Location	37.1917999629278, -80.1572996658088		GPS Location	37.1555892611268, -80.1287587825955	
Description	Area stabilized with Curlex, seed and mulch on soil piles, and EarthGuard in areas between. All ECD's in good condition. No issues.		Description	All ground disturbance has been seeded, straw mulched, or Curlexed. All ECD's in good condition. No Issues Or Impacts found.

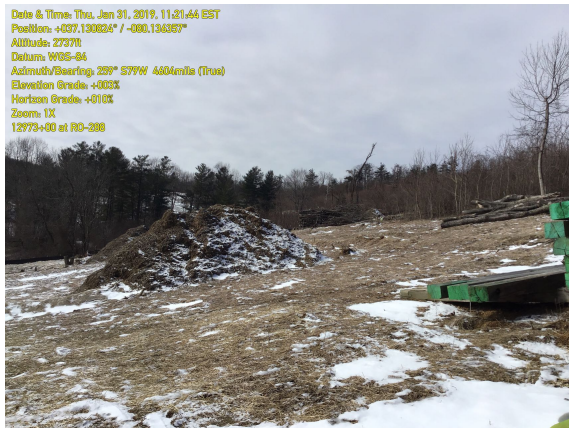
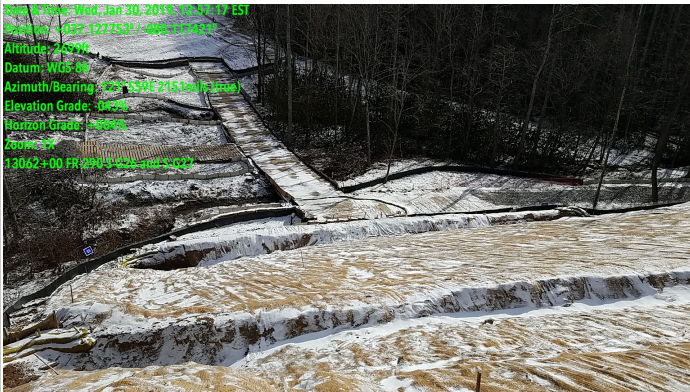
GPS Location	37.1308331005621, -80.1363686286659		GPS Location	37.1261572977874, -80.1186469384284	
Description	ECD's and BMP's in good condition. No issues or impacts on the ROW or access road.		Description	See pic for GPS location. No issues or impacts found throughout the area. 13062+00 FR-290 S-G26 and S-G27.	
<p>Date & Time: Wed, Jan 30, 2019, 1:25:02 EST Position: +037.125417° / -080.12116° Altitude: 2646ft Datum: WGS-84 Azimuth/Bearing: 296° S30W 4451mils (True) Elevation Grade: +081% Horizon Grade: +001% Zoom: 1X 13044+00 S-G24 S-G25 and S-G25</p>

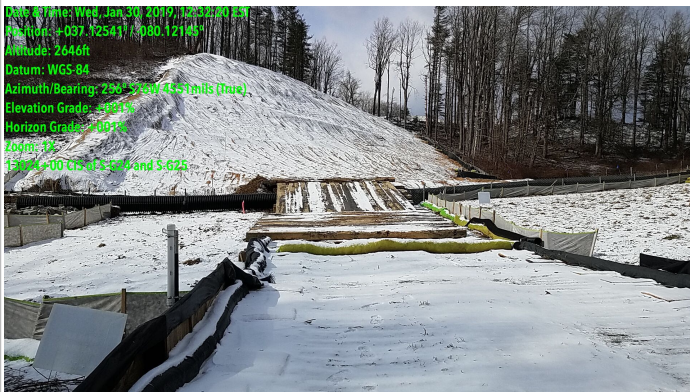
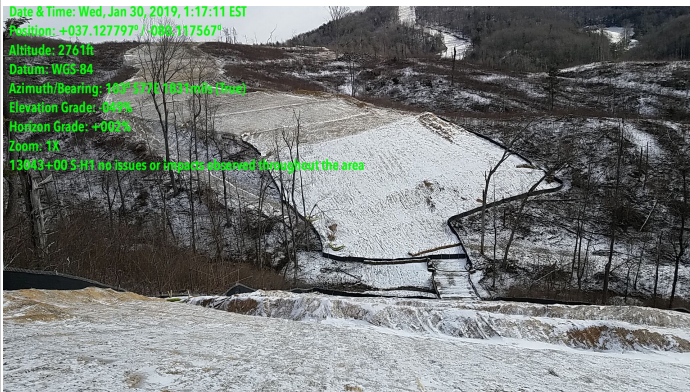
GPS Location	37.1261572977874, -80.1186469384284		GPS Location	37.1261519333693, -80.1185995806755	
Description	See pic for GPS location. No issues or impacts observed in the area. 13024+00 S-G24 and S-G25 and BRP		Description	See pic for GPS location. No issues or impacts found throughout the area. 13043+00 S-H1.

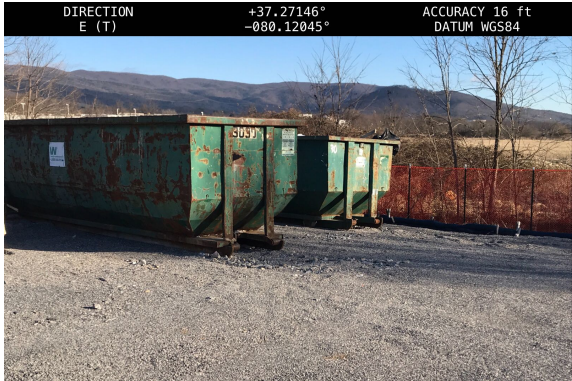
GPS Location	37.2711444832732, -80.1221277751775		GPS Location	37.2711444832732, -80.1221277751775	
Description	MVP-LY-09_013119 condition of containment under porta toilets. Looking NE. See photo for gps data.		Description	MVP-LY-049_013119 dumpster area clear of loose trash. Looking E. See photo for gps data.	
<div>DIRECTION W (T)</div> <div>+37.27076° -080.12001°</div> <div>ACCURACY 16 ft DATUM WGS84</div>   <div>2019-01-31 09:16:18-05:00</div>			<div>DIRECTION W (T)</div> <div>+37.27166° -080.12306°</div> <div>ACCURACY 16 ft DATUM WGS84</div>

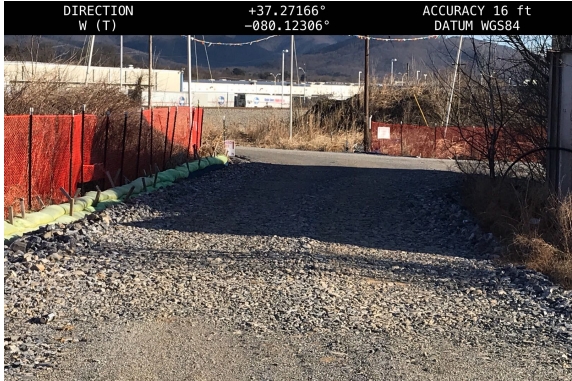
<div>2019-01-31 09:20:26-05:00</div>		
GPS Location	37.2711444832732, -80.1221277751775		GPS Location	37.2711444832732, -80.1221277751775	
Description	MVP-LY-049_013119 condition of safety fence and compost filter sock along south boundary. Looking W. See photo for gps data.		Description	MVP-LY-049_013119 condition of rock approach on north drive. Looking W. See photo for gps data.
