# Visual Site Inspection Report

<b>Project Name</b>	H-600 Pipeline Spread H	<b>AFE</b>	124300138	<b>Spread</b>	H-600 Pipeline Spread H
<b>Contractor</b>	Precision			<b>Report #</b>	13699
<b>Inspector</b>	Dustin Lyons			<b>Date/Time</b>	2/6/2019 7:06 PM
<b>Permit #</b>	TBD	<b>Inspection Type</b>	VA SWPP	<b>Station Begin</b>	12005+00
<b>State</b>	VA	<b>Inspection Area</b>	Partial	<b>Station End</b>	12072+00
<b>County</b>	Montgomery	<b>Ground</b>	Wet	<b>Temperature (°F)</b>	51.00
<b>Municipality</b>	N/A	<b>Weather</b>	Cloudy	<b>Rain Gauge (in)</b>	0.00
<b>GPS Location</b>	37.2356021963407, -80.2295745537432			<b>Rain Accumulation Time (days)</b>	1.00

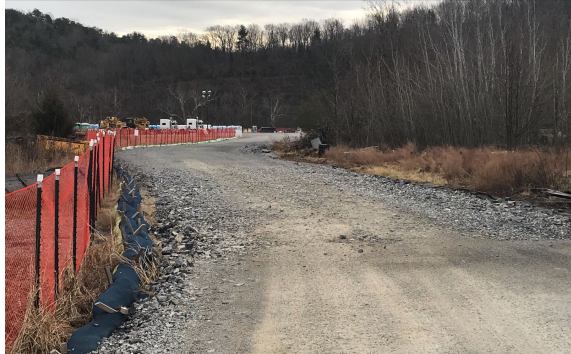
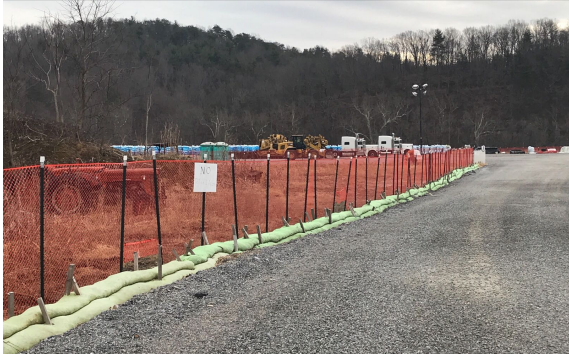
<div>2019-02-06 09:10:53-05:00</div>		
GPS Location	37.2695708647717, -80.1222804934533		GPS Location	37.2695701942195, -80.122279739082	
Description	MVP-LY-049_020619 condition of rock approach. Looking S. See photo for gps data.		Description	MVP-LY-049_020619 condition of compost filter sock and safety fence along drive. Looking S. See photo for gps data.	
<div>DIRECTION E (T)</div> <div>+37.27101° -080.12208°</div> <div>ACCURACY 16 ft DATUM WGS84</div>

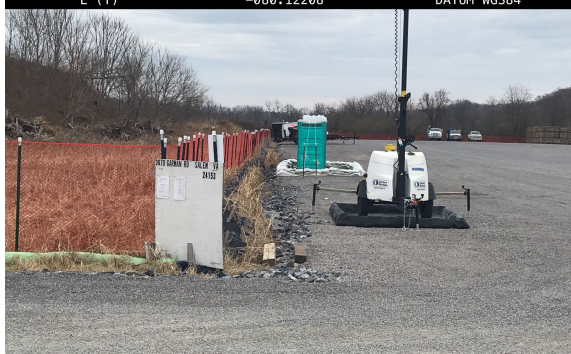
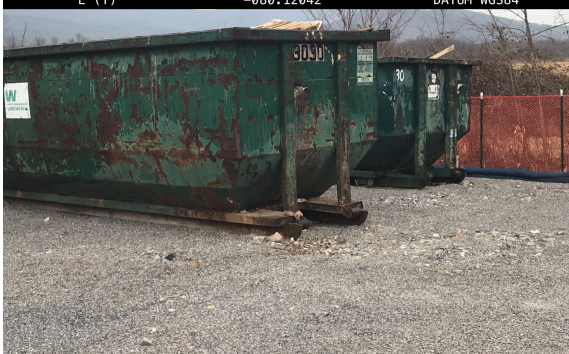
GPS Location	37.2695701942195, -80.122279739082		GPS Location	37.2695701942195, -80.122279739082	
Description	MVP-LY-049_020619 light plant in containment. Looking E. See photo for gps data.		Description	MVP-LY-049_020619 dumpster area free of loose trash. Looking E. See photo for gps data.	
<div>DIRECTION SW (T)</div> <div>+37.26929° -080.12248°</div> <div>ACCURACY 16 ft DATUM WGS84</div>

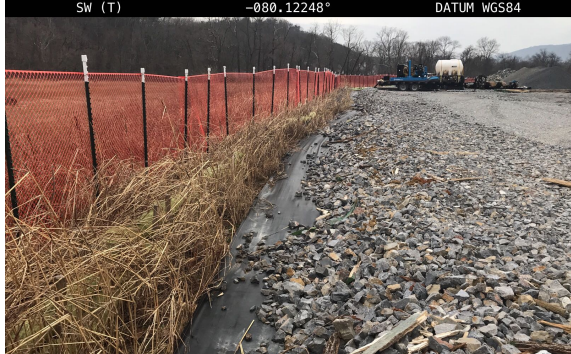
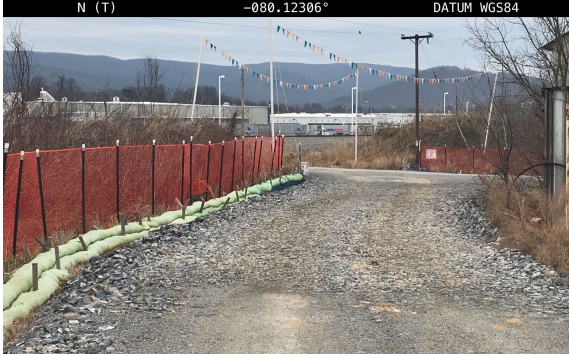
<div>2019-02-06 09:20:07-05:00</div>		
GPS Location	37.2695701942195, -80.122279739082		GPS Location	37.2695701942195, -80.122279739082	
Description	MVP-LY-049_020619 condition of compost filter sock and safety fence on south boundary. Looking SW. See photo for gps data.		Description	MVP-LY-049_020619 Condition of Rock approach on north drive. Looking N. See photo for gps data.

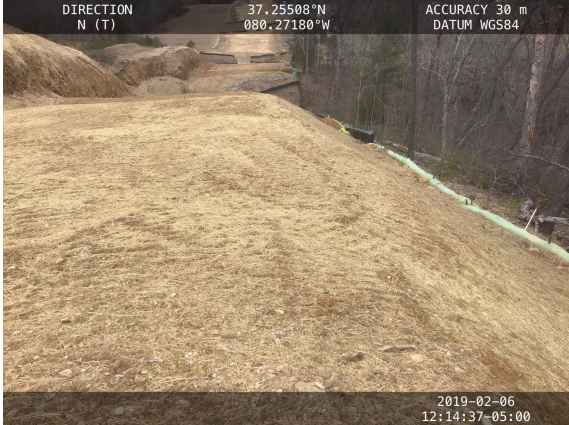
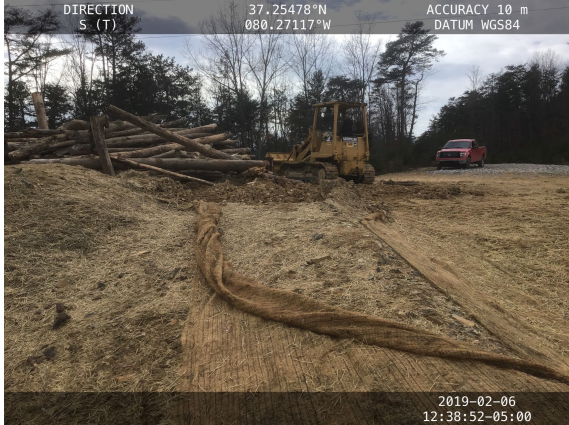
<b>GPS Location</b>	37.255049049889, -80.271804006845	<b>GPS Location</b>	37.2549589444299, -80.2713087201866		
<b>Description</b>	Station 12151+00, facing north.	<b>Description</b>	Erosion control blanket displaced where landowner used a dozer to retrieve logs from the pile @ station 12153+50, ~MP 230.0~.

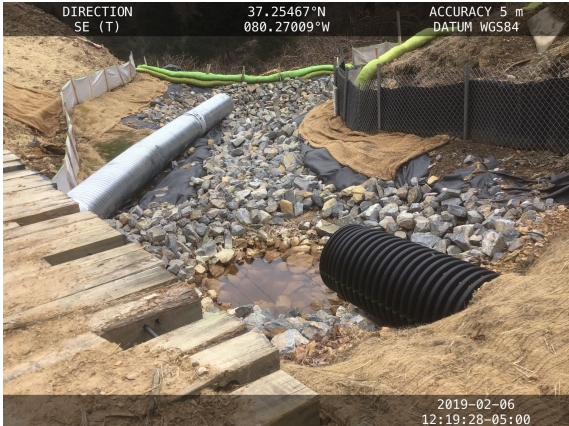
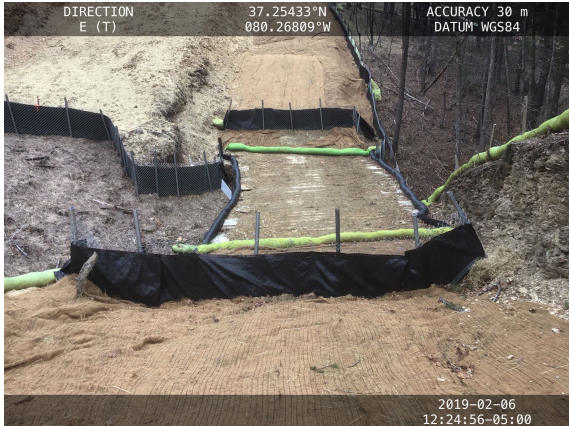
<b>GPS Location</b>	37.2546622669671, -80.2700604033473	<b>GPS Location</b>	37.2543142503474, -80.2680906561019		
<b>Description</b>	Sump drain and clean water diversion pipe are functioning properly @ station 12157+00, ~MP 230.1~.	<b>Description</b>	Stream S-C25, facing east.

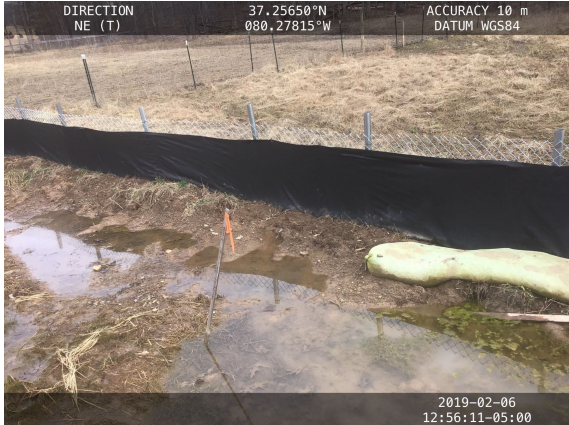
<b>GPS Location</b>	37.2541325725962, -80.267052138299	<b>GPS Location</b>	37.2564215446238, -80.2781964652988		
<b>Description</b>	Stream S-C24, facing east.	<b>Description</b>	PL item #1841 has been completed @ station 12132+00, ~MP 229.6~.
