Visual Site Inspection Report

Project Name	H-600 Pipeline Spread H	AFE	124300138	Spread	H-600 Pipeline Spread H	
Contractor	Precision			Report #	13913	
Inspector	Pat Davis			Date/Time	2/12/2019 5:45 PM	
Permit #	TBD	Inspection Type	VA SWPP	Station Begin	+0	
State	VA	Inspection Area	Partial	Station End	+0	
County	Montgomery	Ground	Muddy	Temperature (°F)	34.00	
Municipality	N/A	Weather	Light Rain	Rain Gauge (in)	0.70	
GPS Location	37.2356013162408, -80.2296562772991			Rain Accumulation Time (days)	0.00

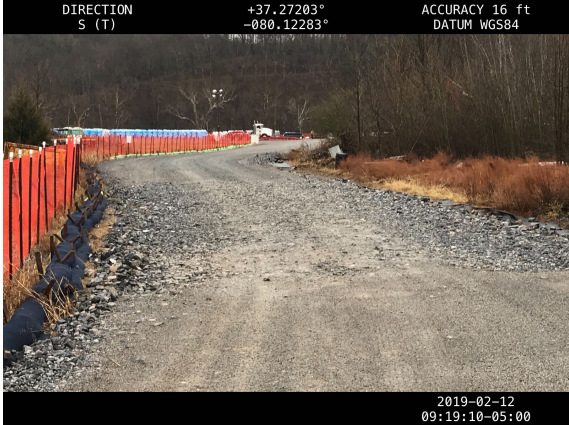
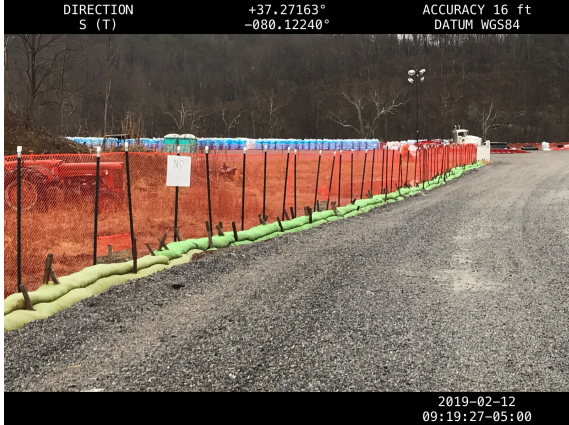
<p>DIRECTION S (T) +37.27163° -080.12240° ACCURACY 16 ft DATUM WGS84</p> <p>2019-02-12 09:19:27-05:00</p>		GPS Location 37.2705469793056, -80.1233286504449	
Description MVP-LY-049_021219 condition of rock approach. Looking S. See photo for gps data.		Description MVP-LY-049_021219 condition of safety fence and compost filter sock along the drive. Looking S. See photo for gps data.		GPS Location 37.2705469793056, -80.1233286504449

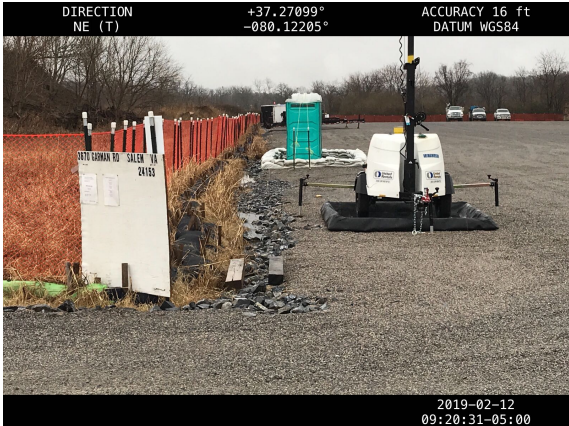
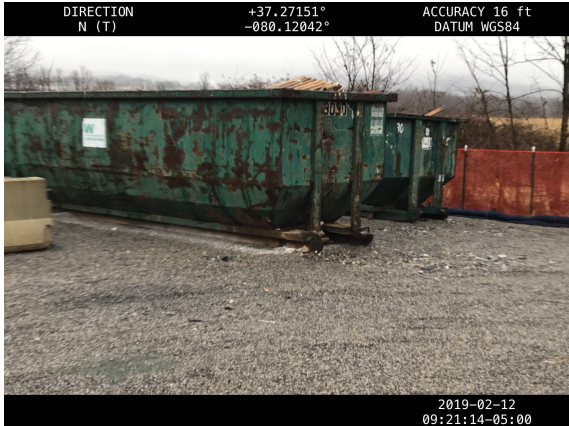
<p>DIRECTION N (T) +37.27151° -080.12042° ACCURACY 16 ft DATUM WGS84</p> <p>2019-02-12 09:21:14-05:00</p>		GPS Location 37.2705493262385, -80.1233252138646	
Description MVP-LY-049_021219 condition of compost filter sock and containment along north boundary. Looking NE. See photo for gps.		Description MVP-LY-049_021219 dumpster area free of loose trash. Looking N. See photo for gps data.		GPS Location 37.2705493262385, -80.1233252138646

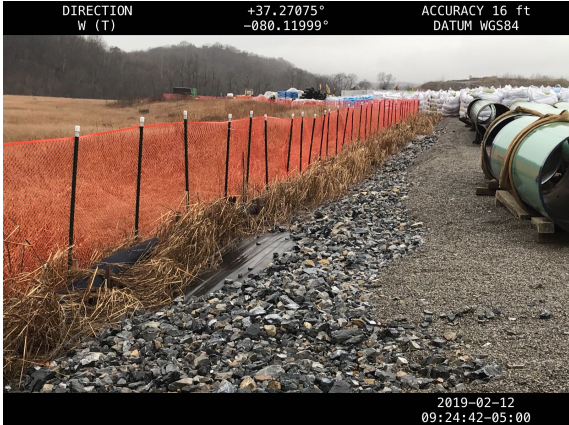
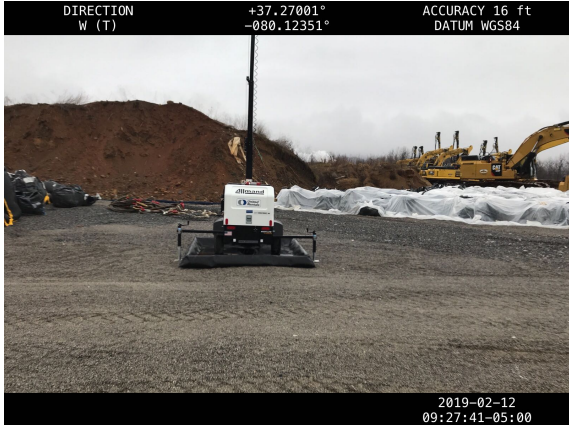
<p>DIRECTION W (T) +37.27001° -080.12351° ACCURACY 16 ft DATUM WGS84</p> <p>2019-02-12 09:27:41-05:00</p>		GPS Location 37.2705493262385, -80.1233252138646	
Description MVP-LY-049_021219 condition of filter sock and safety fence along south boundary. Looking W. See photo for gps data.		Description MVP-LY-049_021219 containment under light plant in yard. Looking W. See photo for gps data.		GPS Location 37.2705493262385, -80.1233252138646

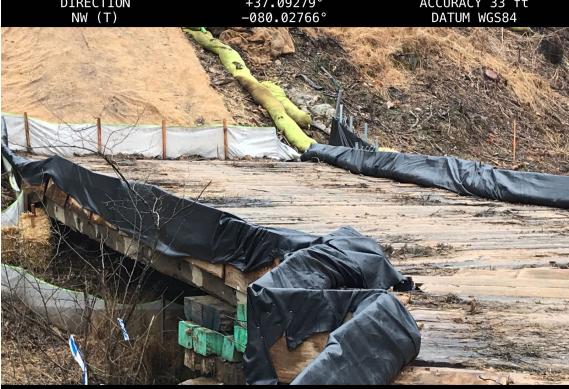
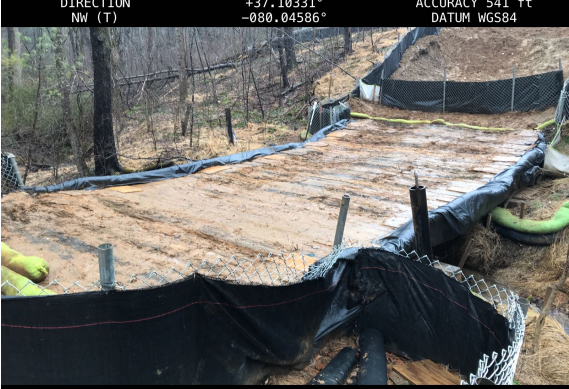
2019-02-12 11:49:38-05:00			
GPS Location	37.0924432296651, -80.0270283781737		GPS Location	37.0924432296651, -80.0270283781737	
Description	13413+05_021219 S-IJ1 mat bridge clean and closed. Looking NW. See photo for gps data.		Description	13337+13_021219 S-GH9 mat bridge clean and closed. Looking NW. See photo for gps data.	
DIRECTION E (T) +37.10434° -080.04539° ACCURACY 33 ft DATUM WGS84

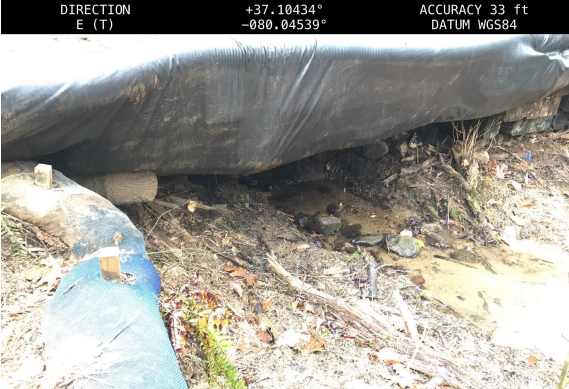
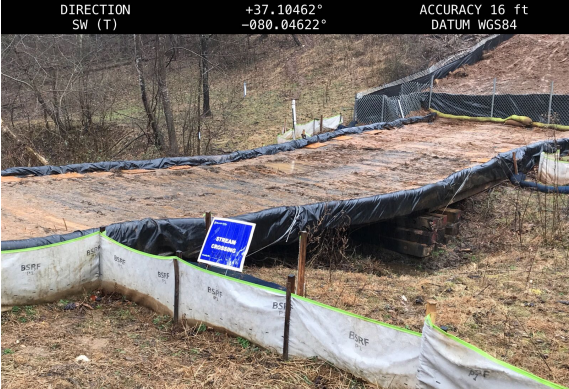
2019-02-12 11:56:34-05:00			
GPS Location	37.0924594905573, -80.0270579662919		GPS Location	37.0924594905573, -80.0270579662919	
Description	13334+17_021219 S-GH11 geotech under the bridge sagging and full. Looking E. See photo for gps data.		Description	13334+17_021219 S-GH11 mat bridge clean and closed. Looking SW. See photo for gps data.

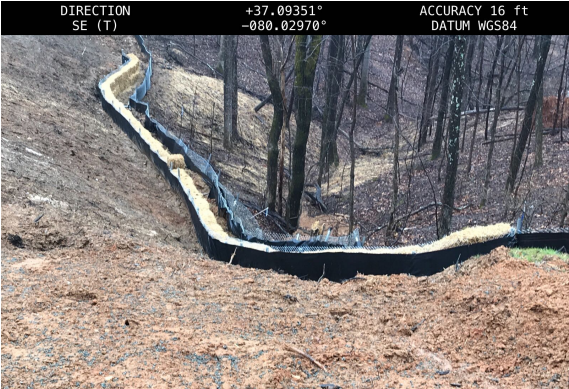
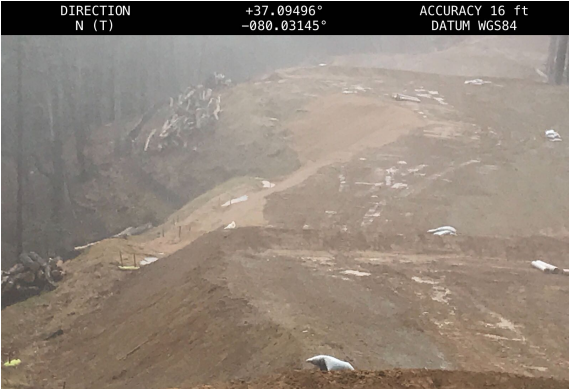
2019-02-12 13:52:35-05:00			
GPS Location	37.0924594905573, -80.0270579662919		GPS Location	37.0924594905573, -80.0270579662919	
Description	13410+00_021219 slide area stabilize. Looking SE. See photo for gps data.		Description	13395+00_021219 area has erosion control blanket installed and bags of Earth Guard staged. Looking N. See photo for gps data.

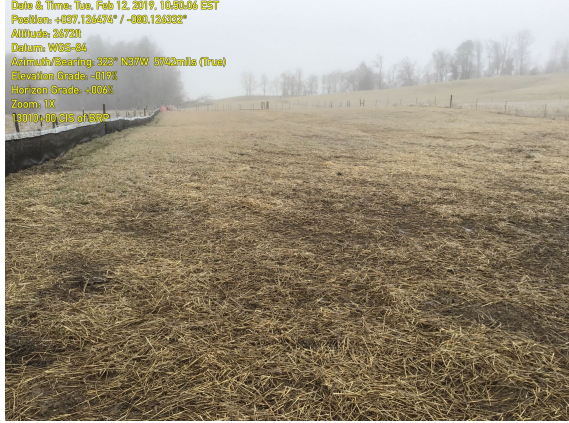
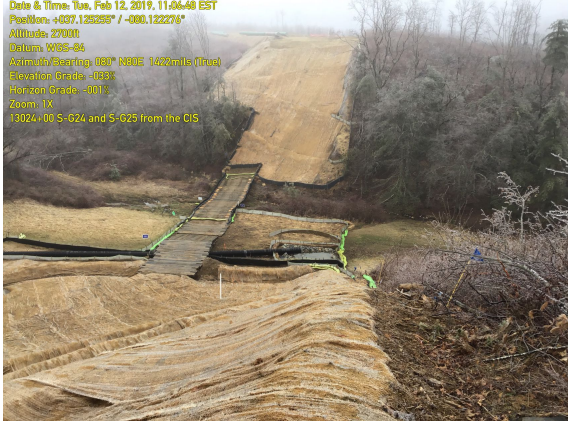
GPS Location	37.1264506224889, -80.1263281144948	GPS Location	37.1251927083704, -80.1222720277311		
Description	The environmental crew was in the area repairing curlex that had blown in the wind and straw mulched areas where wind blew the straw away.	Description	No issues or impacts were observed throughout the area near S-G24 and S-G25.

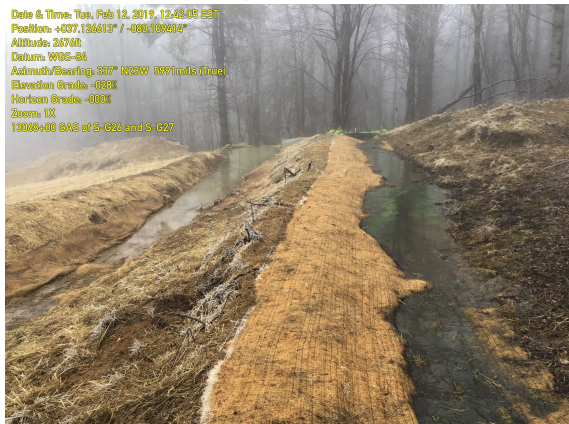
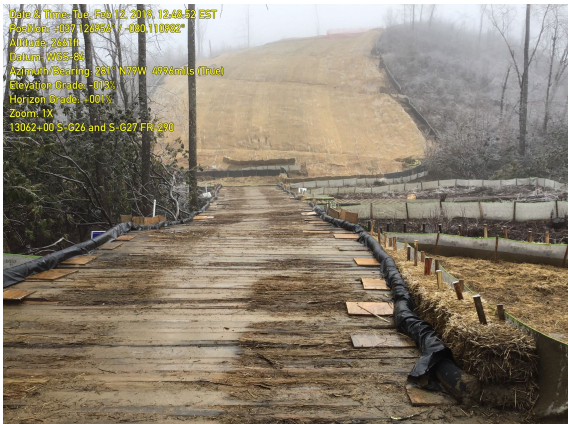
GPS Location	37.1266046399596, -80.1093275193871	GPS Location	37.1269818256024, -80.1112081670017		
Description	Sumps are full of water from the recent rain event. No impacts observed.	Description	ECD's and BMP's in the area of S-G26 and S-G27 remain in good condition. No impacts observed.		
<p>Date & Time: Tue, Feb 12, 2019, 14:12:07 EST Position: +037.155232° / -080.128864° Altitude: 2741ft Datum: WGS-84 Azimuth/Bearing: 218° S49W 4227mils (True) Elevation Grade: -012% Horizon Grade: -005% Zoom: 1X 12824+00 CIS of Bottom Creek Road</p>

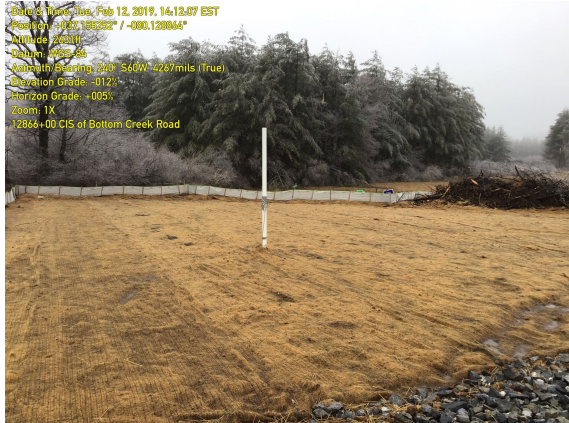
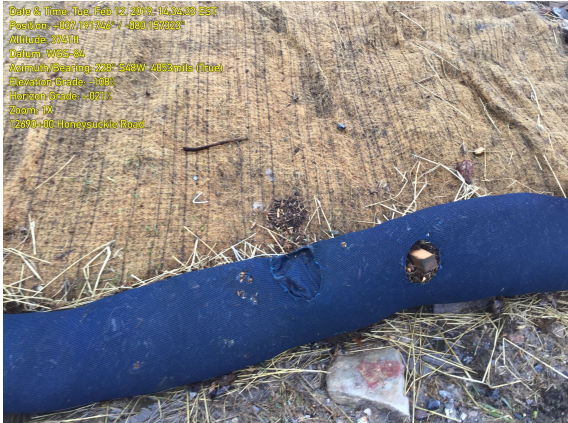
GPS Location	37.1551618678841, -80.1288581919671	GPS Location	37.1917969454426, -80.1573309303077		
Description	No deficiencies or impacts found in the Bottom Creek Road work areas.	Description	No issues or impacts found in the area near the Honeysuckle Road crossing after the 12" cfs was repaired.

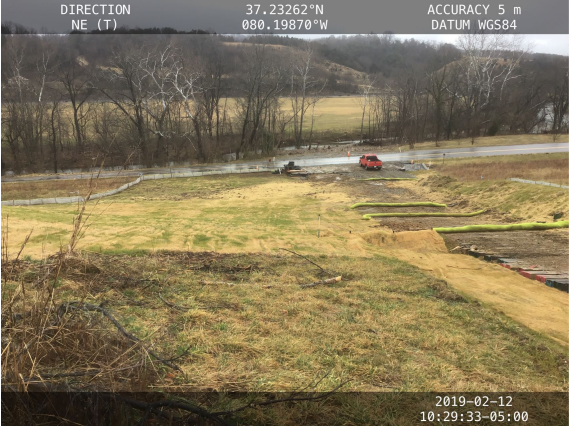
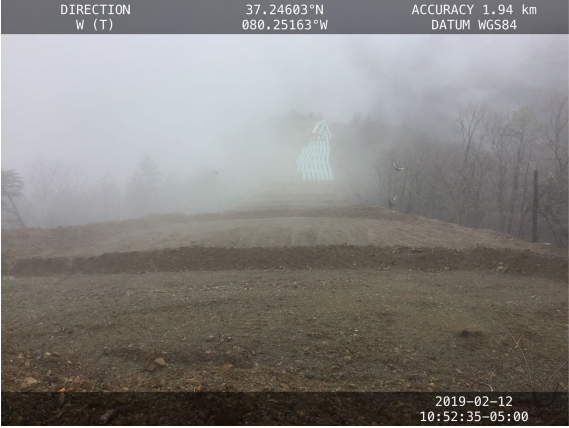
GPS Location	37.232677498867, -80.1986577362569	GPS Location	37.2515564365659, -80.2461698838326		
Description	Station 12444+00, facing northeast.	Description	Station 12312+00, facing west.

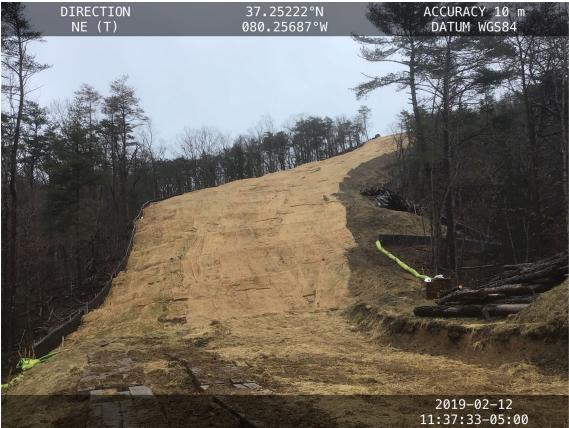
GPS Location	37.2516033333142, -80.2460379526766	GPS Location	37.2521409904931, -80.2568660304698		
Description	Station 12315+00, facing northeast.	Description	Station 12200+30, facing northeast.

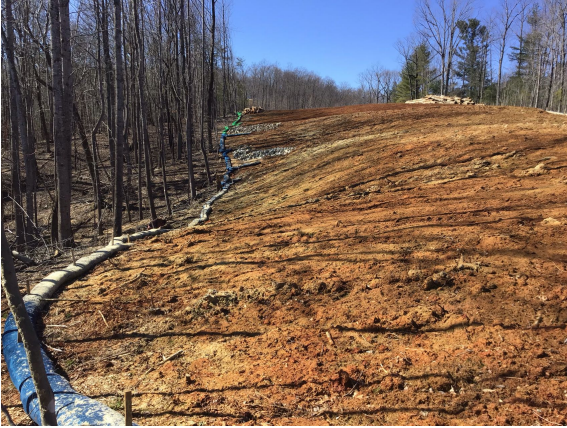
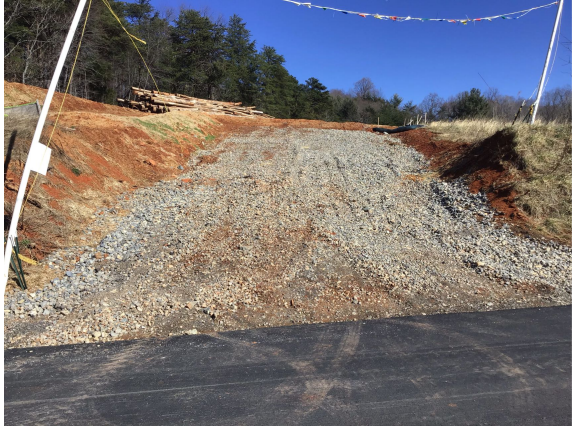
GPS Location	36.9719738481979, -79.8702914553133	GPS Location	36.9721635477962, -79.8699635826795		
Description	All perimeter ECD's in good condition at approximately 13626+00	Description	RCE on the GAS of Monty Rd in compliance.

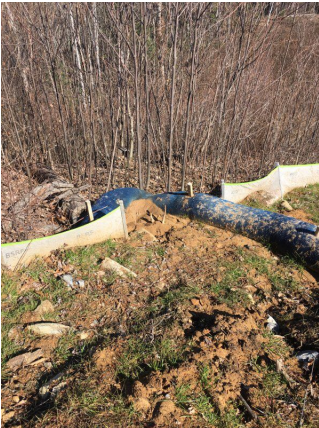
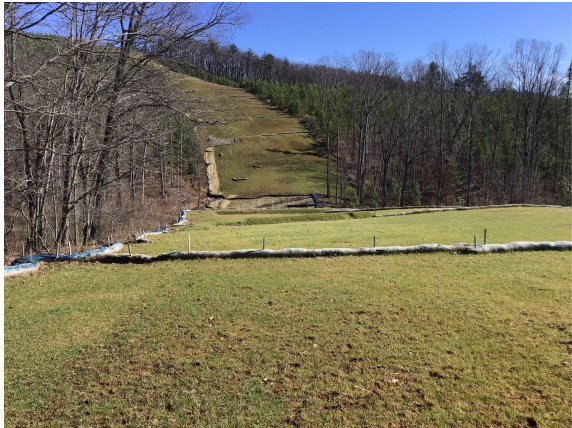
GPS Location	36.9721635477962, -79.8699635826795	GPS Location	36.9721635477962, -79.8699635826795		
Description	CFS at 13462+00 on 50% full of sediment needs maintenance.	Description	Permanent stabilization and E&S controls in good condition on GAS of 13421+00

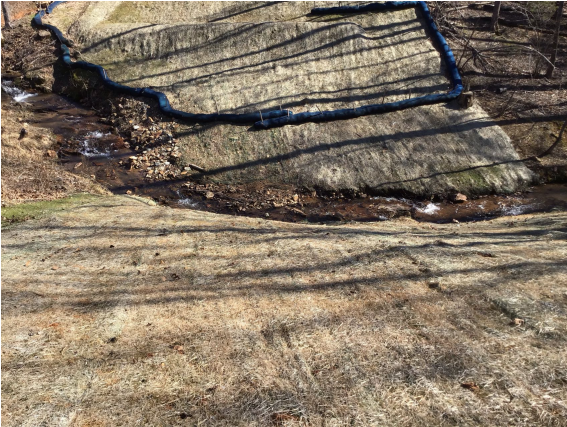
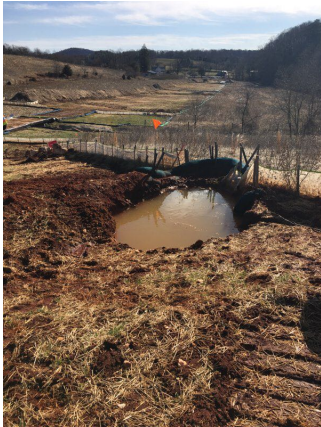
GPS Location	36.9721635477962, -79.8699635826795	GPS Location	36.9716456681408, -79.8698813414008		
Description	Stream S-IJ4 flowing free and clear of any sediment.	Description	CFS at end treatment needs maintenance at 13664+00 and 13665+00.
