# Visual Site Inspection Report

<b>Project Name</b>	H-600 Pipeline Spread H	<b>AFE</b>	124300138	<b>Spread</b>	H-600 Pipeline Spread H
<b>Contractor</b>	Precision			<b>Report #</b>	14129
<b>Inspector</b>	Dustin Lyons			<b>Date/Time</b>	2/18/2019 2:46 PM
<b>Permit #</b>	TBD	<b>Inspection Type</b>	VA SWPP	<b>Station Begin</b>	12005+00
<b>State</b>	VA	<b>Inspection Area</b>	Partial	<b>Station End</b>	12072+00
<b>County</b>	Montgomery	<b>Ground</b>	Wet	<b>Temperature (°F)</b>	46.00
<b>Municipality</b>	N/A	<b>Weather</b>	Cloudy	<b>Rain Gauge (in)</b>	1.10
<b>GPS Location</b>	37.2700953204532, -80.3138301149759			<b>Rain Accumulation Time (days)</b>	3.00

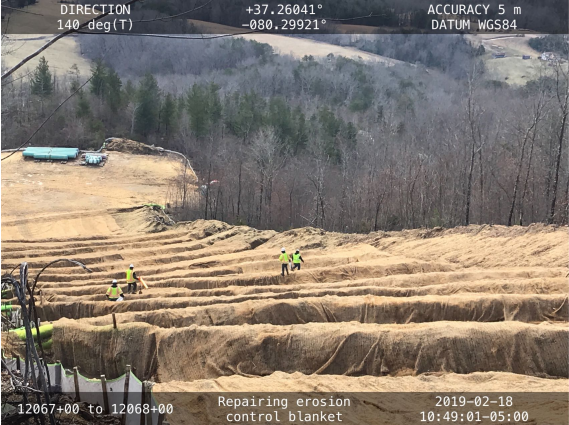
<p>DIRECTION 140 deg(T) +37.26041° -080.29921° ACCURACY 5 m DATUM WGS84</p> <p>12067+00 to 12068+00 Repairing erosion control blanket 2019-02-18 10:49:01-05:00</p>		  <p>DIRECTION 297 deg(T) +37.26139° -080.30094° ACCURACY 5 m DATUM WGS84</p> <p>12055+00 to 12058+00 Perimeter ECDs 2019-02-18 11:02:54-05:00</p>		<b>GPS Location</b> 37.270120005158, -80.3137504868957	
<b>Description</b> See photo for gps data. Photo shows the contractor maintaining erosion control blanket from 12067+00 inches o 12068+00.		<b>Description</b> See photo for gps data. Photo shows the perimeter ECDs from 12055+00 to 1205+00.

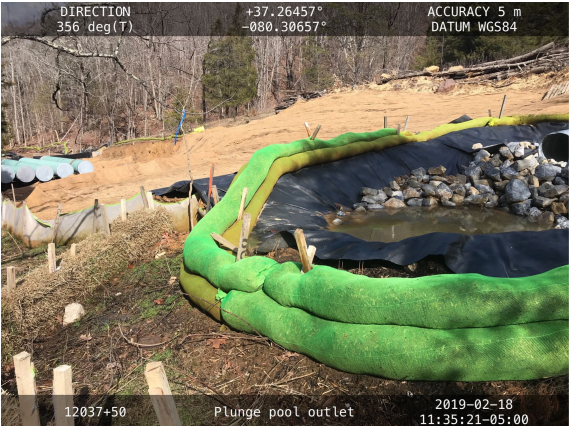
<p>DIRECTION 356 deg(T) +37.26457° -080.30657° ACCURACY 5 m DATUM WGS84</p> <p>12037+50 Plunge pool outlet 2019-02-18 11:35:21-05:00</p>

<b>Description</b> See photo for gps data. Photo shows the general condition of the plunge pool outlet at 12037+50.		<b>Description</b> See photo for gps data. Photo shows the condition of S-G40 downstream from the ROW.

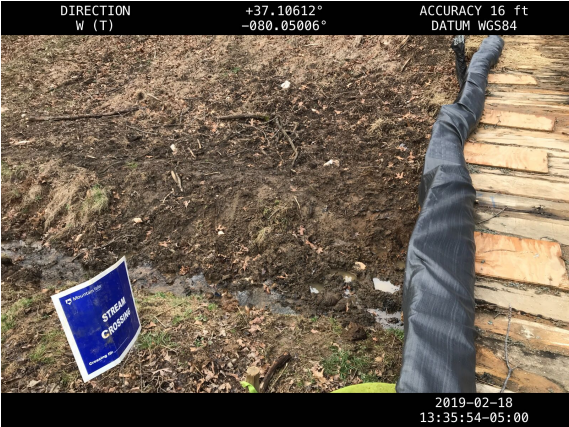
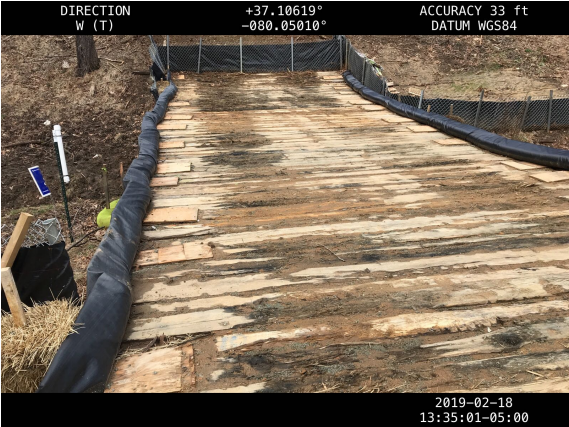
<b>GPS Location</b>	37.1038336074325, -80.0435740035773	<b>GPS Location</b>	37.1038336074325, -80.0435740035773		
<b>Description</b>	13321+47_021819 S-GH15 more cattle damage to stream banks. Looking W. See photo for gps data.	<b>Description</b>	13321+7_021819 S-GH15 mat bridge cleaned and closed. Looking W. See photo for gps data.

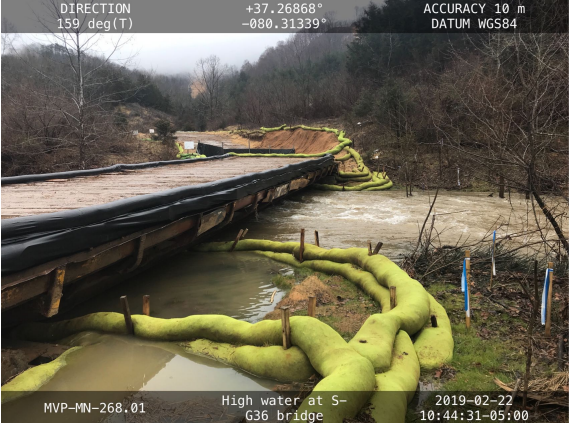
MVP-MN-268.01    High water at S-G36 bridge    2019-02-22 10:44:31-05:00		<b>GPS Location</b> 37.1922450419862, -80.3665465024117	
<b>Description</b> See photo for gps data. Photo shows stream S-G38 downstream of the ROW.		<b>Description</b> See photo for gps data. Photo shows the high water downstream of the bridge over SG36 on MVP-MN268.01.		<b>GPS Location</b> 37.1922450419862, -80.3665465024117	
<b>Description</b>		<b>Description</b>

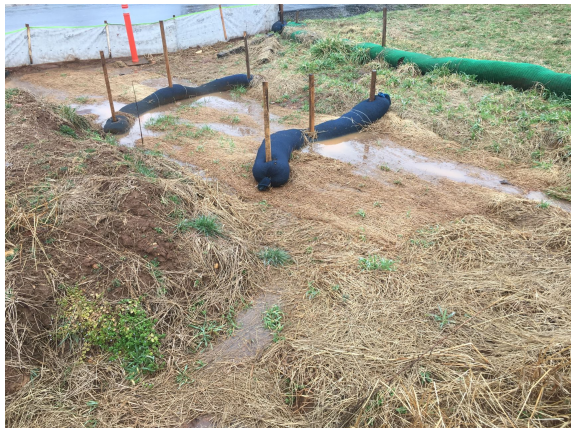
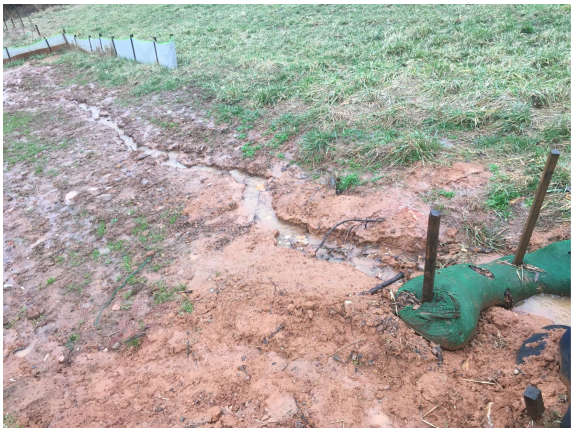
GPS Location	36.9721185369761, -79.8699471541493	GPS Location	36.9718851428823, -79.8697658535837		
Description	Erosion control blanket and CFS check dams functioning properly at 13645+00.	Description	CFS behind triple stack undermined creating erosion rill at 13540+00 needs maintenance.

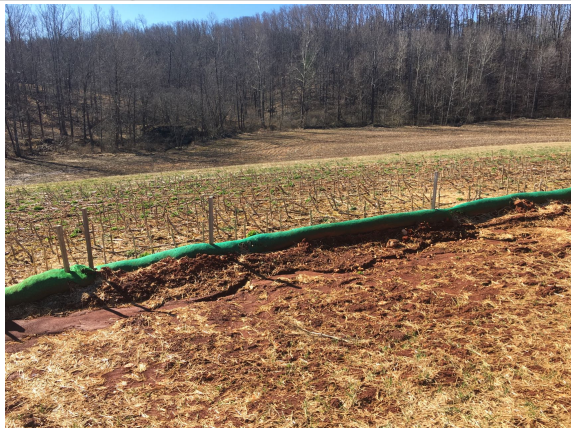
Insert image here			
GPS Location	36.9720215164469, -79.8699797597526	GPS Location			
Description	Perimeter CFS needs cleaned and repaired at 13652+00	Description
