Visual Site Inspection Report

Project Name	H-600 Pipeline Spread H	AFE	124300138	Spread	H-600 Pipeline Spread H	
Contractor	Precision			Report #	14429	
Inspector	Pat Davis			Date/Time	2/28/2019 5:30 PM	
Permit #	TBD	Inspection Type	VA SWPP	Station Begin	+0	
State	VA	Inspection Area	Partial	Station End	+0	
County	Montgomery	Ground	Muddy	Temperature (°F)	56.00	
Municipality	N/A	Weather	Cloudy	Rain Gauge (in)	0.00	
GPS Location	37.2356988396842, -80.2295867075028			Rain Accumulation Time (days)	0.00

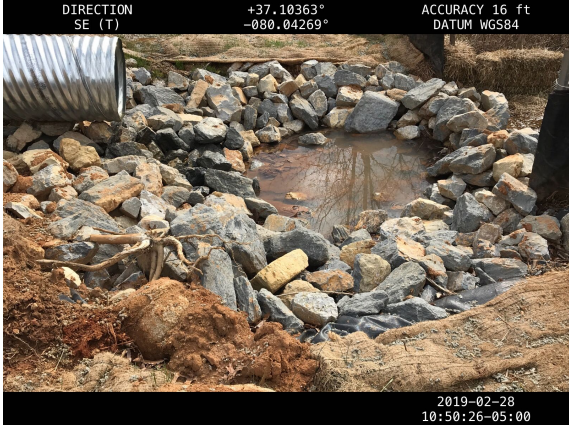
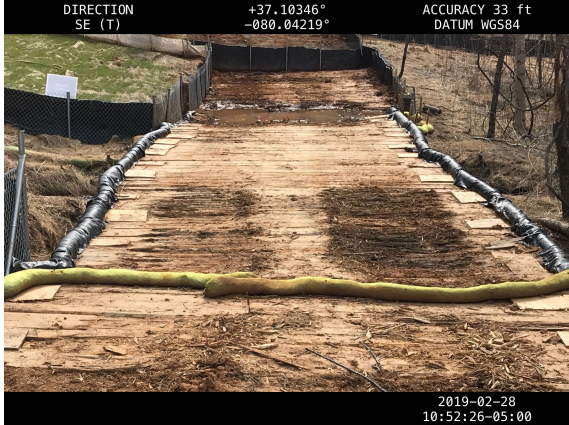
GPS Location	37.1038826415661, -80.0434391387552	GPS Location	37.1038826415661, -80.0434391387552		
Description	13345+00_022819 condition of plunge pool. Looking SE. See photo for gps data.	Description	13348+46_022819 S-RR08 mat bridge over feature clean and closed. Looking SE. See photo for gps data.

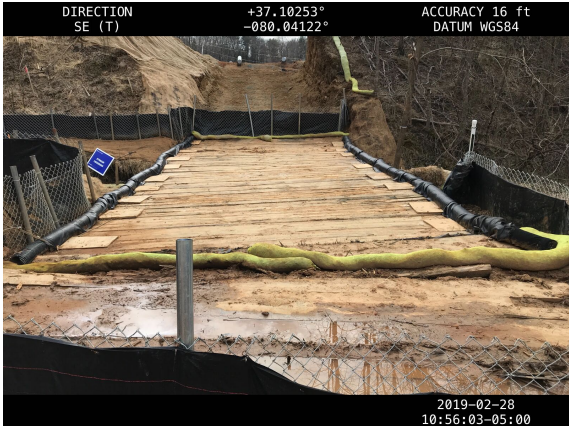
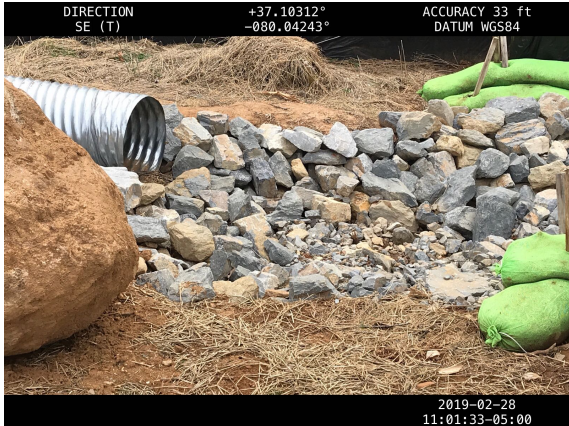
GPS Location	37.103878576343, -80.0434329361469	GPS Location	37.103878576343, -80.0434329361469		
Description	13352+23_022819 S-RR09 mat bridge clean and closed. Looking SE. See photo for gps data.	Description	13348+00_022819 condition of plunge pool. Looking SE. See photo for gps data.

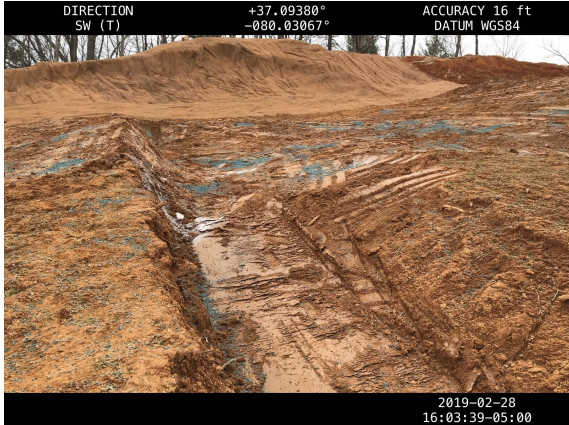
GPS Location	37.1038799593571, -80.0434256438911	GPS Location	37.1038799593571, -80.0434256438911		
Description	13413+05_022819 S-IJ1 mat bridge over feature clean and closed. Looking NW. See photo for gps data.	Description	13404+00_022819 waterbar opened spoil pile smoothed. Blanket installed. Looking SW. See photo for gps data.

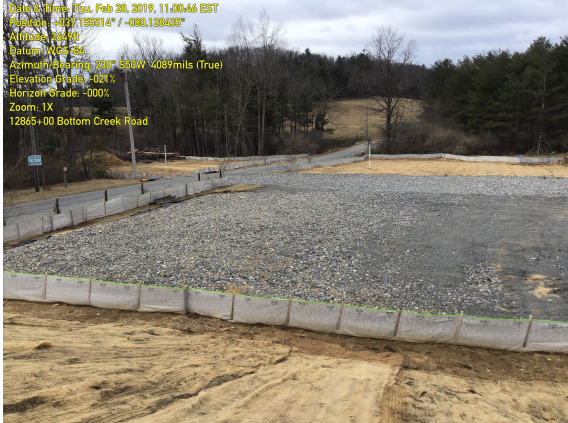
GPS Location	37.1919246018279, -80.157522121519	GPS Location	37.1555930329833, -80.1284580399097		
Description	No deficiencies in ECD's and no off ROW impacts found in the work area.	Description	All P1 silt fence and RCE's in good condition. Curlex and Straw mulch adequate. No off ROW or stream/wetland impacts.

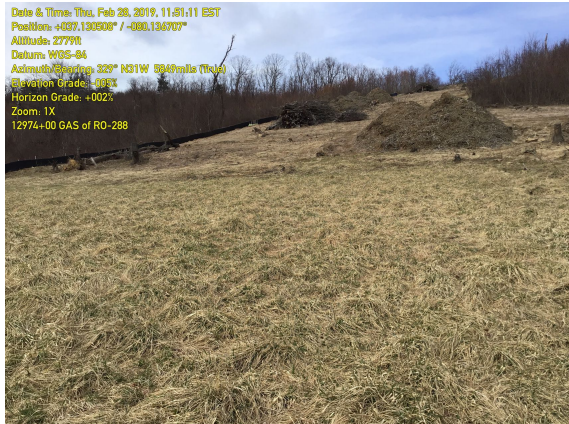
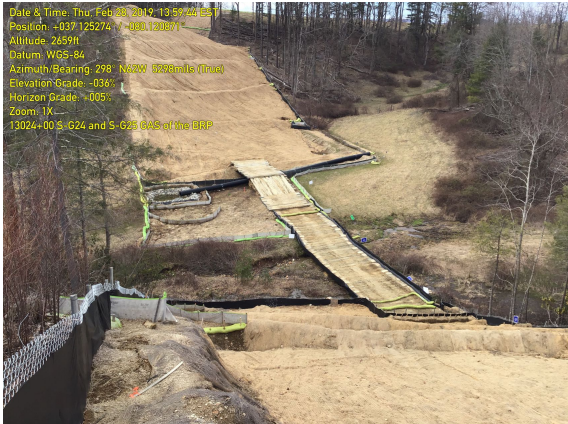
GPS Location	37.1303206729117, -80.1367066708208	GPS Location	37.1252599312338, -80.1208820567281		
Description	No issues or impacts were found in this area today.	Description	All ECD's, BMP's, mat bridge, and stabilized row remain in good condition. No impacts observed.		
<p>Date & Time: Thu, Feb 28, 2019, 14:13:01 EST Position: +037.127859° / -080.117464° Altitude: 2620 ft Datum: WGS-84 Azimuth Bearing: 077° S68E 3740mils (True) Elevation Grade: +007% Horizon Grade: +003% Zoom: 1X 13063+00 S-G17 from the S25</p>

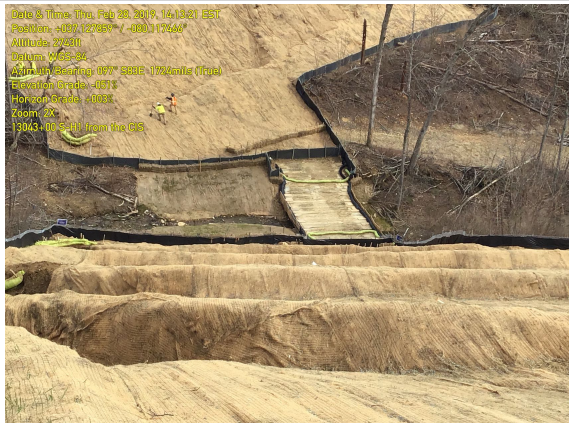
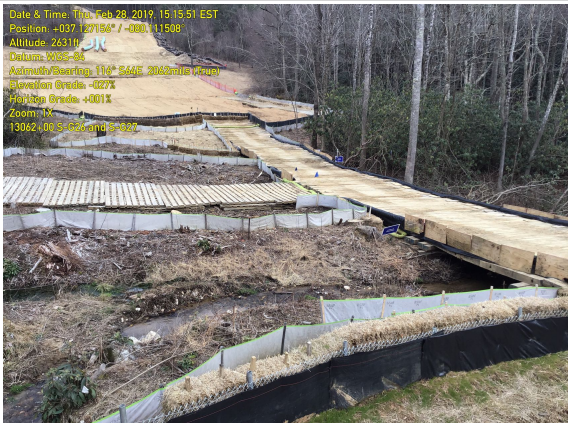
GPS Location	37.1278591594073, -80.1174655091764	GPS Location	37.1269244933847, -80.1114684250952		
Description	The S-H1 stream crossing and surrounding area remains in good condition. No impacts found throughout the area.	Description	No stream impacts observed at S-G26 and S-G27

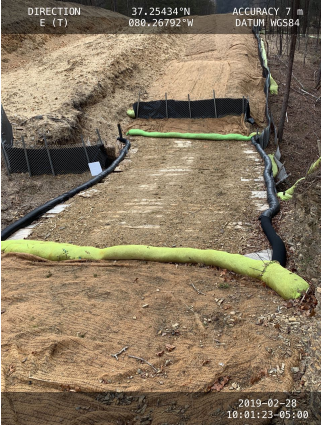
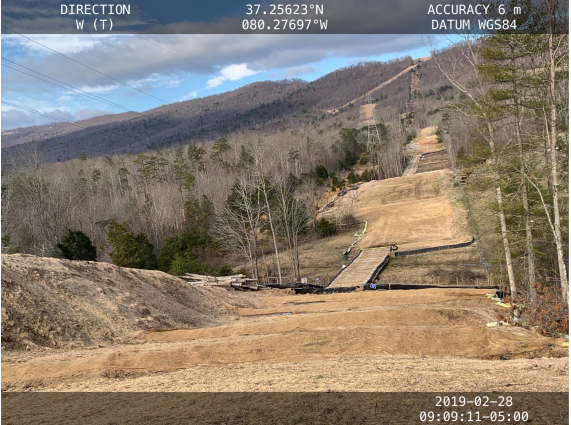
GPS Location	37.2356322228115, -80.2295569709611	GPS Location	37.2356322228115, -80.2295569709611		
Description	12163+05_022819 Bridge crossing S-C25. Looking E. See picture for GPS data.	Description	12165+00_022819 Stabilized ROW. Looking W. See picture for GPS data.

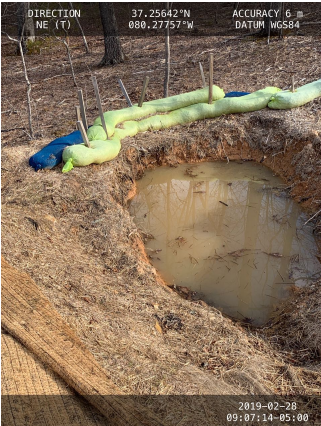
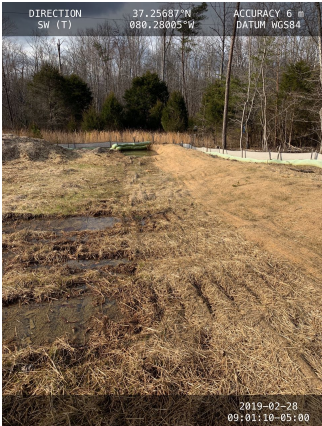
GPS Location	37.2356414664847, -80.2296806069147	GPS Location	37.2356112147138, -80.229562088918		
Description	12180+00_022819 Sump pit. Looking NE. See picture for GPS data.	Description	12126+00_022819 Water bar crossing ROW. Looking SW. See picture for GPS data.

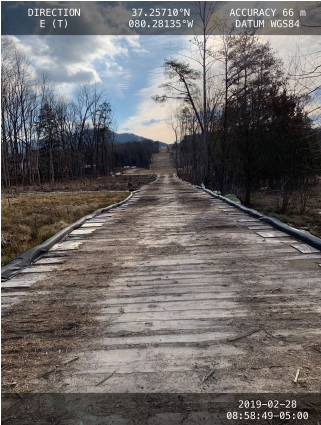
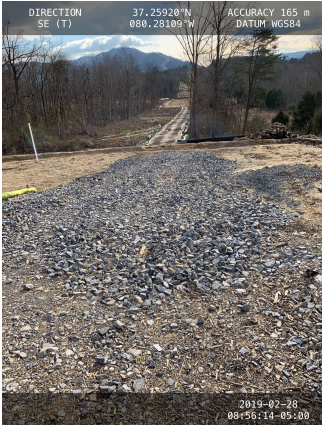
GPS Location	37.2356321857891, -80.2295790838018	GPS Location	37.2356289890954, -80.229574965328		
Description	12121+29_022819 Bridge crossing multiple wetlands and streams. Looking E. See picture for GPS data.	Description	12119+25_022819 RCE. Looking SE. See picture for GPS data.

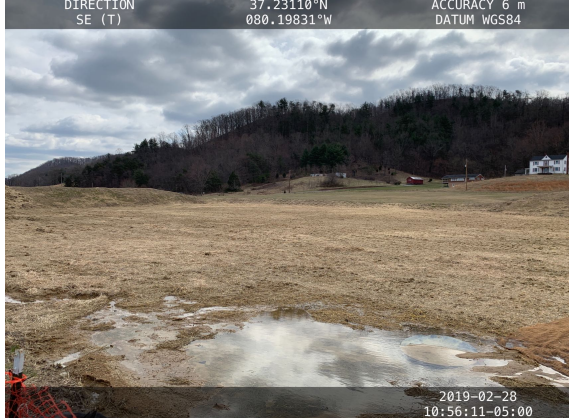
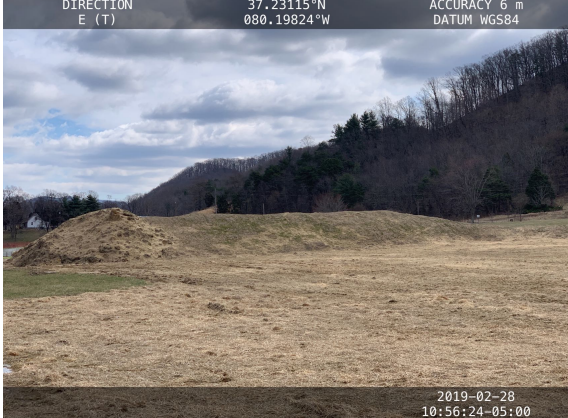
<div>2019-02-28 10:56:24-05:00</div>				
GPS Location		37.2356438612268, -80.2295617156984		GPS Location		37.2356438612268, -80.2295617156984	
Description		12445+86_022819 Stabilized ROW. Looking SE. See picture for GPS data.		Description		12445+86_022819 Stabilized topsoil pile. Looking E. See picture for GPS data.	
<div>DIRECTION E (T)</div> <div>37.23068°N 080.19894°W</div> <div>ACCURACY 19 m DATUM WGS84</div>

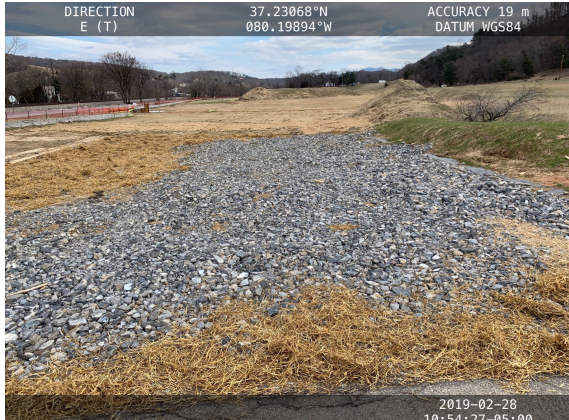
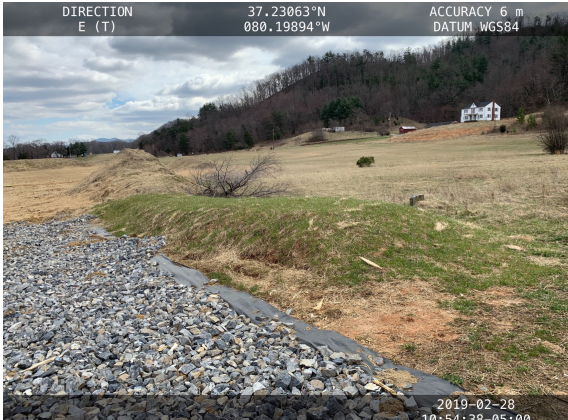
GPS Location		37.2357269310532, -80.2297636542715		GPS Location		37.2356438612268, -80.2295617156984	
Description		12448+12_022819 RCE. Looking E. See picture for GPS data.		Description		12448+12_022819. Top soil pile. Looking E. See picture for GPS data.	
<div>DIRECTION SW (T)</div> <div>37.23126°N 080.19918°W</div> <div>ACCURACY 200 m DATUM WGS84</div>

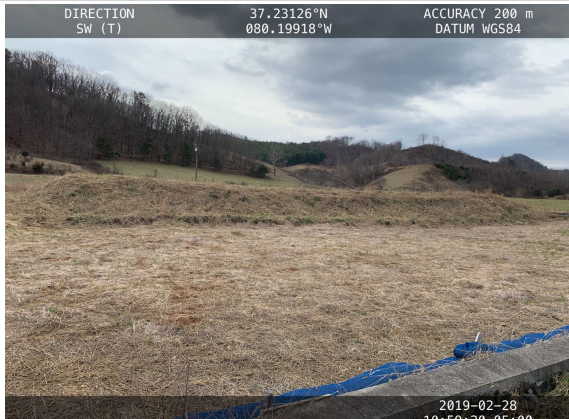
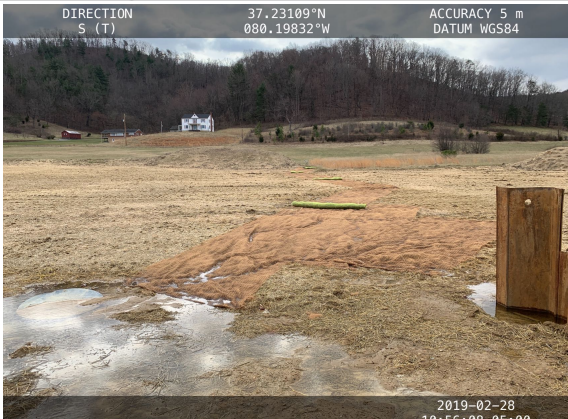
<div>2019-02-28 10:56:08-05:00</div>				
GPS Location		37.2356511753118, -80.2296644858843		GPS Location		37.2356170013869, -80.2296434370488	
Description		12449+00_022819 Stabilized ROW and top soil in variance disturbance. Looking SW. See picture for GPS data.		Description		12445+86_022819 Curlexed Area where water is crossing ROW. Looking S. See picture for GPS data.

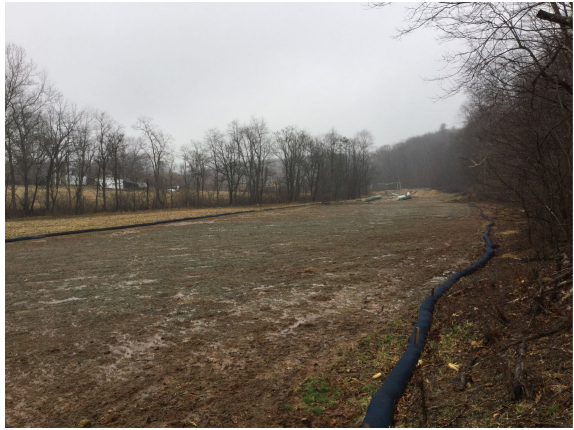
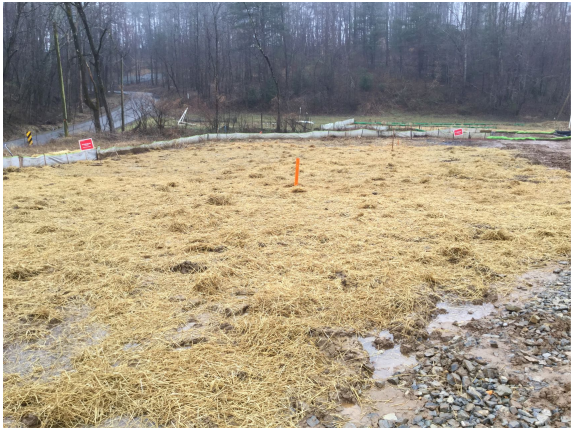
GPS Location	36.9721465325327, -79.8701346573232		GPS Location	36.9721110351728, -79.8700349964945	
Description	Stabilization and perimeter controls in good condition at 13633+00.		Description	Temporary stabilization near valve location at 13644+41

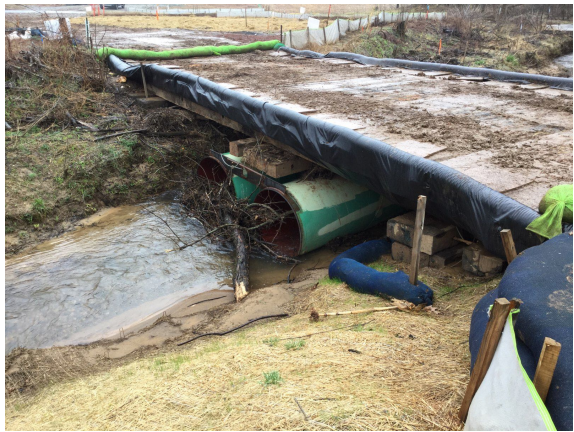
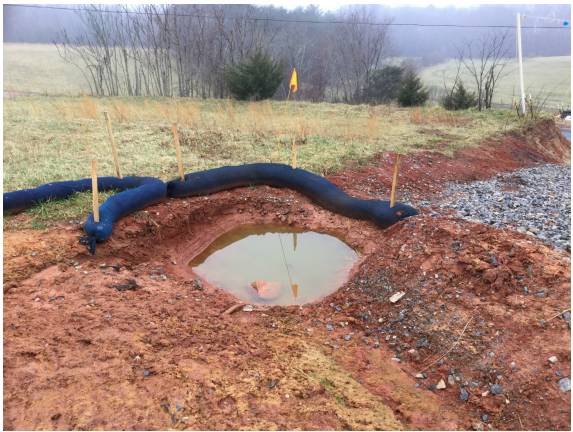
GPS Location	36.9720056327404, -79.8700231780111		GPS Location	36.9721211353661, -79.8700166401266	
Description	Flume pipe at stream crossing S-E28 beginning to dam and divert water.		Description	Sump needs maintenance at 13577+00

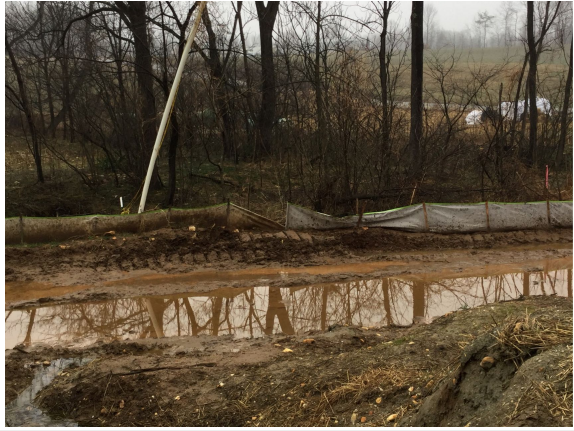
Insert image here			
GPS Location	36.9720474165277, -79.8699629121272		GPS Location		
Description	P1 silt fence near 13640+00 requires maintenance.		Description
