# Visual Site Inspection Report

<b>Project Name</b>	H-600 Pipeline Spread H	<b>AFE</b>	124300138	<b>Spread</b>	H-600 Pipeline Spread H	
<b>Contractor</b>	Precision			<b>Report #</b>	14619	
<b>Inspector</b>	Pat Davis			<b>Date/Time</b>	3/6/2019 5:42 PM	
<b>Permit #</b>	TBD	<b>Inspection Type</b>	VA SWPP	<b>Station Begin</b>	+0	
<b>State</b>	VA	<b>Inspection Area</b>	Partial	<b>Station End</b>	+0	
<b>County</b>	Montgomery	<b>Ground</b>	Muddy	<b>Temperature (°F)</b>	21.00	
<b>Municipality</b>	N/A	<b>Weather</b>	Sunny	<b>Rain Gauge (in)</b>	0.00	
				<b>Rain Accumulation Time (days)</b>	0.00

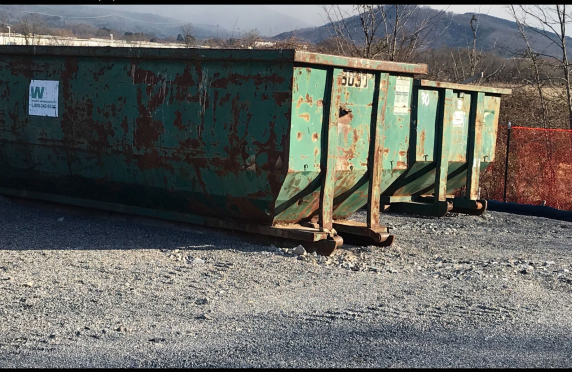
<div>2019-03-06 08:20:45-05:00</div>		
GPS Location	37.26	Field Station#	+0		
Description	MVP-LY-049_030619 crew preforming maintenance on stone. Looking S. See photo for gps data.				
GPS Location	37.26	Field Station#	+0		
Description	MVP-LY-049_030619 dumpster area clean and free of loose trash. Looking NE. See photo for gps data.

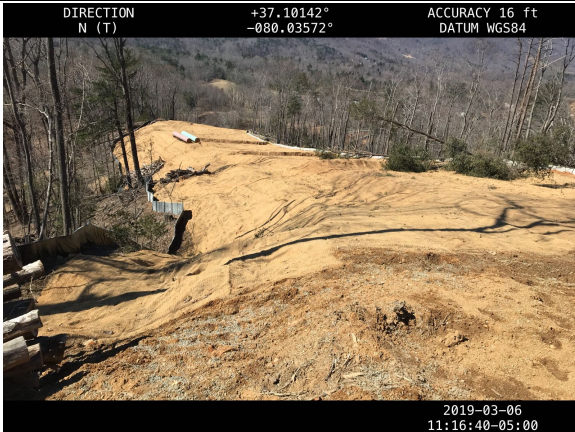
<div>2019-03-06 09:54:07-05:00</div>									
GPS Location		37.09		Field Station#		13413+05		GPS Location		37.09		Field Station#		13408+00	
Description		13413+05_030619 S-IJ1 mat bridge clean and closed. Looking NW. See photo for gps data.						Description		13408+00_030619 slope in slide area stabilized. Looking NW. See photo for gps data.					
<div>DIRECTION N (T) +37.10142° -080.03572° ACCURACY 16 ft DATUM WGS84</div>

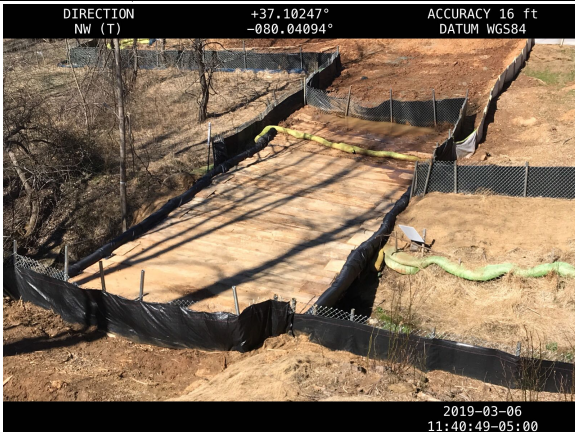
Description		13371+50_030619 condition of erosion control blanket on steep slope. Looking N. See photo for gps data.						Description		13358+64_030619 S-RR11 mat bridge clean and closed. Looking S. See photo for gps data.					
<div>DIRECTION NW (T) +37.10247° -080.04094° ACCURACY 16 ft DATUM WGS84</div>

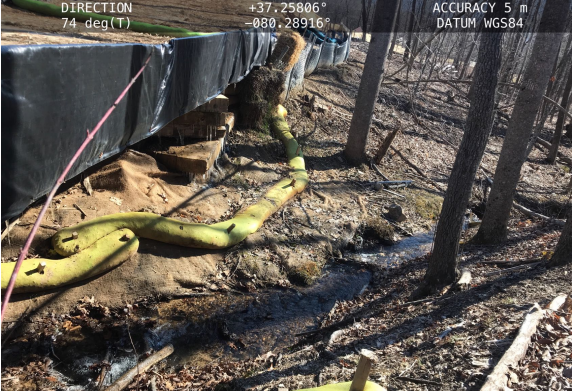
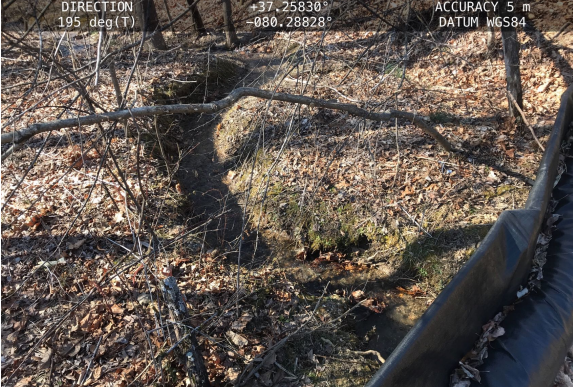
GPS Location	37.26	Field Station#	12076+95	GPS Location	37.27	Field Station#	12098+44
Description	See photo for gps data. Photo shows stream S-MM15 downstream of the ROW.			Description	See photo for gps data. Photo shows stream S-MM13 downstream of the ROW.		
<div>DIRECTION 195 deg(T)</div> <div>+37.25830° -080.28828°</div> <div>ACCURACY 5 m DATUM WGS84</div>

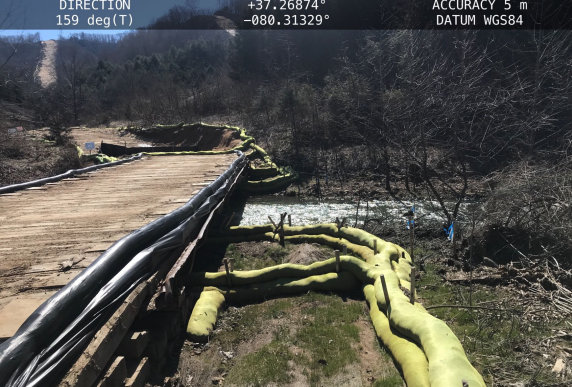
<div>S-G36</div> <div>MVP-MN-268.01</div> <div>2019-03-06 11:08:56-05:00</div>				
GPS Location	37.27	Field Station#	12101+57	GPS Location	37.27	Field Station#	12013+97
Description	See photo for gps data. Photo shows stream S-MM11 downstream of the ROW.			Description	See photo for gps data. Photo shows stream S-G36 downstream from access road MVP-MN-268.01.

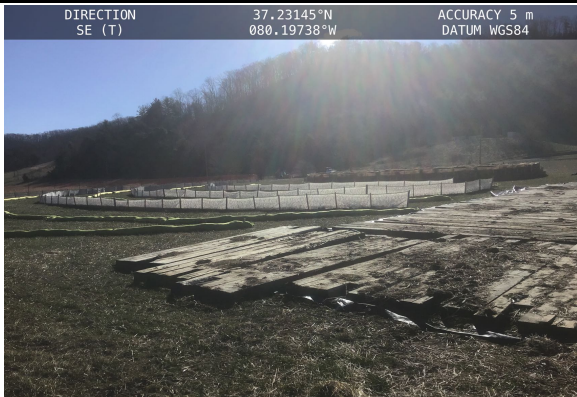
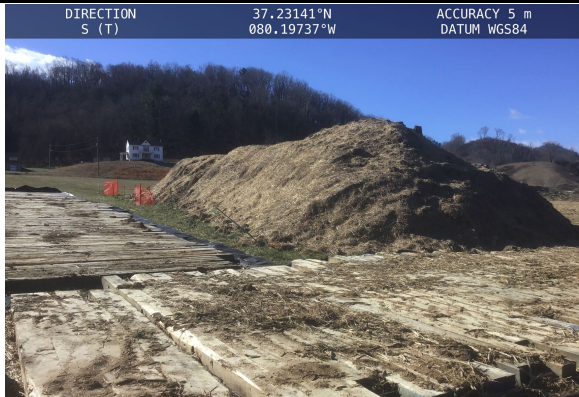
<div>2019-03-06 09:28:48-05:00</div>											
GPS Location		37.23		Field Station#		12452+00		GPS Location		37.23		Field Station#		12451+50	
Description		Topsoil pile and CFS in satisfactory condition.						Description		ECDs parallel to Cove Hollow Road are all in acceptable condition.					
<div>DIRECTION SE (T)</div> <div>37.23145°N 080.19738°W</div> <div>ACCURACY 5 m DATUM WGS84</div>

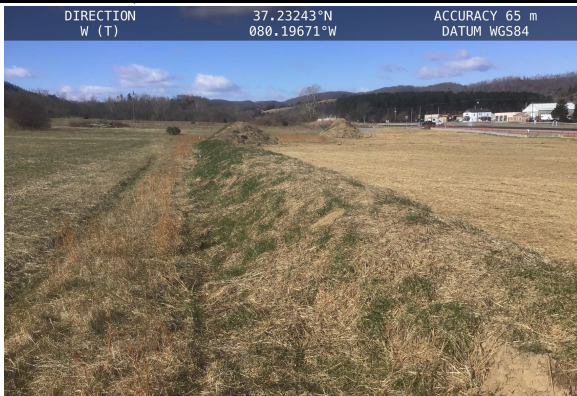
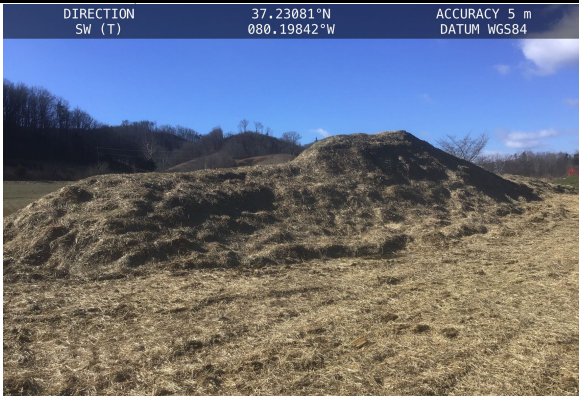
GPS Location		37.23		Field Station#		12452+00		GPS Location		37.23		Field Station#		12452+00	
Description		ECDs installed for dewatering are all intact.						Description		Stockpile still stable.					
<div>DIRECTION W (T)</div> <div>37.23243°N 080.19671°W</div> <div>ACCURACY 65 m DATUM WGS84</div>

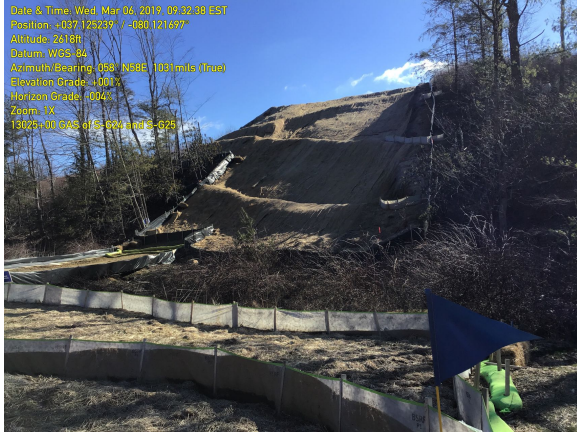
GPS Location	37.12	Field Station#	13024+00	GPS Location	37.12	Field Station#	13062+00
Description	No stream impacts were observed at S-G24 and S-G25.			Description	ROW and ECD conditions remain adequate.		
<div><p>Date &amp; Time: Wed, Mar 06, 2019, 10:14:59 EST Position: +037.125889° / -080.117863° Altitude: 2606ft Datum: WGS-84 Azimuth/Bearing: 295° N85W 314mils (True) Elevation Grade: -000% Horizon Grade: -001% Zoom: 1X 13064+00 FR-290 and CIS</p> </div>		<div><p>Date &amp; Time: Wed, Mar 06, 2019, 10:17:55 EST Position: +037.126255° / -080.116825° Altitude: 2610ft Datum: WGS-84 Azimuth/Bearing: 086° N86E 1029mils (True) Elevation Grade: -021% Horizon Grade: -001% Zoom: 1X 13062+25 S-G24 and S-G25</p> </div>					
GPS Location	37.12	Field Station#	13064+00	GPS Location	37.12	Field Station#	13062+25
Description	No issues or impacts were found.			Description	Streams S-G26 and S-G27 where they meet downstream of the project showed no signs of impact from the project.

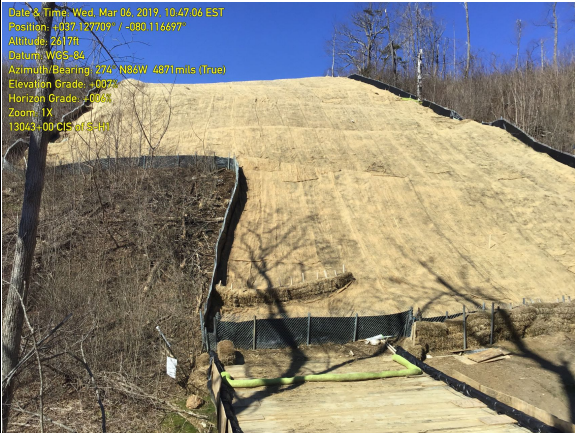
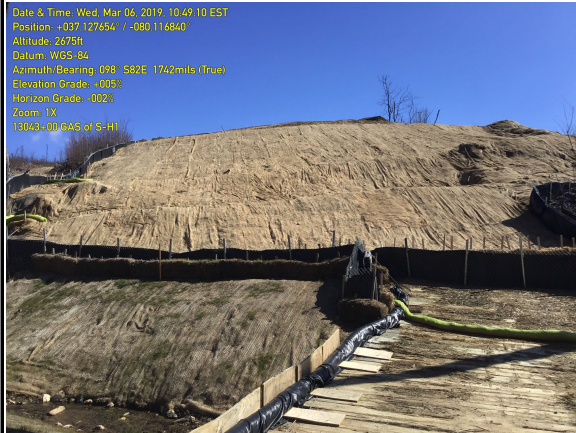
<b>GPS Location</b>		37.12		<b>Field Station#</b>		13043+00		<b>GPS Location</b>		37.12		<b>Field Station#</b>		13043+00	
<b>Description</b>		No deficiencies were found in the area.						<b>Description</b>		ROW and ECD's remain in good condition.

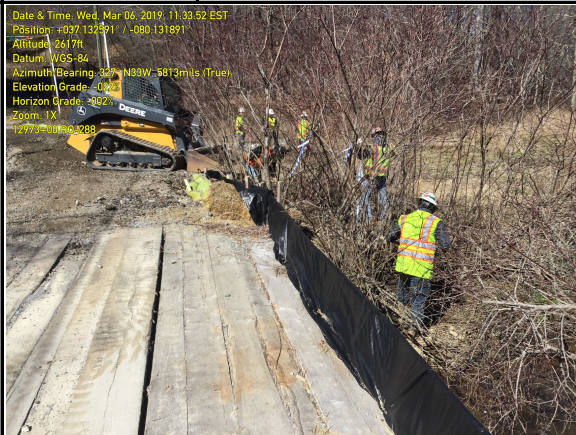
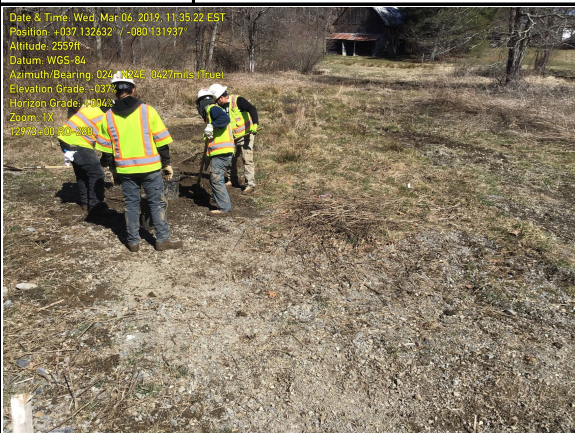
<b>GPS Location</b>		37.12		<b>Field Station#</b>		13043+00		<b>GPS Location</b>		37.13		<b>Field Station#</b>		12973+00	
<b>Description</b>		S-H1 downstream side of the mat bridge showed no signs of impact from the project.						<b>Description</b>		Environmental crew retrieving rock beyond the LOD on RO-288					
<p><small>Date &amp; Time: Wed, Mar 06, 2019, 11:35:22 EST Position: +037.132632° / -080.131937° Altitude: 2559ft Datum: WGS-84 Azimuth/Bearing: 029° N54E 3027mits (True) Elevation Grade: +037% Horizon Grade: +004% Zoom: 1X 12973+00 S-288</small></p>

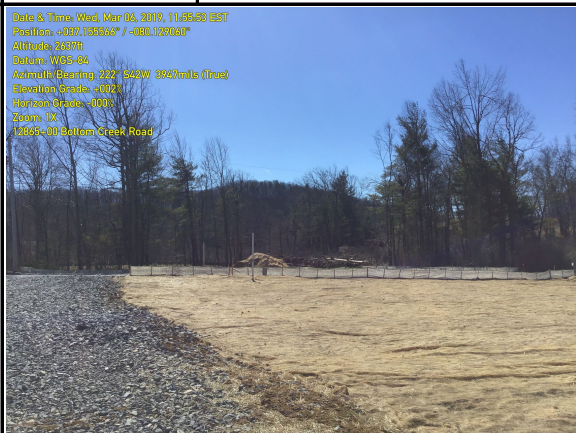
<b>GPS Location</b>		37.13		<b>Field Station#</b>		12973+00		<b>GPS Location</b>		37.15		<b>Field Station#</b>		12865+00	
<b>Description</b>		All rock from the access road is being retrieved by shovel and bucket.						<b>Description</b>		Bottom Creek road work area, ECD's and BMP's remain within compliance.

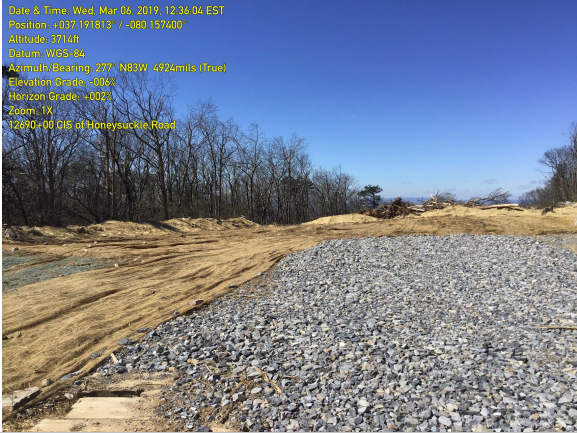
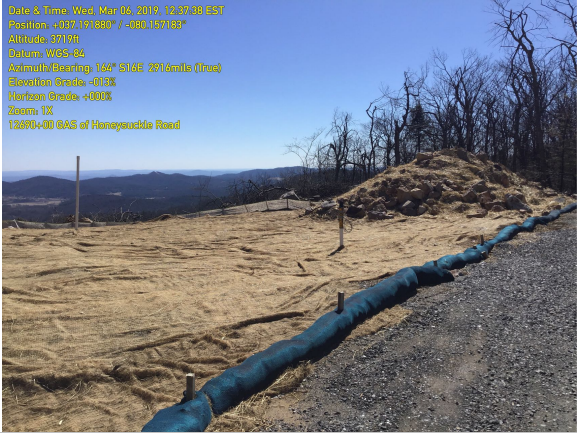
<b>GPS Location</b> 37.19		<b>Field Station#</b> 12690+00		<b>GPS Location</b> 37.19	
<b>Field Station#</b> 12690+50		<b>Description</b>		<b>Description</b>	
		Curlex and stabilization practices remain in good condition despite the strong winds today.		No issues or impacts were observed on the GAS of Honeysuckle road.

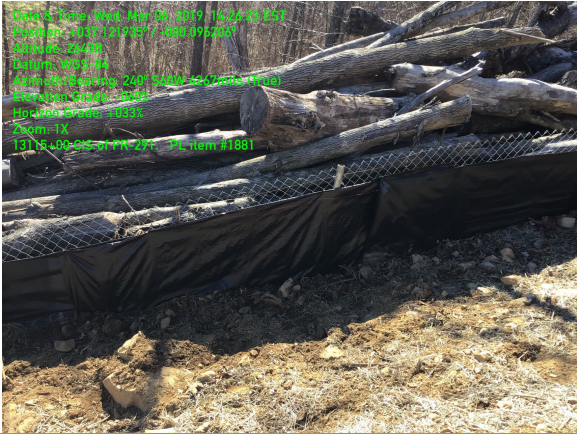
Insert image here		
<b>GPS Location</b>		<b>Field Station#</b> 13115+00		<b>GPS Location</b>	
<b>Field Station#</b>		<b>Description</b>		<b>Description</b>	
		Punch list item #1881 completion.			
Insert image here			Insert image here		
<b>GPS Location</b>		<b>Field Station#</b>		<b>GPS Location</b>	
<b>Field Station#</b>		<b>Description</b>		<b>Description</b>

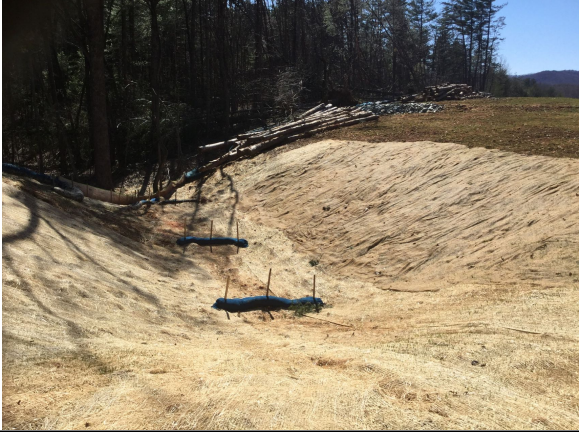
<b>GPS Location</b> 36.97		<b>Field Station#</b> 13560+00		<b>GPS Location</b> 36.97	
<b>Description</b>		Stabilization blanket functioning properly		<b>Field Station#</b> 13420+00	
<b>Description</b>		CFS requires maintenance

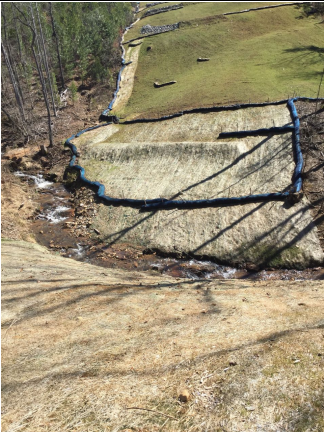
<b>GPS Location</b> 36.97		<b>Field Station#</b> 13420+00		<b>GPS Location</b> 36.97	
<b>Description</b>		SSF requires maintenance		<b>Field Station#</b> 13425+01	
<b>Description</b>		Stabilization and ECD's functioning properly at stream S-IJ4

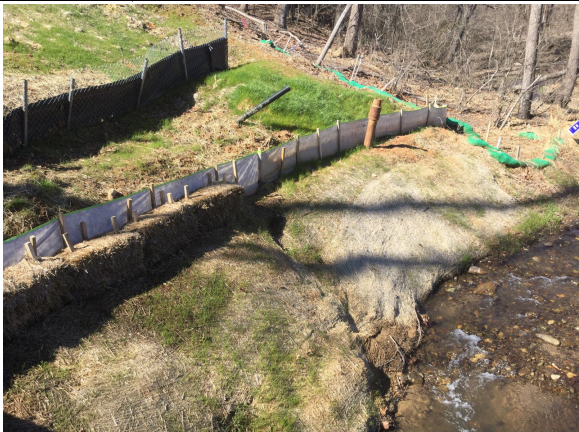
Insert image here		
<b>GPS Location</b> 36.97		<b>Field Station#</b> 13543+11		<b>GPS Location</b>	
<b>Description</b>		Curled needs to be stapled down to prevent potential erosion issue.		<b>Field Station#</b>	
<b>Description</b>
