Visual Site Inspection Report

Project Name	H-600 Pipeline Spread H	AFE	124300138	Spread	H-600 Pipeline Spread H	
Contractor	Precision			Report #	14774	
Inspector	Pat Davis			Date/Time	3/12/2019 6:49 AM	
Permit #	TBD	Inspection Type	VA SWPP	Station Begin	+0	
State	VA	Inspection Area	Partial	Station End	+0	
County	Montgomery	Ground	Damp	Temperature (°F)	39.00	
Municipality	N/A	Weather	Sunny	Rain Gauge (in)	0.00	
				Rain Accumulation Time (days)	0.00

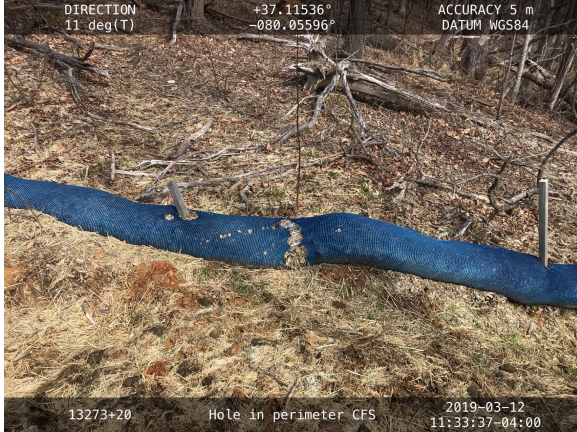
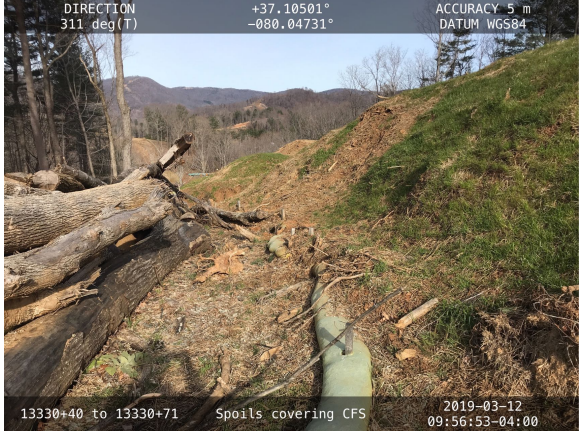
GPS Location	37.06	Field Station#	13273+20	GPS Location	37.06	Field Station#	13330+71
Description	See photo for gps data. Photo shows the hole observed in the CFS at about 13273+20.			Description	See photo for gps data. Photo shows the topsoil covering the perimeter CFS from about 13330+40 to 13330+71.

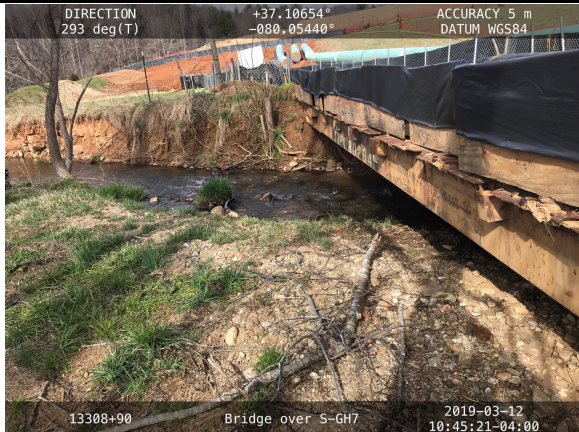
GPS Location	37.06	Field Station#	13334+70	GPS Location	37.06	Field Station#	13308+90
Description	See photo for gps data. Photo shows the tree that has fallen on the super silt fence at about 13334+70.			Description	See photo for gps data. Photo shows the downstream side of the bridge over S-GH7.

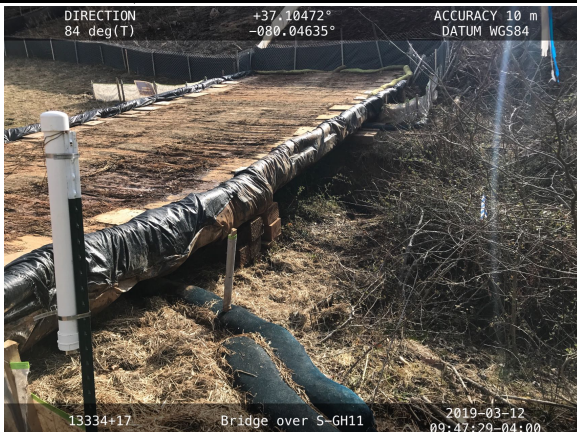
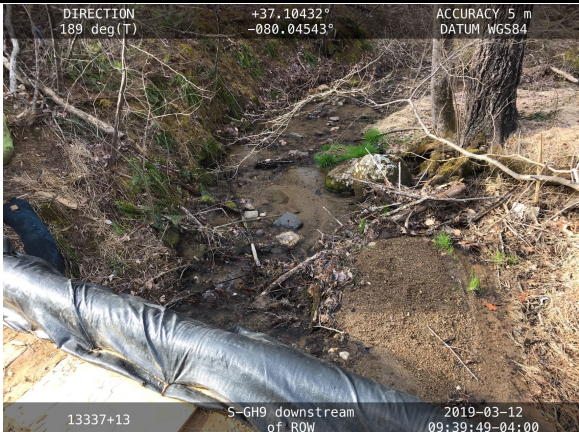
GPS Location	37.06	Field Station#	13334+17	GPS Location	37.06	Field Station#	13337+13
Description	See photo for gps data. Photo shows the downstream side of the bridge over S-GH11.			Description	See photo for gps data. Photo shows stream S-GH9 down stream of the ROW.

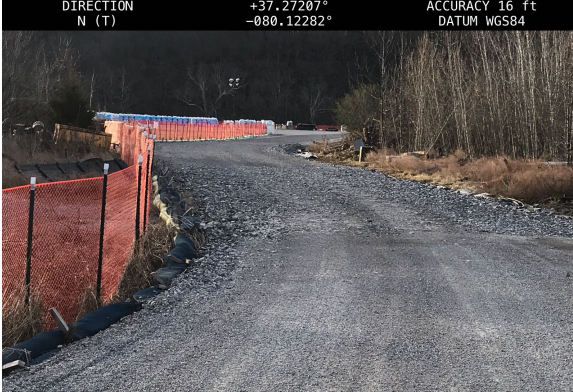
Description		MVP-LY-049_031219 condition of containment under light plant. Looking E. See photo for gps data.		Description		MVP-LY-049_031219 condition of compost filter sock and safety fence along drive. Looking E. See photo for gps data.	
<div>DIRECTION NW (T) +37.27152° -080.12040° ACCURACY 16 ft DATUM WGS84</div>   <div>2019-03-12 08:32:16-04:00</div>			<div>DIRECTION N (T) +37.26996° -080.12358° ACCURACY 16 ft DATUM WGS84</div>

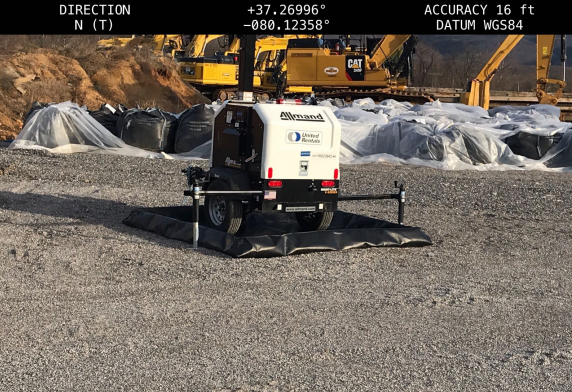
<div>2019-03-12 08:47:50-04:00</div>				
GPS Location 37.27		Field Station# +0		GPS Location 37.27		Field Station# +0	
Description		MVP-LY-049_031219 dumpster area free of loose trash. Looking NE. See photo for gps data.		Description		MVP-LY-049_031219 condition of containment under light plant. Looking N. See photo for gps data.

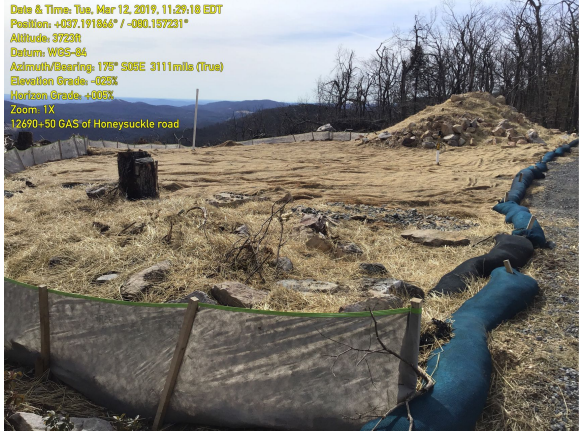
GPS Location	37.15	Field Station#	12865+00		GPS Location	37.19	Field Station#	12690+50
Description	Bottom Creek road. No deficiencies or off ROW impacts found.			Description	Honeysuckle Road. No deficiencies in ECD's or BMP's were found. Environmental crew has recently performed maintenance throughout the area.

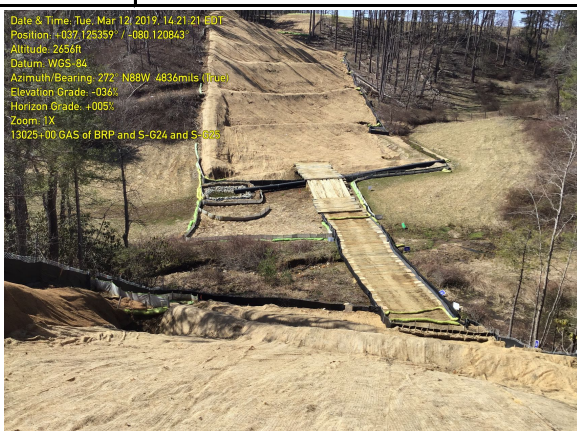
GPS Location	37.12	Field Station#	13025+00		GPS Location	37.12	Field Station#	13041+00
Description	S-G24 and S-G25 had no deficiencies and no observed impacts.			Description	S-H1 remains in good condition throughout the area. No issues or impacts.

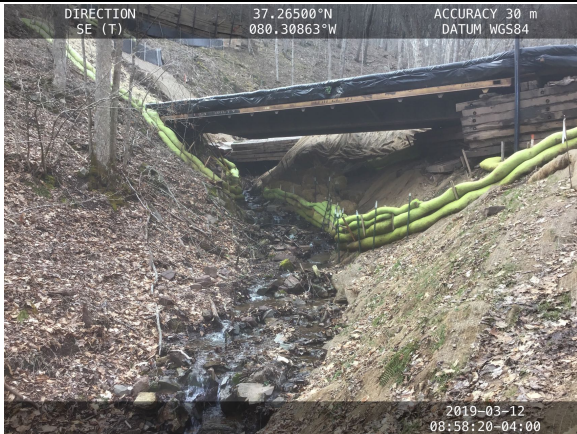
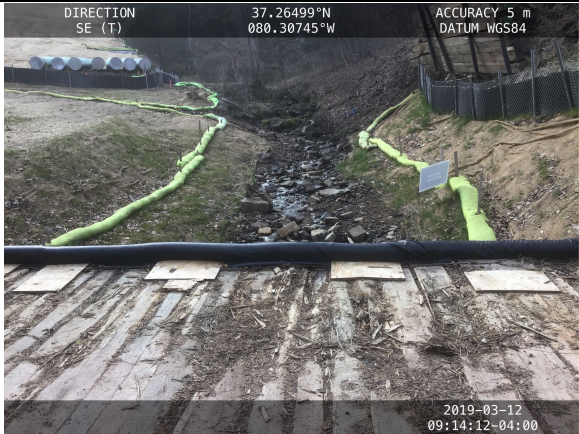
GPS Location	37.26	Field Station#	12031+51	GPS Location	37.26	
Description	Stream S-G39, facing southeast.			Description	Stream S-G40, facing southeast.

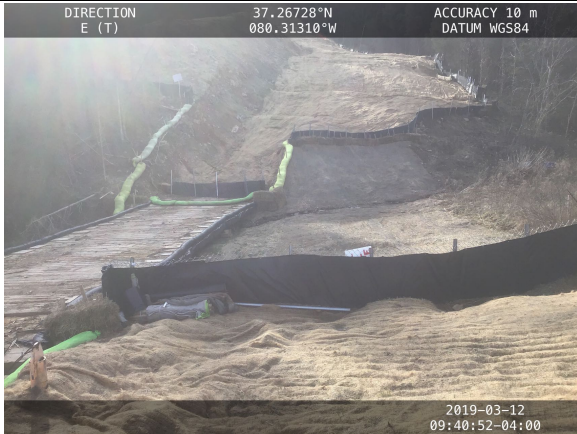
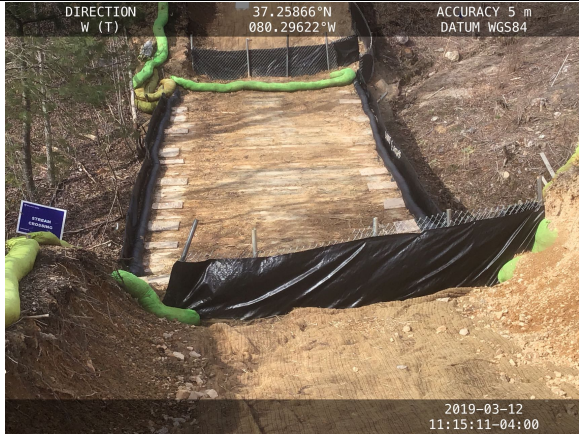
GPS Location	37.26	Field Station#	12015+84	GPS Location	37.25	
Description	Stream S-G38, facing east.			Description	Stream S-MM15, facing west.

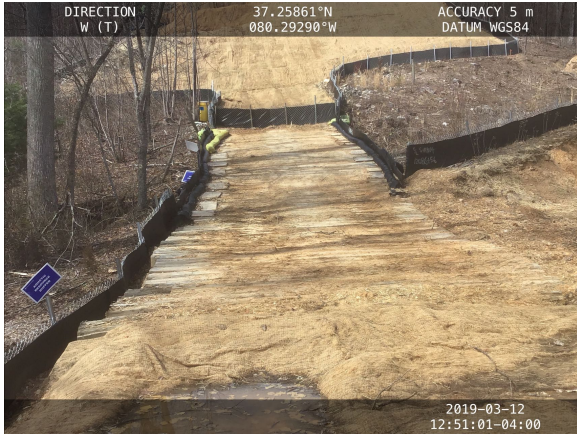
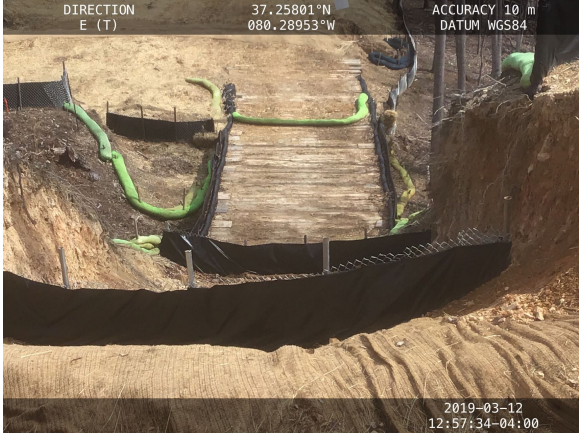
GPS Location	37.25	Field Station#	12086+56	GPS Location	37.25	
Description	Stream S-MM14, facing west.			Description	Stream S-MM15, facing east.

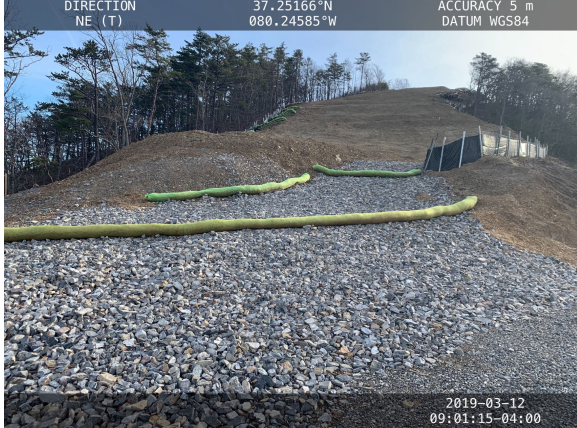
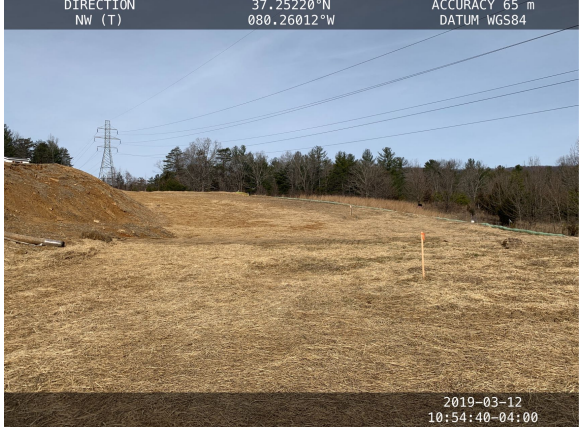
<div>2019-03-12 10:54:40-04:00</div>										
GPS Location		37.33	Field Station#		12234+77		GPS Location		37.33	Field Station#		12186+92	
Description		RCE GAS Reese Mountain switch back. Looking NE. See picture for GPS data.					Description		Stabilized ROW. Looking NW. See picture for GPS data.				
<div>DIRECTION W (T) 37.21150°N 080.26645°W ACCURACY 1.42 km DATUM WGS84</div>

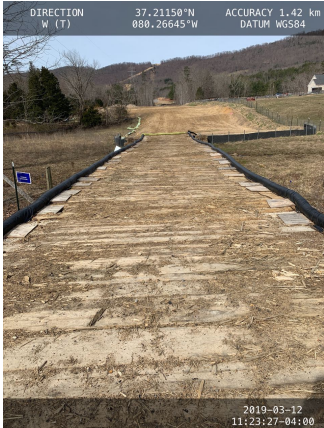
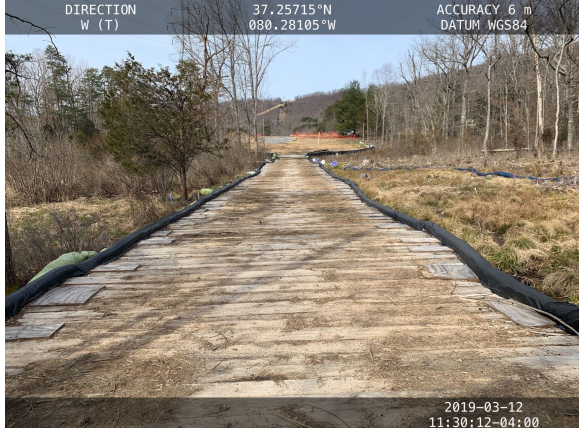
Description		Bridge crossing over S-C29. Looking W. See picture for GPS data.					Description		Bridge crossing over multiple streams and wetlands. Looking W. See picture for GPS data.				
<div>DIRECTION S (T) 37.25737°N 080.28254°W ACCURACY 10 m DATUM WGS84</div>

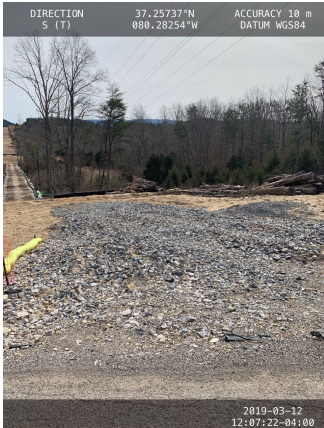
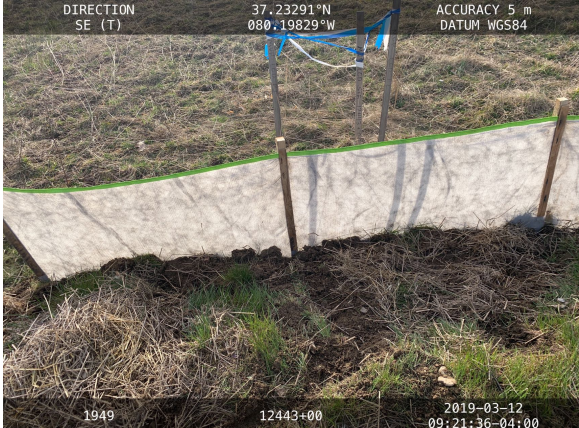
<div>1949 12443+00 2019-03-12 09:21:36-04:00</div>										
GPS Location		37.33	Field Station#		12119+27		GPS Location		37.33	Field Station#		12443+00	
Description		RCE GAS of Flatwoods road. Looking S. See picture for GPS data.					Description		Punch list item number 1949 completed. Looking SE. See picture for GPS data.

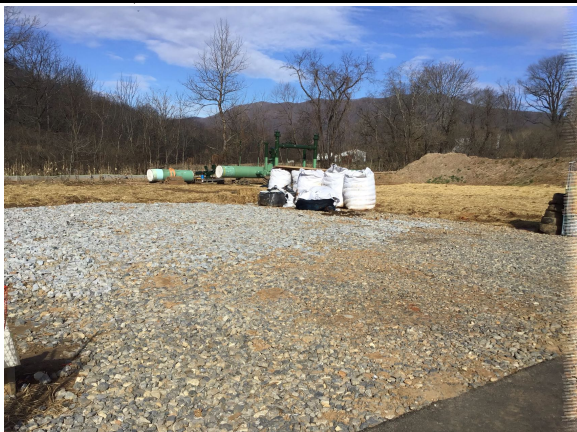
GPS Location		36.97		Field Station#		13644+73		GPS Location		36.97	
Description		RCE on CIS of Leaning Oak in good condition.									
Description		Stream S-E28 flume clear of any debris.

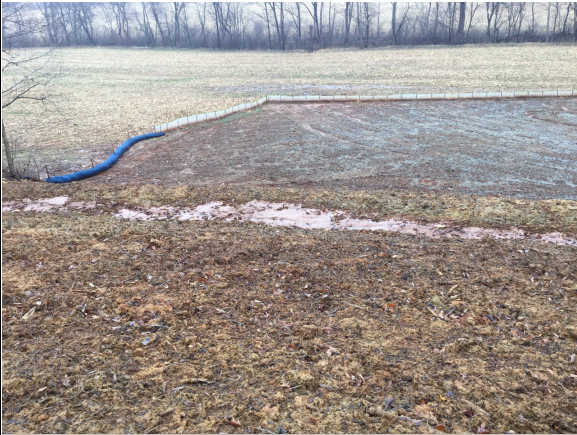
<p>Insert image here</p>			
GPS Location	36.97	Field Station#	13562+00	GPS Location	
Description	Waterbar needs throat cleaned		Description		
<p>Insert image here</p>			<p>Insert image here</p>		
GPS Location		Field Station#		GPS Location	
Description			Description		
<p>Insert image here</p>			<p>Insert image here</p>		
GPS Location		Field Station#		GPS Location	
Description			Description		
<p>Insert image here</p>			<p>Insert image here</p>		
GPS Location		Field Station#		GPS Location	
Description			Description
