Visual Site Inspection Report

Project Name	H-600 Pipeline Spread H	AFE	124300138	Spread	H-600 Pipeline Spread H	
Contractor	Precision			Report #	14933	
Inspector	Pat Davis			Date/Time	3/18/2019 6:45 PM	
Permit #	TBD	Inspection Type	VA SWPP	Station Begin	+0	
State	VA	Inspection Area	Partial	Station End	+0	
County	Roanoke	Ground	Dry	Temperature (°F)	50.00	
Municipality	N/A	Weather	Sunny	Rain Gauge (in)	0.00	
				Rain Accumulation Time (days)	0.00

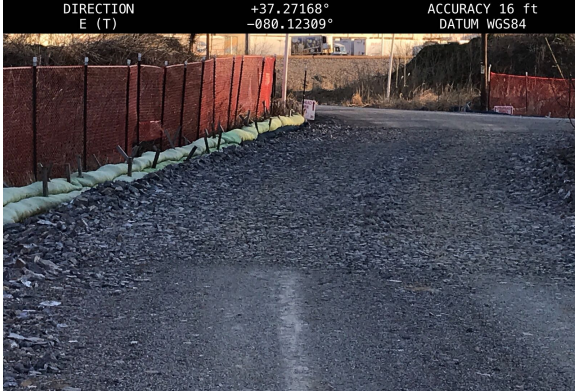
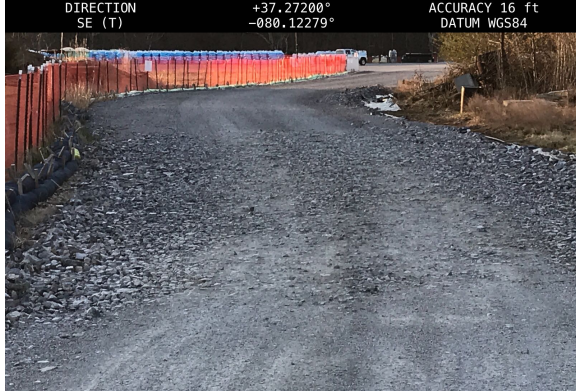
<div>2019-03-18 08:03:30-04:00</div>											
GPS Location		37.27		Field Station#		+0		GPS Location		37.27		Field Station#		+0	
Description		MVP-LY-049_031819 dumpster area free of loose trash. Looking NE. See photo for gps data.						Description		MVP-LY-049_031819 condition of CFS and safety fence along north drive. Looking NW. See photo for gps data.					
<div>DIRECTION E (T)</div> <div>+37.27168° -080.12309°</div> <div>ACCURACY 16 ft DATUM WGS84</div>

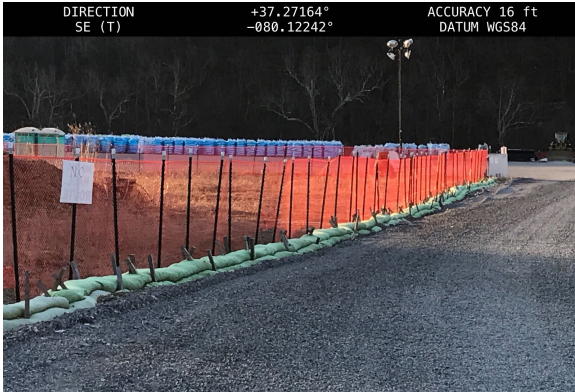
GPS Location		37.27		Field Station#		+0		GPS Location		37.27		Field Station#		+0	
Description		MVP-LY-049_031819 condition of rock entrance on north drive. Looking E. See photo for gps data.						Description		MVP-LY-049_031819 condition of rock entrance on center drive. Looking SE. See photo for gps data.					
<div>DIRECTION SE (T)</div> <div>+37.27164° -080.12242°</div> <div>ACCURACY 16 ft DATUM WGS84</div>

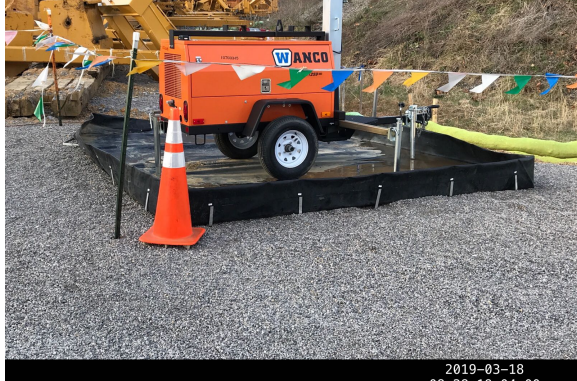
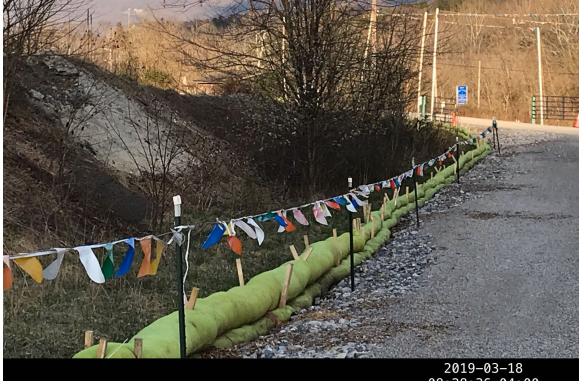
GPS Location	37.23	Field Station#	+0	GPS Location	37.23	Field Station#	+0
Description	MVP-PY-006_031819 feature signage. Looking W. See photo for gps data.			Description	MVP-PY-006_031819 condition of containment under light plant. Looking N. See photo for gps data.		
<div>DIRECTION S (T)</div> <div>+37.23511° -080.22870°</div> <div>ACCURACY 16 ft DATUM WGS84</div>

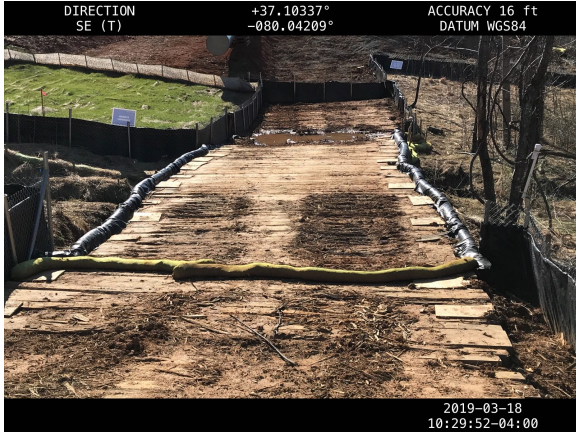
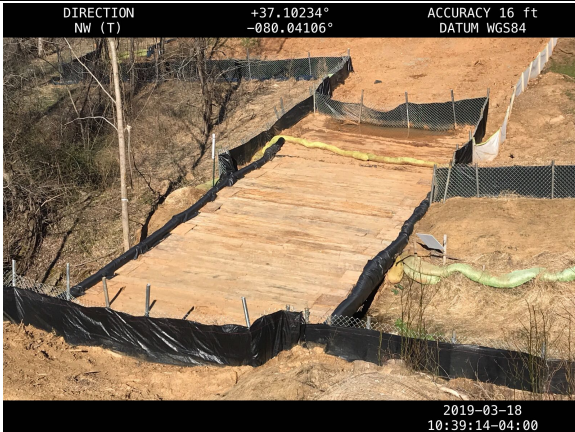
<div>2019-03-18 10:29:52-04:00</div>											
GPS Location		37.10		Field Station#		13413+05		GPS Location		37.10		Field Station#		13348+40	
Description		13413+05_031819 S-IJ1 mat bridge clean and closed. Looking NW. See photo for gps data.						Description		13348+40_031819 S-RR08 mat bridge clean and closed. Looking SE. See photo for gps data.					
<div>DIRECTION NW (T) +37.10234° -080.04106° ACCURACY 16 ft DATUM WGS84</div>

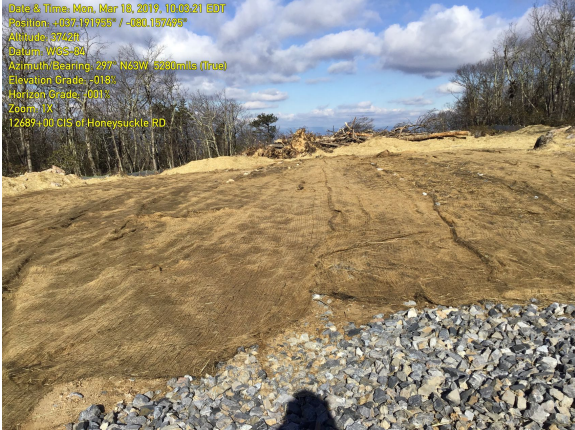
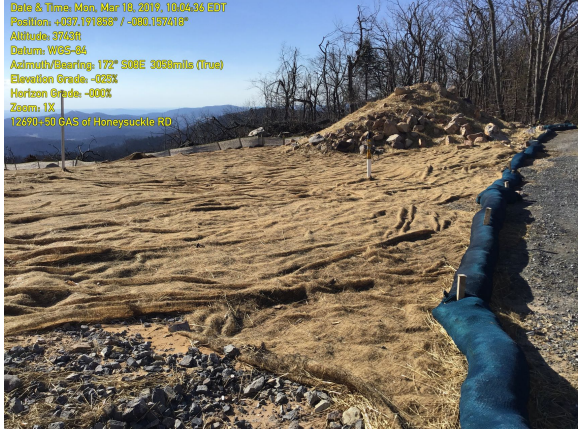
GPS Location	37.19	Field Station#	12689+00	GPS Location	37.19	Field Station#	12690+50
Description	No deficiencies observed. Curlex undamaged by strong winds.			Description	No issues or impacts found in the area.		
<p>Date & Time: Mon, Mar 18, 2019, 10:05:00 EDT Position: +4287.182587° / -880.125012° Altitude: 3810ft Datum: WGS-84 Azimuth/Bearing: 000° S10E 3022mils (True) Elevation Grade: -000° Horizon Grade: +000° Zoom: 1X 12866+50 GAS of Bottom Creek Road</p>

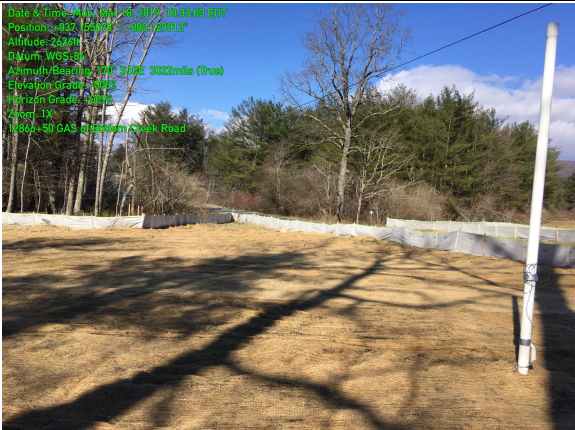
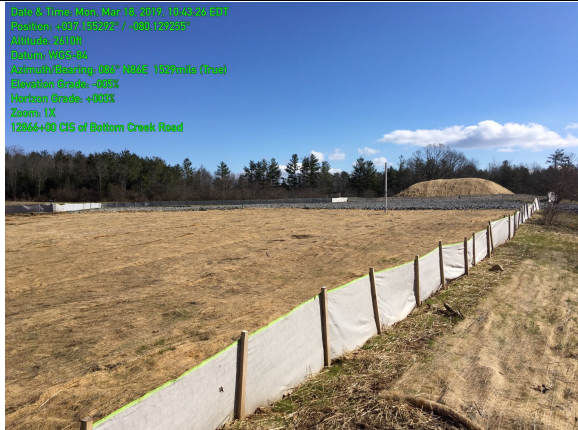
GPS Location	37.15	Field Station#	12866+50	GPS Location	37.15	Field Station#	12866+00
Description	No damaged or deficient ECD's observed on the GAS of Bottom Creek Road.			Description	No compliance issues found on the CIS of Bottom Creek Road.		
<p>Date & Time: Mon, Mar 18, 2019, 11:02:05 EDT Position: +4287.132265° / -880.131440° Altitude: 3730ft Datum: WGS-84 Azimuth/Bearing: 236° N249° 430mils (True) Elevation Grade: -011° Horizon Grade: -000° Zoom: 1X 12973+00 Access road RD-288 & stream S-Q20</p>

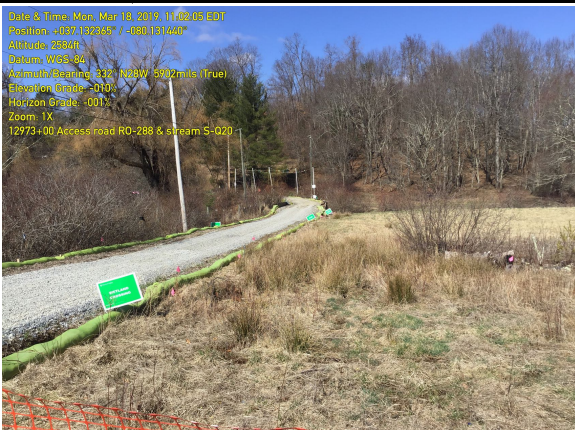
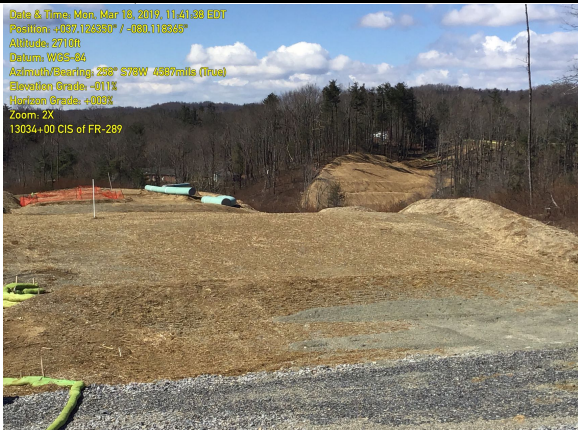
GPS Location	37.13	Field Station#	12973+00	GPS Location	37.12	Field Station#	13034+00
Description	No compliance issues found in the area.			Description	No issues or impacts found.

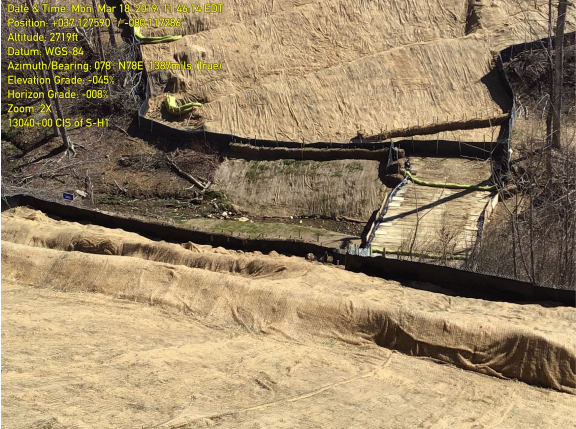
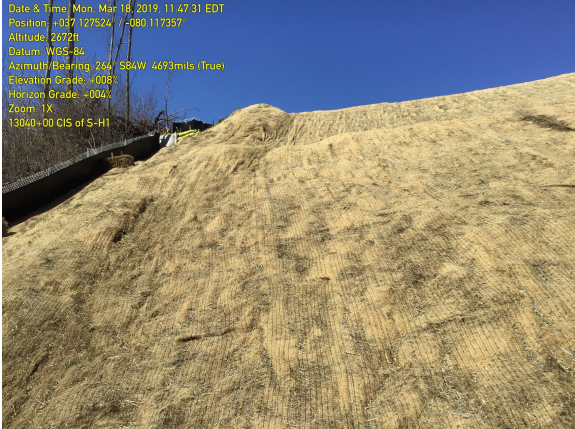
GPS Location	37.12	Field Station#	13040+00	GPS Location	37.12
Description	No stream impacts were observed today.		Description	Stabilization continues to function throughout the area.	
Insert image here			Insert image here		
GPS Location		Field Station#		GPS Location	
Description			Description		
Insert image here			Insert image here		
GPS Location		Field Station#		GPS Location	
Description			Description

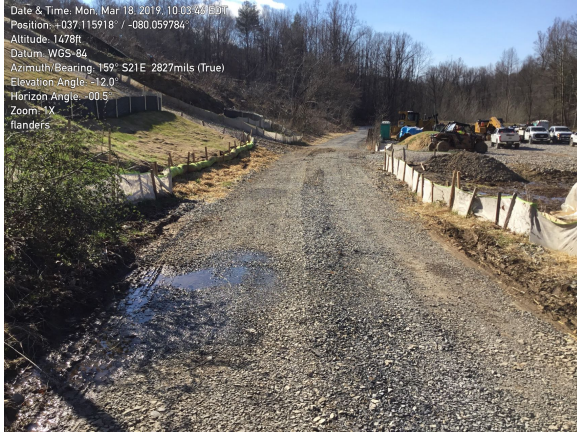
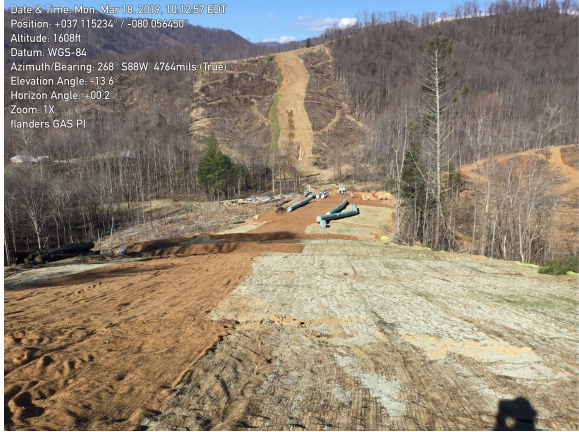
GPS Location	37.32	Field Station#	13262+58	GPS Location	37.32	Field Station#	13273+46
Description	Please see photo for coordinates. MVP-FR-293.01, minor wear from continued logging activity.			Description	Please see photo for coordinates. ROW stabilized, seed and curlex added to travel lane and soil piles.		
<p>Date & Time: Mon, Mar 18, 2019, 10:27:49 EDT Position: +037.112711 / -080.056708 Altitude: 1521ft Datum: WGS-84 Azimuth/Bearing: 197° S17W 3502mils (True) Elevation Angle: -16.0° Horizon Angle: +00.3° Zoom: 1X flanders GAS PI downstream</p>

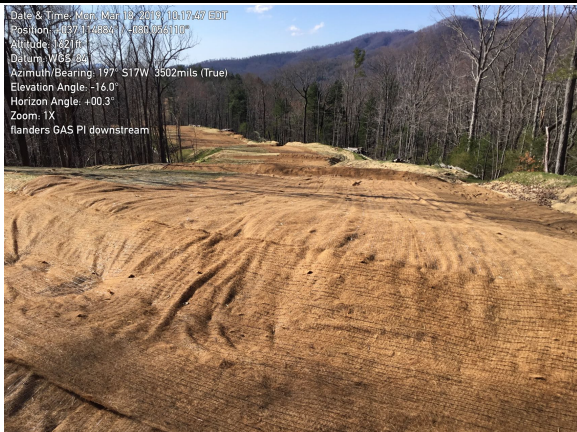
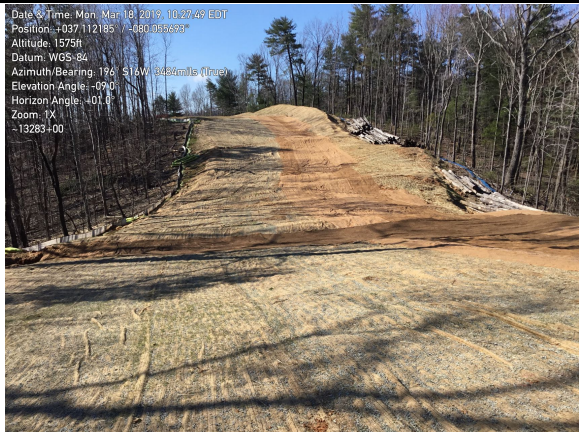
GPS Location	37.32	Field Station#	13274+00	GPS Location	37.32	Field Station#	13283+00
Description	Please see photo for coordinates. ROW seeded and stabilized with curlex.			Description	Please see photo for coordinates. Travel lane repaired and stabilized.		
<p>Date & Time: Mon, Mar 18, 2019, 11:38:57 EDT Position: +037.115391 / -080.059842 Altitude: 1427ft Datum: WGS-84 Azimuth/Bearing: 041° N61E 1084mils (True) Elevation Angle: -00.5° Horizon Angle: -00.5° Zoom: 1X flanders</p>

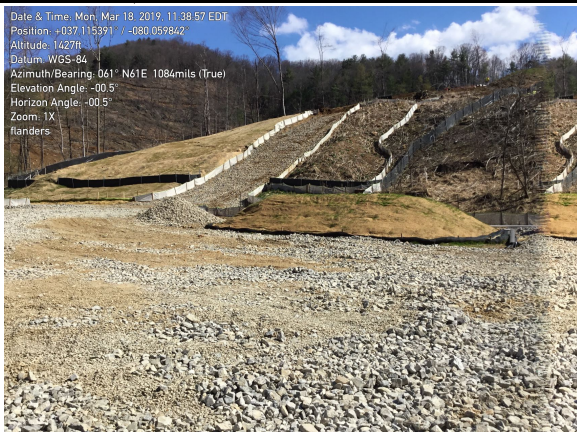
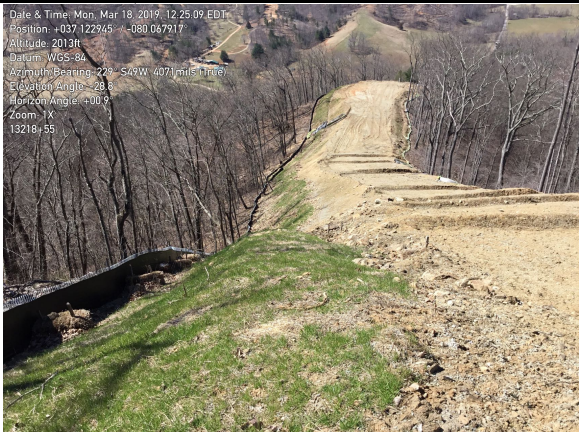
GPS Location	37.32	Field Station#	13262+58	GPS Location	37.32	Field Station#	13218+53
Description	Please see photo for coordinates. MVP-FR-293.01, Flanders Road, top soil stabilized, RCE maintained.			Description	Please see photo for coordinates. Topsoil and subsoil piles stable, ECDs functioning acceptably.

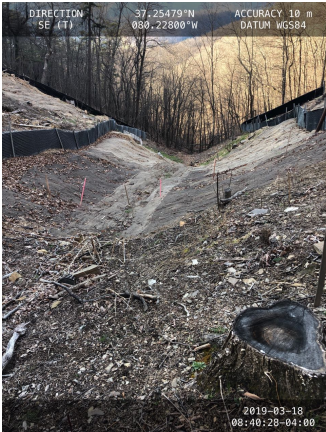
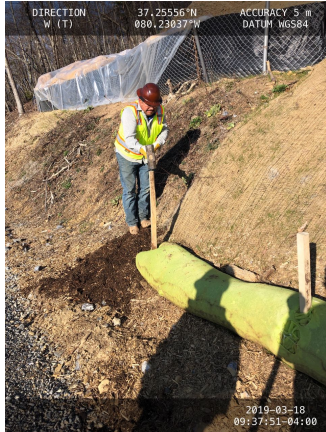
GPS Location	37.33	Field Station#	12291+64	GPS Location	37.33	Field Station#	12284+70
Description	Drainage feature that has been stabilized and has no issues. Looking SE. See picture for GPS data.			Description	Laborers repairing CFS that had been damaged by passing traffic. Looking W. See picture for GPS data.

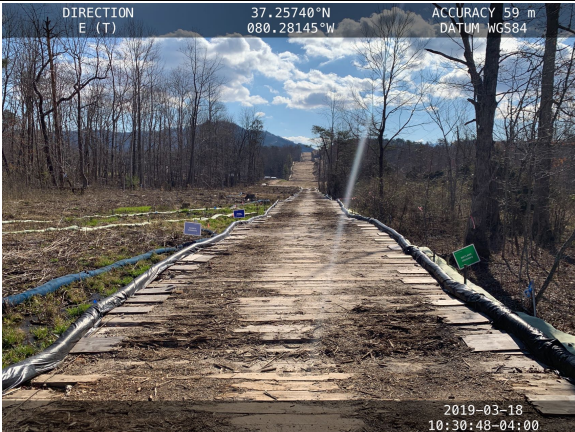
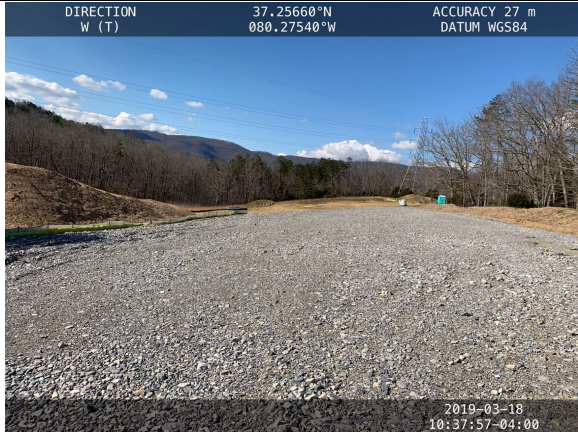
GPS Location	37.33	Field Station#	12121+29	GPS Location	37.33	Field Station#	12140+00
Description	Bridge crossing multiple streams and wetlands, good condition and clean. Looking E. See picture for GPS data.			Description	Gravel parking/staging area at access road MVP-MN-272. Looking W. See picture for GPS data.

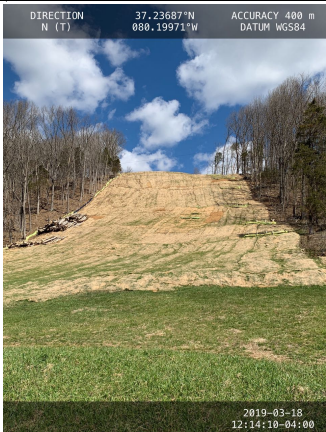
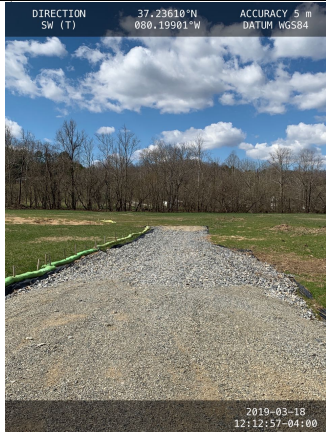
GPS Location	37.33	Field Station#	12418+00	GPS Location	37.33	Field Station#	12424+01
Description	Stabilized steep slope hill side. Looking N. See picture for GPS data.			Description	RCE. Looking SW. See picture for GPS data.

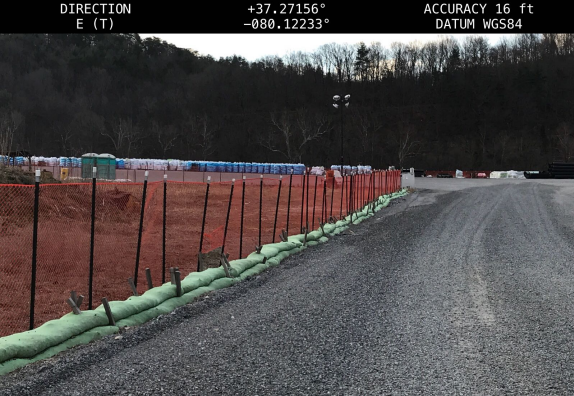
<div>2019-03-22 08:19:57-04:00</div>		
GPS Location	37.27	Field Station#	+0		
Description	MVP-LY-049_032219 condition on rock entrance. Looking E. See photo for gps data.				
<div>DIRECTION NW (T)</div> <div>+37.27097° -080.12190°</div> <div>ACCURACY 16 ft DATUM WGS84</div>

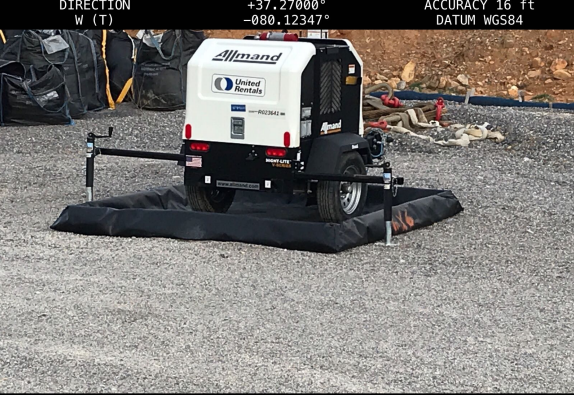
<div>2019-03-22 08:23:25-04:00</div>		
GPS Location	37.27	Field Station#	+0		
Description	MVP-LY-049_032219 yard free of loose trash. Looking SW. See photo for gps data.				
GPS Location	37.27	Field Station#	+0		
Description	MVP-LY-049_032219 condition of containment under light plant. Looking W. See photo for data.

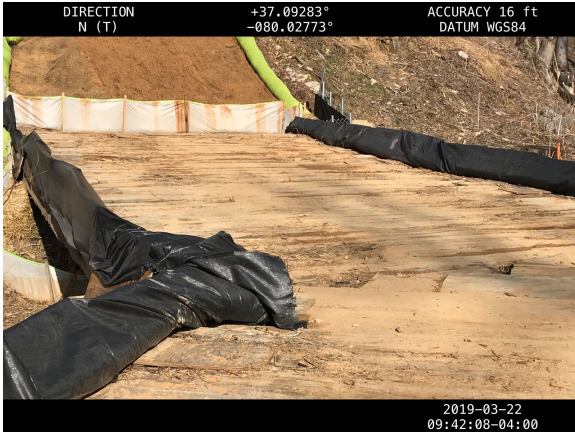
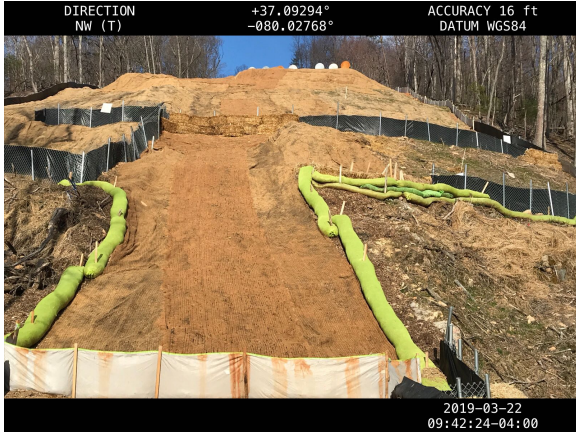
<div>2019-03-22 09:42:24-04:00</div>				
GPS Location	37.10	Field Station#	13413+05	GPS Location	37.10	Field Station#	13412+75
Description	13413+05_032219 S-IJ1 mat bridge clean and closed. Looking N. See photo for gps data.			Description	13412+75_032219 travel lane and steep slope stabilized. Looking NW. See photo for gps data.		
<div>DIRECTION E (T) <div>+37.10365° -080.04277° ACCURACY 16 ft DATUM WGS84</div></div>

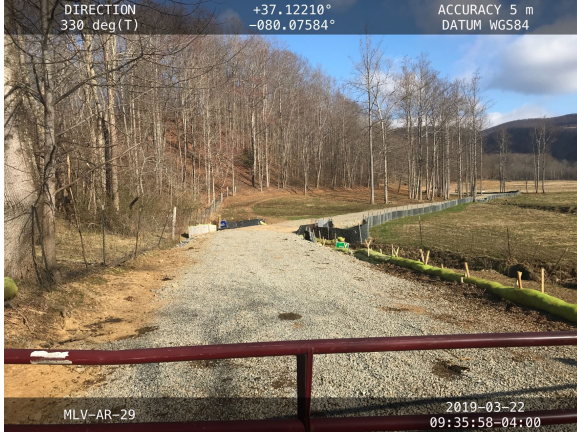
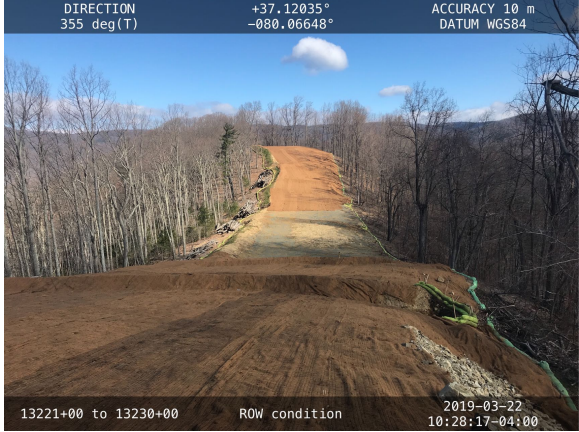
GPS Location	37.11	Field Station#	13196+31	GPS Location	37.11	Field Station#	13230+00
Description	See photo for gps data. Photo shows access road MLV-AR-29.			Description	See photo for gps data. Photo shows the ROW condition from about 13221+00 to 13230+00.

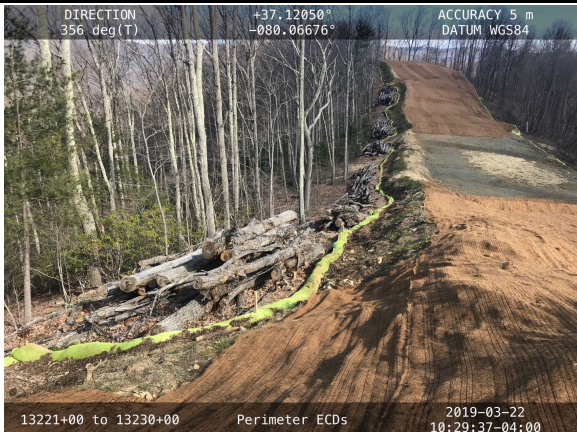
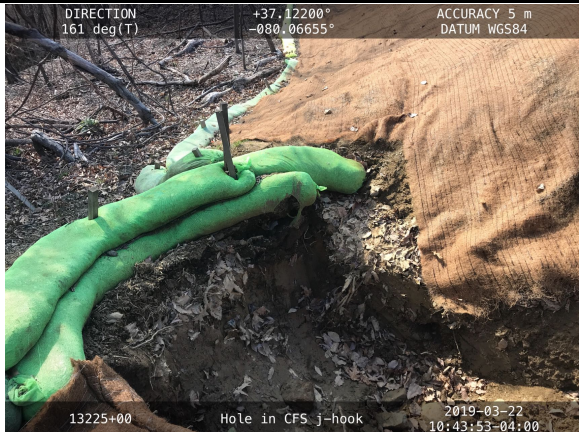
GPS Location	37.11	Field Station#	13230+00	GPS Location	37.11	Field Station#	13225+00
Description	See photo for gps data. Photo shows the perimeter ECDs from 13221+00 to 13230+00.			Description	See photo for gps data. Photo shows a hole in the CFS J-hook at 13225+00.

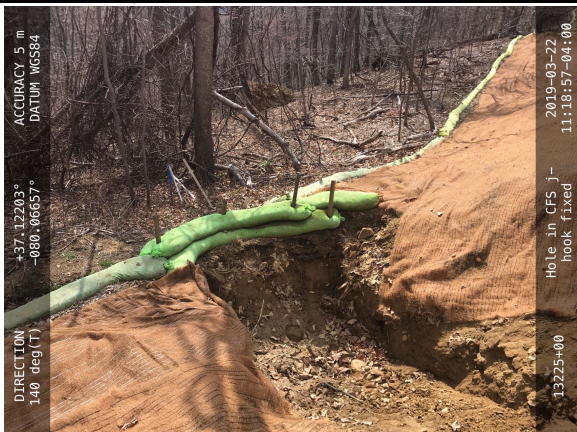
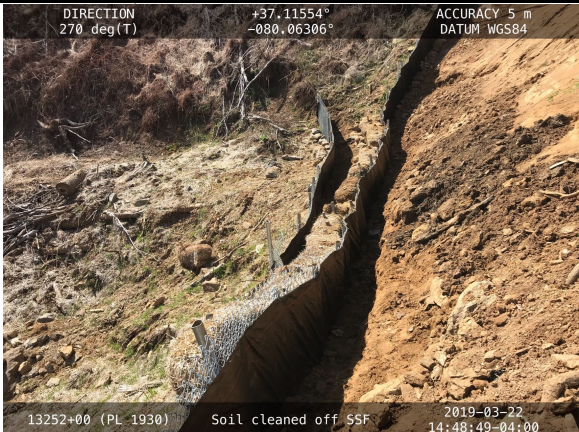
GPS Location	37.11	Field Station#	13225+00	GPS Location	37.11	Field Station#	13252+00
Description	See photo for gps data. Photo shows the repaired CFS J-hook at 13225+00.			Description	See photo for gps data. Photo shows the SSF that was cleaned out and repaired at 1325200. Punch list item 1930.

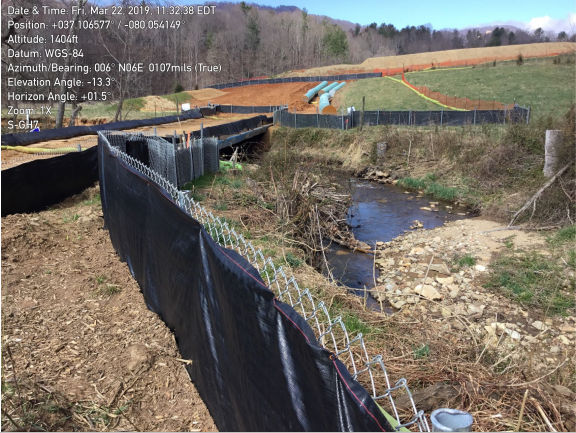
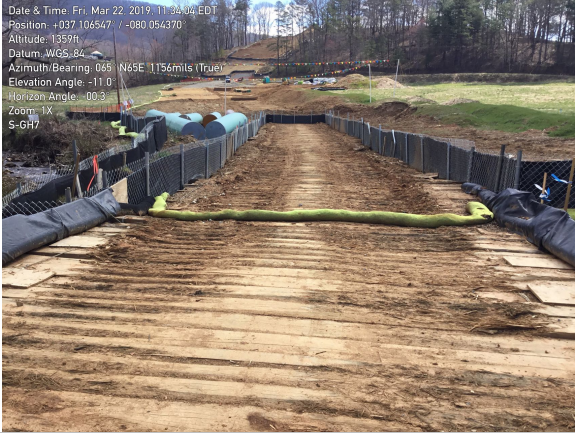
GPS Location 37.23		Field Station# 13309+09		GPS Location 37.23	
Description		Please see photo for coordinates. S-GH7, upstream side of bridge crossing, ECDs functioning acceptably.		Description	
				Please see photo for coordinates. S-GH7, looking towards Wade's Gap Road crossing, soil piles stable.	
<small>Date & Time: Fri, Mar 22, 2019, 11:28:35 EDT Position: +037.106589 / -080.052355 Altitude: 1387ft Datum: WGS-84 Azimuth/Bearing: 276° N84W 4907mils (True) Elevation Angle: +13.4° Horizon Angle: +01.2° Zoom: 1X GIS wades</small>

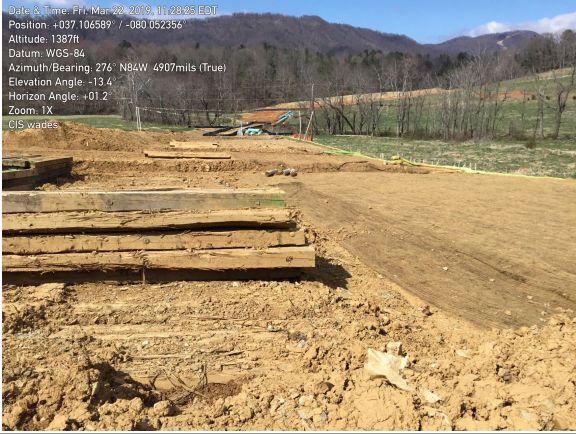
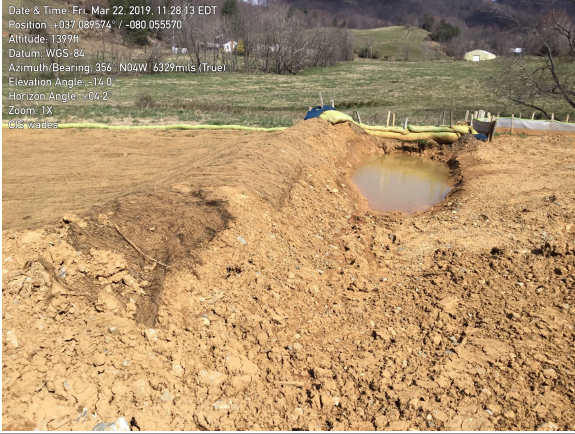
GPS Location 37.23		Field Station# 13315+00		GPS Location 37.23	
Description		Please see photo for coordinates. ~Sta. No. 13315+70, CIS of Wade's Gap, ROW stabilized with curlex.		Description	
				Please see photo for coordinates. ~Sta. No. 13314+00, waterbar and sump functioning acceptably.	
Insert image here			Insert image here		
GPS Location		Field Station#		GPS Location	
Description				Description

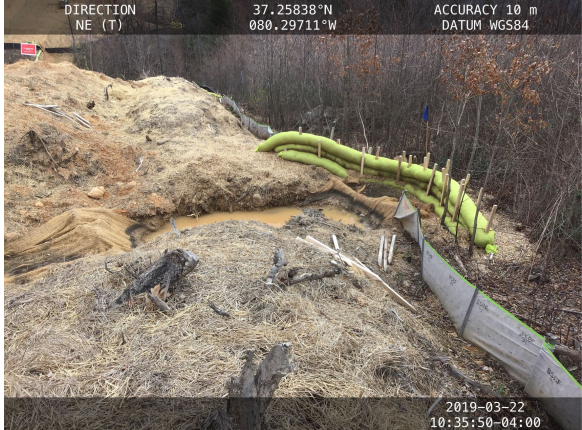
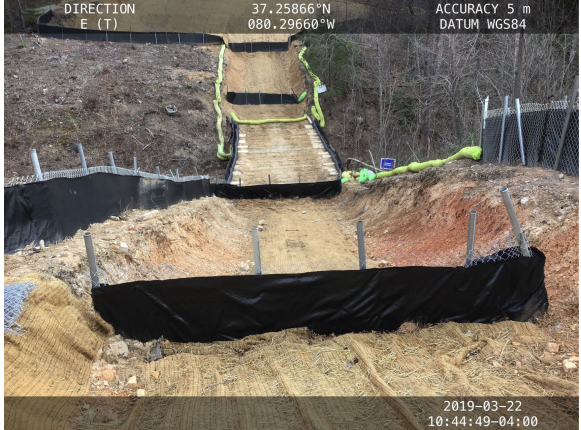
GPS Location	37.25	Field Station#	12083+00	GPS Location	37.25	Field Station#	12076+00
Description	End treatments and perimeter controls are intact and functioning properly.			Description	Stream S-MM15, facing east. Bridge and ECDs in good condition.

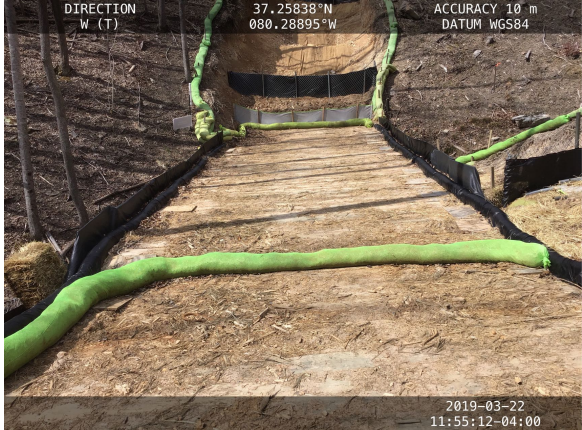
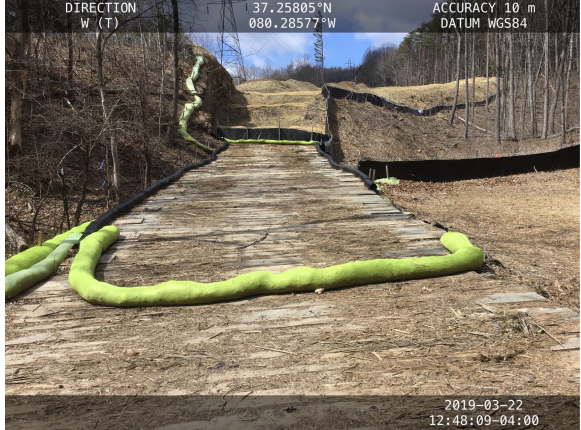
GPS Location	37.25	Field Station#	12098+44	GPS Location	37.25	Field Station#	12108+41
Description	Stream S-MM13, facing west. Bridge and ECDs functioning as needed.			Description	Stream S-F15, facing west. Bridge and ECDs in satisfactory condition.

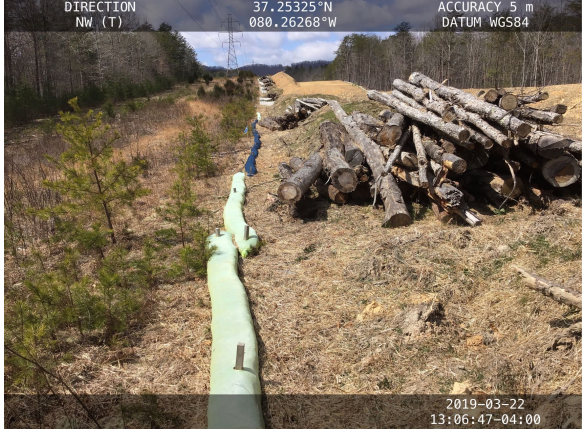
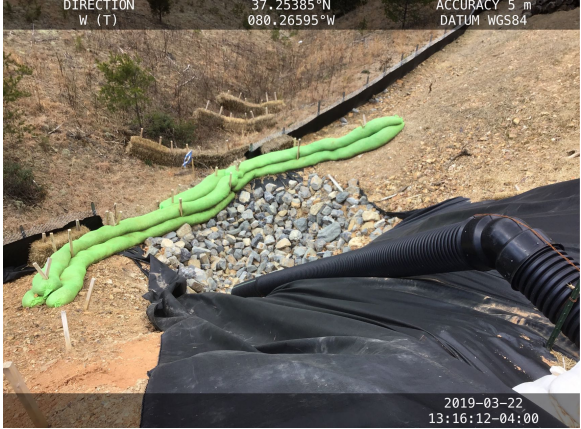
GPS Location	37.25	Field Station#	12177+00	GPS Location	37.25	Field Station#	12170+00
Description	Facing northwest. Perimeter controls in satisfactory condition.			Description	Fill slope drain in good condition and functioning as needed.

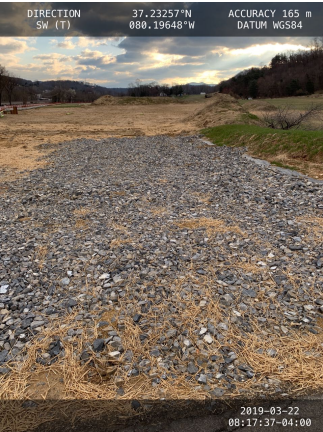
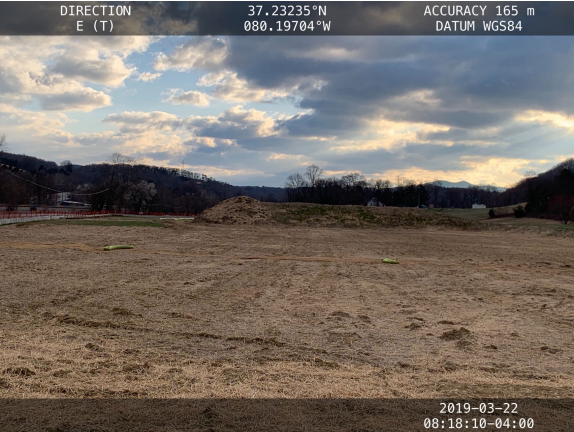
GPS Location	37.33	Field Station#	12448+12	GPS Location	37.33	Field Station#	12447+80
Description	RCE. Looking SW. See picture for GPS data.			Description	Stabilized ROW. Looking E. See picture for GPS data.
