**Subject: Mountain Valley Pipeline Project  
FINAL Historic Structure Report, St. Bernard's Church and Cemetery (NR #85001583)  
WVDCH File #15-67-MULTI  
FERC Docket #CP16-10**

St. Bernard's Church and Cemetery (NR #85001583)

Lewis County, West Virginia

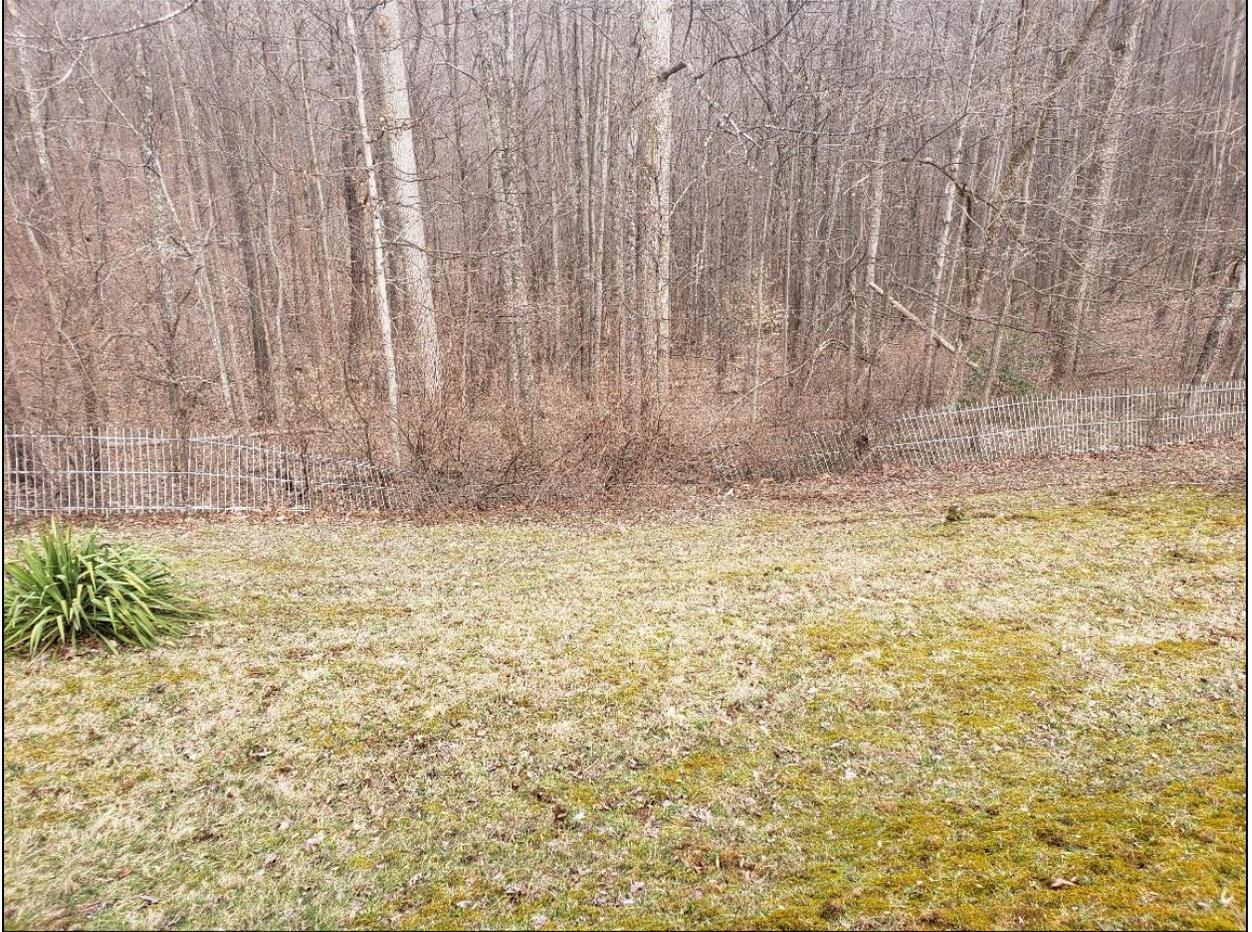
**Photo 3.4.1-1. Overgrown vegetation and portion of collapsed fence along eastern fence line. View East.**

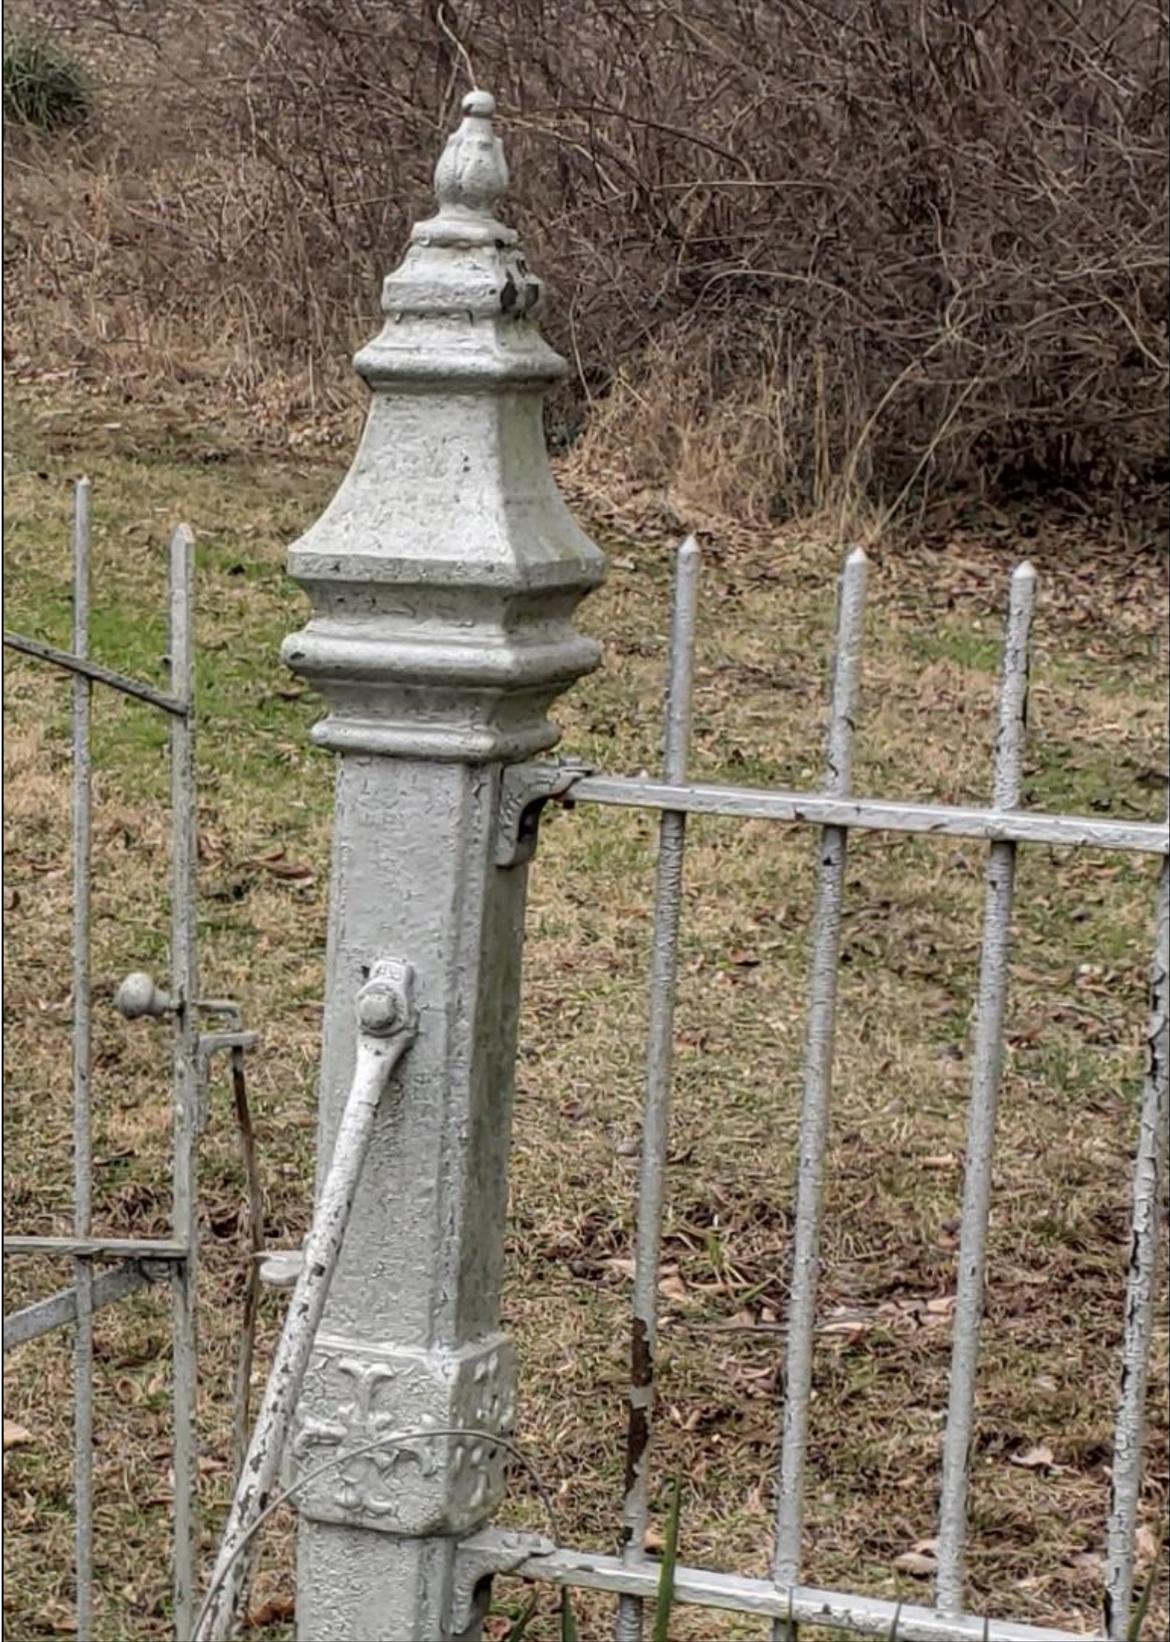
**Photo 3.4.1-2. Loose and flaking coating on fence revealing exposed raw metal. View North.**

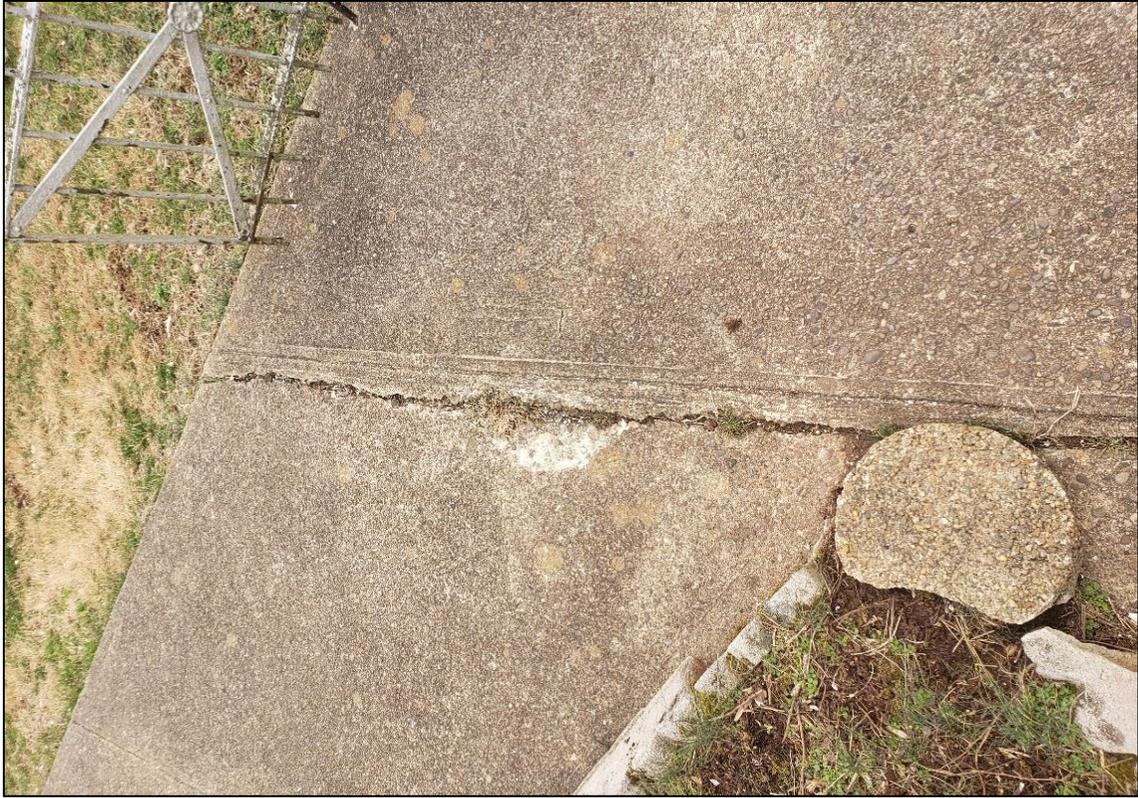
**Photo 3.4.1-3. Minor crack and erosion in sidewalk. View North.**

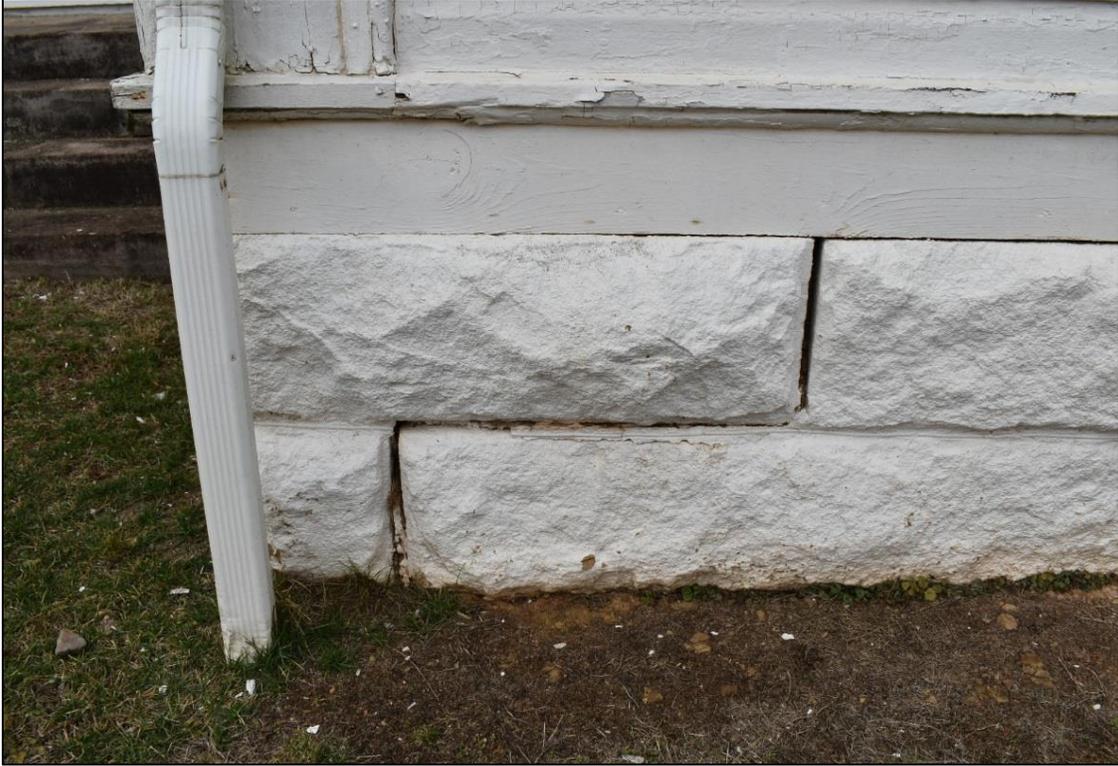
**Photo 3.4.1-5. Stair step crack in south foundation wall. View North.**

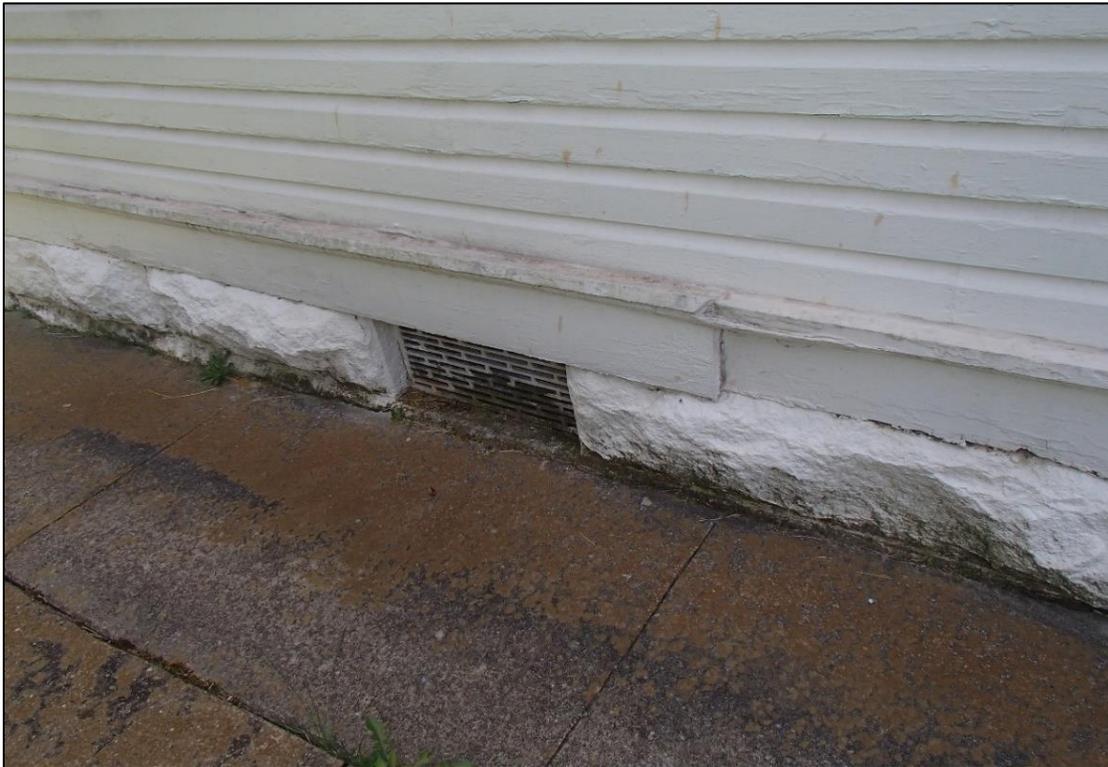
**Photo 3.4.1-6. Rim board movement along the north foundation wall. View Southeast.**

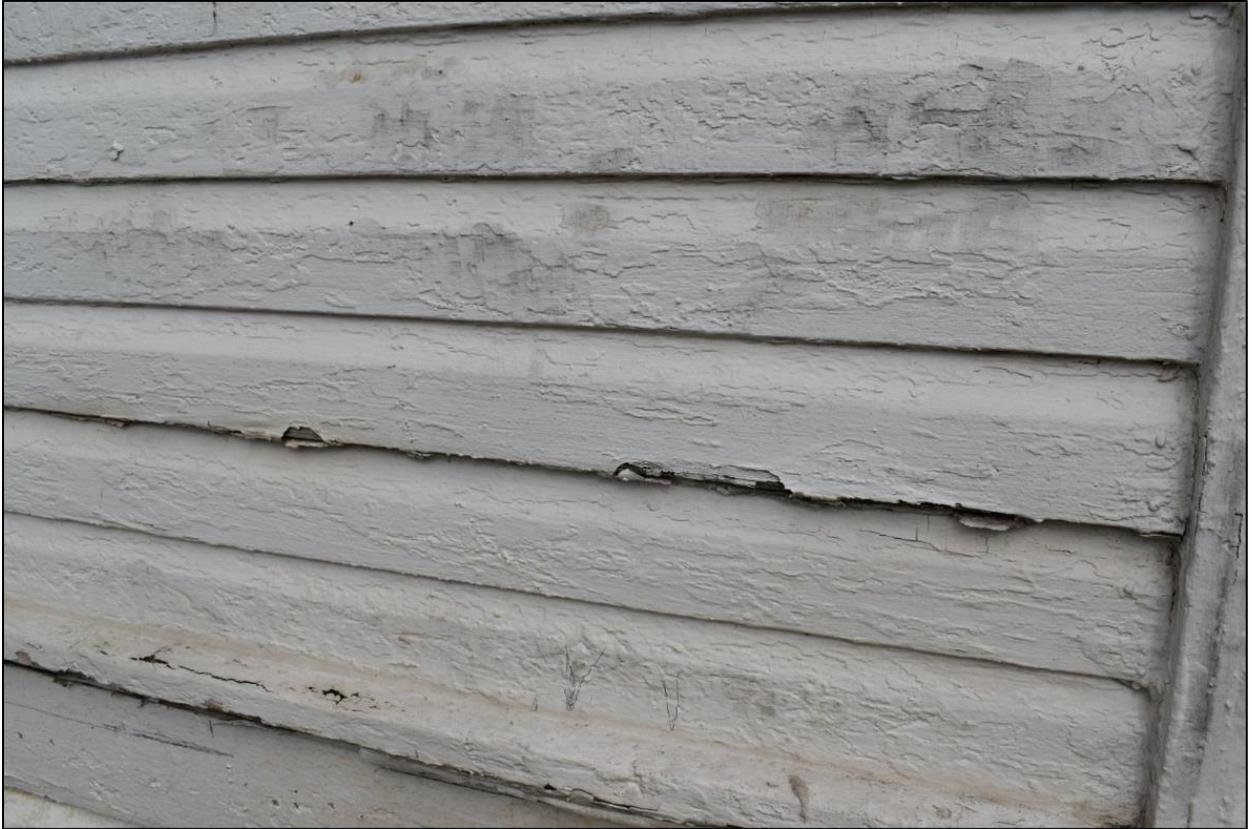
**Photo 3.4.1-9. Water penetrating under siding and settling at the bottom edge of boards, causing wood rot.  
View West.**

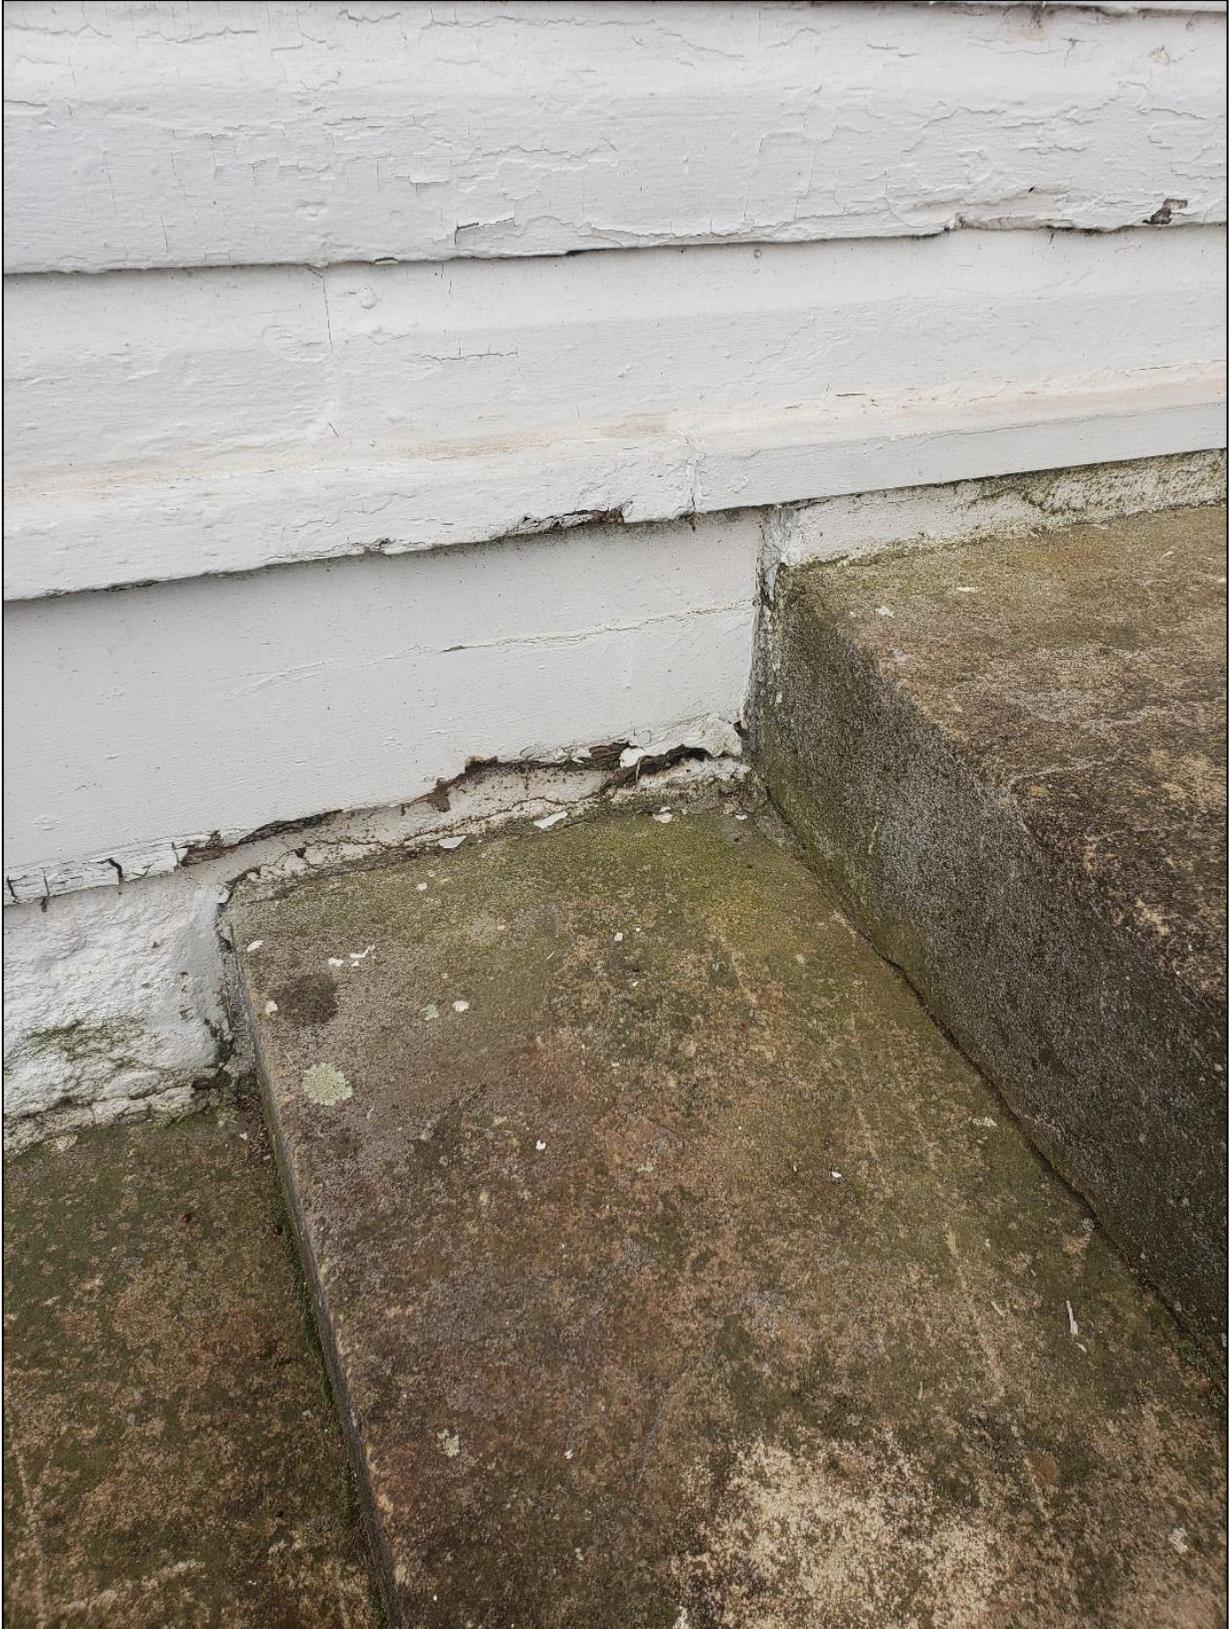
**Photo 3.4.1-10. Water splashing off of concrete stairs, causing wood rot. View East.**

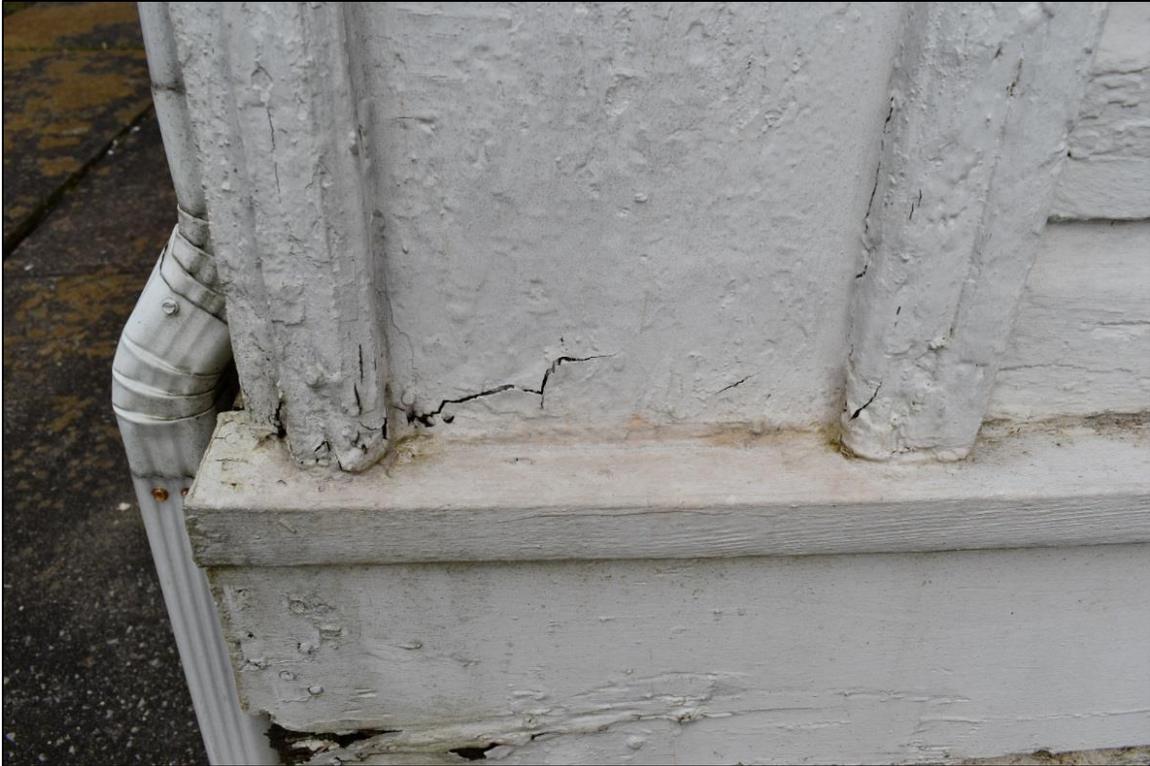
Photo 3.4.1-11. Moisture from downspout at corners of building causing rim board to rot. View East.

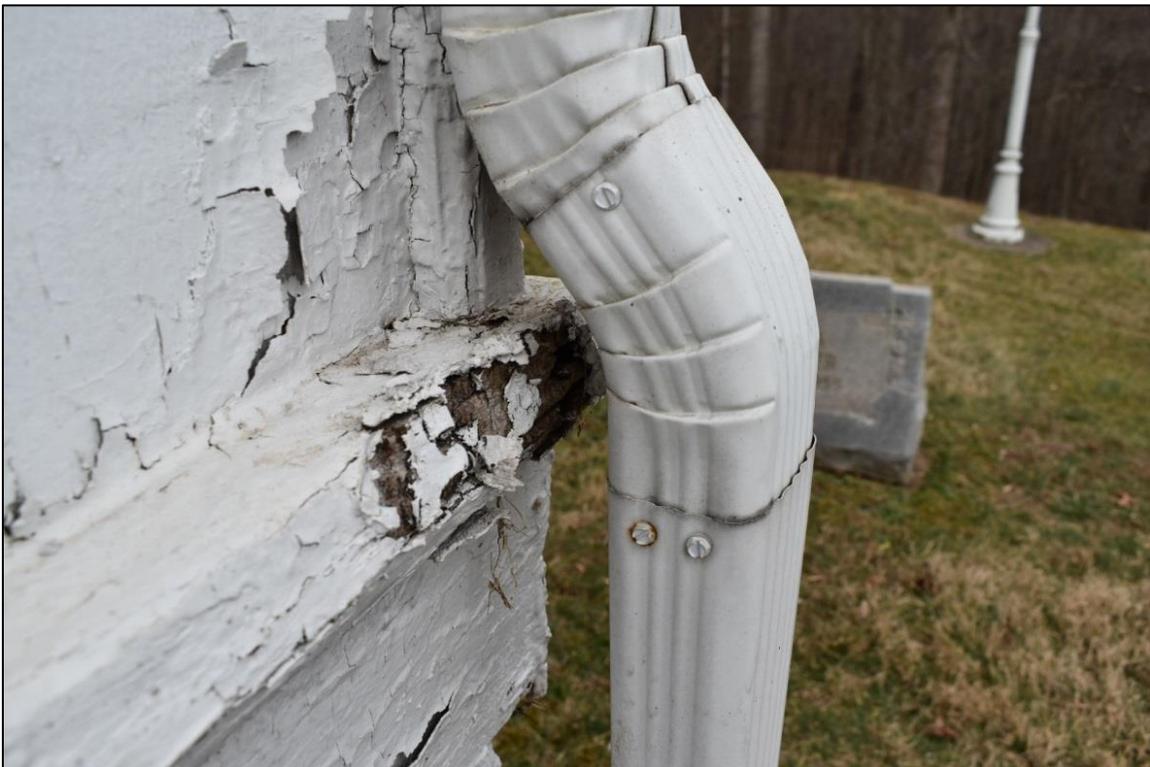
Photo 3.4.1-12. Moisture from downspout at corners of building causing decorative/water-shedding counterpart to rim board to rot. View East.

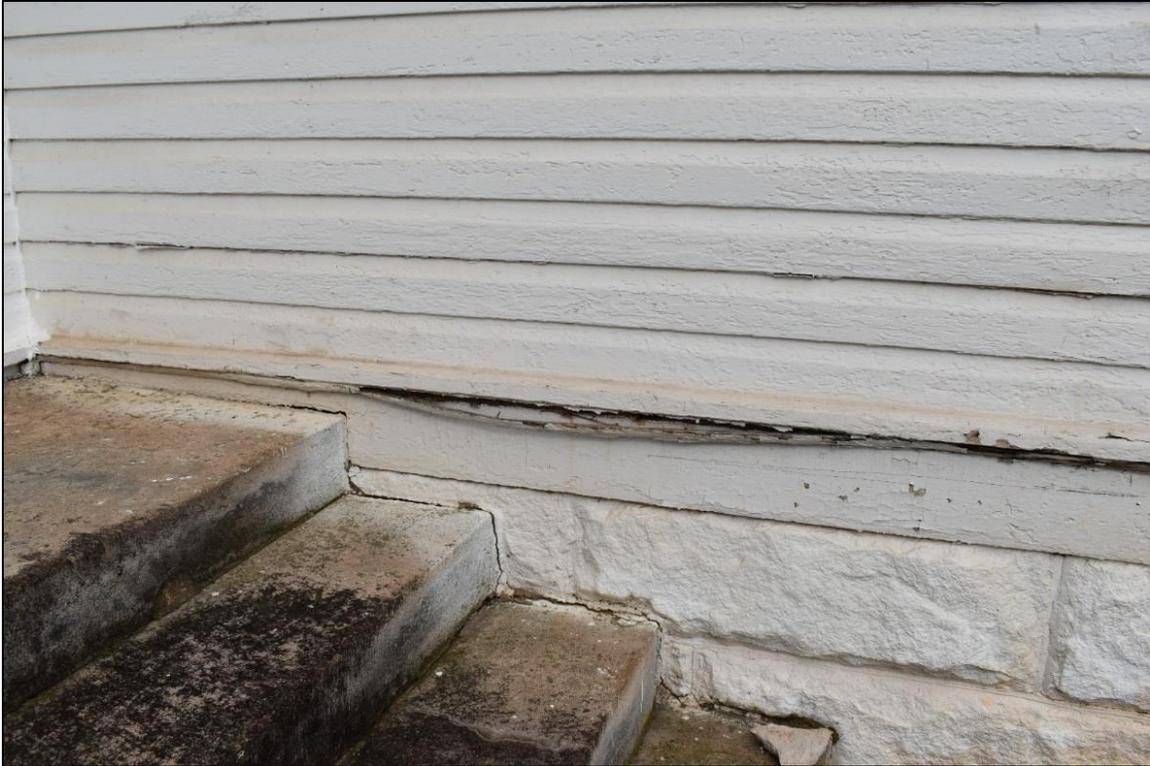
**Photo 3.4.1-13. Moisture collection causing decorative/water-shedding counterpart to rim board to rot. View East.**

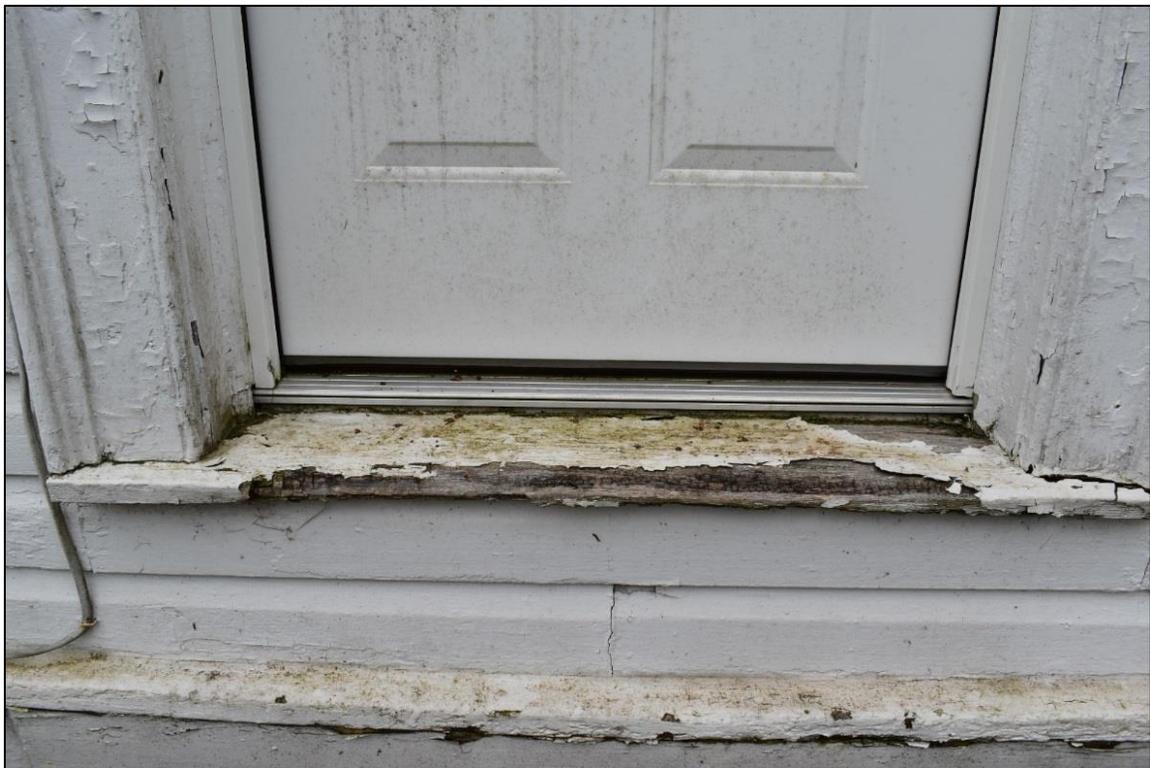
**Photo 3.4.1-14. Moisture collection causing rear door wood sill to rot. View West.**

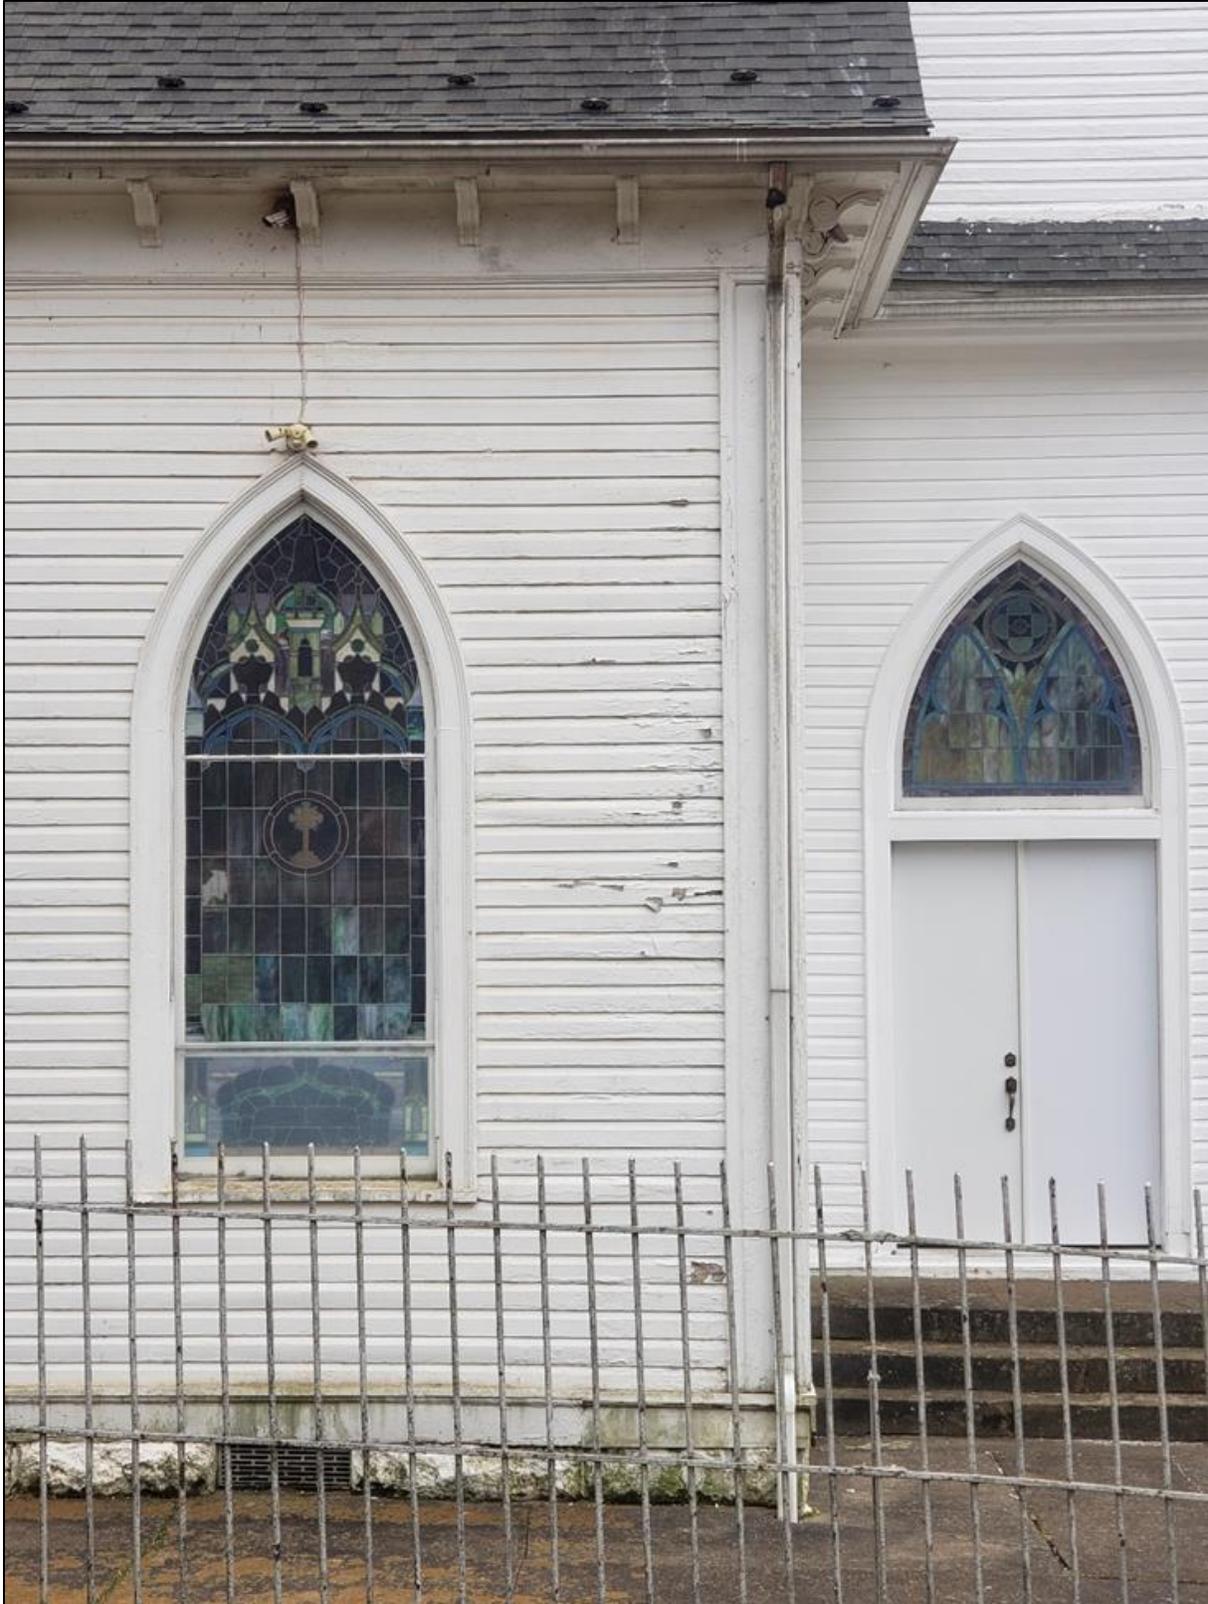
**Photo 3.4.2-1. Paint peeling along northwestern corner of building where siding meets cornerboard. View South.**

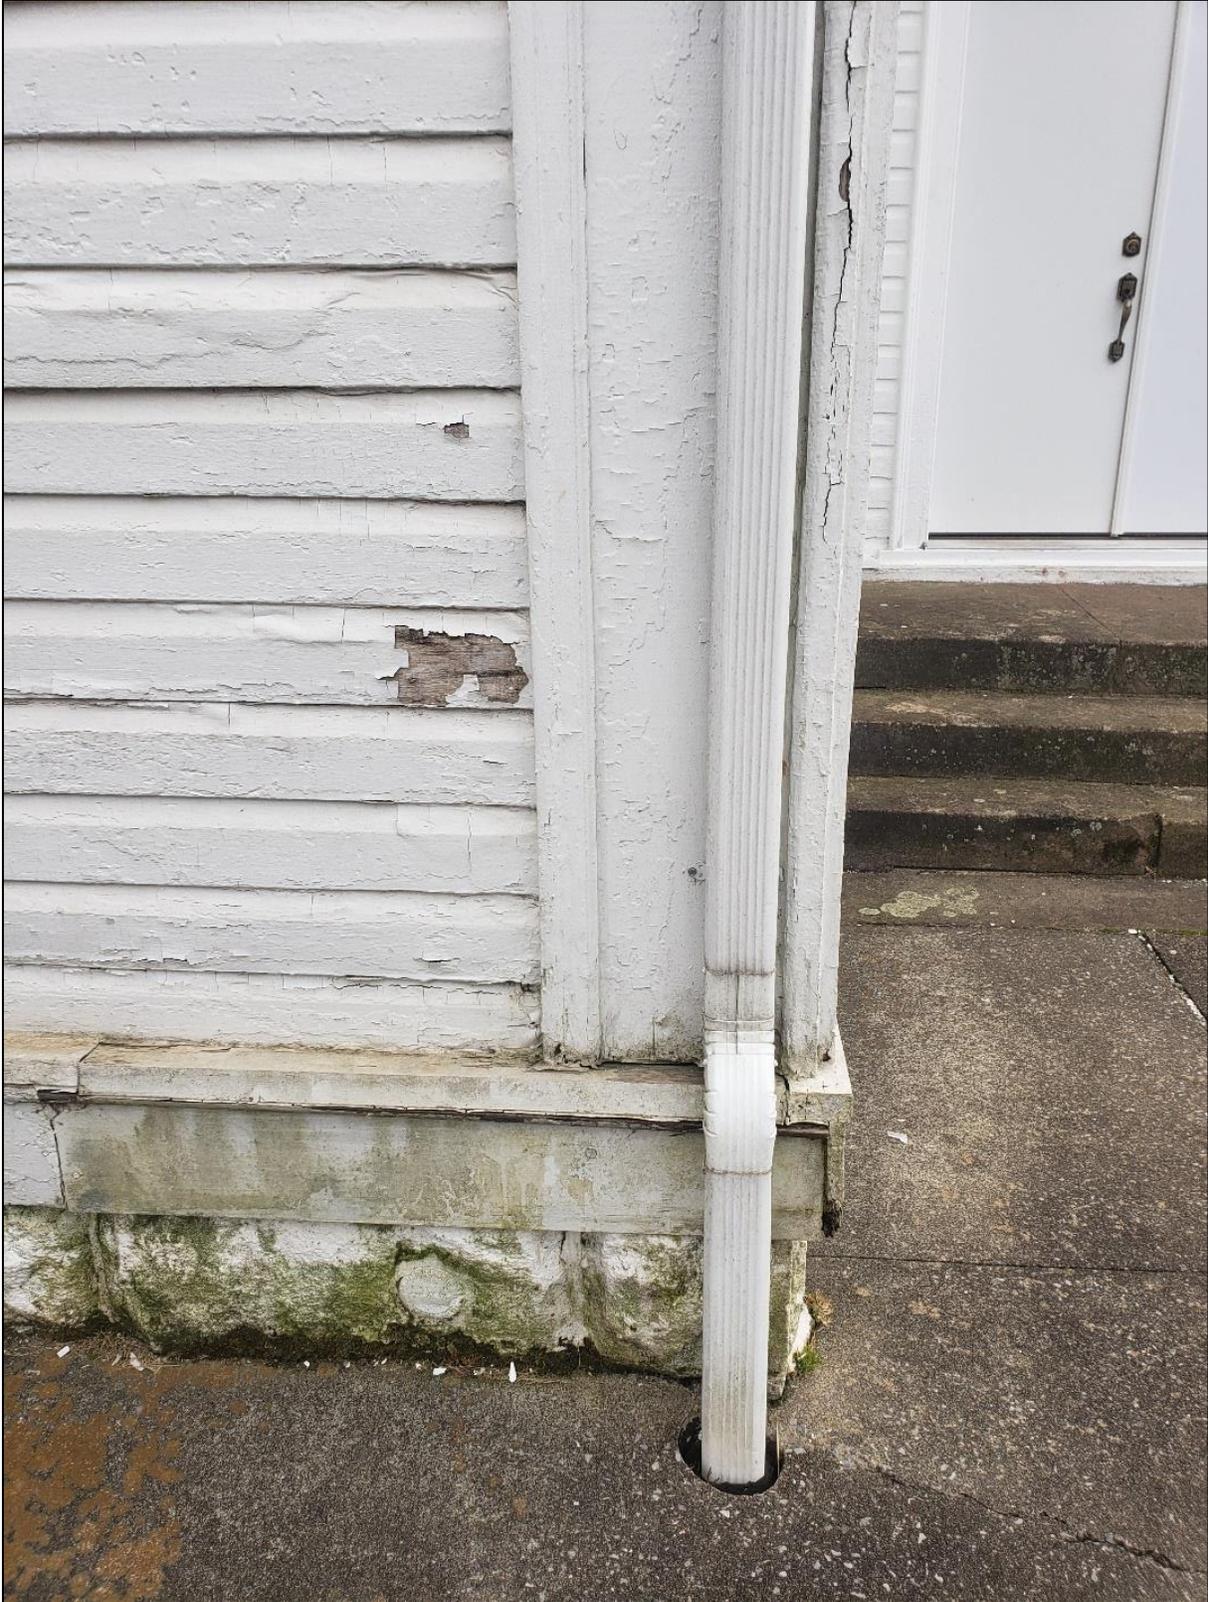
**Photo 3.4.2-2. Paint peeling along northwestern corner of building where siding meets cornerboard. View South.**

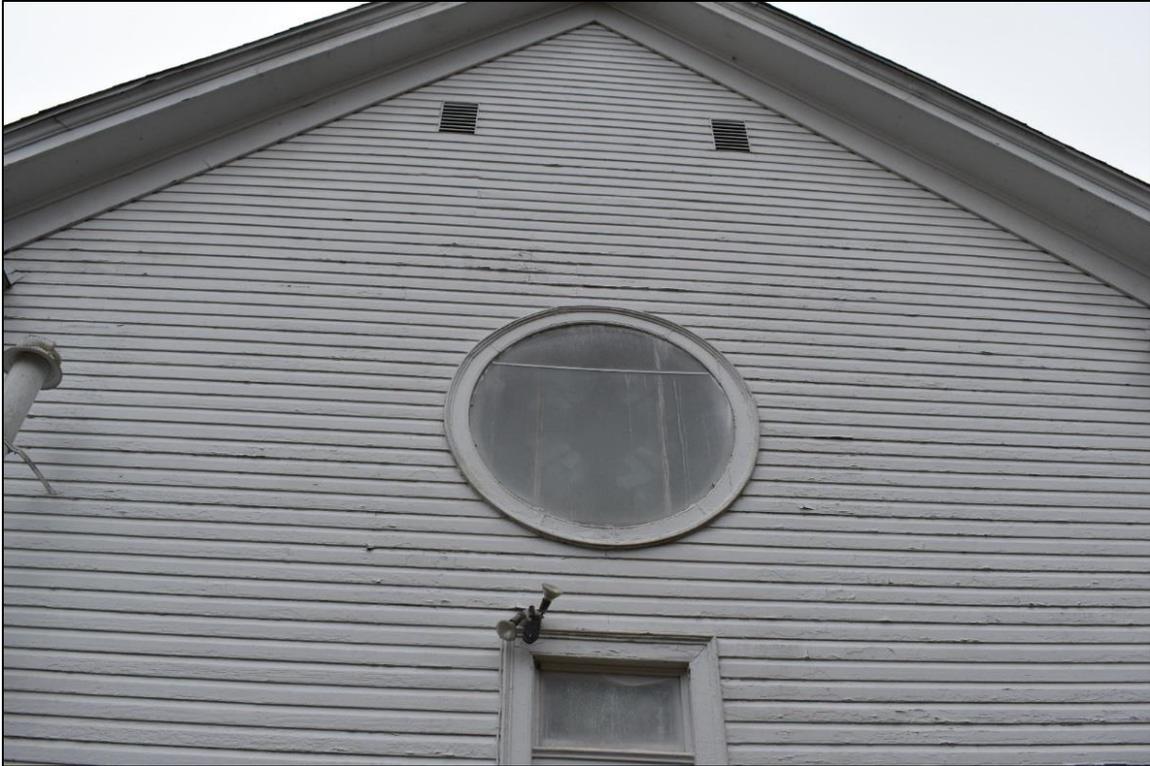
**Photo 3.4.2-3. Paint peeling on east (rear) elevation. View West.**

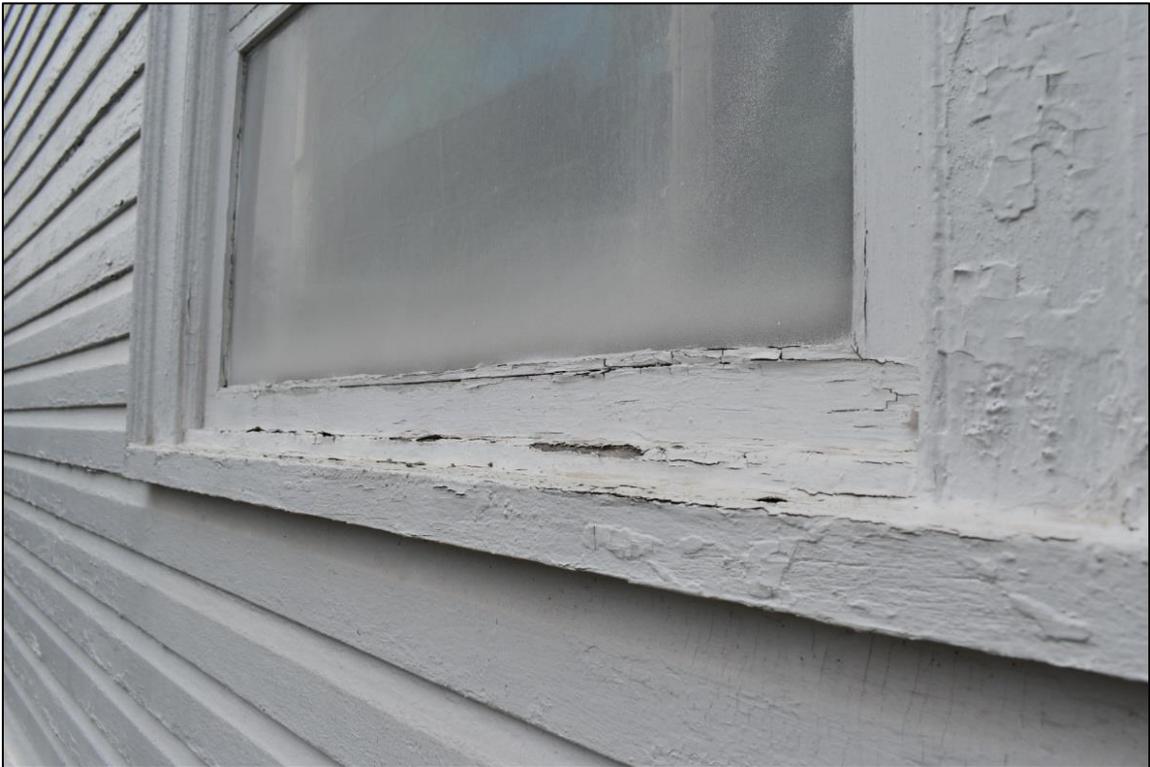
**Photo 3.4.2-4. Paint peeling on wood frame for acrylic window protection on south elevation. View Northwest.**

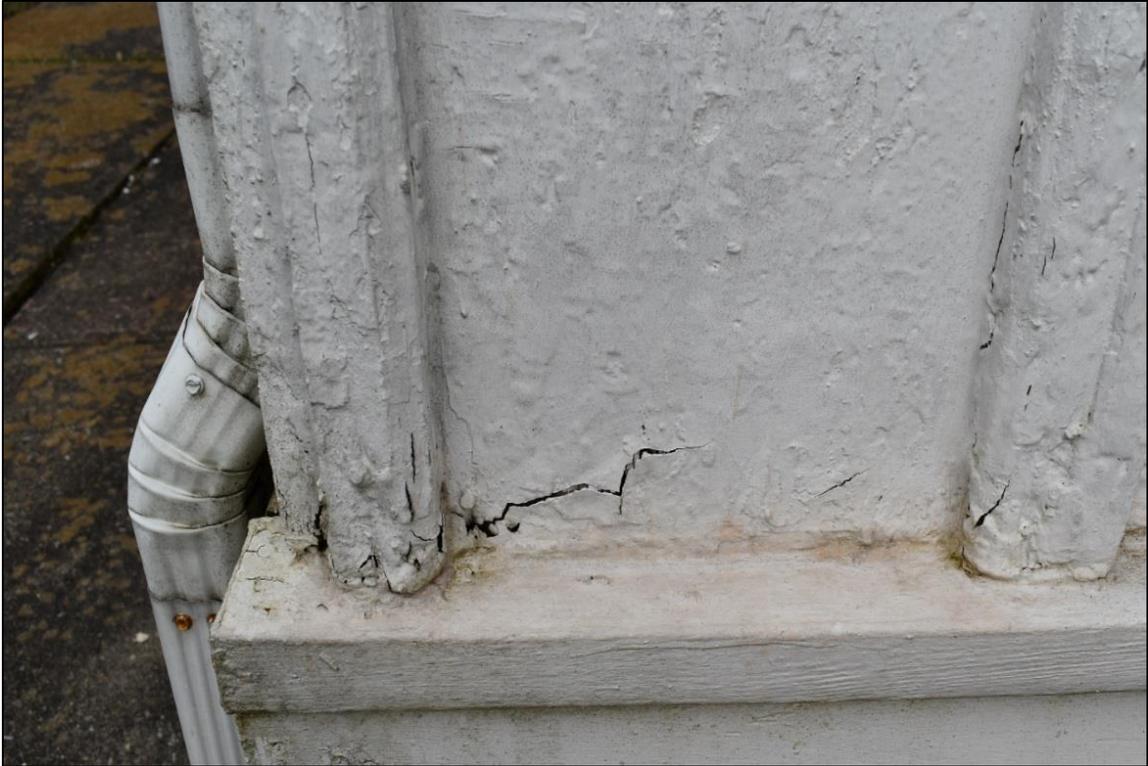
**Photo 3.4.2-5. Paint peeling on corner board at northwest corner. View East.**

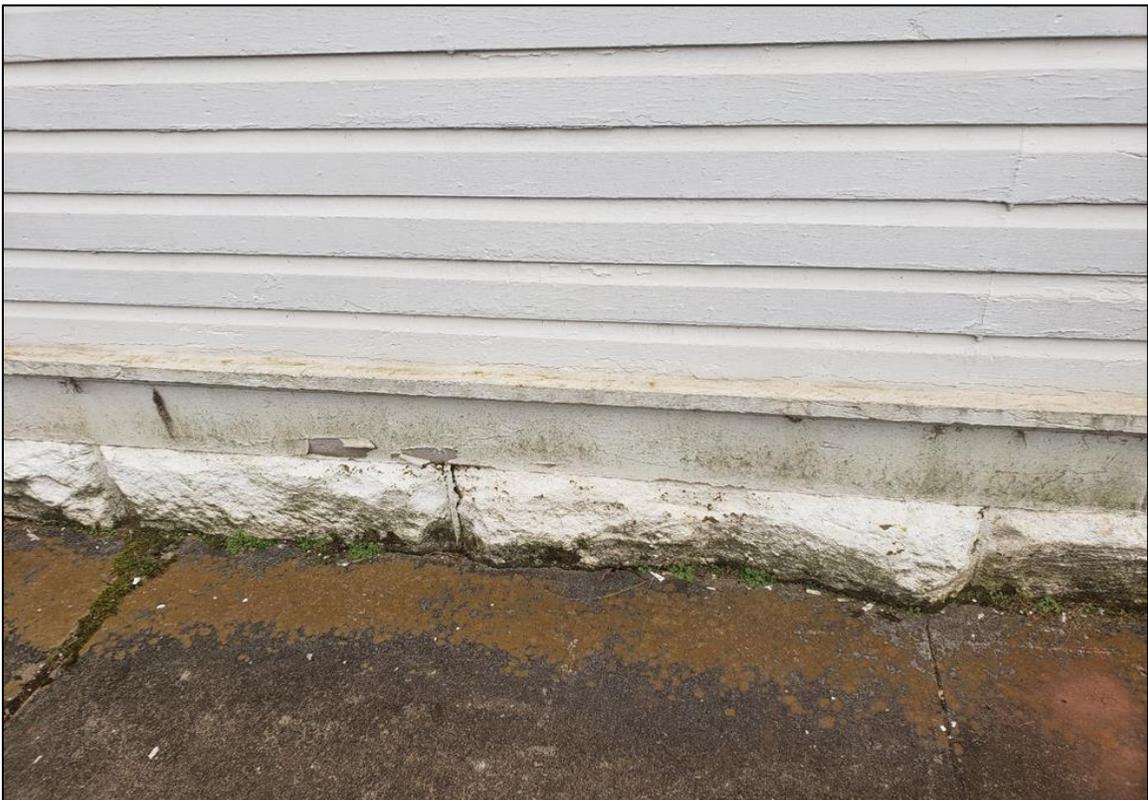
**Photo 3.4.2-6. Paint peeling on rim board on north elevation. View South.**

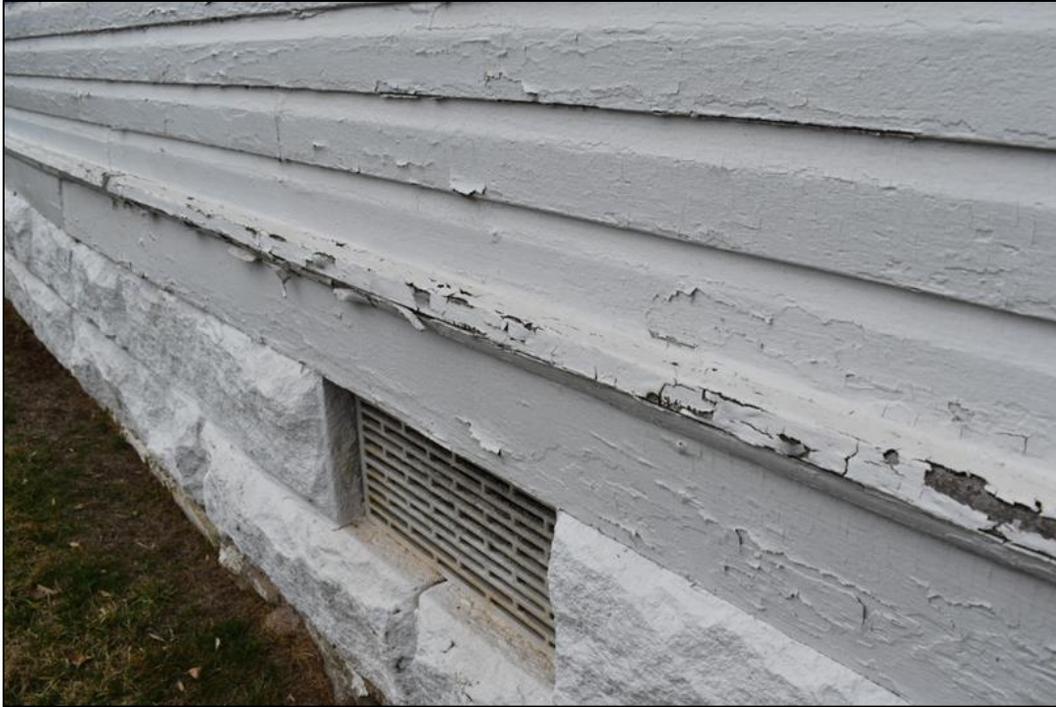
**Photo 3.4.2-7.** Paint peeling on decorative/water-shedding counterpart to rim board on south elevation. View Northwest.

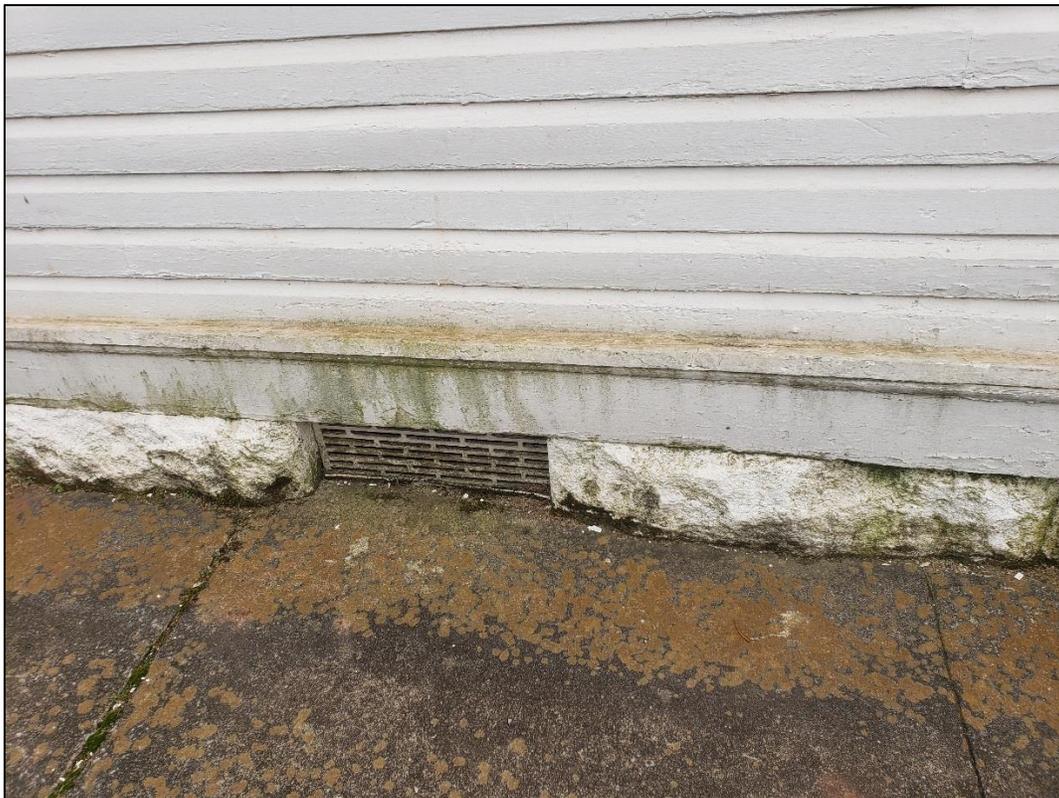
**Photo 3.4.2-8.** Dirt, mildew, and staining on decorative/water-shedding counterpart to rim board on north elevation. View South.

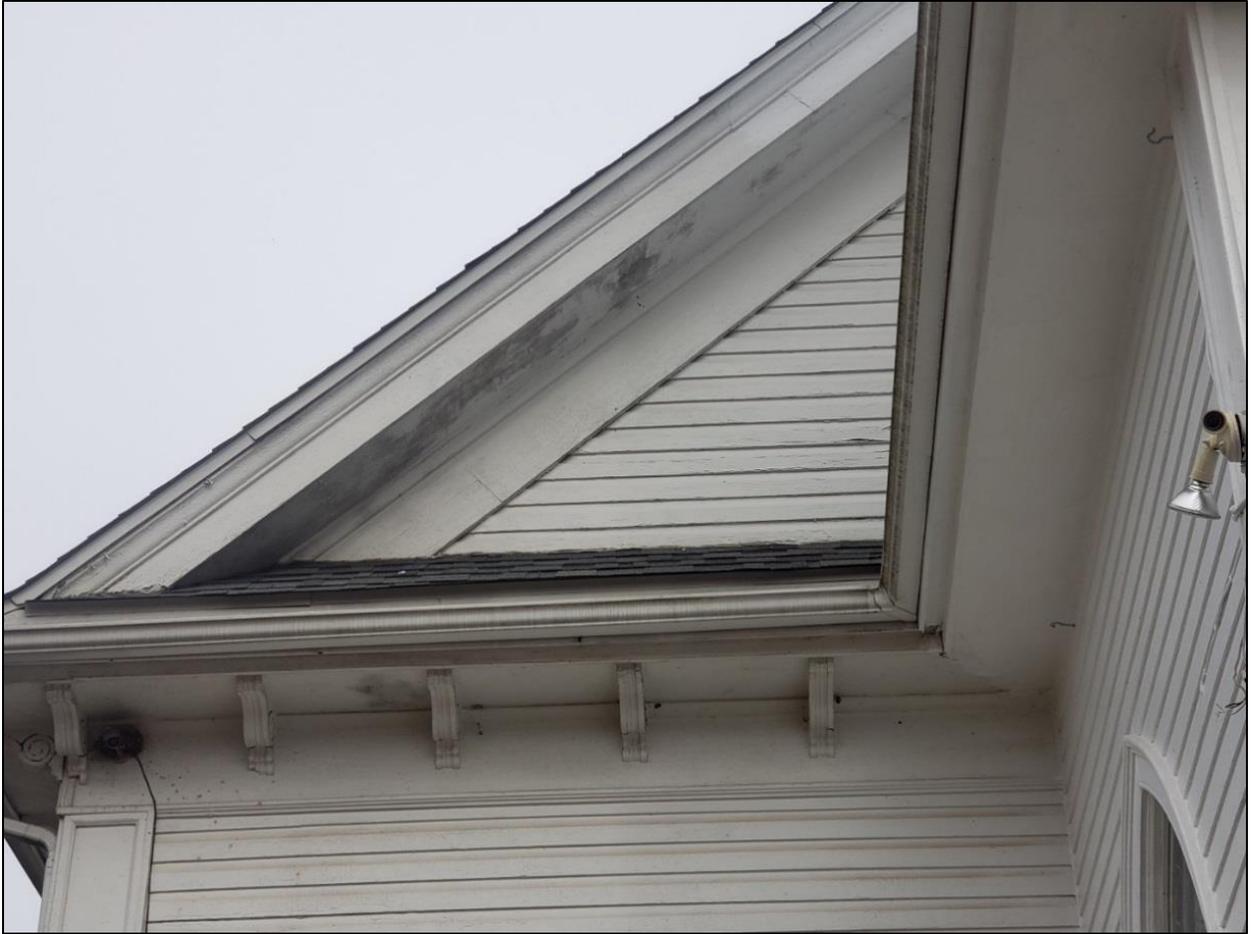
**Photo 3.4.2-9. Dirt and crazing on eaves on west elevation. View East.**
