**Subject: Mountain Valley Pipeline Project  
FINAL Historic Structure Report, St. Bernard's Church and Cemetery (NR #85001583)  
WVDCH File #15-67-MULTI  
FERC Docket #CP16-10**

St. Bernard's Church and Cemetery (NR #85001583)

Lewis County, West Virginia

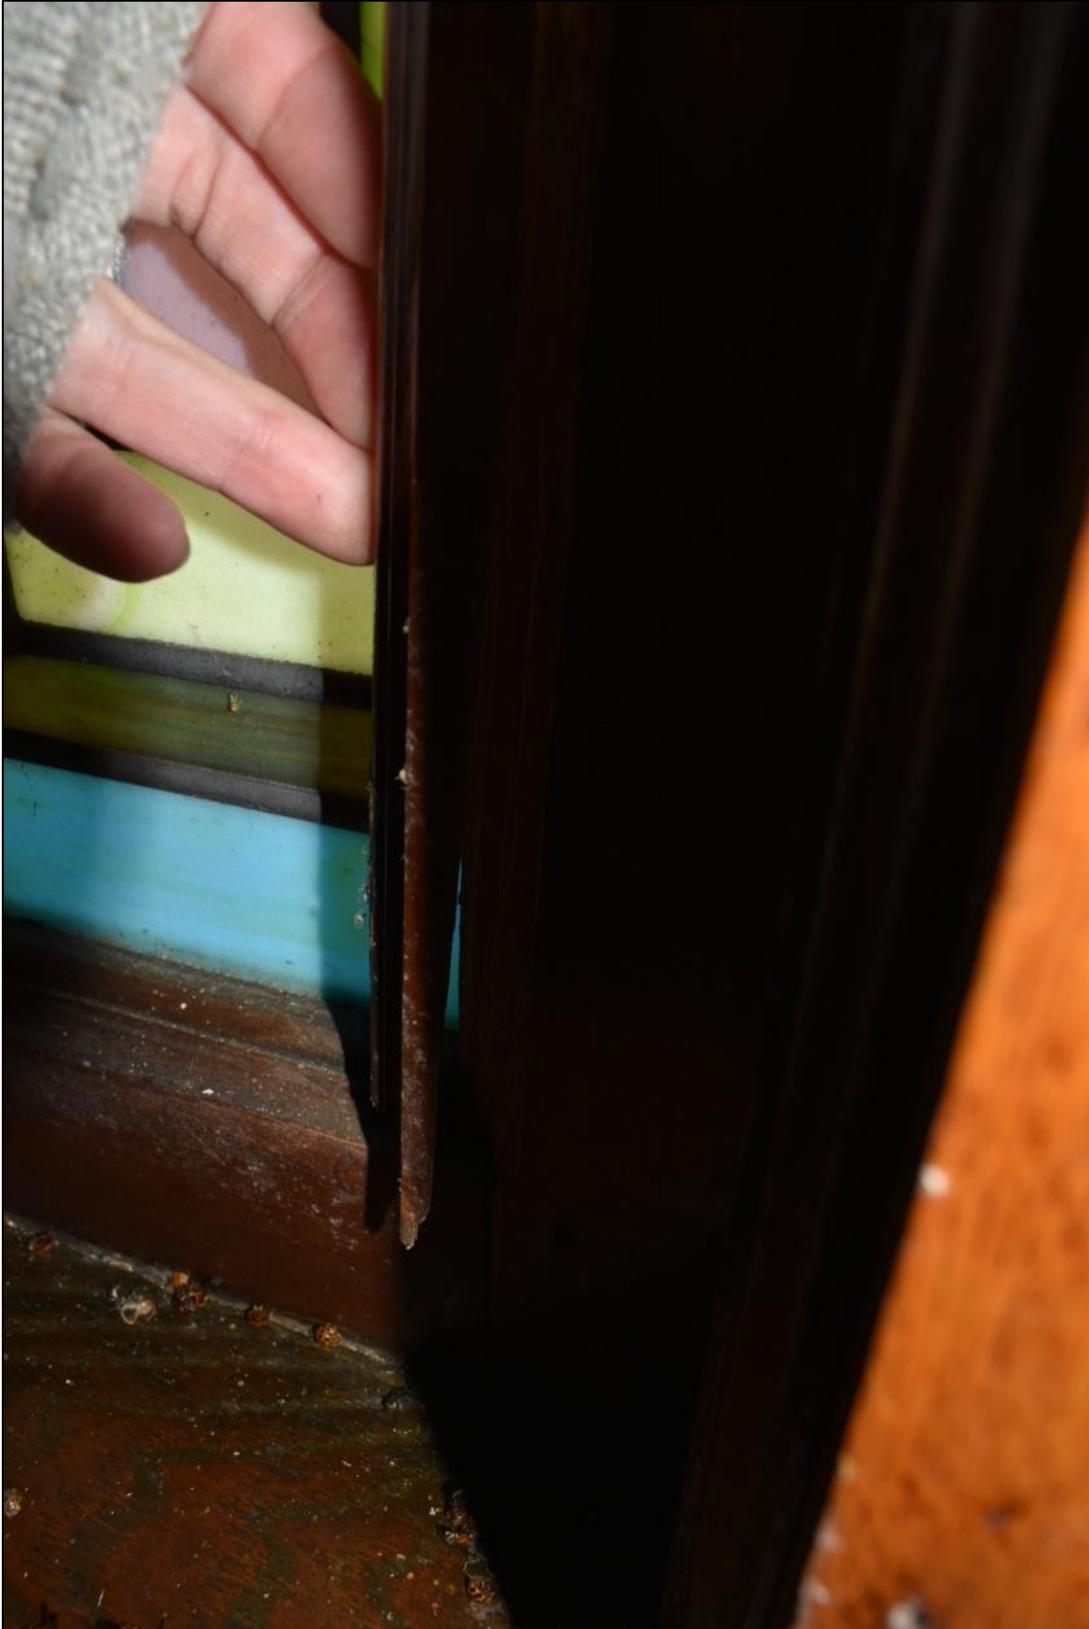
**Photo 3.4.2-10. Split in wood frame at lower right corner of window (W1).**

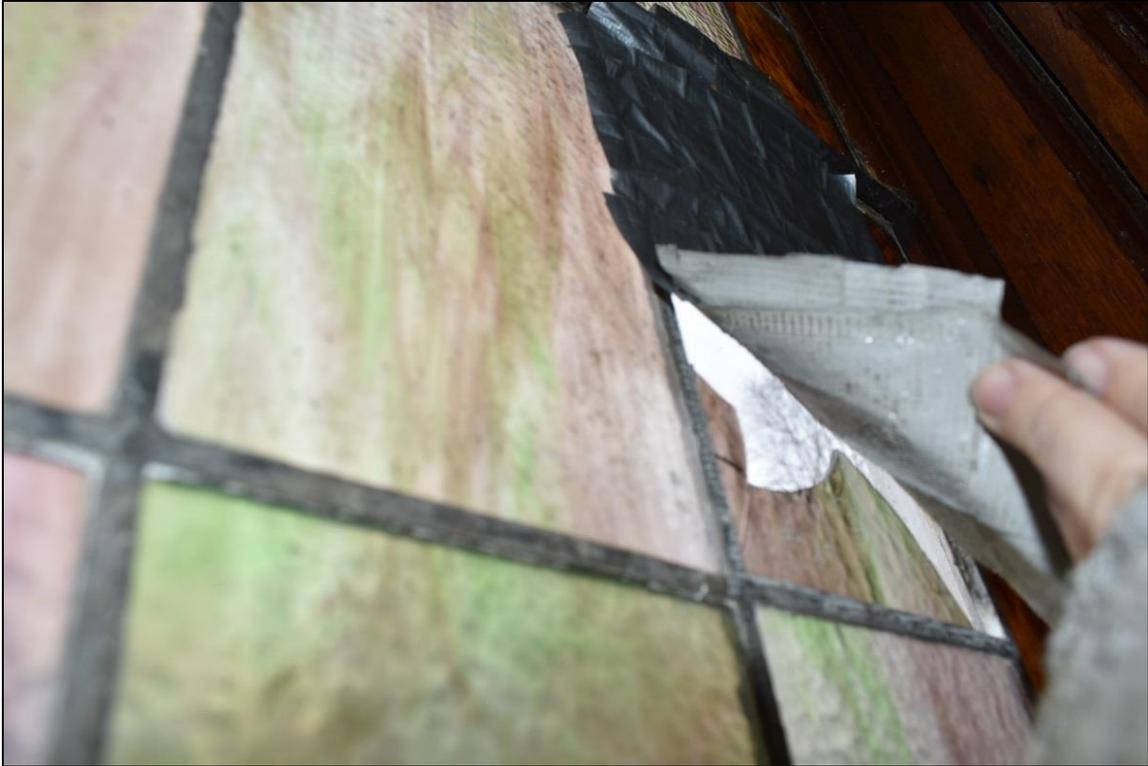
Photo 3.4.2-11. Broken and missing glass (Panel 2) in window (W1).

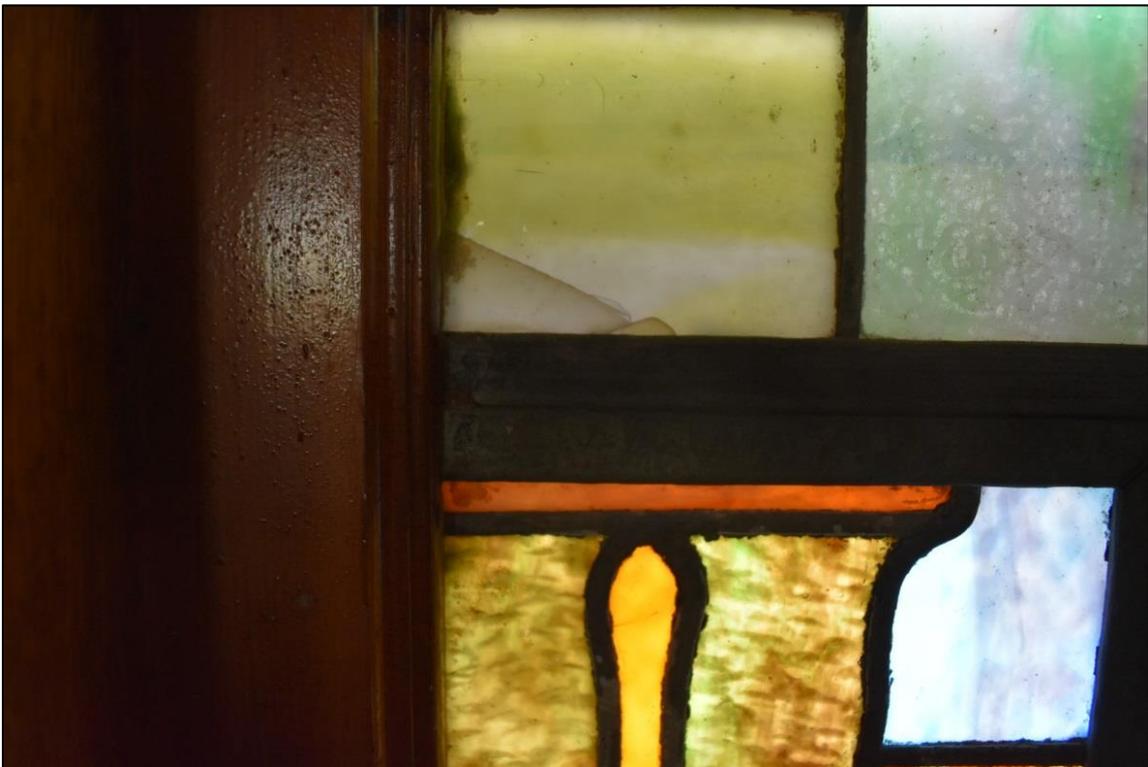
Photo 3.4.2-12. Crack above steel frame (Panel 2) in window (W2).

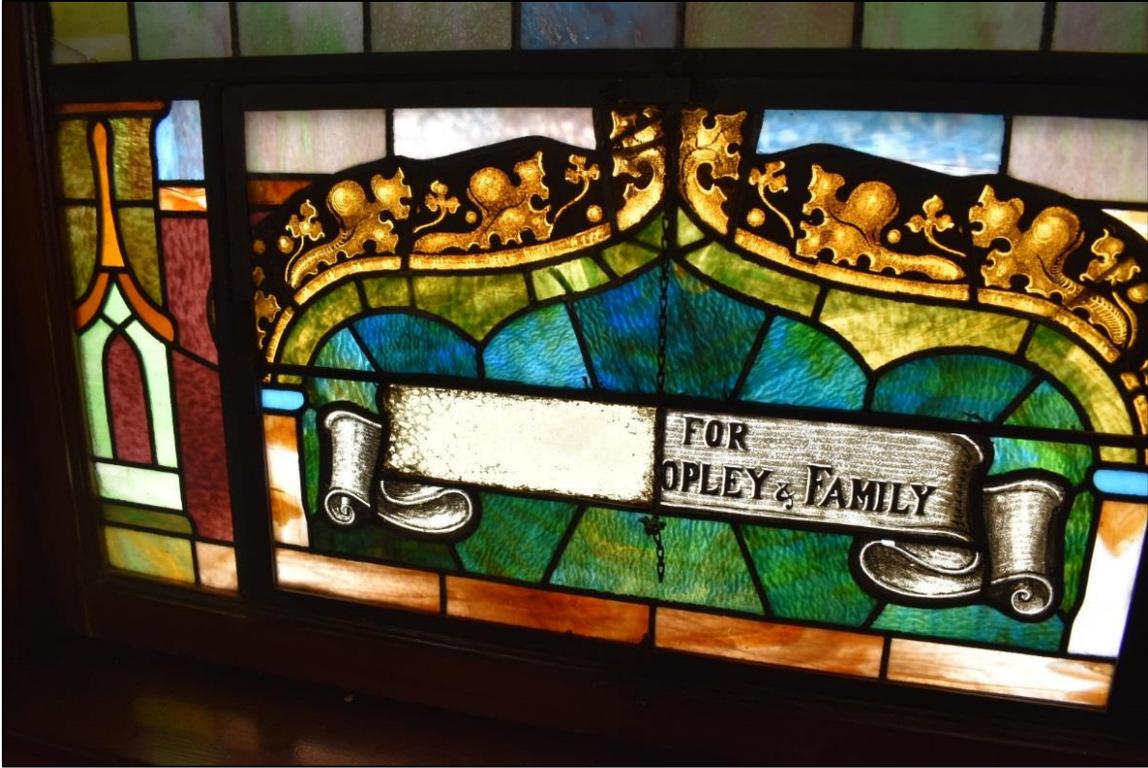
Photo 3.4.1-13. Stain missing in scroll design (Panel 1) in window (W2).

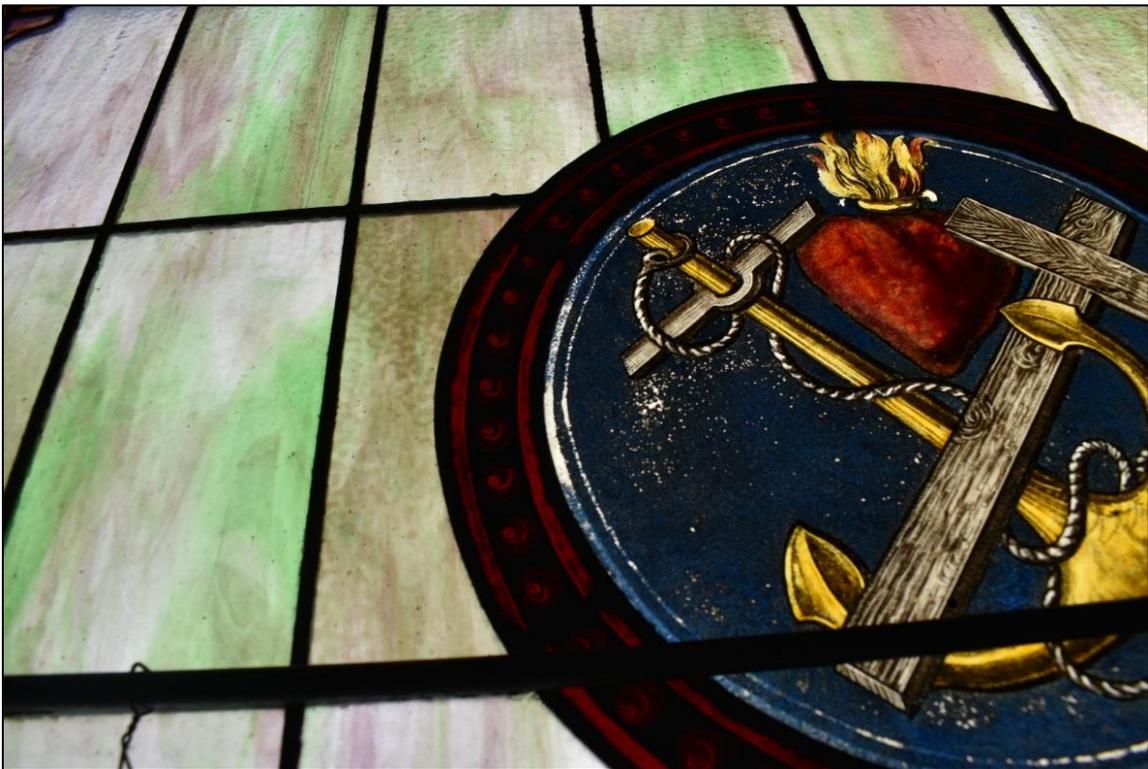
Photo 3.4.2-14. Stain missing in medallion (Panel 2) in window (W7).

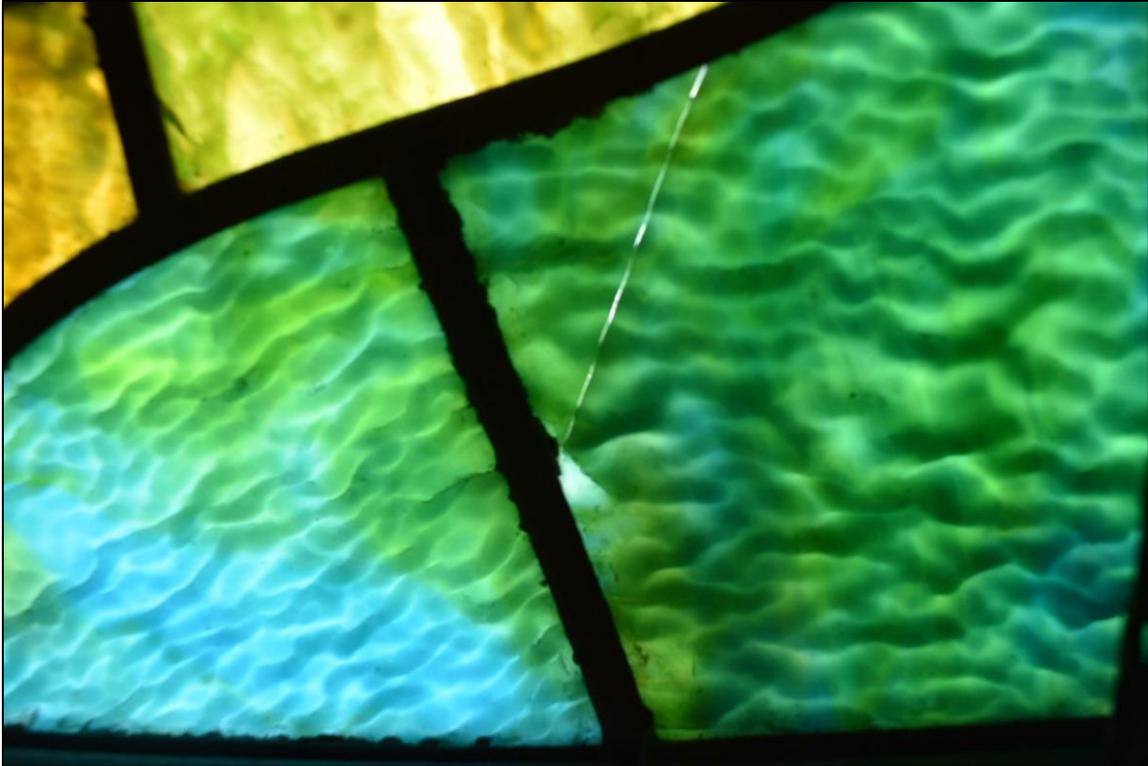
Photo 3.4.2-15. Slight crack (Panel 1) in window (W8).

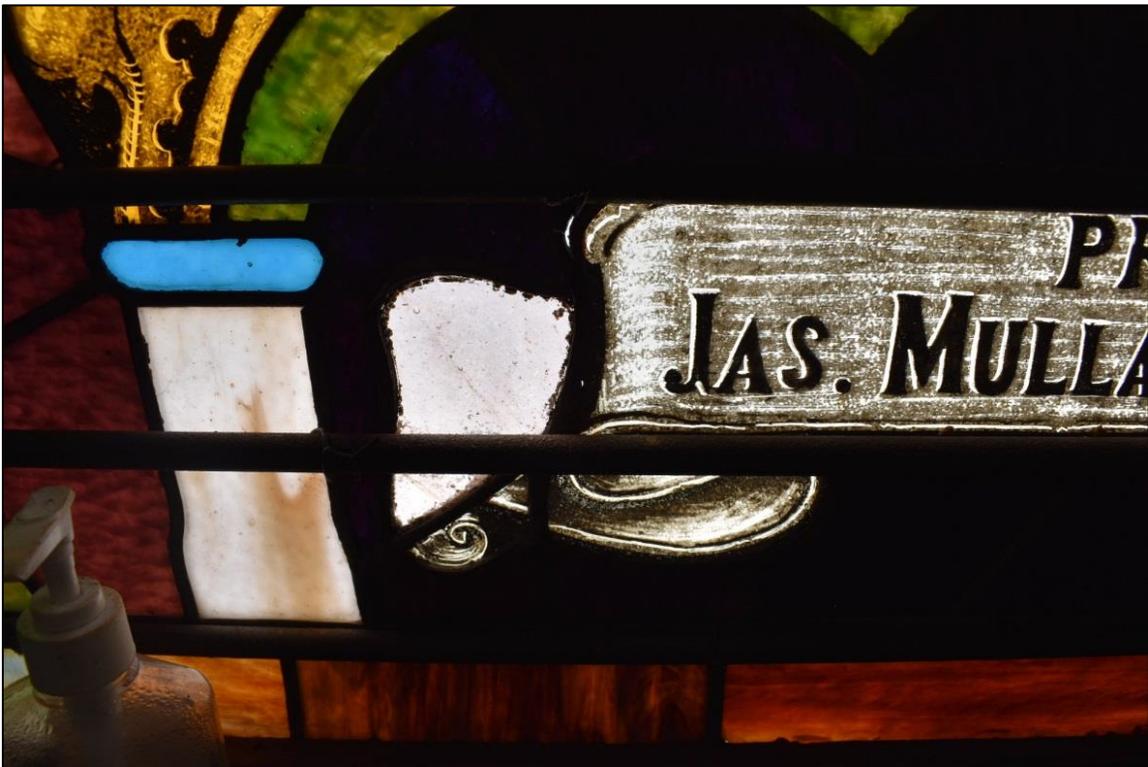
Photo 3.4.2-16. Stain missing in scroll design (Panel 1) in window (W11).

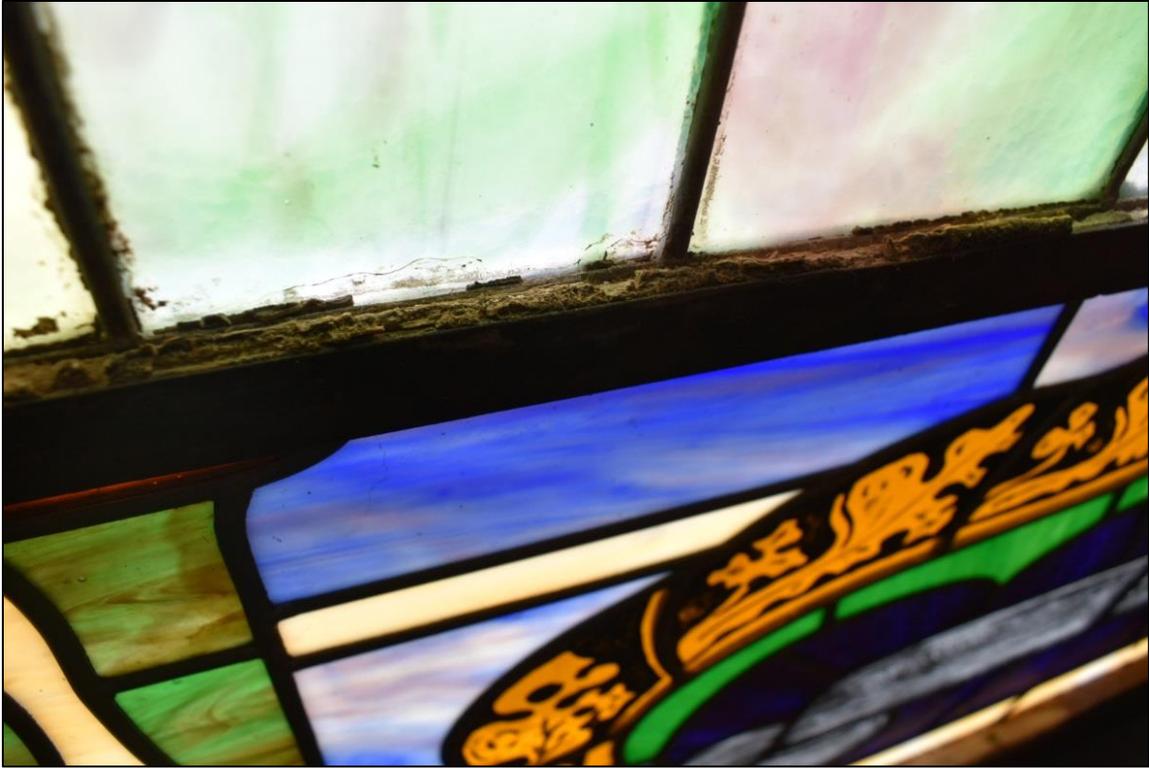
Photo 3.4.2-17. Deteriorated glazing compound (Panel 1) in window (W12).

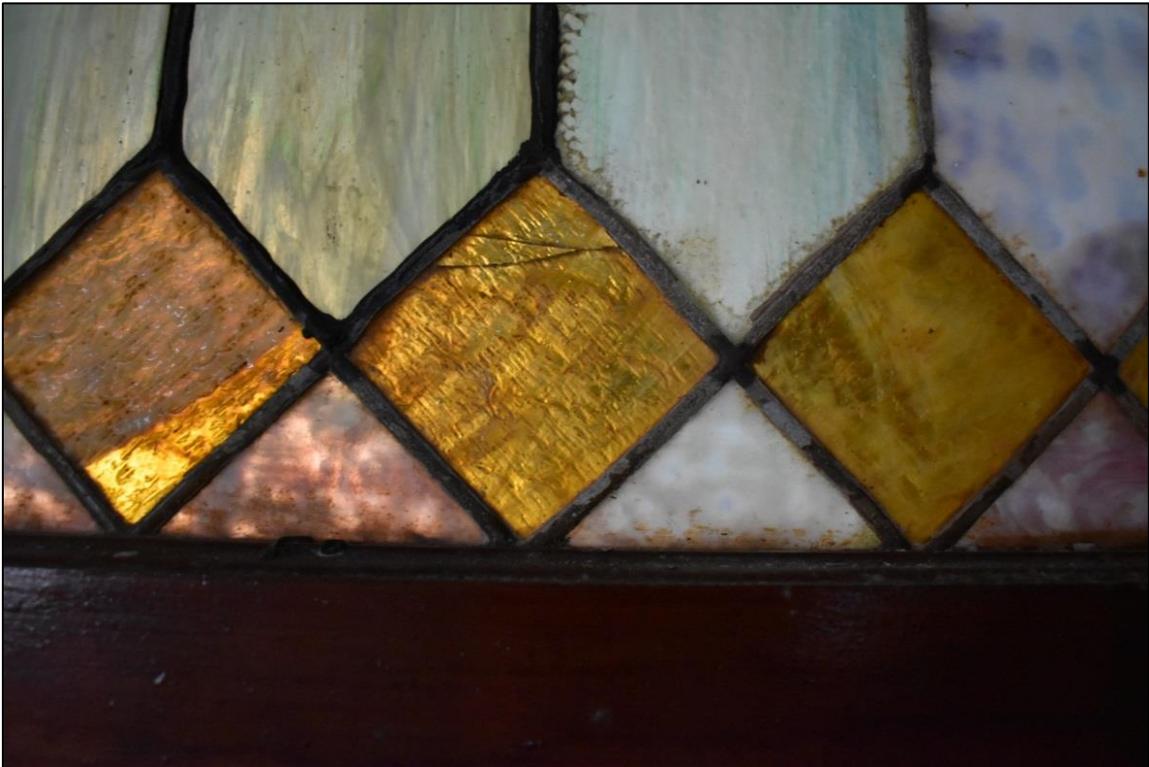
Photo 3.4.2-18. Slight crack (Panel 2) in window (TW2).

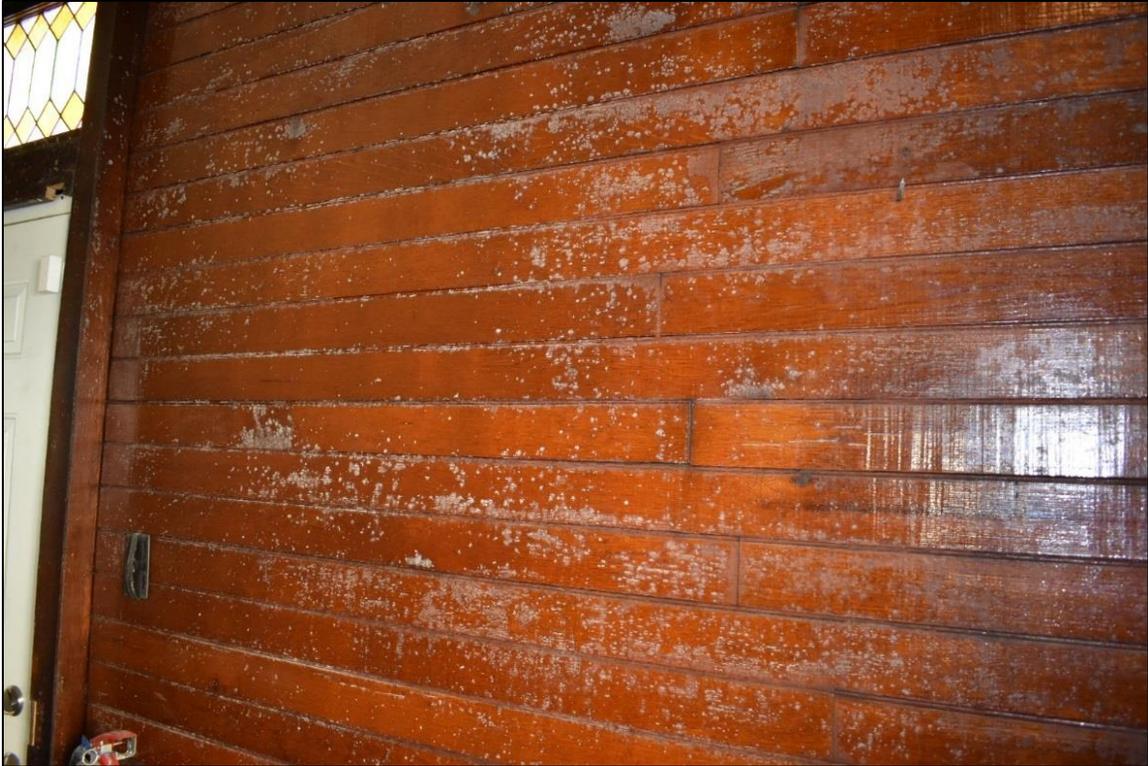
**Photo 3.4.3-1. Mold growth on east (rear) exterior wall. View East.**

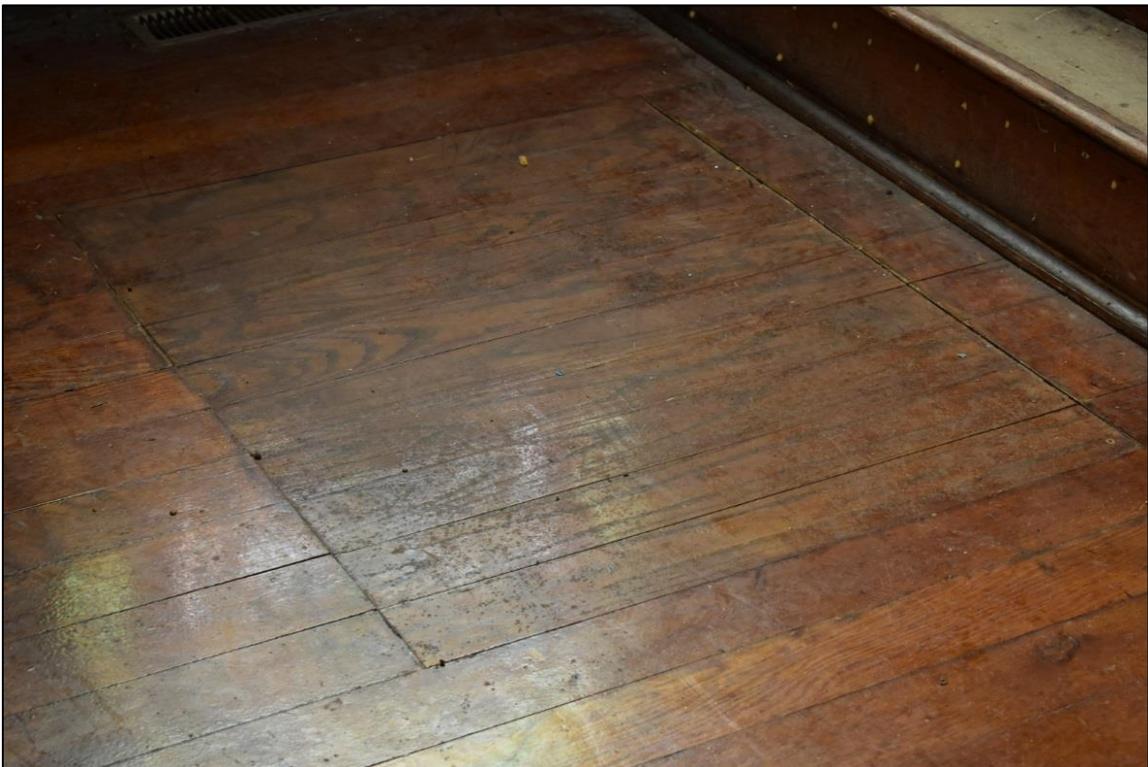
**Photo 3.4.3-2. Patch in oak tongue-and-groove flooring in front of Mary side altar. View Northeast.**

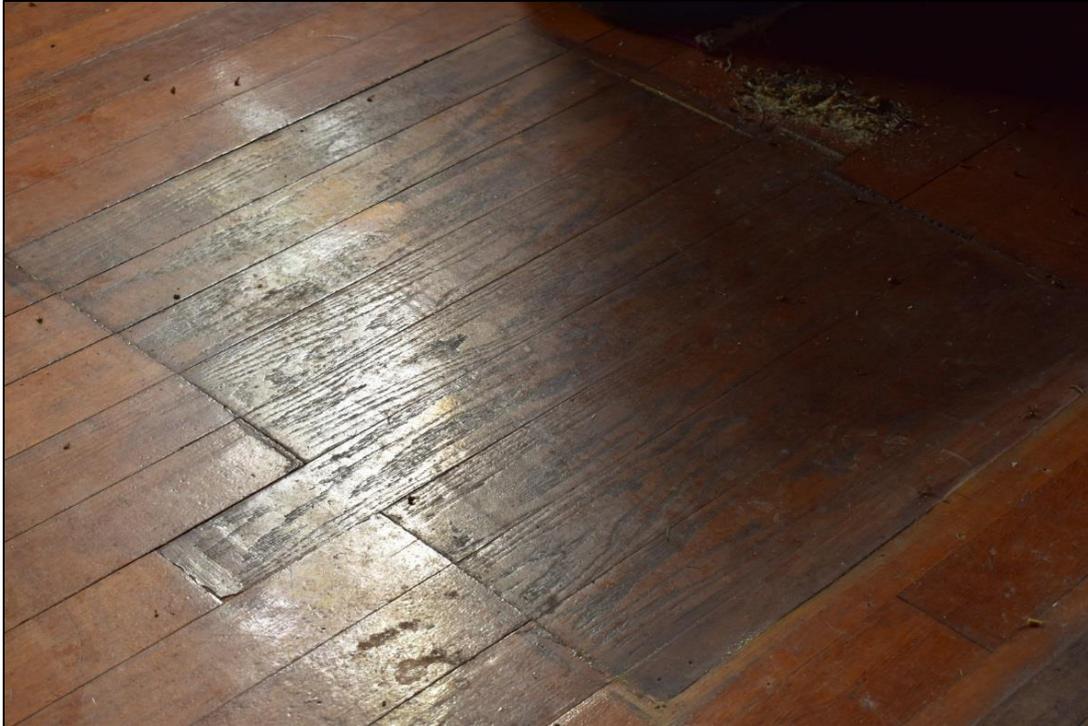
**Photo 3.4.3-3. Patch in oak tongue-and-groove flooring to the right of the interior doors at the rear of the sanctuary. View Southwest.**

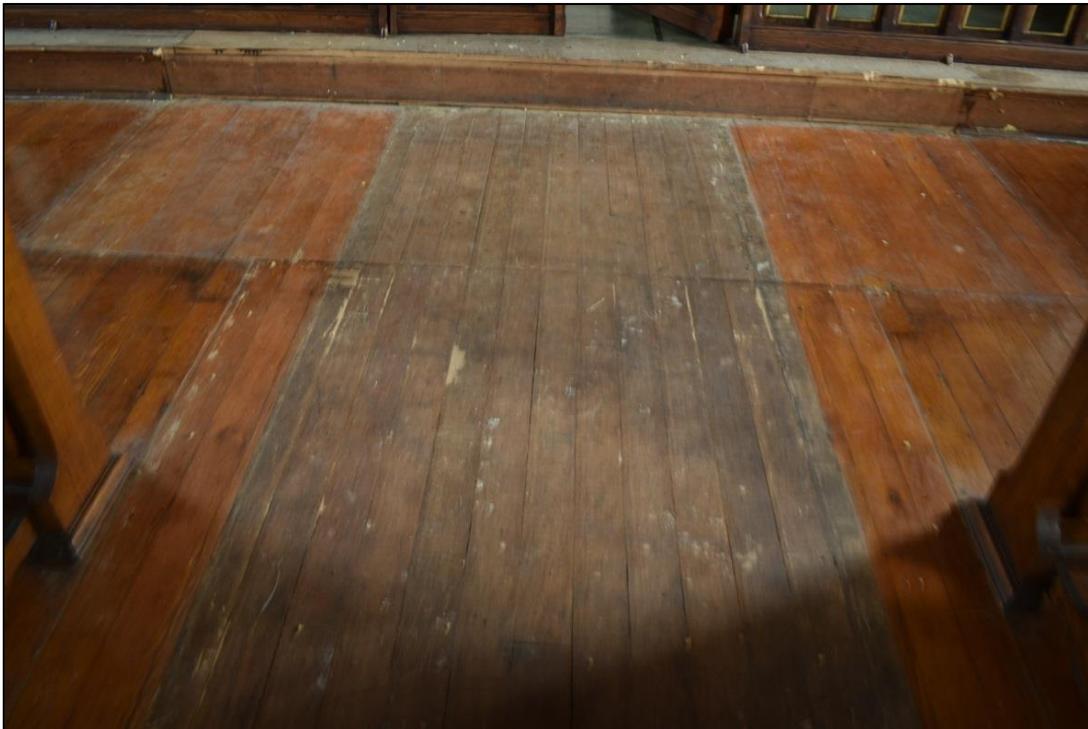
**Photo 3.4.3-4. Exposed unfinished oak flooring where original center aisle runner was installed and where kneeling bench at chancel rail was carpeted. The shape of the circa-1970 raised platform (removed 2018) remains. View East.**

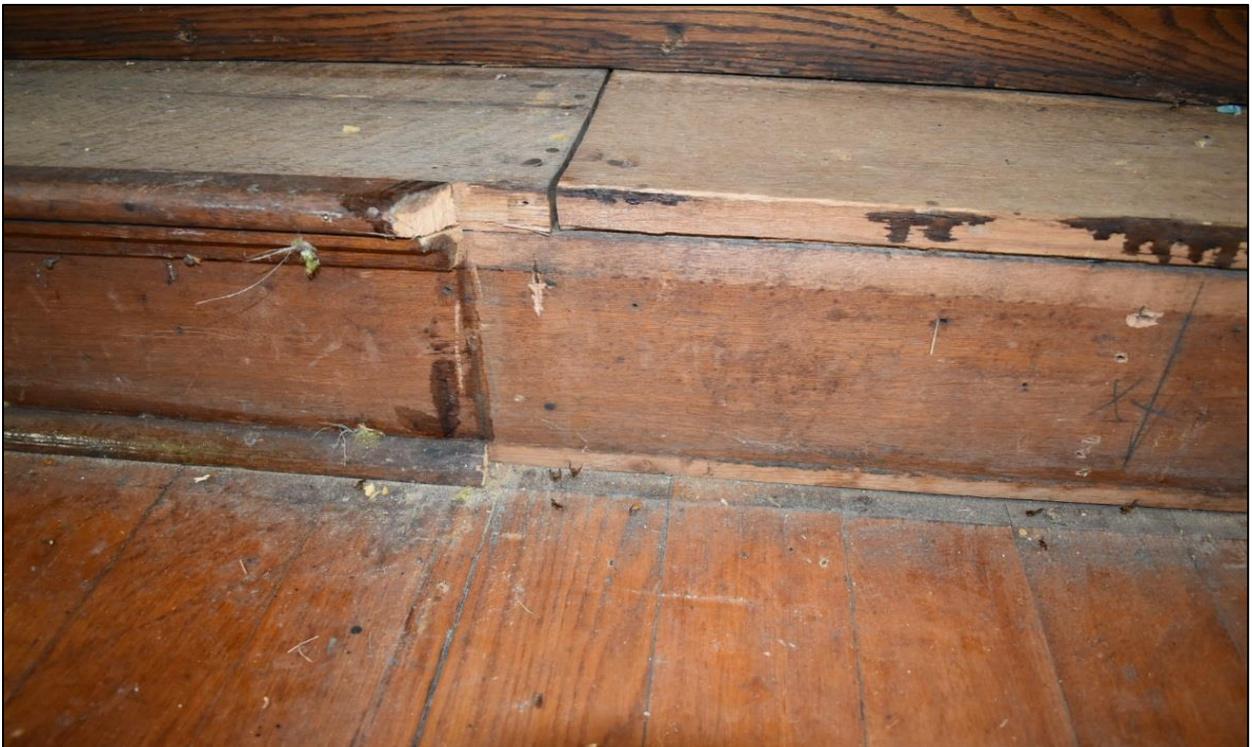
**Photo 3.4.3-6.** Exposed unfinished wood on kneeling bench and missing quarter-round trim where circa 1970 raised platform was removed in 2018. View East.
