**Appendix B - Site Plan  
Historic Structure Report**

**ST. BERNARD'S CHURCH AND CEMETERY**

LEWIS COUNTY, WEST VIRGINIA

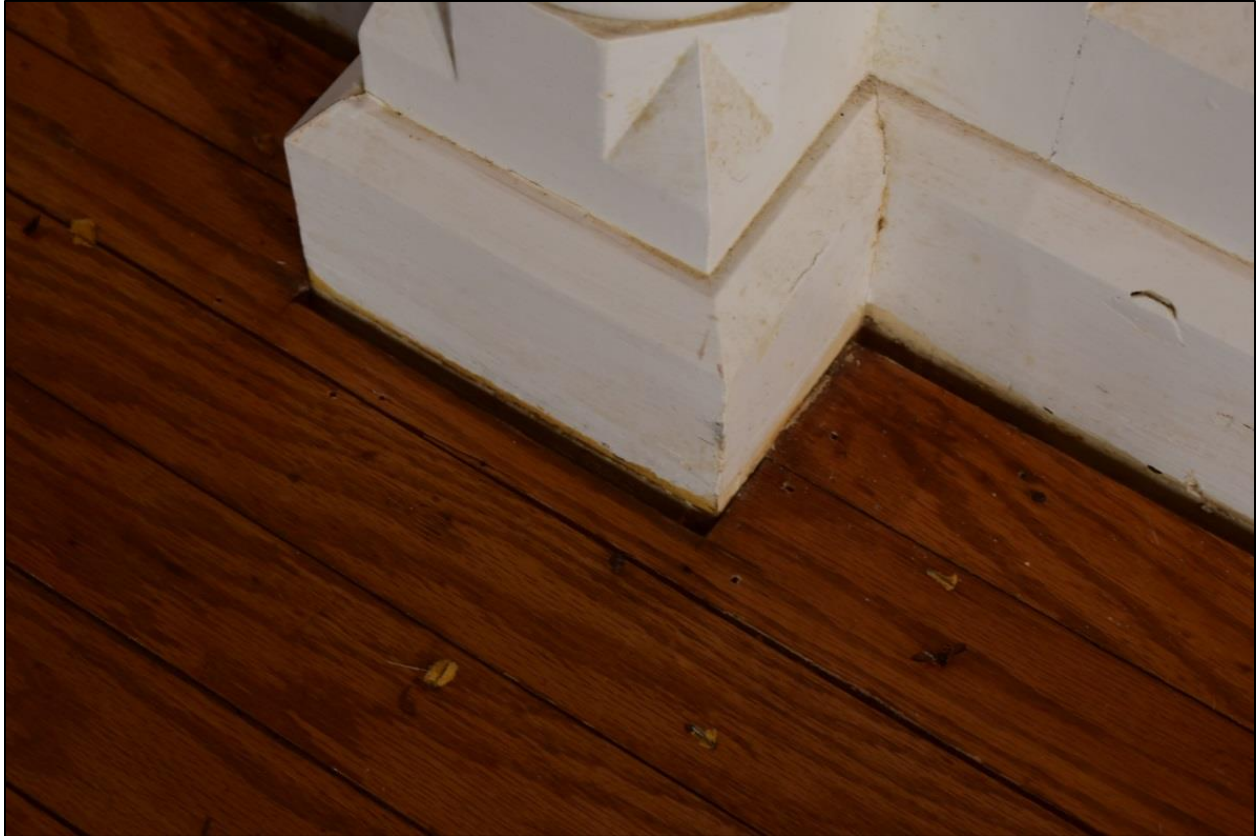
**Photo 3.4.3-7. Missing quarter-round trim at bottom of main altar where carpet was removed. View Northeast.**

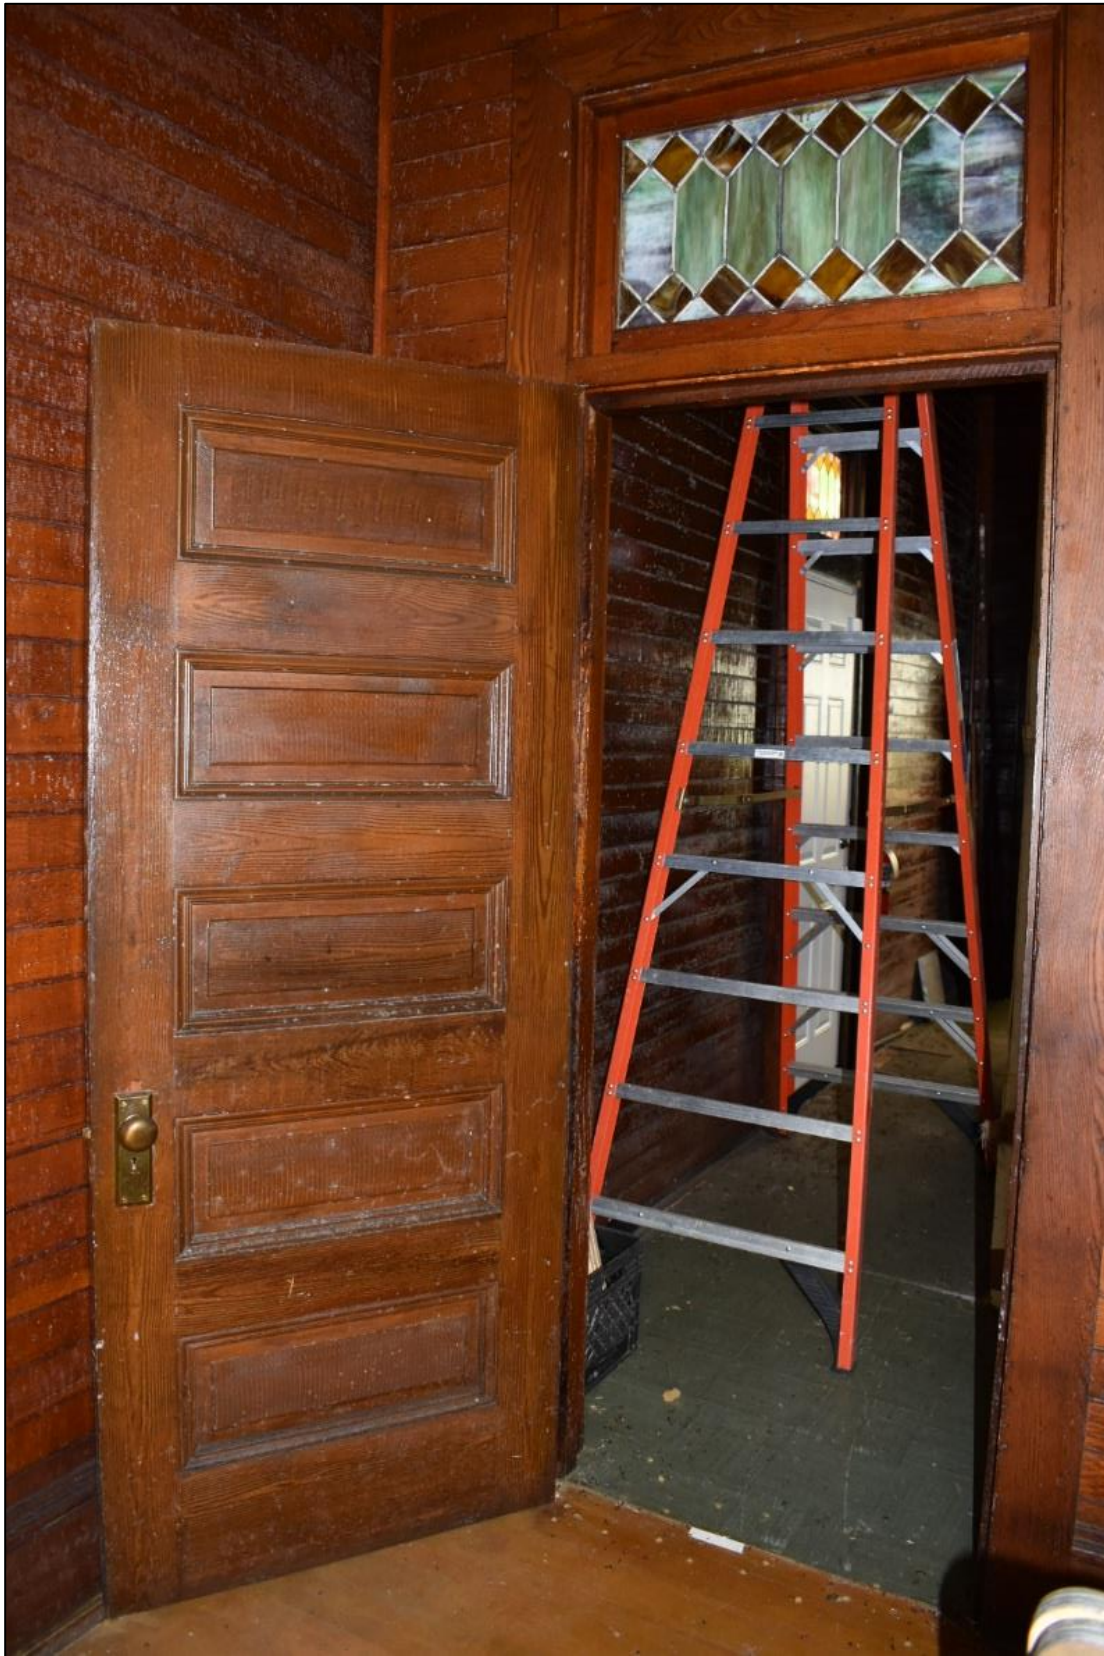
Photo 3.4.3-8. Door to sacristy with observable mold. View Southeast.

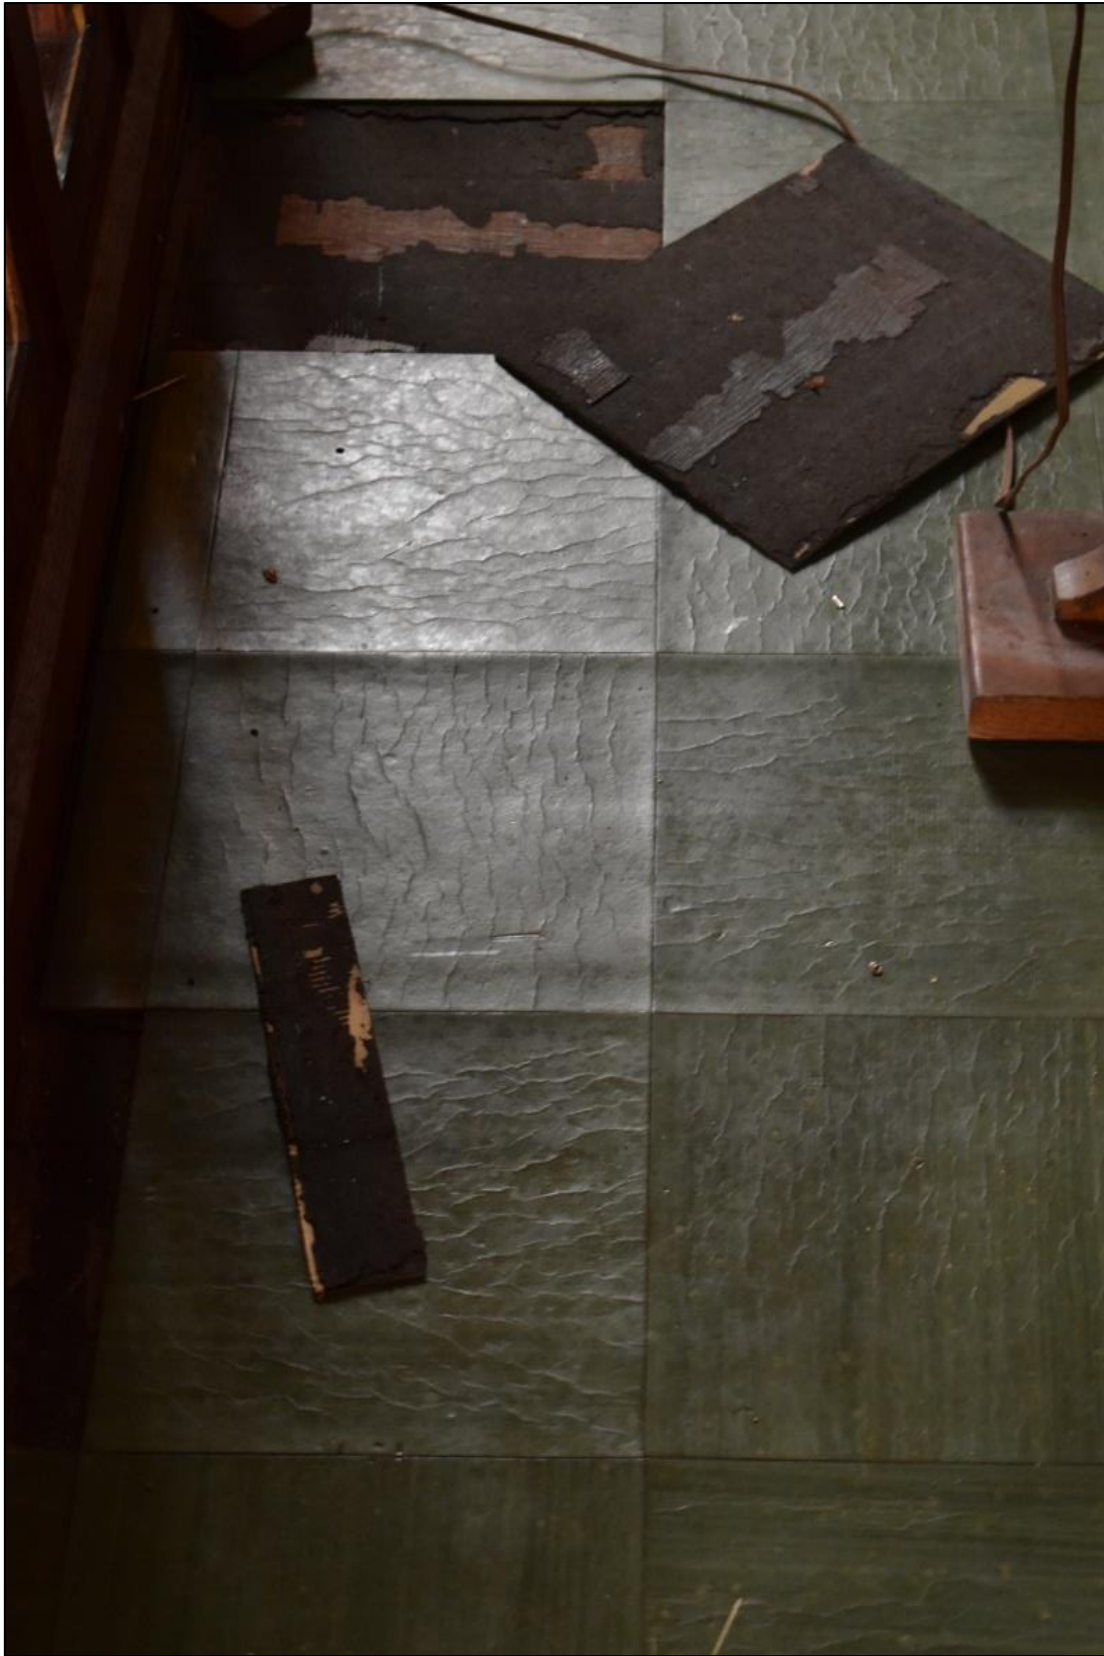
**Photo 3.4.3-9. Loose VAT on chancel floor. View North.**

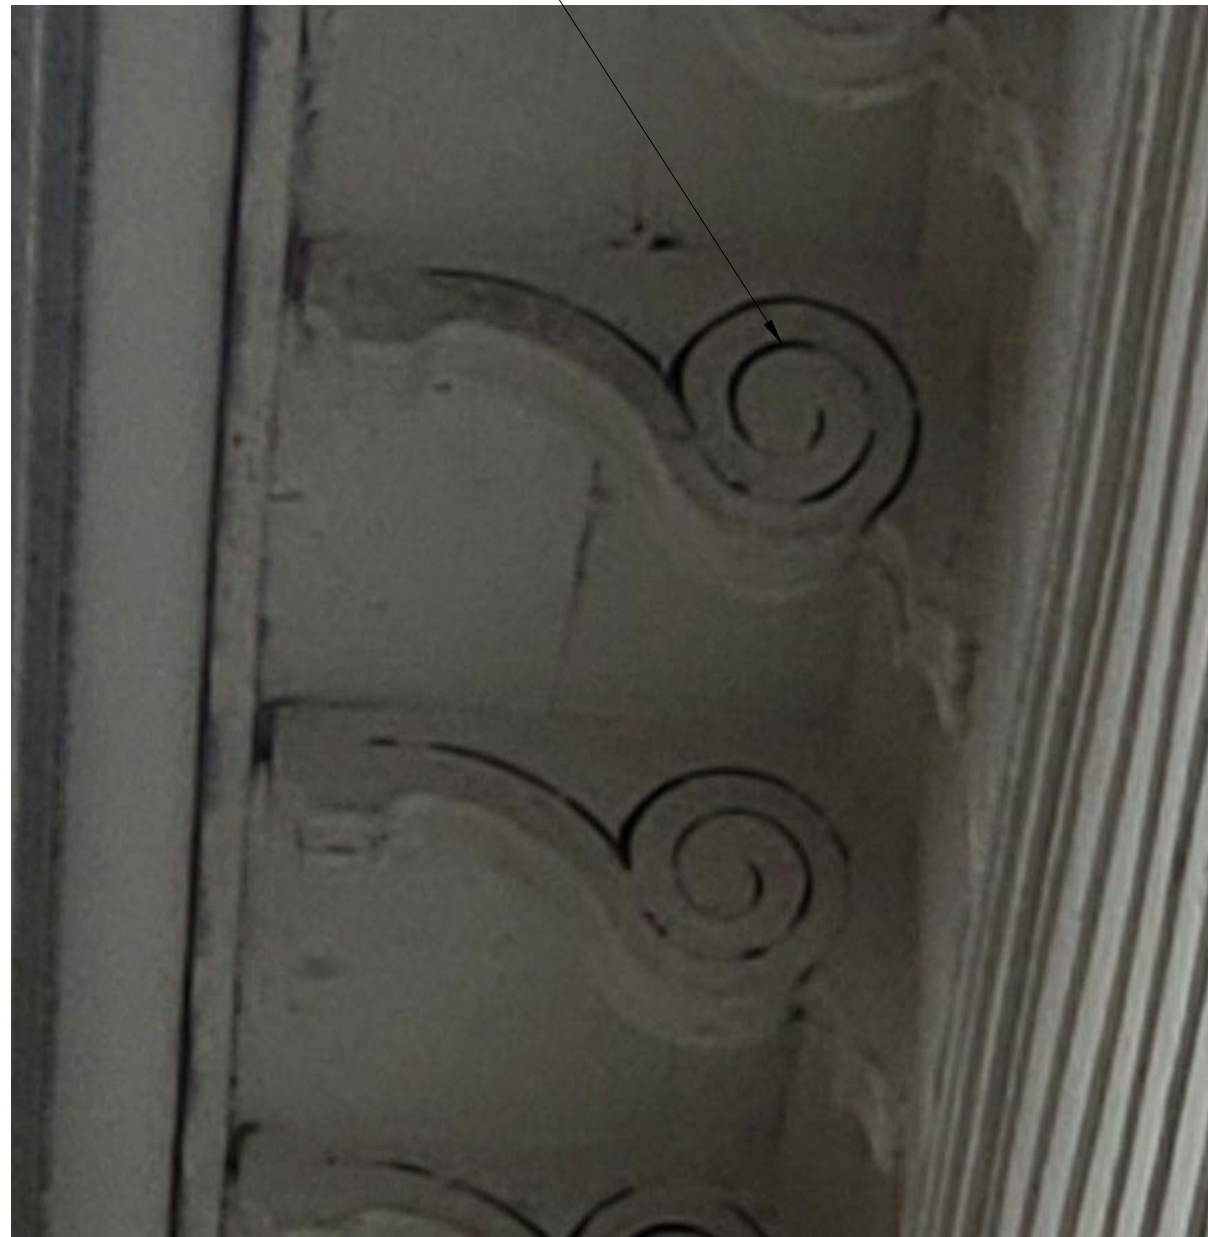
CLOSE-UP ORIGINAL BRACKET

INTRICATE SCROLLWORK

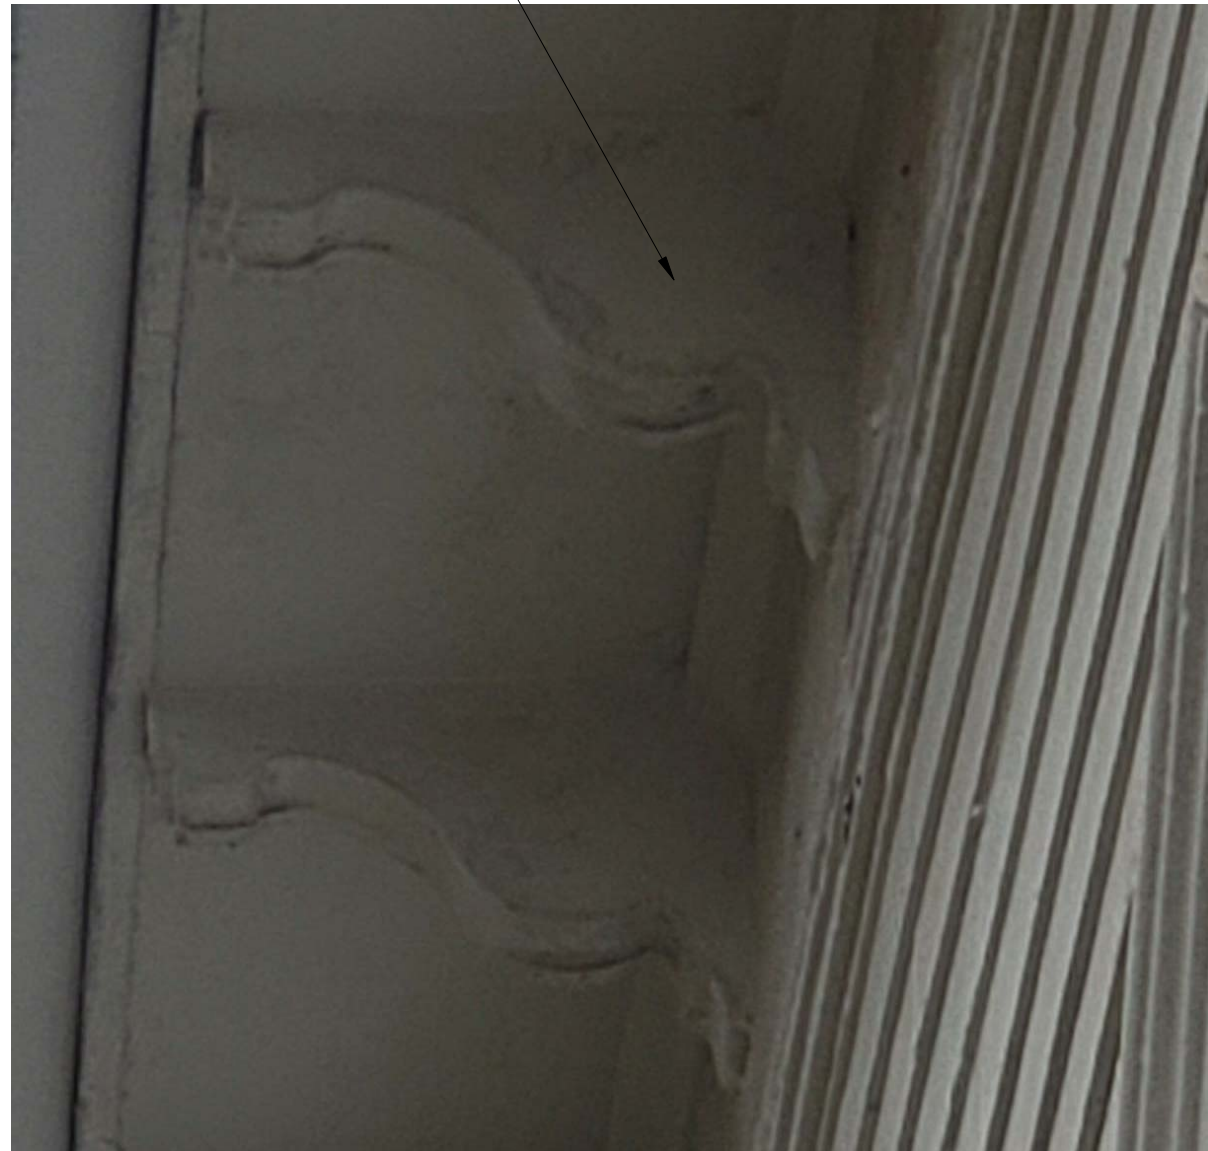
CLOSE-UP REPLACEMENT BRACKET

NO SCROLLWORK

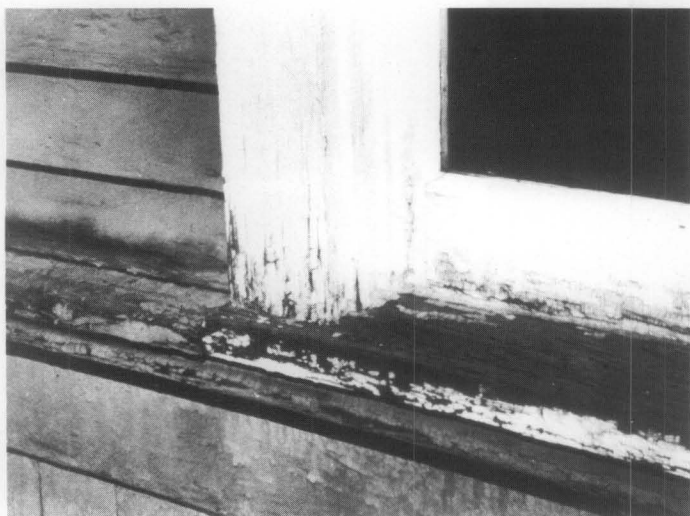
Figure 3. Deterioration of poorly maintained windows usually begins on horizontal surfaces and at joints where water can collect and saturate the wood. The problem areas are clearly indicated by paint failure due to moisture. Photo: Baird M. Smith, AIA

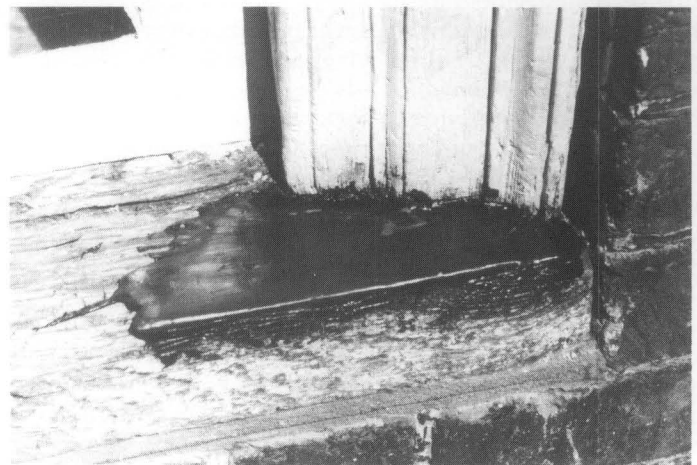
Figure 5. This illustrates a two-part epoxy patching compound used to fill the surface of a weathered sill and rebuild the missing edge. When the epoxy cures, it can be sanded smooth and painted to achieve a durable and waterproof repair. Photo: John H. Myers

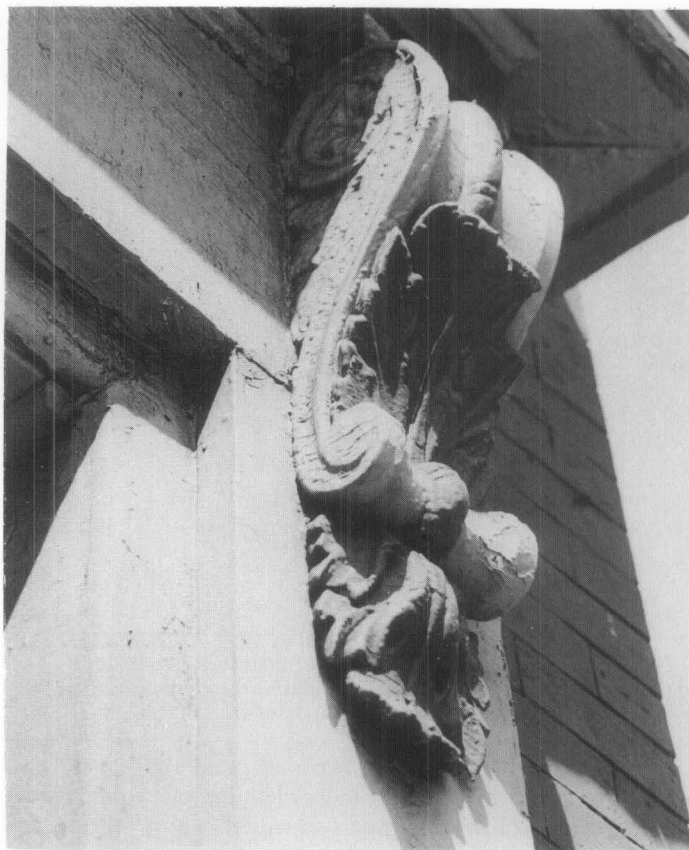
Fig. 1 Excessive paint build-up on architectural details such as this ornamental bracket does not in itself justify total paint removal. If paint is cracked and peeling down to bare wood, however, it should be removed using the gentlest means possible. Photo: David W. Look, AIA.

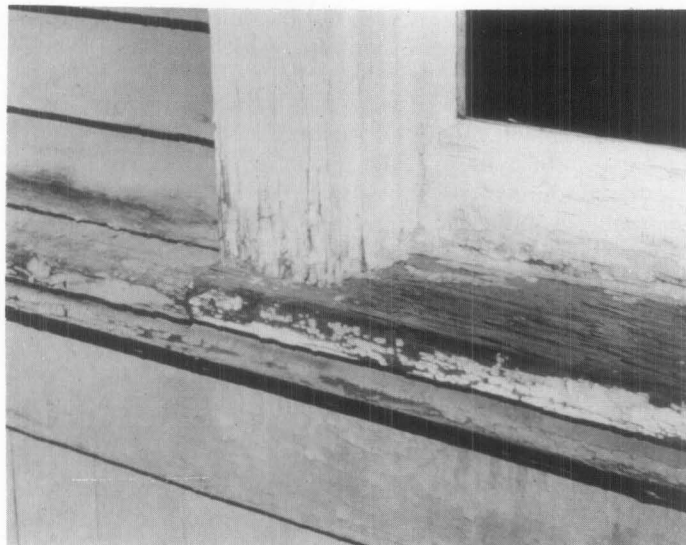
Fig. 4 Paint films wear unevenly depending on exposure and location. Exterior locations which are susceptible to accelerated deterioration are horizontal surfaces such as window sills. These and similar areas will require repainting more often than less vulnerable surfaces. In the case of this window sill where paint has peeled off and adjacent areas have cracked and alligatored, the paint should be totally removed. Prior to repainting, any weathered wood should be rejuvenated using a solution of 3 cups exterior varnish, 1 oz. paraffin wax, and mineral spirits/paint thinner/or turpentine to make 1 gallon. Liberal brush application should be made. This formula was tested over a 20-year period by the U.S. Department of Agriculture's Forest Products Laboratory and proved to be just as effective as water-repellent preservatives containing pentachlorophenol. After the surface has thoroughly dried (2-3 days of warm weather), the treated surface can be painted. A high quality oil-base primer followed by two top coats of a semi-gloss oil-enamel or latex-enamel paint is recommended. Photo: Baird M. Smith, AIA.

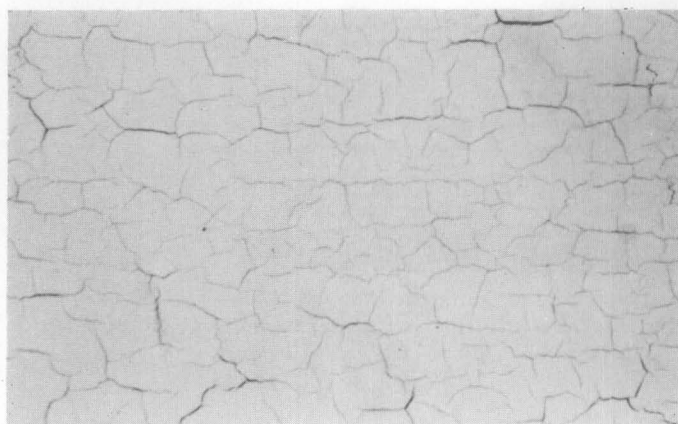
Fig. 5 Crazing—or surface cracking—is an exterior surface condition which can be successfully treated by sanding and painting. Photo: Courtesy, National Decorating Products Association.

Crazing can be treated by hand or mechanically sanding the surface, then repainting. Although the hairline cracks may tend to show through the new paint, the surface will be protected against exterior moisture penetration.

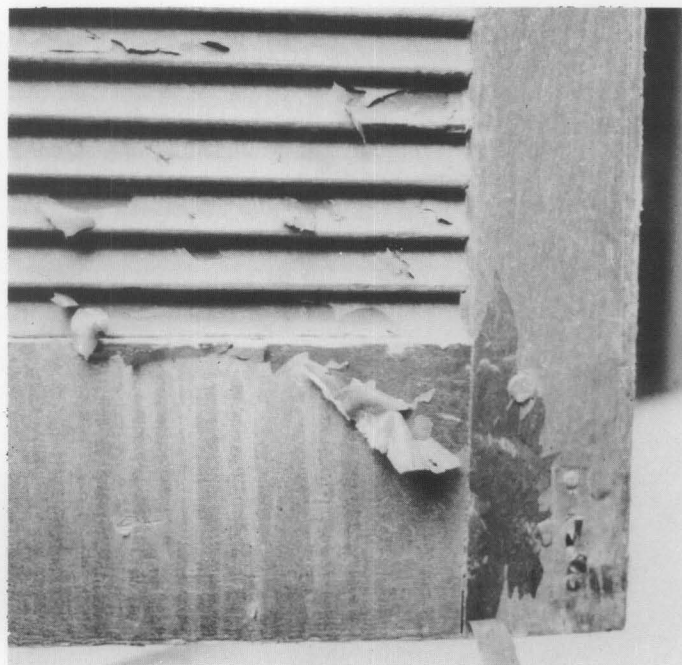
Fig. 6 This is an example of intercoat peeling. A latex top coat was applied directly over old oil paint and, as a result, the latex paint was unable to adhere. If latex is being used over oil, an oil-base primer should be applied first. Although much of the peeling latex paint can be scraped off, in this case, the best solution may be to chemically dip strip the entire shutter to remove all of the paint down to bare wood, rinse thoroughly, then repaint. Photo: Mary L. Oehrlein, AIA.

Where peeling was the result of using incompatible paints, the peeling top coat should be scraped and hand or mechanically sanded. Application of a high quality oil type exterior primer will provide a surface over which either an oil or a latex topcoat can be successfully used.

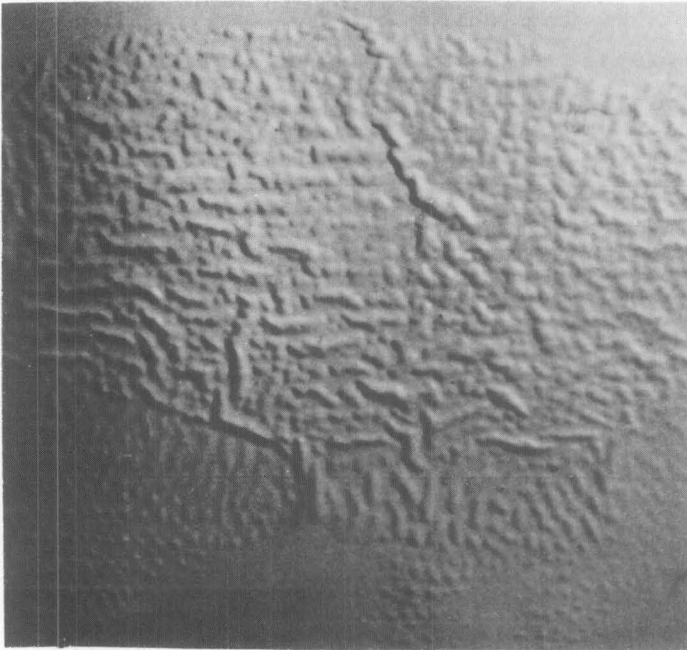
Fig. 7 Wrinkled layers can generally be removed by scraping and sanding as opposed to total paint removal. Following manufacturers' application instructions is the best way to avoid this surface condition. Photo: Courtesy, National Decorating Products Association.

The wrinkled layer can be removed by scraping followed by hand or mechanical sanding to provide as even a surface as possible, then repainted following manufacturer's application instructions.

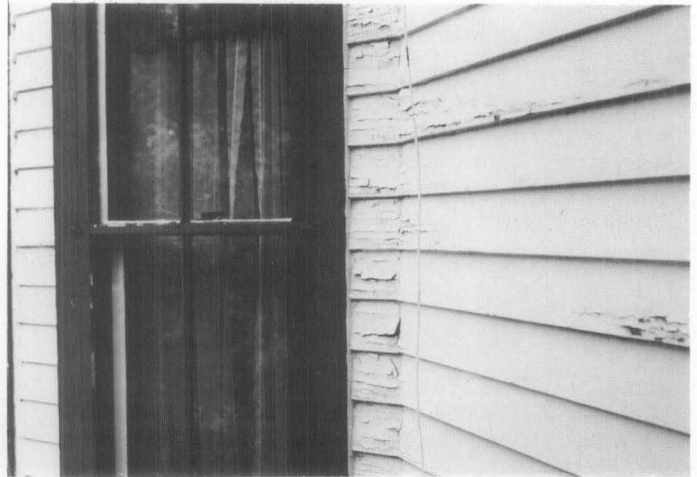
Fig. 8 Peeling to bare wood—one of the most common types of paint failure—is usually caused by an interior or exterior moisture problem. Photo: Anne E. Grimmer.

There is no sense in repainting before dealing with the moisture problems because new paint will simply fail. Therefore, the first step in treating peeling is to locate and remove the source or sources of the moisture, not only because moisture will jeopardize the protective coating of paint but because, if left unattended, it can ultimately cause permanent damage to the wood. Excess interior moisture should be removed from the building through installation of exhaust fans and vents. Exterior moisture should be eliminated by correcting the following conditions prior to repainting: faulty flashing; leaking gutters; defective roof shingles; cracks and holes in siding and trim; deteriorated caulking in joints and seams; and shrubbery growing too close to painted wood. After the moisture problems have been solved, the wood must be permitted to dry out thoroughly. The damaged paint can then be scraped off with a putty knife, hand or mechanically sanded, primed, and repainted.

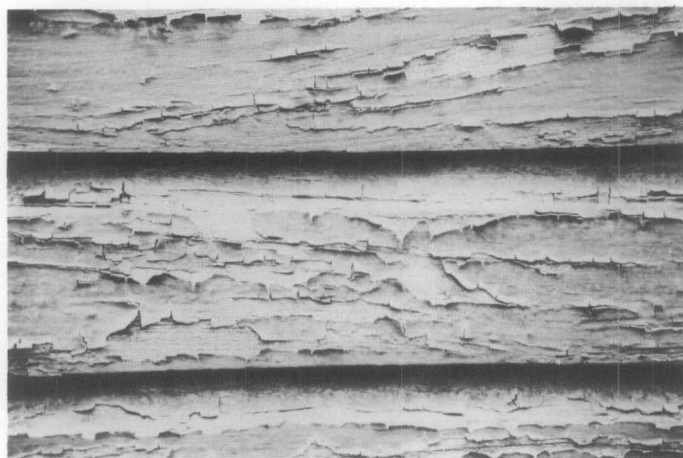
Fig. 9 Cracking, alligatoring, and flaking are evidence of long-term neglect of painted surfaces. The remaining paint on the clapboard shown here can be removed with an electric heat plate and wide-bladed scraper. In addition, unsound wood should be replaced and moisture problems corrected before primer and top coats of paint are applied. Photo: David W. Look, AIA.

bare wood and the paint has begun to flake, it will need to be totally removed. Methods include scraping or paint removal with the electric heat plate, electric heat gun, or chemical strippers, depending on the particular area involved. Bare wood should be primed within 48 hours, then repainted.

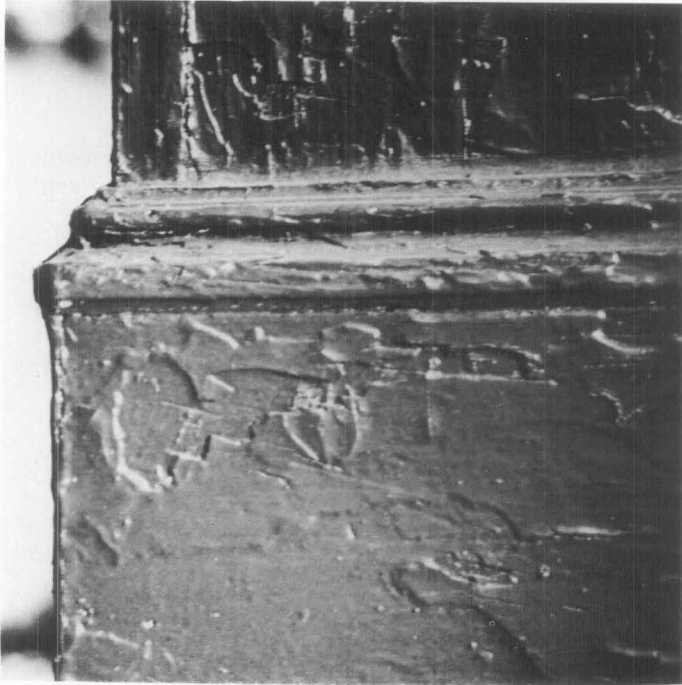
Fig. 10 An excellent example of inadequate scraping before repainting, the problems here are far more than cosmetic. This improperly prepared surface will permit moisture to get behind the paint film which, in turn, will result in chipping and peeling. Photo: Baird M. Smith, AIA.

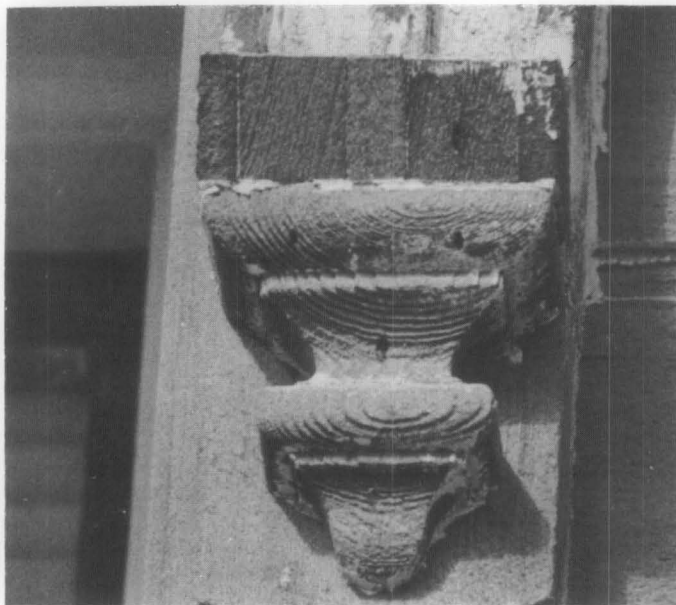
Fig. 12 Sandblasting has permanently damaged this ornamental bracket. Even paint will not be able to hide the deep erosion of the wood. Photo: David W. Look, AIA.
