# Visual Site Inspection Report

<b>Project Name</b>	H-600 Pipeline Spread G	<b>AFE</b>	124300137	<b>Spread</b>	H-600 Pipeline Spread G
<b>Contractor</b>	Precision			<b>Report #</b>	17729
<b>Inspector</b>	Len Kruizenga			<b>Date/Time</b>	5/28/2019 7:46 AM
<b>Permit #</b>	TBD	<b>Inspection Type</b>	VA SWPP	<b>Station Begin</b>	12005+00
<b>State</b>	VA	<b>Inspection Area</b>	Full	<b>Station End</b>	12005+00
<b>County</b>	Giles	<b>Ground</b>	Wet	<b>Temperature (°F)</b>	90.00
<b>Municipality</b>	N/A	<b>Weather</b>	Sunny	<b>Rain Gauge (in)</b>	1.50
				<b>Rain Accumulation Time (days)</b>	2.00

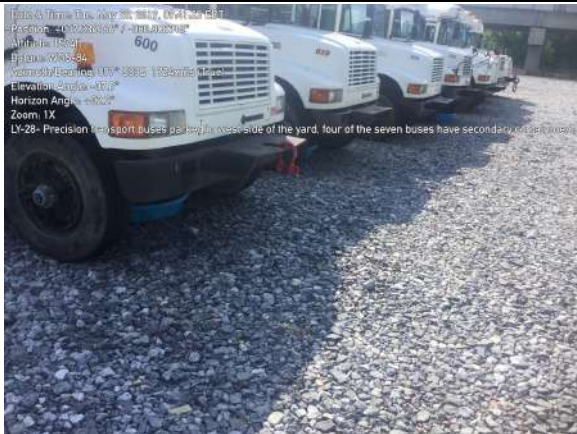
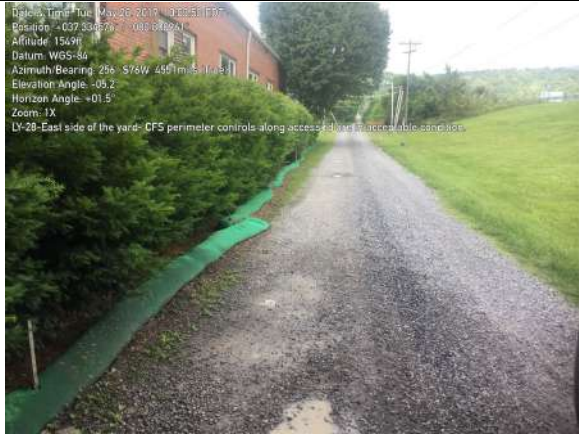
GPS Location	37.33	Field Station#	12005+00	GPS Location	37.33
Description	Transport buses- Four of the seven buses have secondary containment units under their motors.		Description	LY-28- West side of the yard- RCE is maintained in acceptable condition.

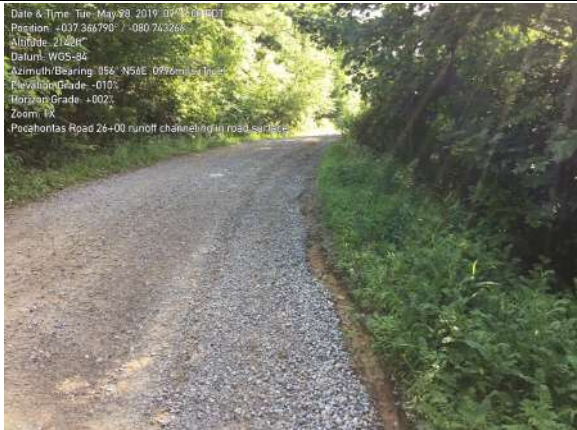
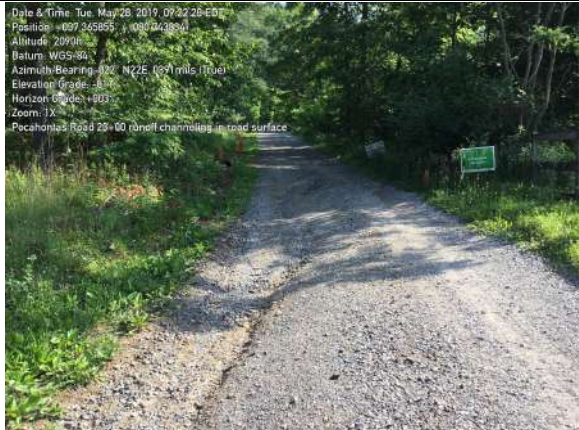
</div>		<div><p>Date &amp; Time: Tue, May 28, 2019, 09:22:28 EDT Position: +037.365855 / -080.743850 Altitude: 2090ft Datum: WGS-84 Azimuth/Bearing: 422° N22E 1091mils (True) Elevation Grade: -003% Horizon Grade: +003% Zoom: 1X Pocahontas Road 23+00 runoff channeling in road surface</p>

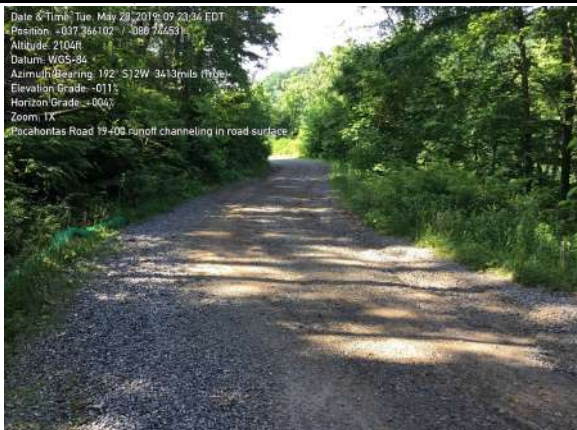
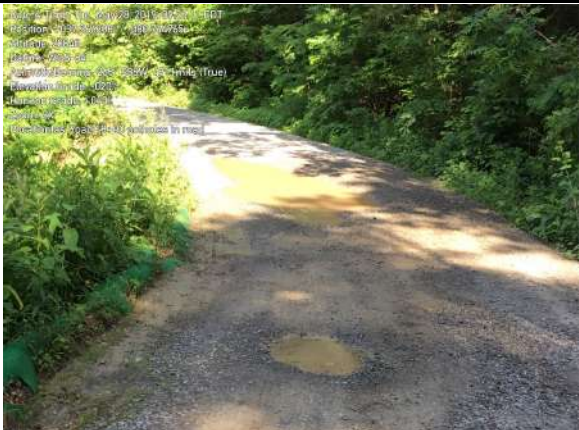
</div>		<div><p>Date &amp; Time: Tue, May 28, 2019, 09:23:34 EDT Position: +037.366102 / -080.742653 Altitude: 2104ft Datum: WGS-84 Azimuth/Bearing: 192° 512W 3413mils (True) Elevation Grade: -011% Horizon Grade: -004% Zoom: 1X Pocahontas Road 18+00 potholes in road</p>

</div>					
GPS Location	37.13	Field Station#	19+00	GPS Location	37.13	Field Station#	18+00
Description	Correct coordinates on photo. Runoff channeling in road surface.			Description	Correct coordinates on photo. Potholes in Pocahontas Road.

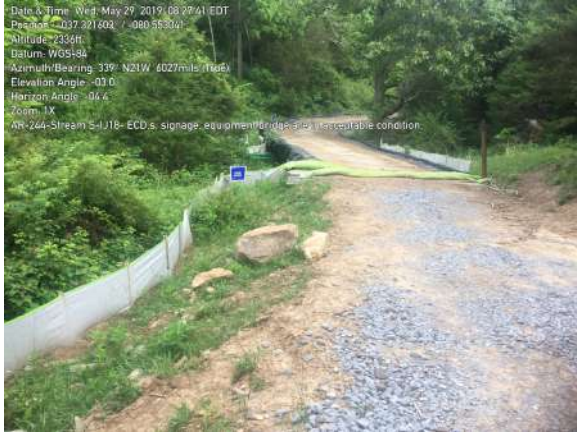
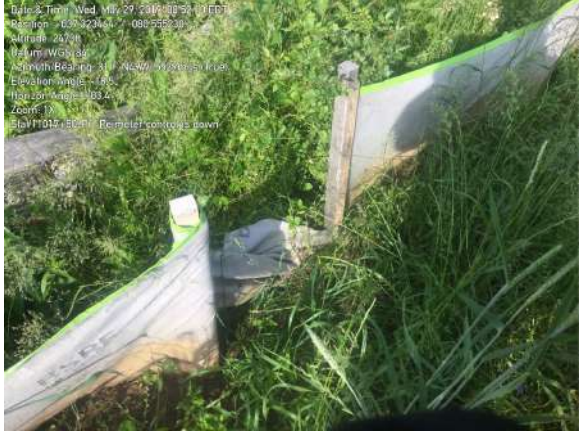
GPS Location		37.32	Field Station#		11022+00
Description		AR-244- Stream S-IJ18- ECD's, signage, equipment bridge are in acceptable condition

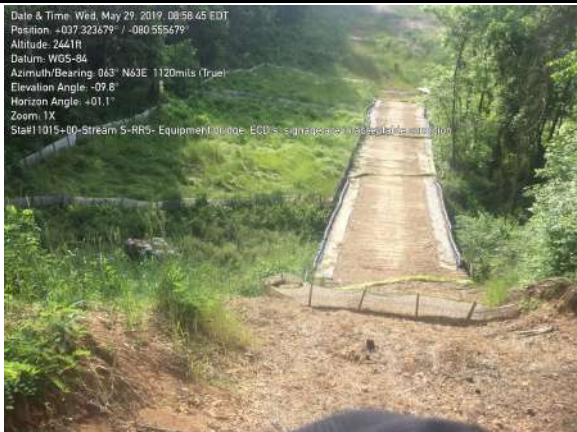
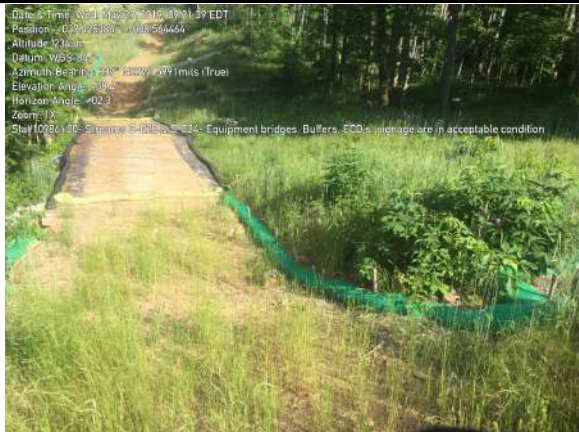
GPS Location		37.32	Field Station#		11015+00
Description		Equipment bridge, ECD's, signage are in acceptable condition.

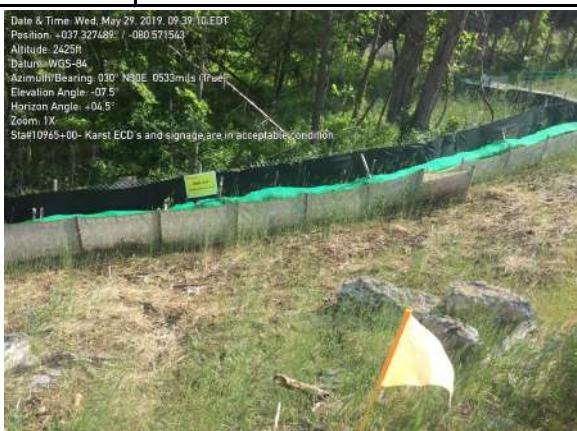
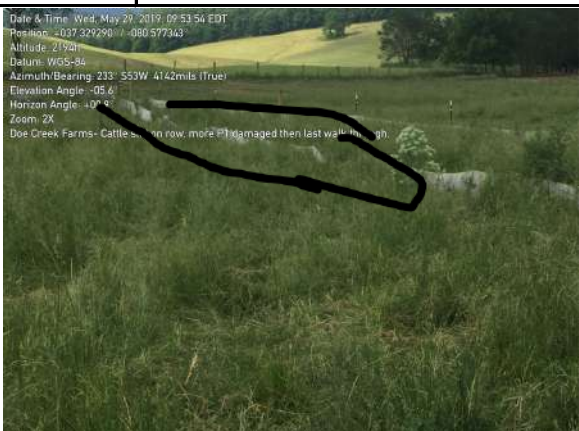
GPS Location		37.32	Field Station#		10965+00
Description		Karst ECD's and signage are in acceptable condition			
GPS Location		37.32	Field Station#		10947+00
Description		Doe Creek Farms- Cattle grazing row, more P1 damage.

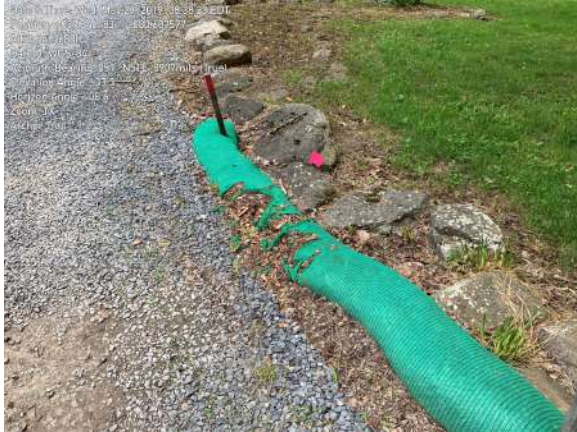
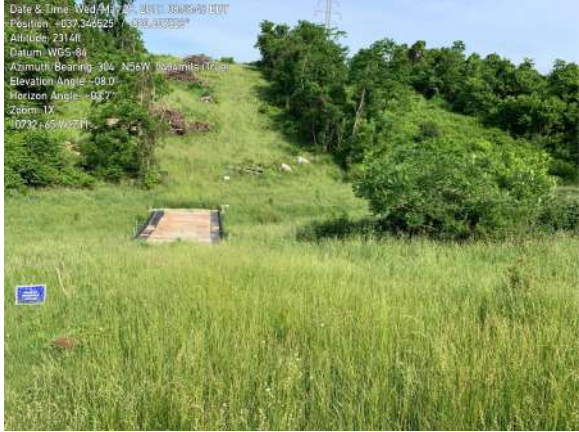
GPS Location	37.18	Field Station#	12005+00	GPS Location	37.18	Field Station#	10732+62
Description	See photo for GPS location. CFS on archer trail damaged.			Description	See photo for GPS location. Sensitive resource buffer in place at wetland W-Z11.

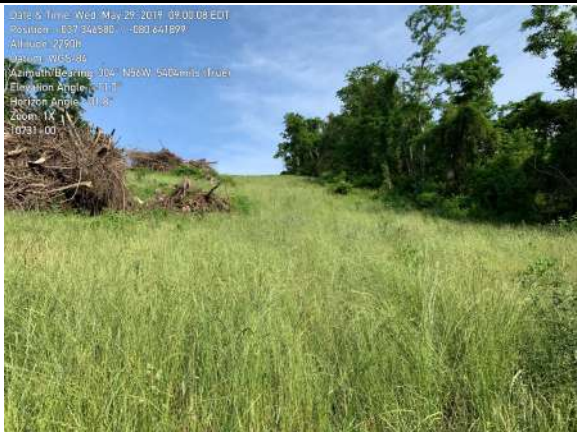
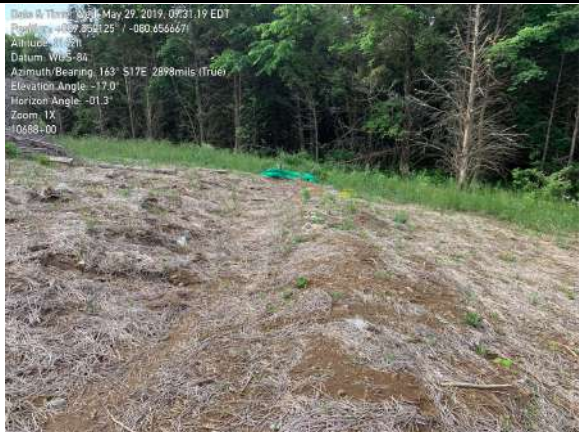
GPS Location	37.18	Field Station#	10731+00	GPS Location	37.18	Field Station#	10688+00
Description	See photo for GPS location. Temporary stabilization.			Description	See photo for GPS location. Waterbar and CFS end treatment in place.

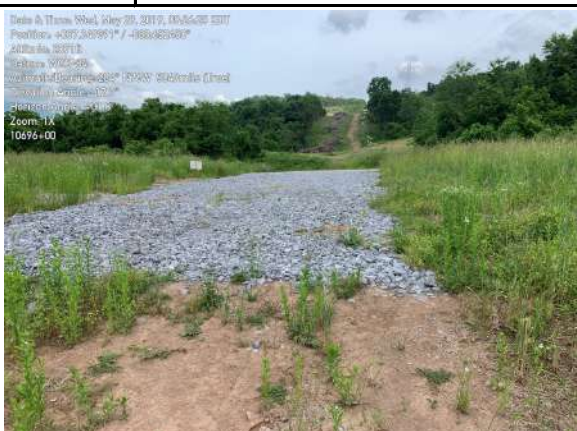
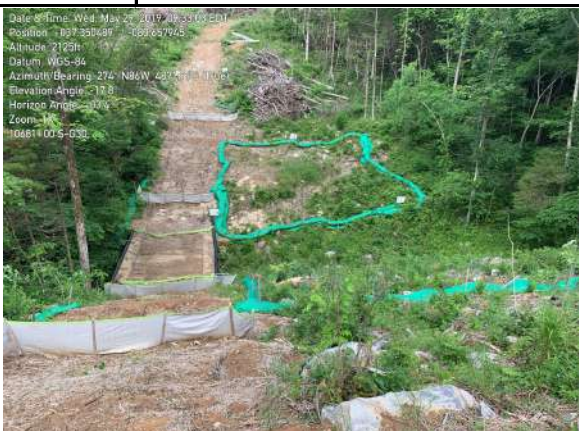
GPS Location	37.18	Field Station#	10697+00	GPS Location	37.18	Field Station#	10681+00
Description	See photo for GPS location. RCE in place at Buffalo Anklets Road.			Description	See photo for GPS location. Sensitive resource buffer in place at stream S-G30.

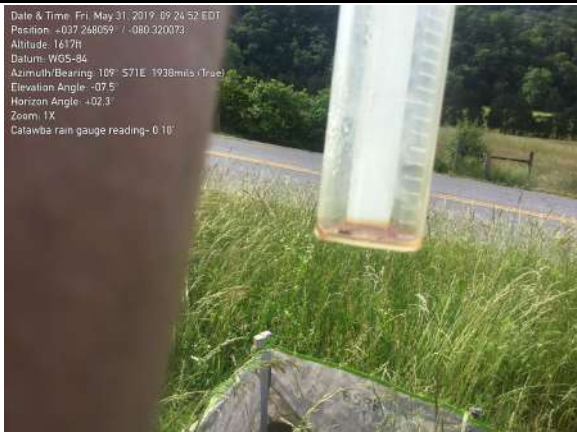
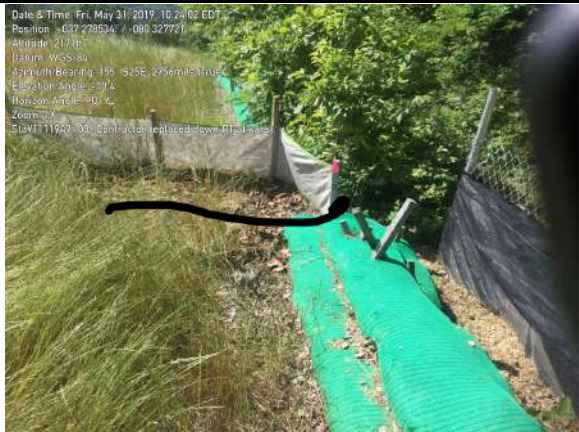
<p>Date &amp; Time: Fri, May 31, 2019 10:24:02 EDT Position: -037.278534° / -080.327721° Altitude: 213ft Datum: WGS-84 Azimuth/Bearing: 155.525E, 2756mils (True) Elevation Angle: -07.4° Horizon Angle: -01.4° Zoom: 1X Staff 111920-03, Contractor replaced down P1 at Karst.</p>

GPS Location	37.26	Field Station#	11988+00	GPS Location	37.27
Description	Catawba rain gauge reading- 0.10"		Description	Contractor replaced down P1 at Karst.	
<p>Date &amp; Time: Fri, May 31, 2019 11:24:52 EDT Position: -037.263527° / -080.327721° Altitude: 1919ft Datum: WGS-84 Azimuth/Bearing: 010.5226, 1687mils (True) Elevation Angle: -06.1° Horizon Angle: -01.0° Zoom: 1X Karst ECD's are in good condition.</p>

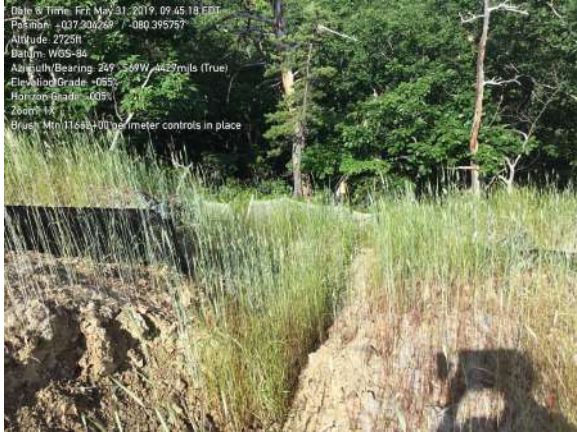
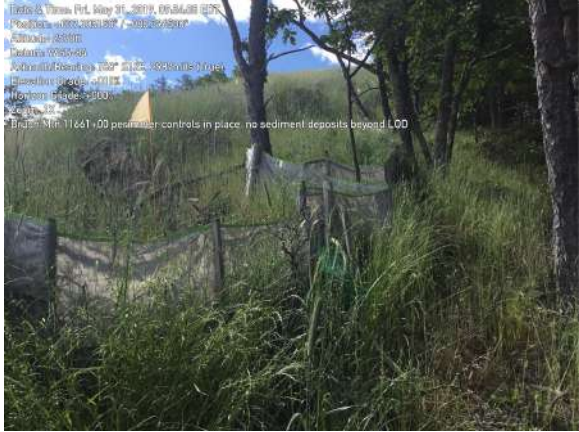
<p>Date &amp; Time: Fri, May 31, 2019, 09:54:58 EDT Position: -037.303187 / -080.397507 Altitude: 2695ft Datum: WGS-84 Azimuth/Bearing: 122° 21E 1825mils (True) Elevation Grade: +00% Horizon Grade: +00% Zoom: 1X Brush Mtn 11661+00 perimeter controls in place; no sediment deposits beyond LOD</p>

GPS Location	37.31	Field Station#	11662+00	GPS Location	37.31	Field Station#	11661+00
Description	Correct coordinates on photo. End treatments checked for maintenance.			Description	Correct coordinates on photo. End treatments effective and conditions stable.

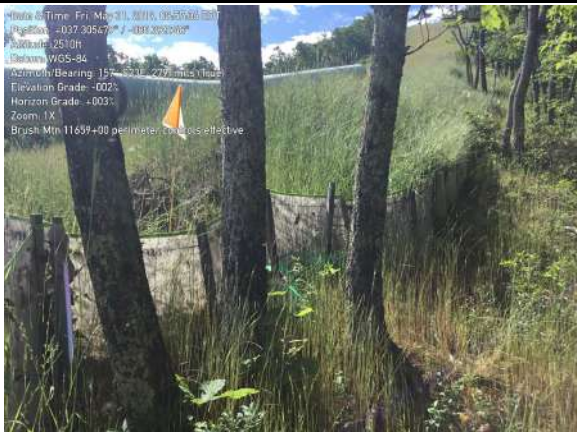
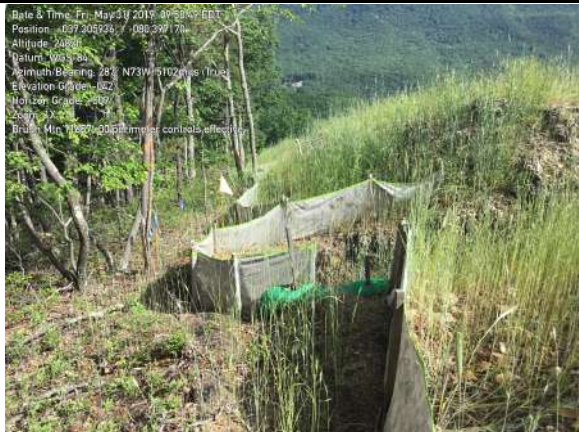
<p>Date &amp; Time: Fri, May 31, 2019, 09:59:03 EDT Position: -037.305524 / -080.391701 Altitude: 2485ft Datum: WGS-84 Azimuth/Bearing: 283° 17W 15102mils (True) Elevation Grade: +02% Horizon Grade: +03% Zoom: 1X Brush Mtn 11657+00 perimeter controls effective</p>

GPS Location	37.31	Field Station#	11659+00	GPS Location	37.31	Field Station#	11657+00
Description	Correct coordinates on photo. No sediment behind perimeter controls.			Description	Correct coordinates on photo. Perimeter controls in place and functional.		
<p>Date &amp; Time: Fri, May 31, 2019, 10:00:00 EDT Position: -037.311639 / -080.392131 Altitude: 2420ft Datum: WGS-84 Azimuth/Bearing: 202° 10SE 12667mils (True) Elevation Grade: +02% Horizon Grade: +00% Zoom: 1X Brush Mtn 11656+00 perimeter controls effective</p>

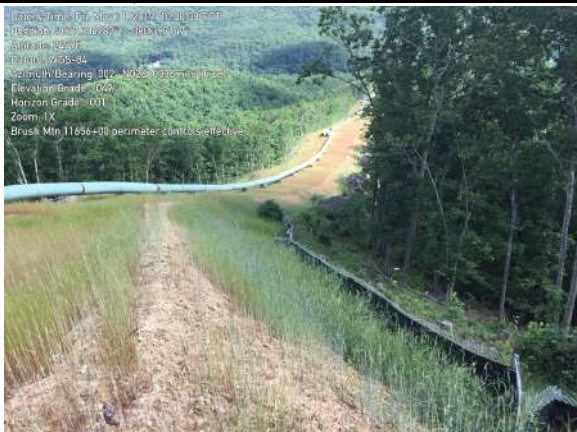
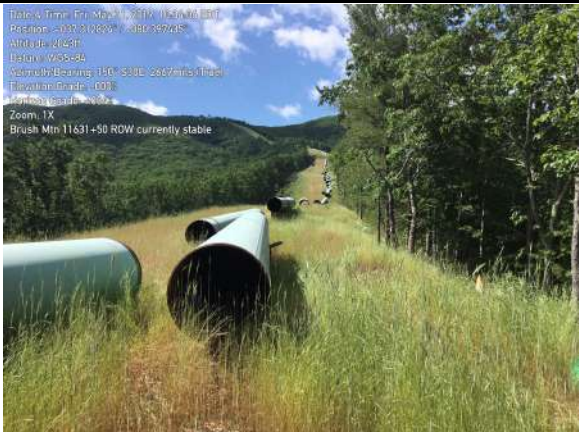
<p>Date &amp; Time: Fri, May 31, 2019, 10:01:00 EDT Position: -037.311631 / -080.392131 Altitude: 2420ft Datum: WGS-84 Azimuth/Bearing: 150° 53SE 12667mils (True) Elevation Grade: +00% Horizon Grade: +00% Zoom: 1X Brush Mtn 11631+50 ROW currently stable</p>

GPS Location	37.31	Field Station#	11656+00	GPS Location	37.31	Field Station#	11631+50
Description	Correct coordinates on photo. Perimeter controls in place.			Description	Correct coordinates on photo. Surface stable with no erosion issues identified.
