Visual Site Inspection Report

Project Name	H-600 Pipeline Spread G	AFE	124300137	Spread	H-600 Pipeline Spread G
Contractor	Precision			Report #	18076
Inspector	Len Kruizenga			Date/Time	6/3/2019 8:00 AM
Permit #	TBD	Inspection Type	VA SWPP	Station Begin	12005+00
State	VA	Inspection Area	Full	Station End	12005+00
County	Giles	Ground	Dry	Temperature (°F)	65.00
Municipality	N/A	Weather	Sunny	Rain Gauge (in)	0.60
				Rain Accumulation Time (days)	2.00

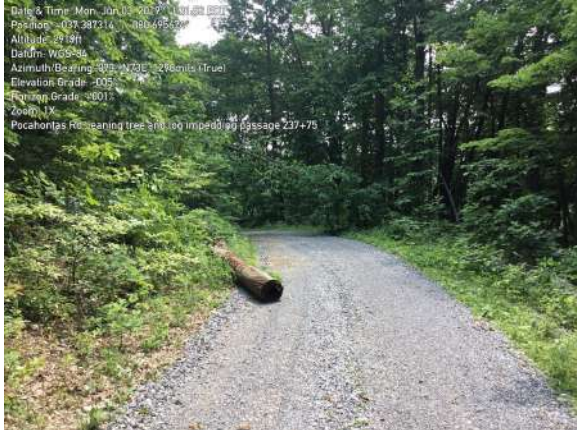
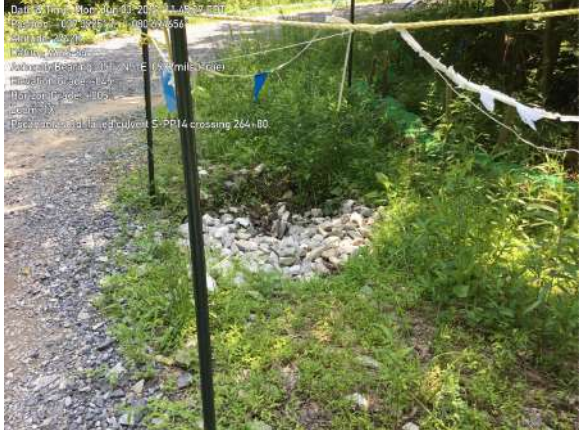
GPS Location	37.31	Field Station#	237+75	GPS Location	37.31	Field Station#	264+80
Description	Correct coordinates on photo. Tree leaning over road and log that has rolled into travel zone need to be removed.			Description	Correct coordinates on photo. Failed culvert at the S-PP14 crossing needs repair.

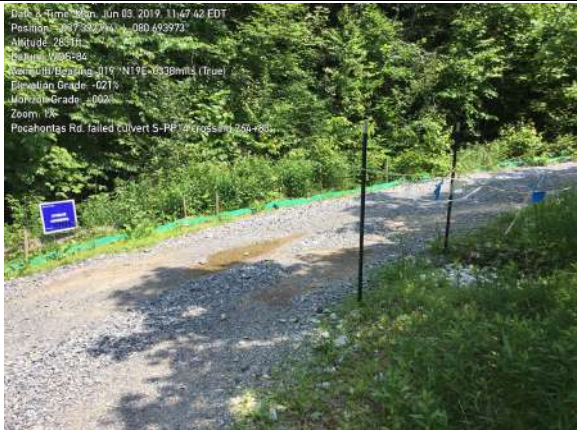
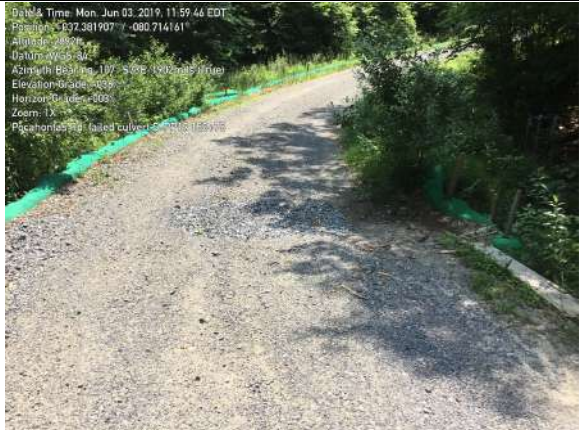
7. Identify all remedial measures that have been taken since the previous inspection was conducted.					
Comments (Reference above questions as appropriate.)					
<p>The failed culverts on Pocahontas Road at 152+80 and 264+92 show little change since last inspection. Channeling of runoff on the road surface continues to deteriorate. Controls are in place along Pocahontas and Mystery Ridge Road but maintenance needs are not being addressed due to lack of approval from the FS. Potholes continue to form and increase in size. No impact to resources is apparent at the features adjacent to or crossed by the roads. There is a tree leaning over Pocahontas Road at 238+00 that needs to be removed. A log has rolled onto the road near 237+75. MVP is waiting to hear from the FS before moving forward.</p>					
Note: It is a condition of National Pollutant Discharge Elimination System and Erosion and Sediment permits that a maintenance program be conducted to provide for the operation and maintenance of all BMPs to be inspected on a weekly basis and after each stormwater event. Please list in the space provided comments to note if repairs or replacement are needed or have been made for BMPs as a result of the inspection. Failure to conduct the required inspection may result in permit suspension or the imposition of civil penalties. If supplemental monitoring is required as part of a permit condition this form may be used to meet those monitoring requirements.

GPS Location	37.31	Field Station#	264+80	GPS Location	37.31	Field Station#	152+75
Description	Correct coordinates on photo. Failed culvert at the S-PP14 crossing needs repair.			Description	Correct coordinates on photo. Failed culvert at the S-PP19 crossing needs repair.

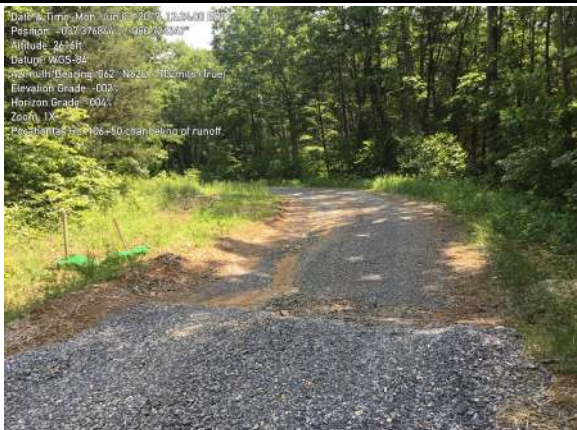
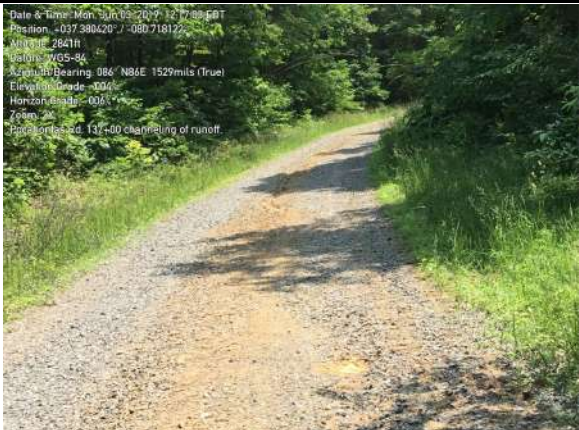
GPS Location	37.31	Field Station#	106+50	GPS Location	37.31	Field Station#	137+00
Description	Correct coordinates on photo. Stormwater runoff is channeling in Road surface.			Description	Correct coordinates on photo. Stormwater runoff is channeling in Road surface.

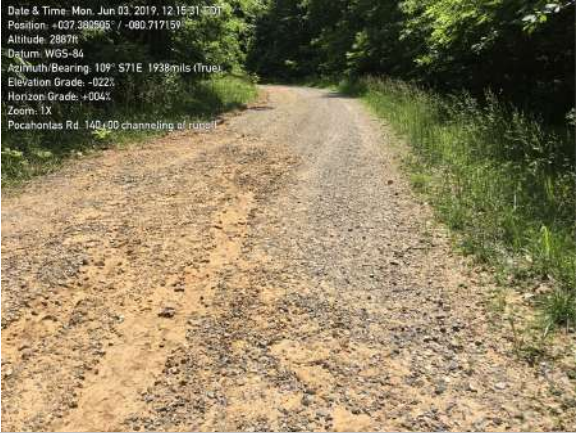
Insert image here			
GPS Location	37.37	Field Station#	140+00	GPS Location	
Description	Correct coordinates on photo. Stormwater runoff is channeling in Road surface.		Description	Correct coordinates on photo.	
Insert image here			Insert image here		
GPS Location		Field Station#		GPS Location	
Description			Description		
Insert image here			Insert image here		
GPS Location		Field Station#		GPS Location	
Description			Description		
Insert image here			Insert image here		
GPS Location		Field Station#		GPS Location	
Description			Description

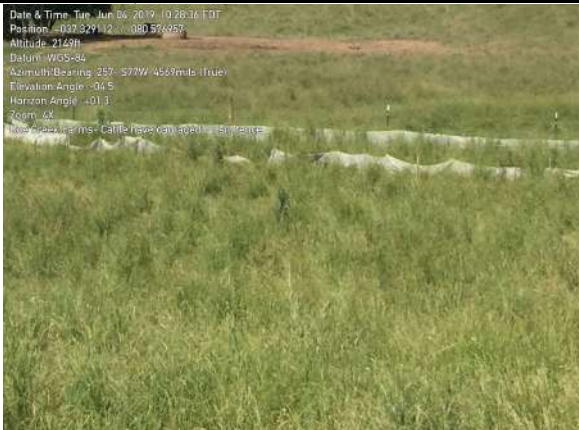
GPS Location	37.30	Field Station#	10950+00	GPS Location	37.31	Field Station#	10947+00
Description	Doe Creek Farms- Cattle crossing gate is open, cattle have been grazing the row.			Description	Doe Creek Farms- P1 silt fence has been damaged by cattle.

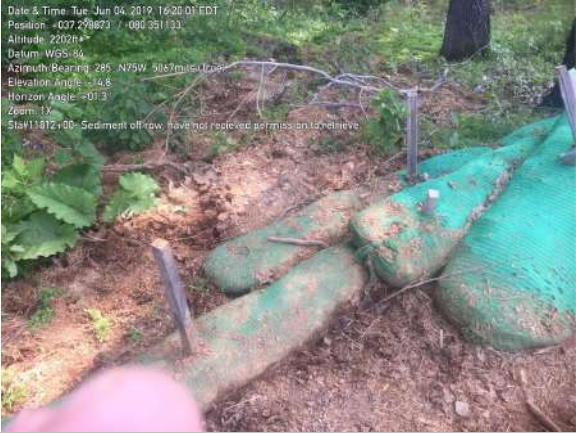
<p>Insert image here</p>	
GPS Location	37.29	Field Station#	11812+00	GPS Location	
Description	Sediment off row, have not received permission to retrieve.		Description		
<p>Insert image here</p>			<p>Insert image here</p>		
GPS Location		Field Station#		GPS Location	
Description			Description		
<p>Insert image here</p>			<p>Insert image here</p>		
GPS Location		Field Station#		GPS Location	
Description			Description		
<p>Insert image here</p>			<p>Insert image here</p>		
GPS Location		Field Station#		GPS Location	
Description			Description

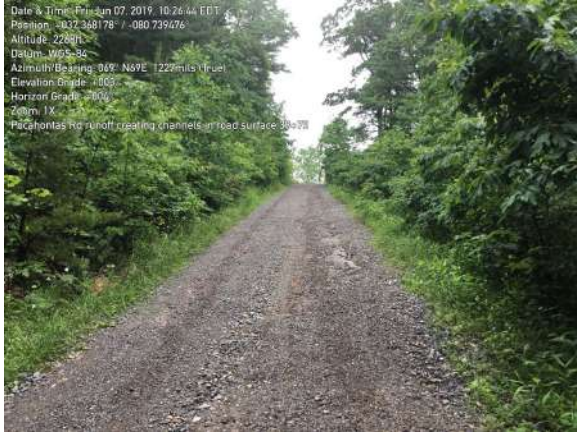
<p>Date & Time: Fri Jun 07, 2019 10:36:16 EDT Position: -037.365793 / -080.727243 Altitude: 2280ft Datum: WGS-84 Azimuth/Bearing: 306° N89E 082mils (True) Elevation Grade: -001% Horizon Grade: -002% Zoom: 1X Pocahontas Rd runoff creating channels in road surface 27+50</p>

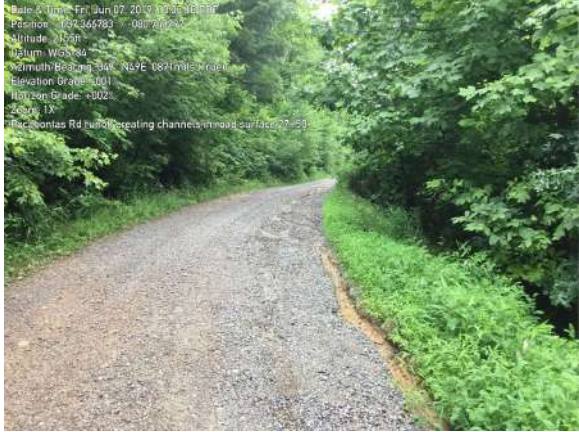
GPS Location	37.31	Field Station#	39+75	GPS Location	37.31	Field Station#	27+50
Description	Correct coordinates on photo. Channeling of runoff on road surface apparent.			Description	Correct coordinates on photo. Channeling of runoff on road surface apparent.		
<p>Date & Time: Fri Jun 07, 2019 10:41:10 EDT Position: -037.360002 / -080.743204 Altitude: 2120ft Datum: WGS-84 Azimuth/Bearing: 024° N24E 0427mils (True) Elevation Grade: -003% Horizon Grade: -003% Zoom: 1X Pocahontas Rd runoff creating channels in road surface 23+00</p>

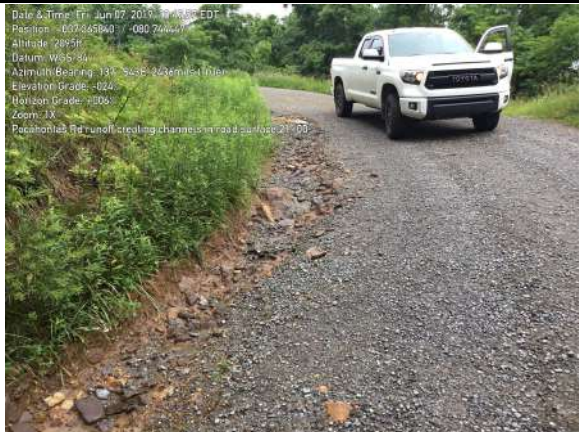
GPS Location	37.31	Field Station#	23+00	GPS Location	37.31	Field Station#	21+00
Description	Correct coordinates on photo. Channeling of runoff on road surface apparent.			Description	Correct coordinates on photo. Channeling of runoff on road surface apparent.		
<p>Date & Time: Fri Jun 07, 2019 10:49:20 EDT Position: -037.364241 / -080.745977 Altitude: 2107ft Datum: WGS-84 Azimuth/Bearing: 146° S31E 300mils (True) Elevation Grade: -013% Horizon Grade: -002% Zoom: 1X Pocahontas Rd runoff creating channels in road surface 18+75</p>

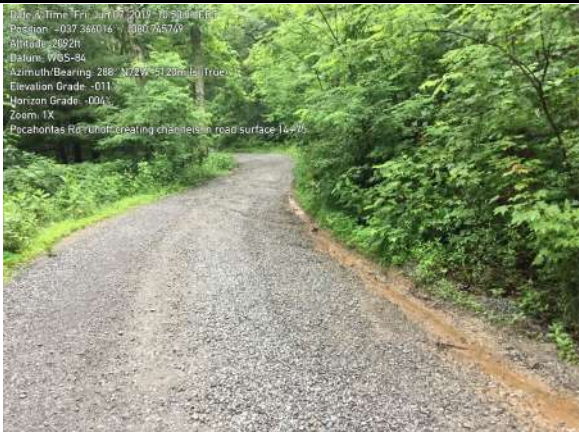
GPS Location	37.31	Field Station#	18+75	GPS Location	37.31	Field Station#	14+75
Description	Correct coordinates on photo. Channeling of runoff on road surface apparent.			Description	Correct coordinates on photo. Channeling of runoff on road surface apparent.
