Visual Site Inspection Report

| Project Name | H-600 Pipeline Spread G | AFE | 124300137 | Spread | H-600 Pipeline Spread G |
| Inspector | Len Kruizenga | | | Date/Time | 6/10/2019 7:39 AM |

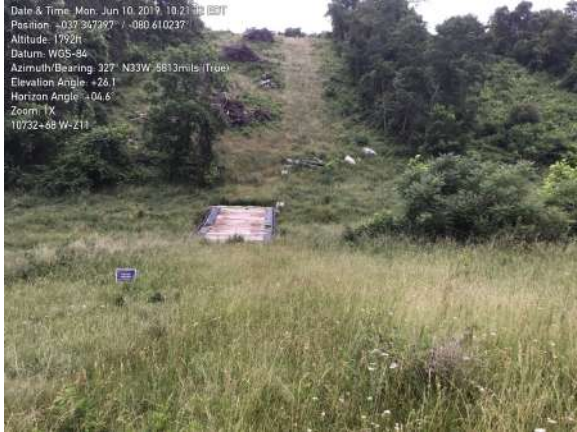
| Description | See photo for GPS location. Sensitive resource buffer in place at wetland W-Z11. | | | Description | See photo for GPS location. ROW stabilized with natural vegetation. | | |

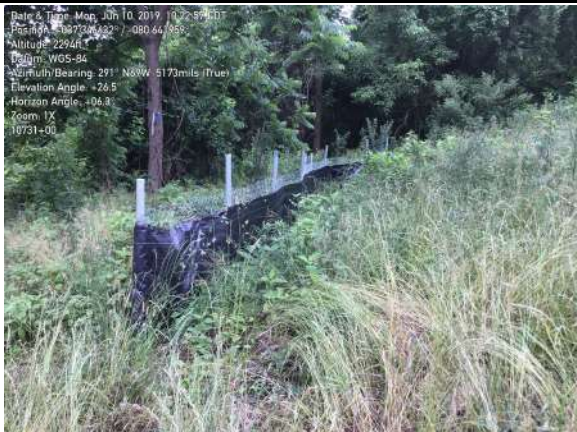
| Description | See photo for GPS location. Reinforced super silt fence in place. | | | Description | See photo for GPS location. RCE in place at Buffalo Anklets Road. | | |

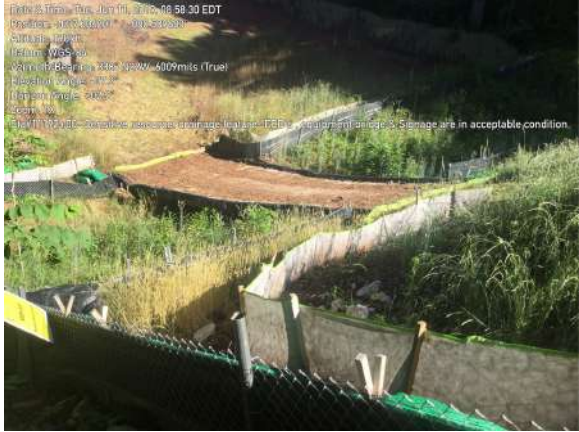
| Description | Winding Way rain gauge reading- 0.70" | | | Description | Sensitive resource area, drainage feature ECD's, signage & Equipment bridge are in acceptable condition | | |

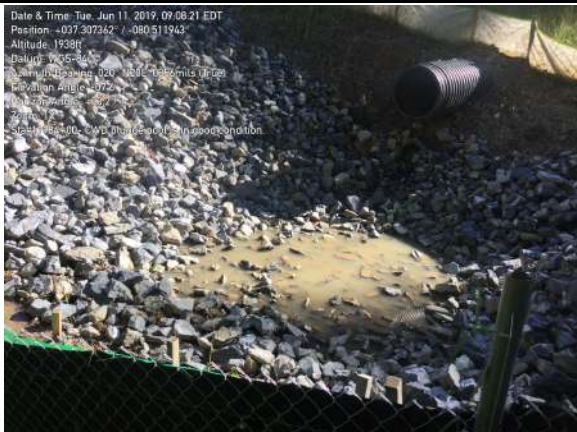
| Description | CWD plunge pool & ECD's are in good condition. | | | Description | Stream S-PP3-ECD's, Equipment bridge & signage are in acceptable condition. | | |

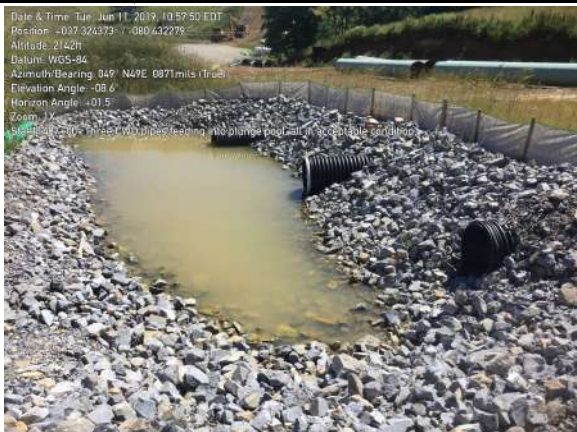
| Description | Three CWD pipes feeding into plunge pool, all in acceptable condition. | | | Description | Equipment staged at Stevers Gap, not in use. | | |

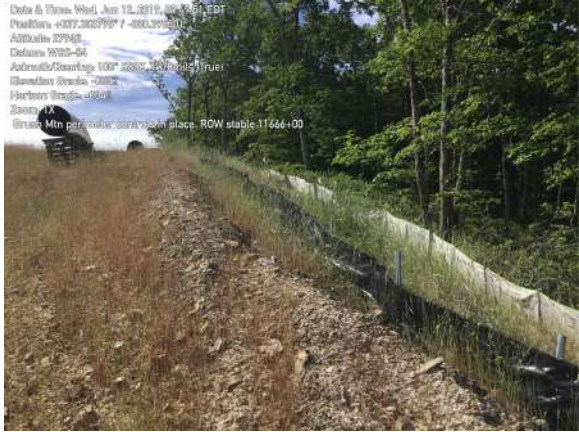
| Description | Correct coordinates on photo. Area void of grass but remains stable. | | | Description | Correct coordinates on photo. ROW ECDs functional. | | |

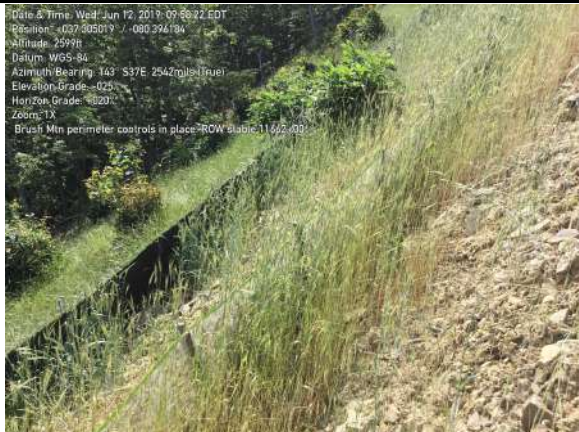
| Description | Correct coordinates on photo. Grasses and perimeter controls have contained sediment. | | | Description | Correct coordinates on photo. Perimeter controls are in place where needed. | | |

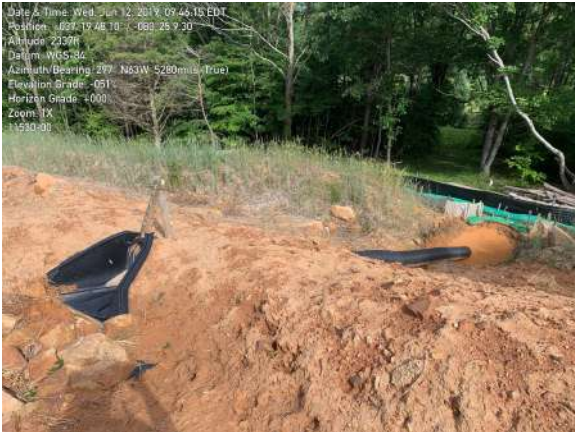
| Description | Slope drain and end treatment | | | Description | Fallen tree, but no damage to P1 | | |

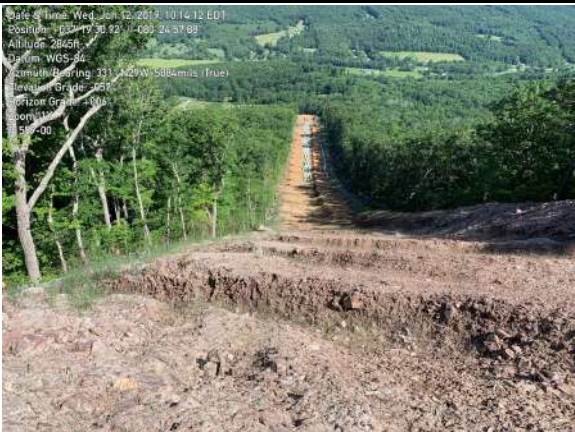
| Description | ECD's and Row conditions | | | Description | Fallen tree, slight damage to SSF | | |

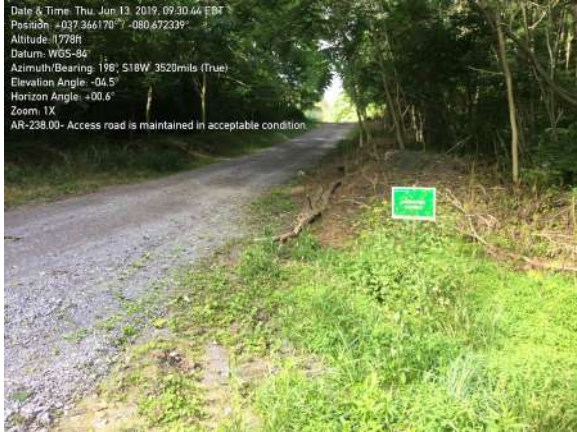
| Description | AR-238.00- Access rd is maintained in acceptable condition | | | Description | LY- 29- Arnold's Equipment & Materials storage. | | |

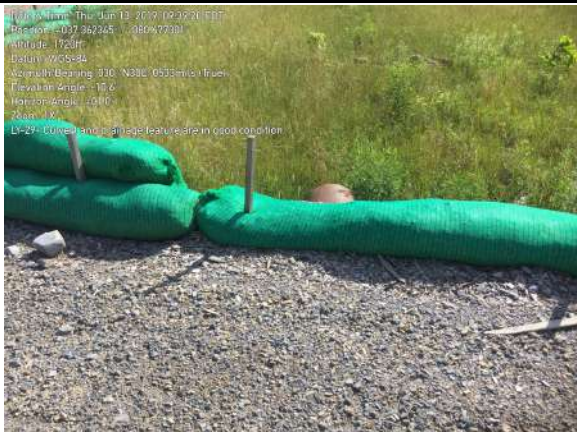
| Description | LY-29- Culvert and drainage feature are in good condition. | | | Description | LY-29- Rock surface is maintained in acceptable condition. | | |

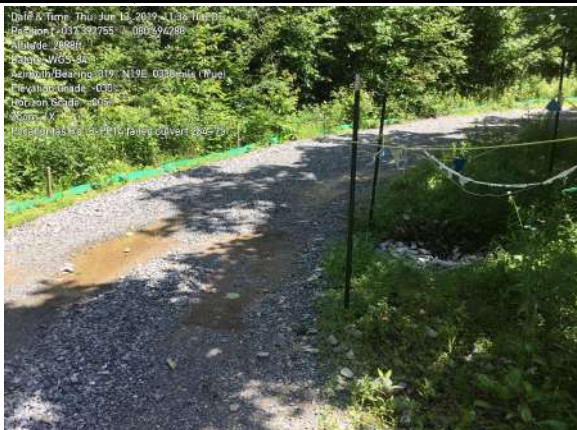
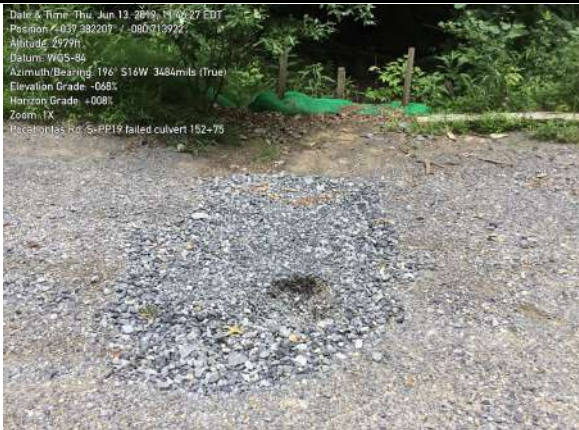
| Date & Time: Thu Jun 13, 2019, 11:36:11 EDT Position: 4037.391753° / -080.694288° Altitude: 2988ft Datum: WGS-84 Azimuth/Bearing: 019° N19E 0289mils (True) Elevation Grade: -032° Horizon Grade: -005° Zoom: 1X Pocahontas Rd. S-PP19 failed culvert 264+75 | | Date & Time: Thu Jun 13, 2019, 11:46:27 EDT Position: 4037.382207° / -080.671372° Altitude: 2979ft Datum: WGS-84 Azimuth/Bearing: 196° S16W 3684mils (True) Elevation Grade: -068° Horizon Grade: +008° Zoom: 1X Pocahontas Rd. S-PP19 failed culvert 152+75 | | | | | |

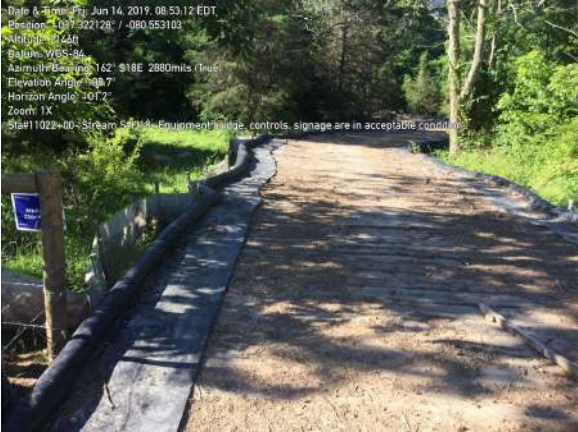
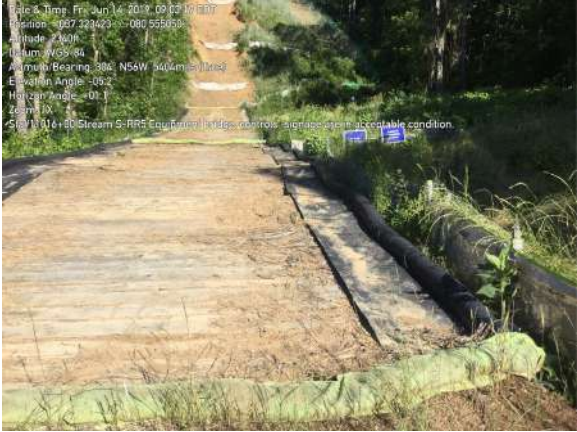
| Description | | Stream S-IJ18- Equipment bridge, controls, signage are in acceptable condition. | | Description | |

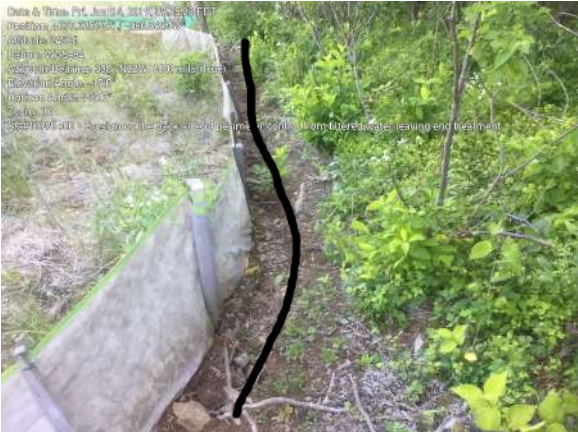
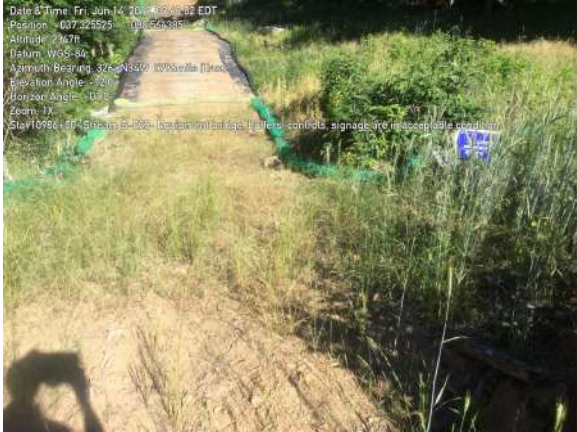
| Description | | Erosion on backside of Perimeter control from filtered water exiting end treatment, on steep slope. | | Description | |

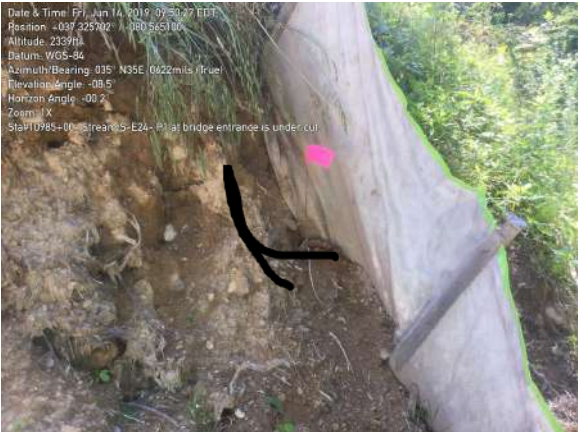
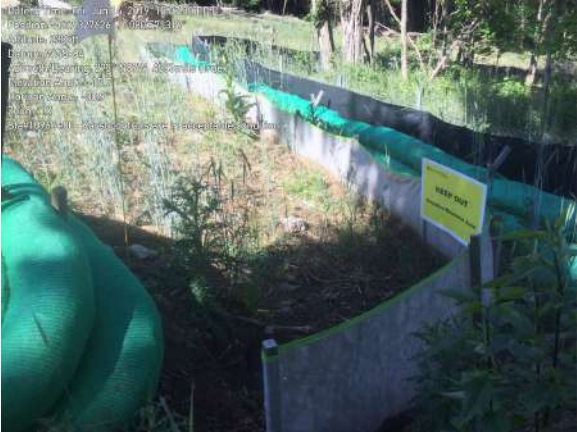
| Description | | Stream S-E24- P1 under cut at bridge entrance. | | Description | |
