Visual Site Inspection Report

Project Name	H-600 Pipeline Spread G	AFE	124300137	Spread	H-600 Pipeline Spread G
Contractor	Precision			Report #	18758
Inspector	Len Kruizenga			Date/Time	6/17/2019 8:57 AM
Permit #	TBD	Inspection Type	VA SWPP	Station Begin	11254+88
State	VA	Inspection Area	Full	Station End	11161+00
County	Giles	Ground	Damp	Temperature (°F)	68.00
Municipality	N/A	Weather	Cloudy	Rain Gauge (in)	0.02
				Rain Accumulation Time (days)	3.00

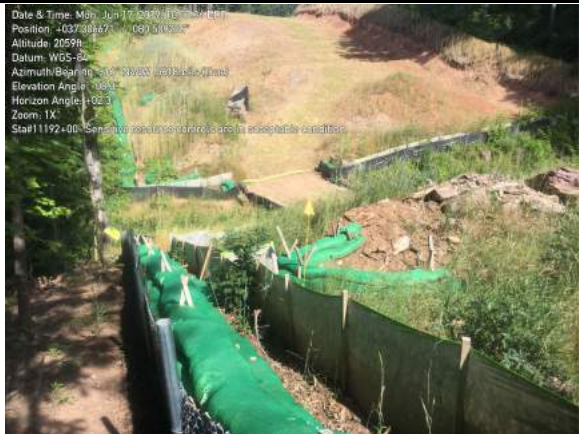
GPS Location	37.30	Field Station#	11227+00	GPS Location	37.30
				Field Station#	11192+00
Description	Winding Way rain gauge reading-0.02"			Description	Sensitive resource controls are in acceptable condition.

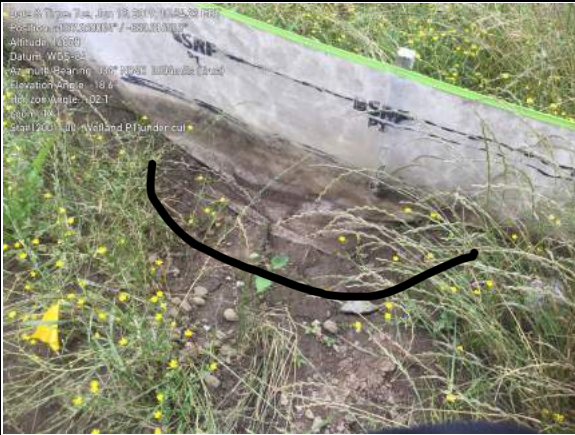
</div>			<div><div>Date & Time: Tue, Jun 18, 2019, 14:46:55 EDT Position: +037.287501° / -080.333972° Altitude: 2276ft Datum: WGS-84 Azimuth/Bearing: 021° N21E 1033mils (True) Elevation Angle: -21.5° Horizon Angle: -23.7° Zoom: 1X Gully (45'x10') near 11903+00</div>

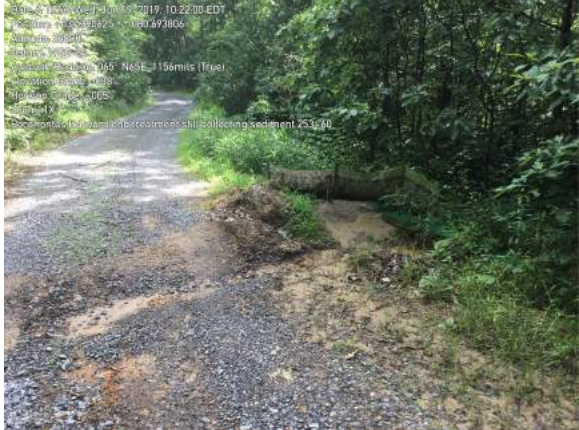
<p>Date & Time: Wed, Jun 19, 2019, 10:22:00 EDT Position: 43°37'39.215" N / 76°03'41.17" W Altitude: 2686ft Datum: WGS-84 Azimuth/Bearing: 248° 15' 31" W 4302mils (True) Elevation Grade: 105° Horizontal Grade: 100° Zoom: 1X Pocahontas Rd ECD crossing shows little change 264+60</p>					
GPS Location	37.31	Field Station#	264+75	GPS Location	37.31	Field Station#	253+60
Description	No change at site of failed culvert on Pocahontas Road S-PP14 crossing.			Description	Waterbars and end treatments in need of maintenance. Awaiting Forest Service approval.

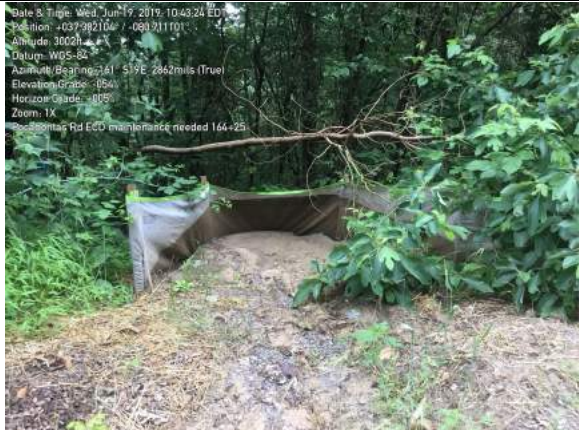
<p>Date & Time: Wed, Jun 19, 2019, 10:43:24 EDT Position: 43°37'39.2104" N / 76°03'41.1701" W Altitude: 2682ft Datum: WGS-84 Azimuth/Bearing: 241° 51' 59" E 2862mils (True) Elevation Grade: 105° Horizontal Grade: 100° Zoom: 1X Pocahontas Rd ECD maintenance needed 164+25</p>					
GPS Location	37.31	Field Station#	162+00	GPS Location	37.31	Field Station#	164+25
Description	End treatments worn and need replacement.			Description	Sediment deposits collecting and worn silt fence.

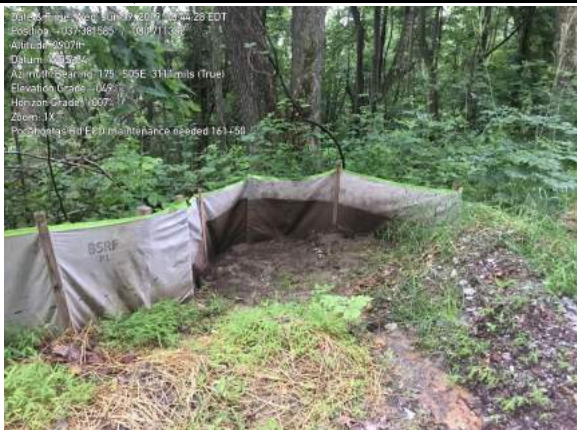
<p>Date & Time: Wed, Jun 19, 2019, 10:47:26 EDT Position: 43°37'38.1565" N / 76°03'41.1535" W Altitude: 2607ft Datum: WGS-84 Azimuth/Bearing: 217° 50' 58" E 311mils (True) Elevation Grade: 104° Horizontal Grade: 100° Zoom: 1X Pocahontas Rd ECD maintenance needed 161+50</p>

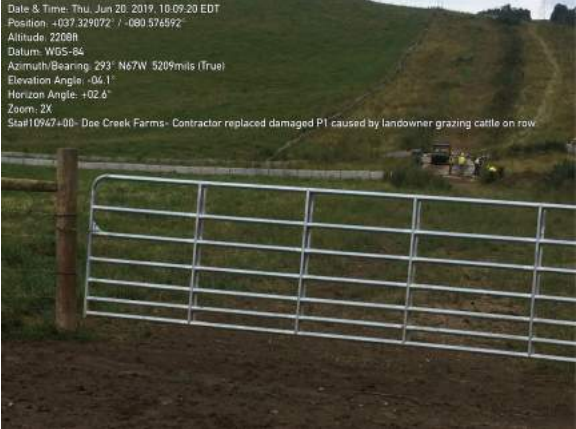
GPS Location	37.32	Field Station#	10947+00	GPS Location	37.32
Description	Contractor replaced damaged P1, caused by landowner grazing row.		Description	Steel Acres rain gauge reading- 0.10"	
Insert image here			Insert image here		
GPS Location		Field Station#		GPS Location

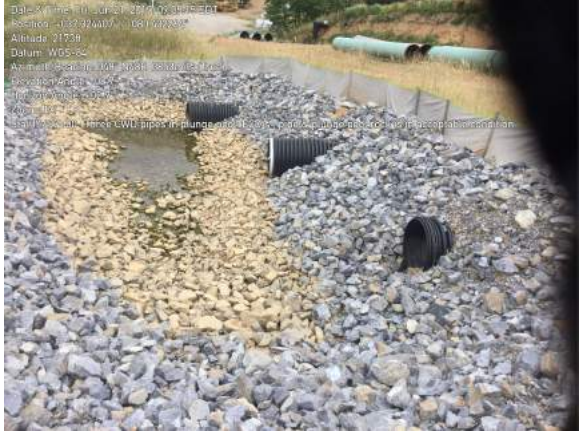
GPS Location	37.33	Field Station#	11471+00	GPS Location	37.32
Description	Steel Acres rain gauge reading- 0.02"		Description	Three CWD pipe discharging into plunge pool- ECD's, plunge pool rock is in acceptable condition

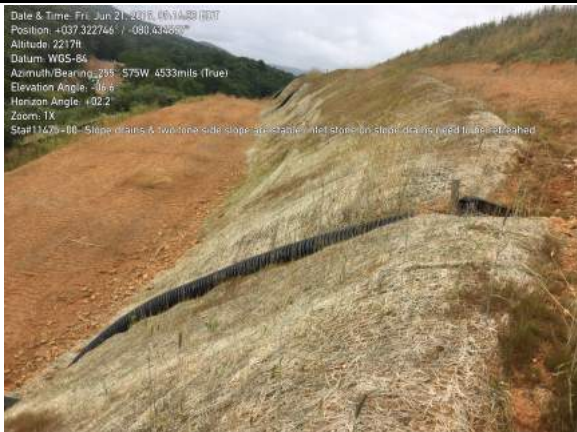
GPS Location	37.32	Field Station#	11475+00	GPS Location	37.30
Description	Slope drains & two tone side slope are stable, inlet stone on slope drains need to be refreshed		Description	Winding Way rain gauge reading- 0.02"

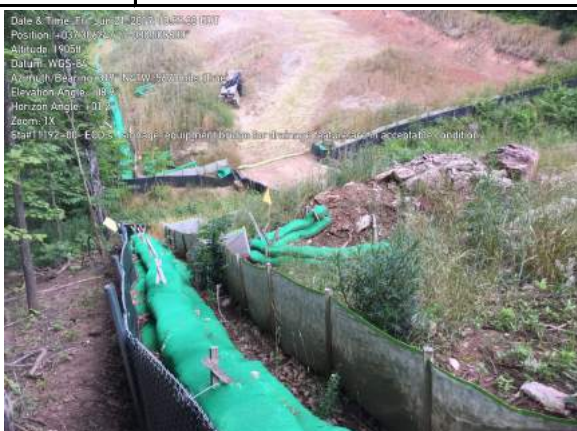
GPS Location	37.30	Field Station#	11192+00	GPS Location	37.30
Description	ECD's, signage, equipment bridge at drainage feature are in acceptable condition.		Description	CWD plunge pool & controls are in good condition
