# Visual Site Inspection Report

| <b>Project Name</b> | H-600 Pipeline Spread G | <b>AFE</b> | 124300137 | <b>Spread</b> | H-600 Pipeline Spread G |
| <b>Contractor</b> | Precision | | | <b>Report #</b> | 19542 |
| <b>Inspector</b> | Len Kruizenga | | | <b>Date/Time</b> | 7/1/2019 8:04 AM |

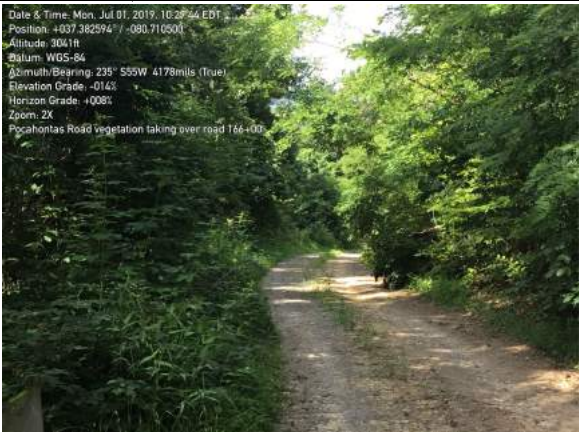
| Description | No change in condition at failed culvert. S-PP19 crossing. | | | Description | Vegetation is encroaching road edge and ECDs. | | |

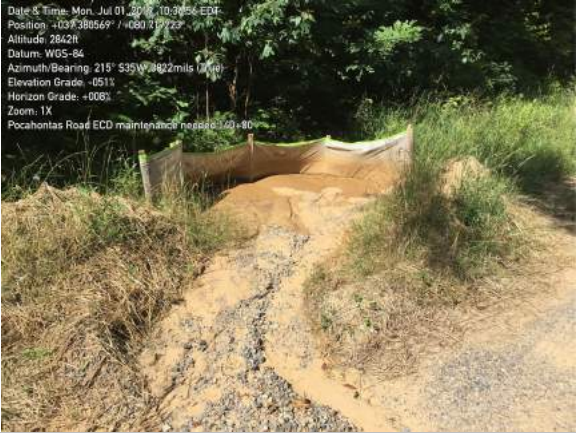
| <b>Description</b> | ECDs need maintenance but are still collecting majority of sediment. No resources have been impacted to date. | | <b>Description</b> | No change in conditions at site of failed culvert on S-PP19 crossing. | |

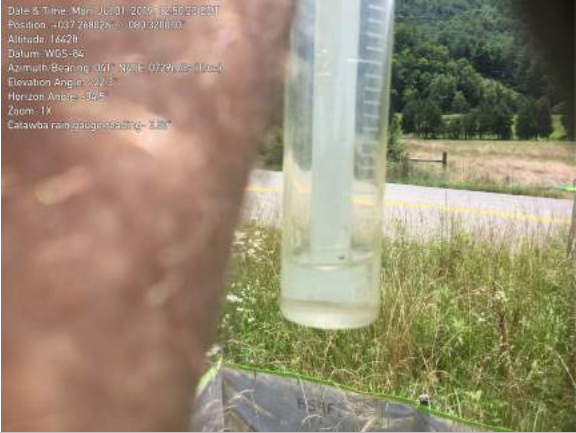
| <b>Description</b> | Catawba rain gauge reading- 0.50" | | | <b>Description</b> | |

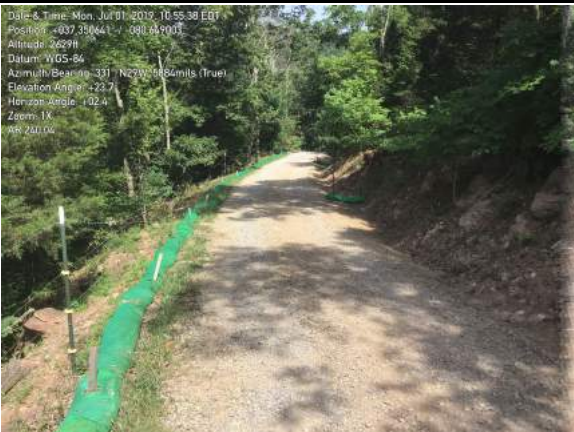
| Description | See photo for GPS location. CFS and CFS checks in place along access road 240.04. | | | Description | See photo for GPS location. Triple stack compost filter sock in place at stream bank S-G32. | | |

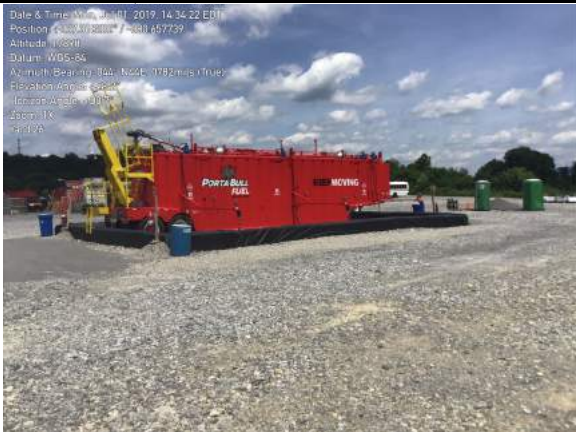
| Description | See photo for GPS location. RCE in place at Buffalo Anklets Road. | | | Description | See photo for GPS location. Secondary containment in place around fuel cell. | | |

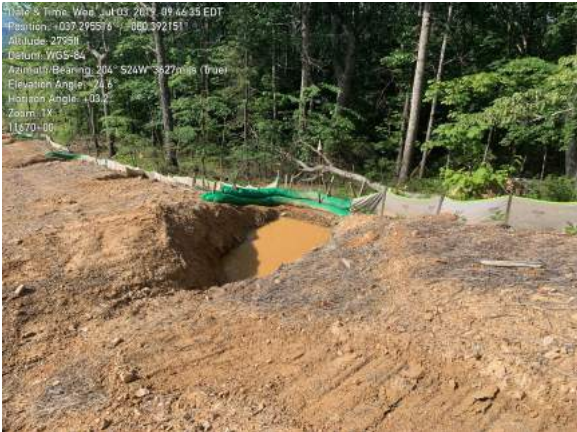
| Description | See photo for GPS location. Water bar sump pit and end treatment in place. | | | Description | See photo for GPS location. Sensitive resource buffer in place at stream S-MN21. | | |

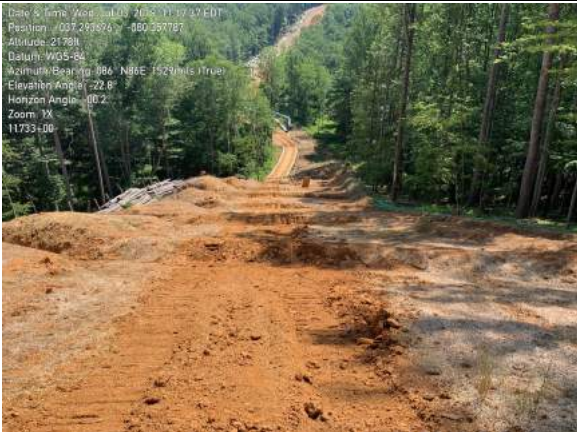
| Description | See photo for GPS location. Waterbars in place. | | | Description | See photo for GPS location. RCE in place at Main Line Valve 26. | | |

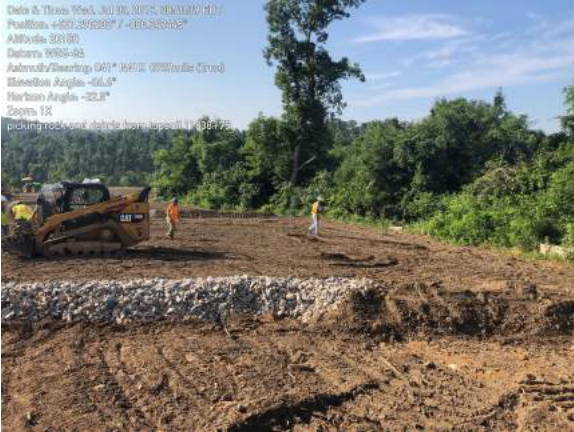
| Description | Crews picking rock from topsoil prior to seeding activities. | | | Description | Replacing P-1 as needed. | | |

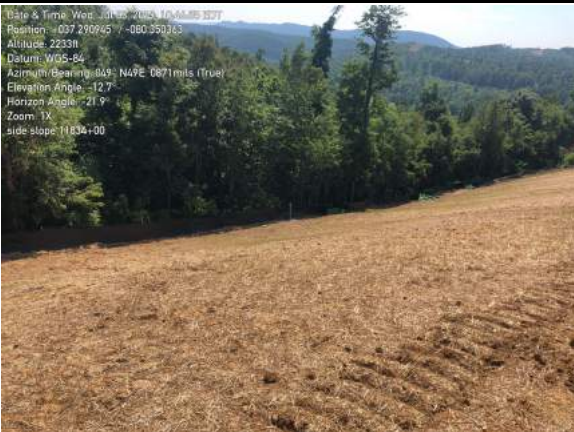
| Description | Controls at base of side slope in good/functioning condition. | | | Description | Crews mulching post seeding activities. | | |

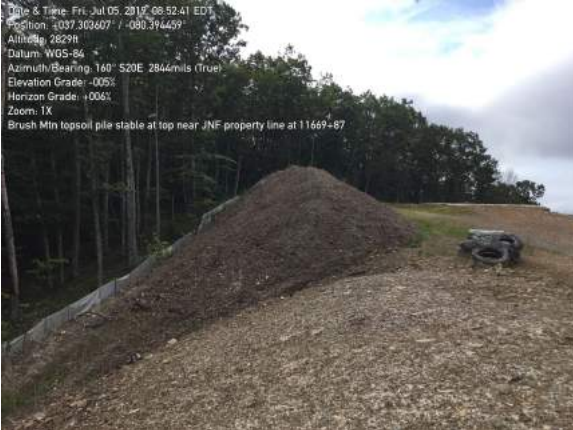
| Description | | Topsoil pile has minimal vegetation but remains stable. | | | | | | Description | | End treatments are functioning properly. | | | | | |

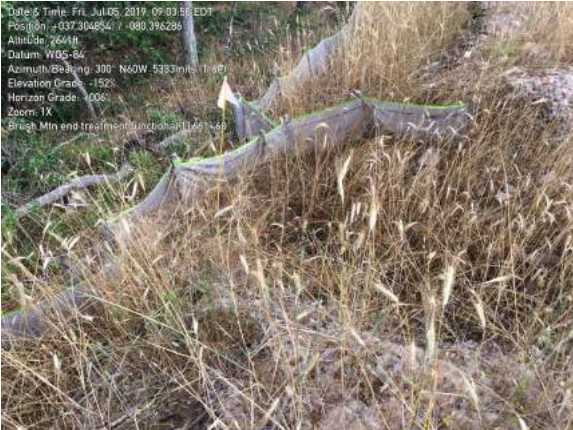
| Description | | End treatments are in place and functioning. | | | | | | Description | | ROW surface stable. Slope breakers functioning. Annual grasses near end of cycle. | | | | | |

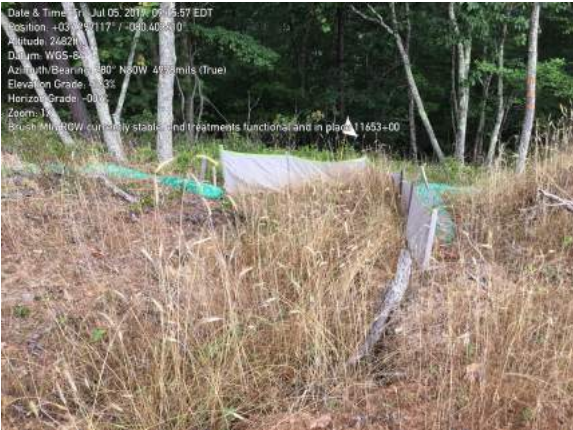
| Description | | End treatments are functional. | | | | | | Description | | Perimeter controls are in place and functioning. | | | | | |

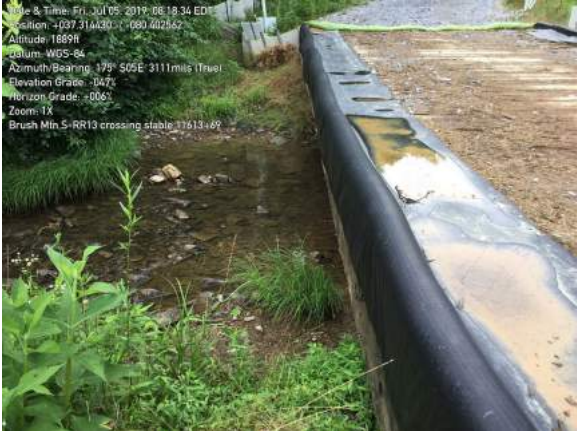
| <b>Description</b> | | Access road equipment bridge spanning Craig Creek is in good condition. | | <b>Description</b> | |

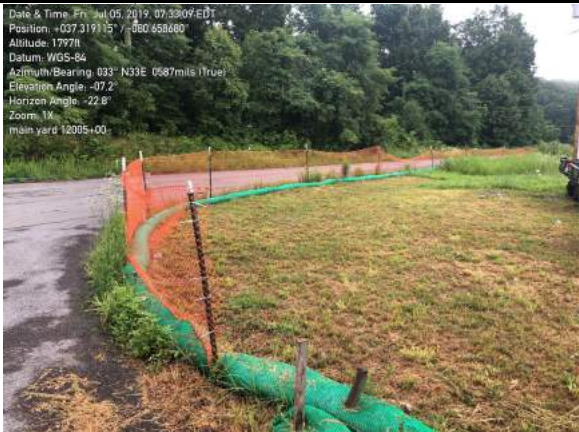
| Description | Secondary containment's of auxiliary fuel tanks. | | | Description | CFS in good condition throughout. | | |
