Visual Site Inspection Report

Project Name	H-600 Pipeline Spread G	AFE	124300137	Spread	H-600 Pipeline Spread G
Contractor	Precision			Report #	20284
Inspector	Len Kruizenga			Date/Time	7/15/2019 9:20 AM
Permit #	TBD	Inspection Type	VA SWPP	Station Begin	11161+00
State	VA	Inspection Area	Full	Station End	11354+00
County	Giles	Ground	Damp	Temperature (°F)	85.00
Municipality	N/A	Weather	Cloudy	Rain Gauge (in)	0.00
				Rain Accumulation Time (days)	4.00

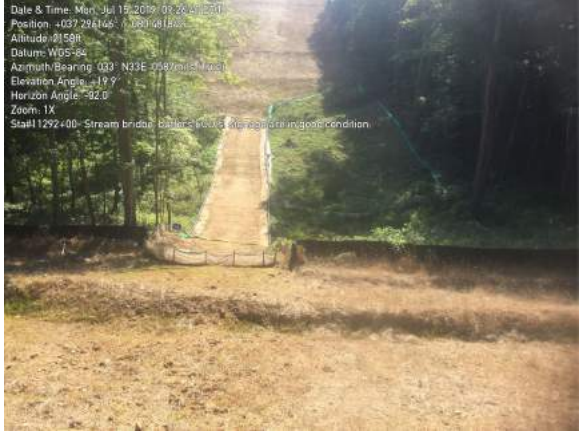
<p>Date & Time: Mon, Jul 15, 2019, 09:26:41 EDT Position: +037 294165 / -090 483188 Altitude: 2056ft Datum: WGS-84 Azimuth/Bearing: 033° N33E 038/mid-Midst Elevation Angle: +19° Horizon Angle: -92° Zoom: 1X Sta#11292+00- Stream bridge, buffers, ECD's, signage are in acceptable condition.</p>

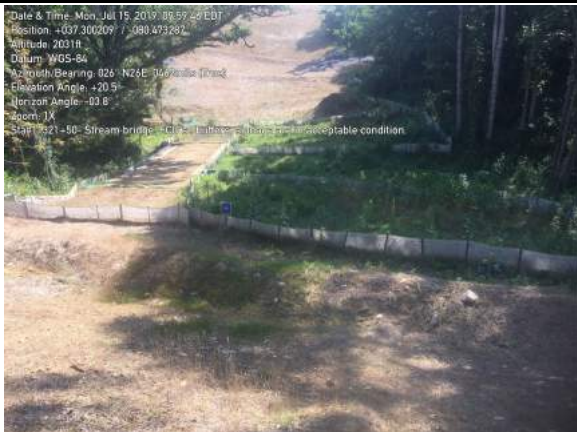
<p>Date & Time: Mon, Jul 15, 2019, 09:59:49 EDT Position: +037 300209 / -090 473282 Altitude: 2031ft Datum: WGS-84 Azimuth/Bearing: 026° N26E 309/mid-Midst Elevation Angle: +20° Horizon Angle: -93° Zoom: 1X Sta#11321+50- Stream bridge, buffers, ECD's, signage are in acceptable condition.</p>

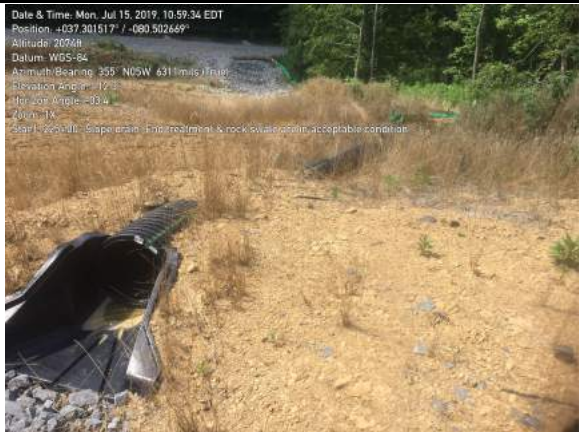
<p>Date & Time: Mon, Jul 15, 2019, 10:59:34 EDT Position: +037 301517 / -090 502649 Altitude: 2056ft Datum: WGS-84 Azimuth/Bearing: 355° N05W 631/mid-Midst Elevation Angle: +17° Horizon Angle: -93° Zoom: 1X Sta#11225+00- Slope drain, end treatment & rock swale are in acceptable condition.</p>

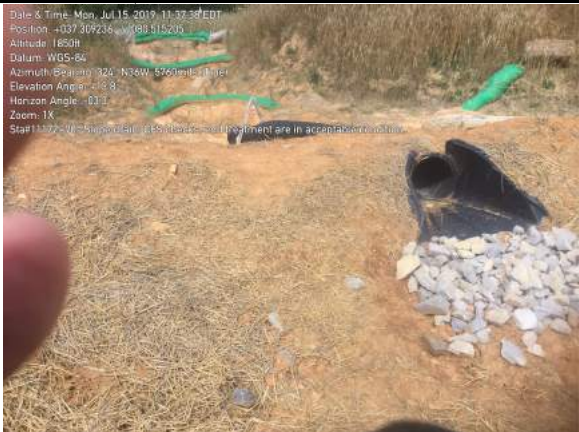
<p>Date & Time: Mon, Jul 15, 2019, 11:37:38 EDT Position: +037 309235 / -090 515205 Altitude: 1699ft Datum: WGS-84 Azimuth/Bearing: 026° N26W 526/mid-Midst Elevation Angle: +13° Horizon Angle: -92° Zoom: 1X Sta#1117270- Slope drain, CFS checks, end treatment are in acceptable condition.</p>

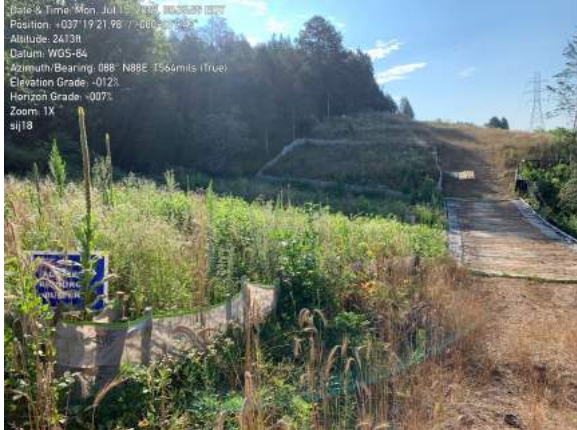
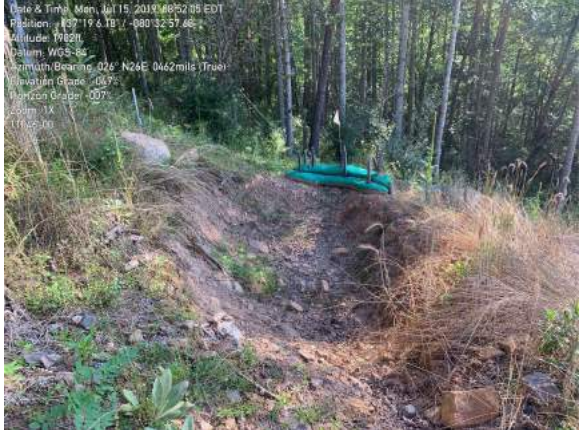
GPS Location	37.24	Field Station#	11025+00	GPS Location	37.24	Field Station#	11027+00
Pic 1 Description	ECD's and row conditions			Pic 2 Description	ECD's and row conditions

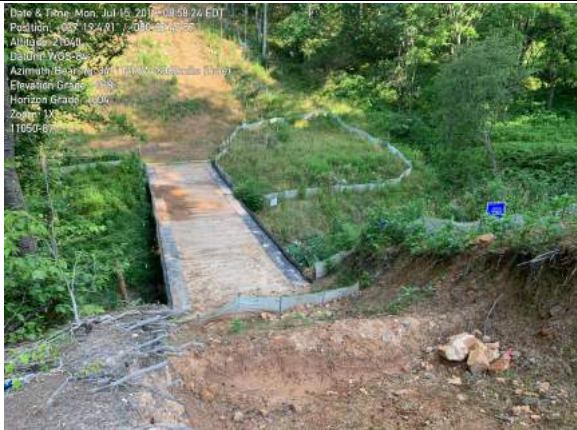
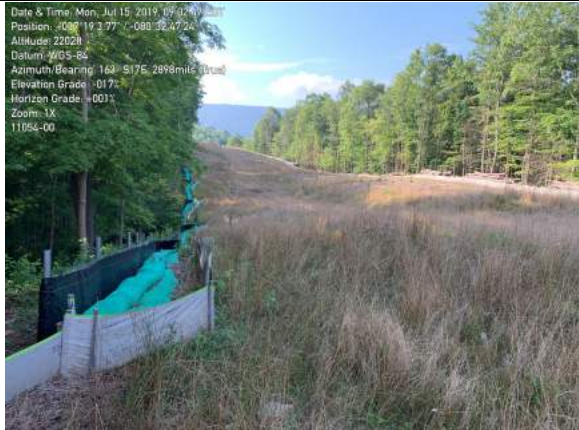
GPS Location	37.24	Field Station#	11050+87	GPS Location	37.24	Field Station#	11054+00
Pic 3 Description	ECD's and row conditions			Pic 4 Description	ECD's and row conditions

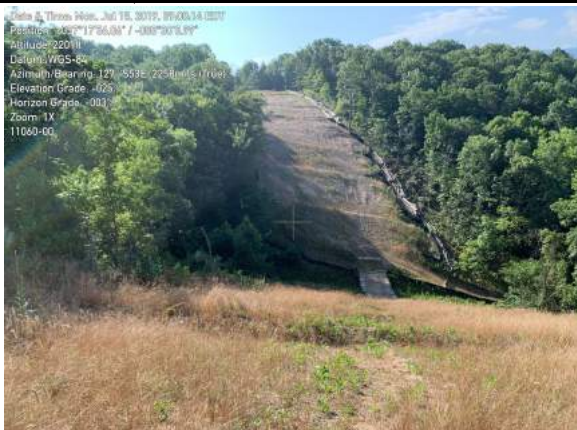
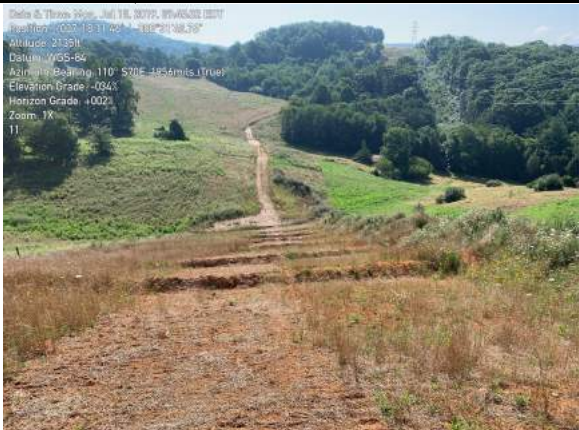
GPS Location	37.24	Field Station#	11060+00	GPS Location	37.24	Field Station#	11101+00
Pic 5 Description	ECD's and row conditions			Pic 6 Description	ECD's and row conditions

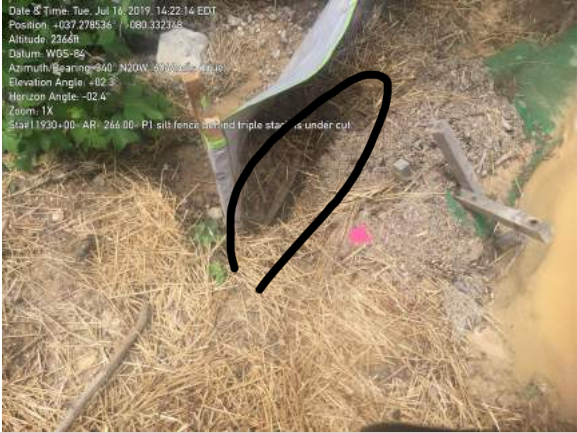
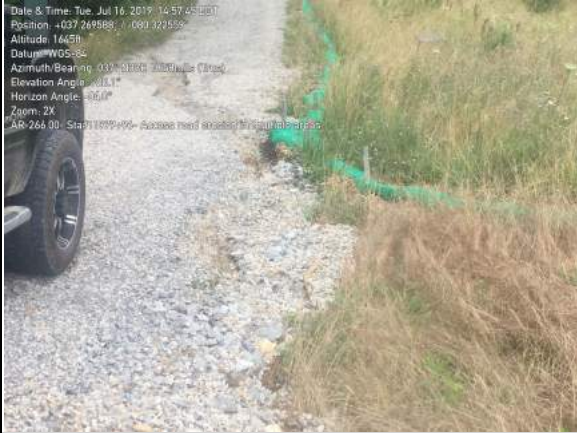
GPS Location 37.27		Field Station# 11930+00		GPS Location 37.26	
Field Station# 11979+96		Pic 13 Description		Pic 14 Description	
AR-266.00- P1 silt fence behind triple stack is under cut.		AR-266.00- Access road erosion in multiple areas

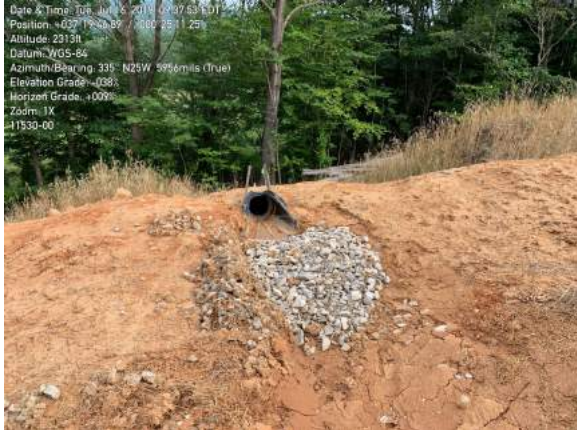
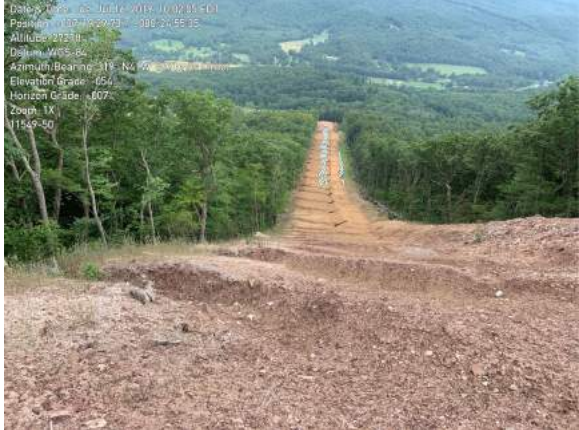
GPS Location	37.24	Field Station#	11530+00	GPS Location	37.24	Field Station#	11549+00
Pic 1 Description	Crews repaired rock inlet			Pic 2 Description	ECD's and row conditions		
<div><div>Date & Time: Tue, Jul 16, 2019 09:25:09 EDT</div><div>Position: 037.1952125, 36.0245197</div><div>Altitude: 2730ft</div><div>Datum: WGS-84</div><div>Azimuth/Bearing: 167.826W, 2302mils (True)</div><div>Elevation Grade: -072</div><div>Horizon Grade: -007</div><div>Zoom: 1X</div><div>11559-00</div></div>

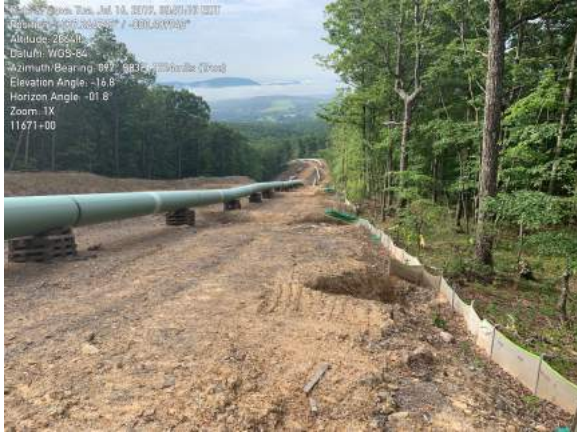
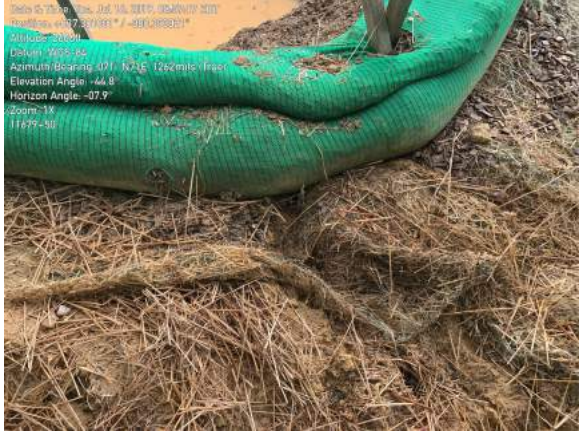
GPS Location	37.18	Field Station#	11671+00	GPS Location	37.18	Field Station#	11679+50
Pic 1 Description	See photo for GPS location. Water bars, sump pits, and end treatment in place.			Pic 2 Description	See photo for GPS location. End treatment undermined.

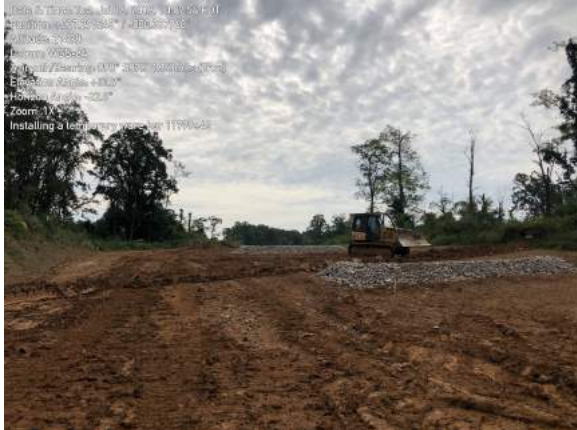
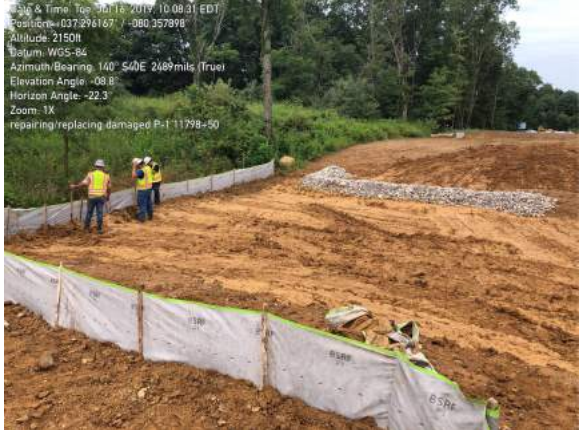
GPS Location	37.32	Field Station#	11799+40	GPS Location	37.32	Field Station#	11798+50
Pic 1 Description	Crews repairing temporary water bars.			Pic 2 Description	Crews replacing damaged ECDs.

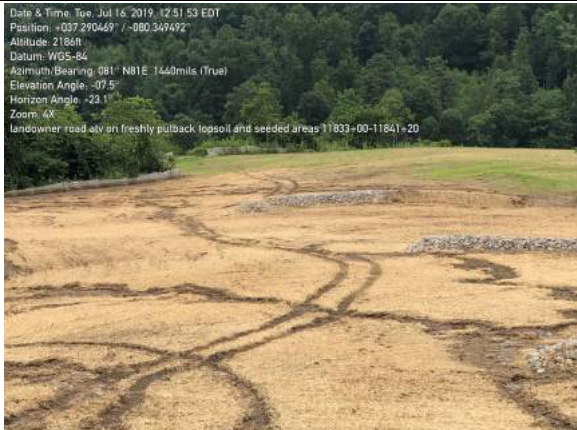
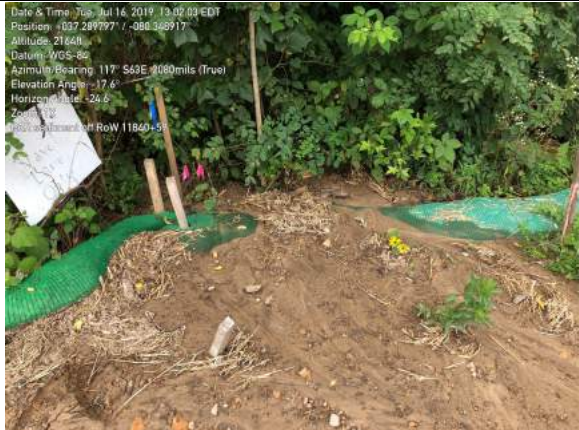
GPS Location	37.32	Field Station#	11837+50	GPS Location	37.32	Field Station#	11840+59
Pic 3 Description	Rills, washes and landowner four wheeler impact on recently restored RoW.			Pic 4 Description	Overtopped CFS with sediment off RoW.

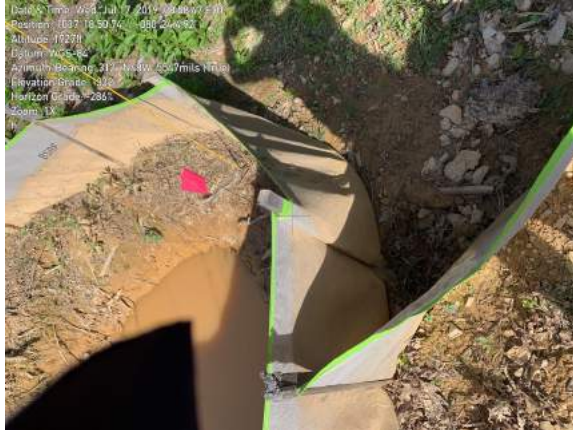
<p>Date & Time: Wed Jul 17 2019 08:08:01 EDT Position: 037.16 50.14 - 080.20 54.62 Altitude: 1527 ft Datum: WGS84 Azimuth Bearing: 312 N44W 5507mils (True) Elevation Grade: -032 Horizon Grade: -026 Zoom: 1X Pic 4</p>

GPS Location	37.24	Field Station#	11620+00	GPS Location	37.24	Field Station#	11617+95
Pic 3 Description	ECD's and row conditions			Pic 4 Description	P1SF undermined

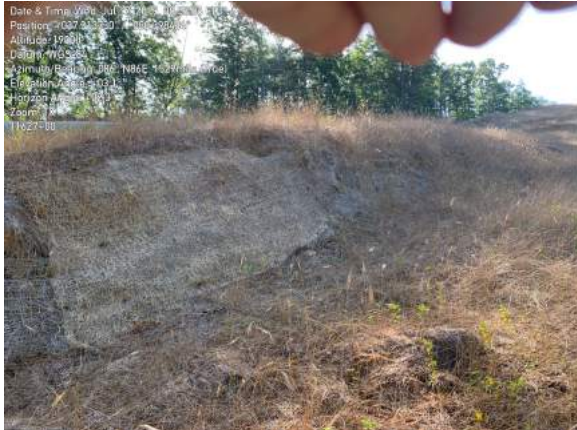
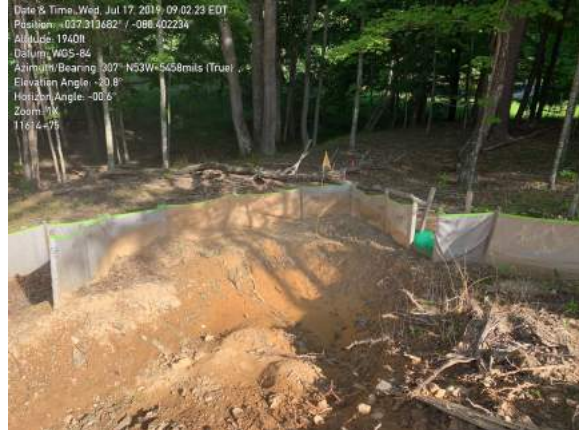
GPS Location	37.18	Field Station#	11627+00	GPS Location	37.18	Field Station#	11614+75
Pic 3 Description	See photo for GPS location. Two tone stabilized with ECB.			Pic 4 Description	See photo for GPS location. Priority one silt fence end treatment needs replaced.

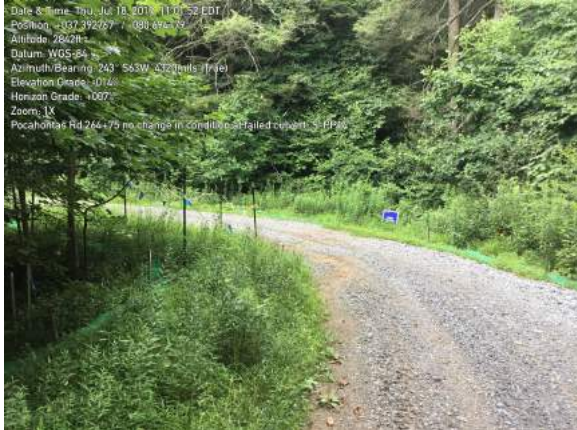
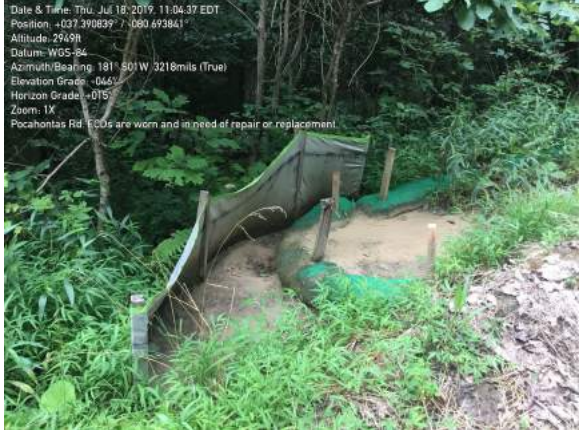
</div></div></div>			<div><div><div>Date & Time: Thu, Jul 18, 2019, 11:04:37 EDT Position: +037.390839° / +080.693861° Altitude: 2949ft Datum: WGS-84 Azimuth/Bearing: 181° S01W 3210mils (True) Elevation Grade: -064% Horizon Grade: -015% Zoom: 1X Pocahontas Rd ECDs are worn and in need of repair or replacement.</div><div>

</div></div></div>				
GPS Location	37.31	Field Station#	264+75	GPS Location	37.31	Field Station#	+00
Pic 1 Description	No change at failed culvert for the S-PP14 crossing.			Pic 2 Description	ECDs are worn and in need of repair or replacement.

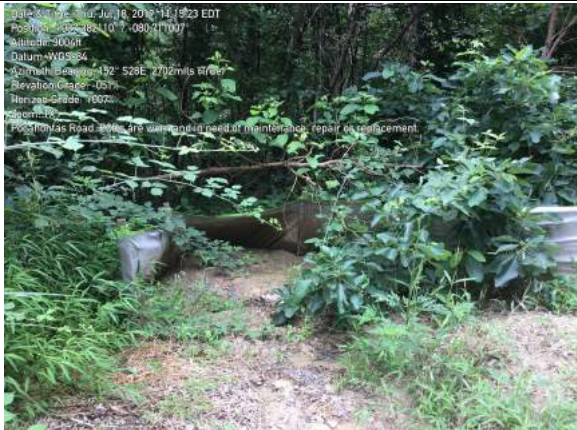
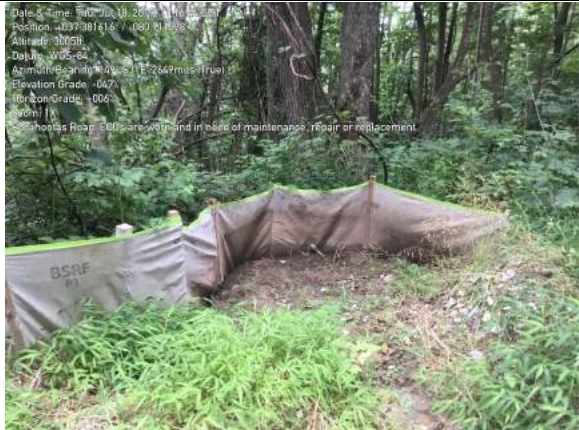
</div></div></div>			<div><div><div>Date & Time: Thu, Jul 18, 2019, 11:01:03 EDT Position: +037.381414° / +080.691003° Altitude: 3005ft Datum: WGS-84 Azimuth/Bearing: 145° S11E 2649mils (True) Elevation Grade: -047% Horizon Grade: +008% Zoom: 1X Pocahontas Road ECDs are worn and in need of maintenance, repair or replacement.</div><div>

</div></div></div>				
GPS Location	37.31	Field Station#	+11	GPS Location	37.31	Field Station#	+22
Pic 3 Description	ECDs are worn and in need of repair or replacement.			Pic 4 Description	ECDs are worn and in need of repair or replacement.

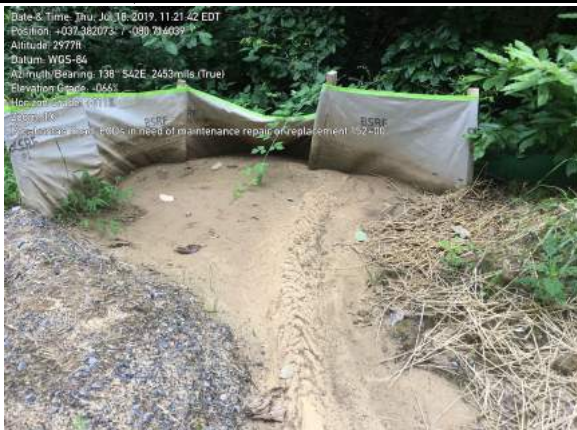
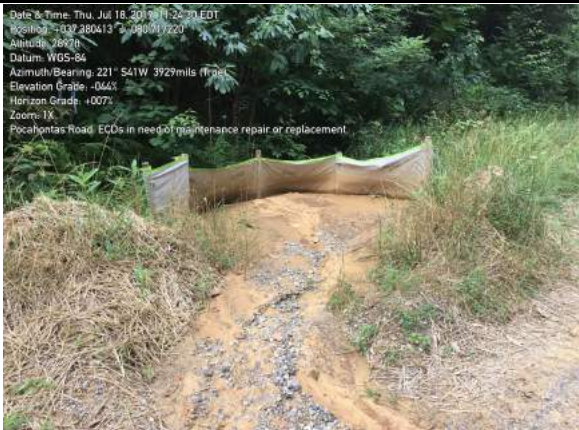
</div></div></div>			<div><div><div>Date & Time: Thu, Jul 18, 2019, 11:20:30 EDT Position: +037.380413° / +080.7031722° Altitude: 2989ft Datum: WGS-84 Azimuth/Bearing: 221° S41W 3929mils (True) Elevation Grade: -064% Horizon Grade: +007% Zoom: 1X Pocahontas Road ECDs in need of maintenance repair or replacement.</div><div>

</div></div></div>				
GPS Location	37.31	Field Station#	152+00	GPS Location	37.31	Field Station#	+33
Pic 5 Description	ECDs are worn and in need of repair or replacement.			Pic 6 Description	ECDs are worn and in need of repair or replacement.

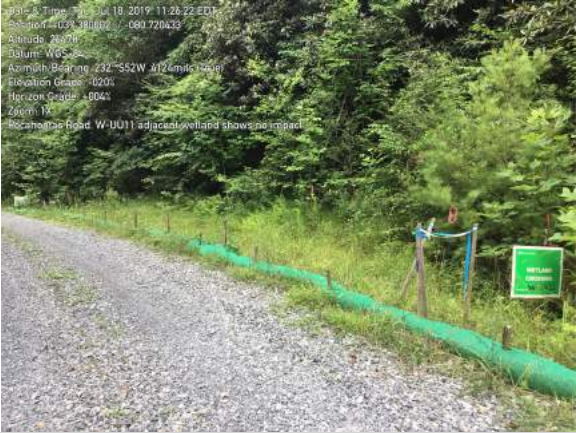
<p> <small> Date & Time: Thu, Jul 18, 2019, 11:28:22 EDT Position: +037.378410, -080.720433 Altitude: 2218ft Datum: WGS-84 Azimuth/Bearing: 232° 55' 2W 490mils (True) Elevation Grade: +020% Horizon Grade: +004% Zoom: 1X Pocahontas Road, WJ0011 adjacent wetland shows no impact </small> </p>

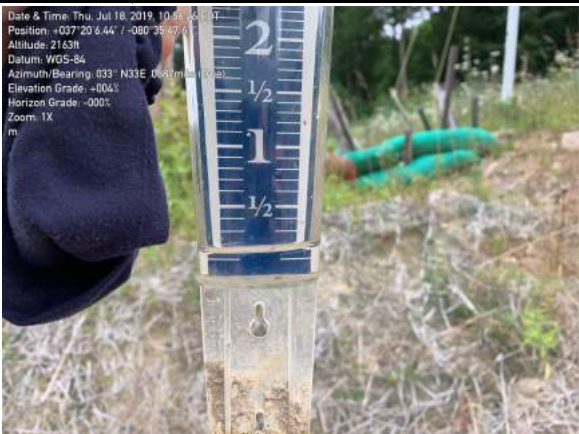
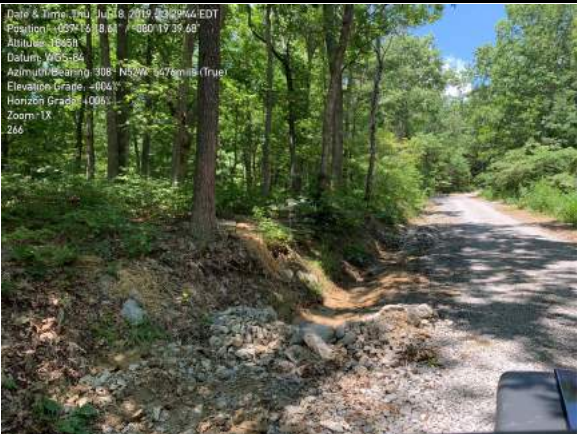
</div></div>					
GPS Location	37.24	Field Station#	2+34	GPS Location	37.24	Field Station#	2+66
Pic 5 Description	.2" of rain recorded @ 234			Pic 6 Description	Crews repaired rock check dams

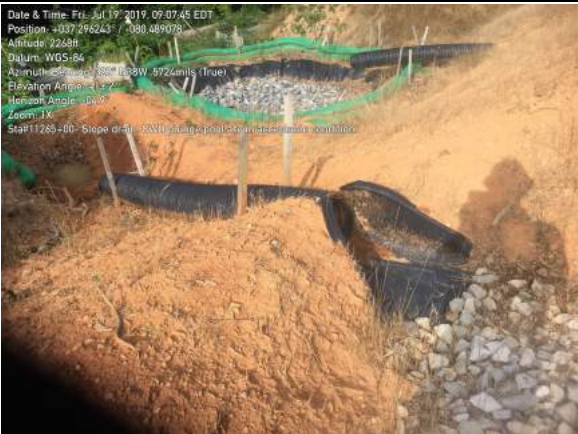
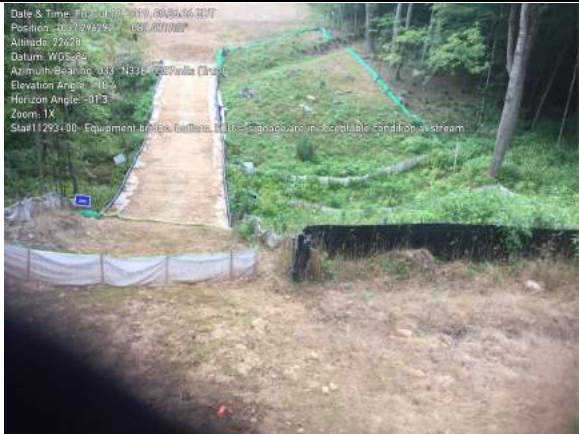
GPS Location	37.29	Field Station#	11265+00	GPS Location	37.29	Field Station#	11293+00
Pic 1 Description	Slope drain, CWD pipe and plunge pool are in acceptable condition.			Pic 2 Description	Stream equipment bridge, buffers, signage, ECD's are in acceptable condition.

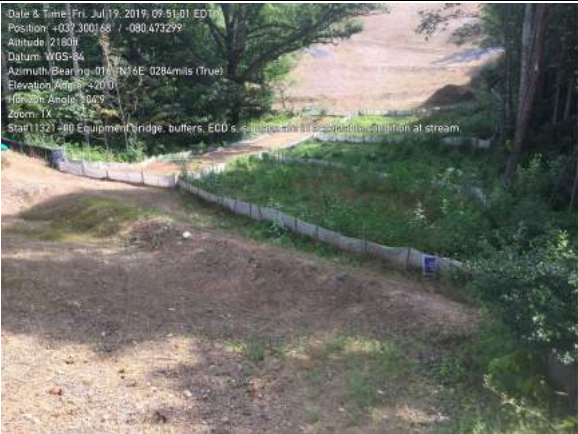
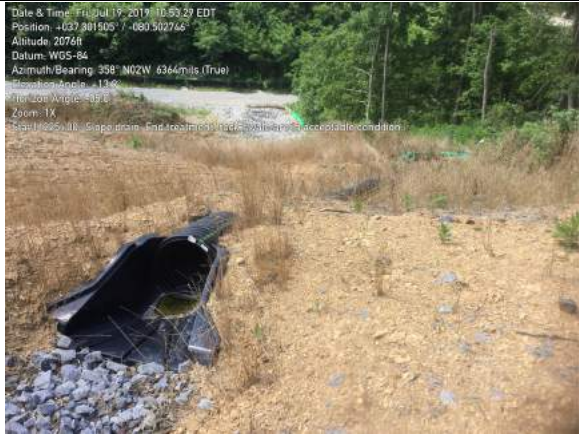
GPS Location	37.30	Field Station#	11321+00	GPS Location	37.30	Field Station#	11225+00
Pic 3 Description	Stream equipment bridge, ECD's, signage, buffers, are in acceptable condition			Pic 4 Description	Slope drain, end treatment, rock swale are in acceptable condition.

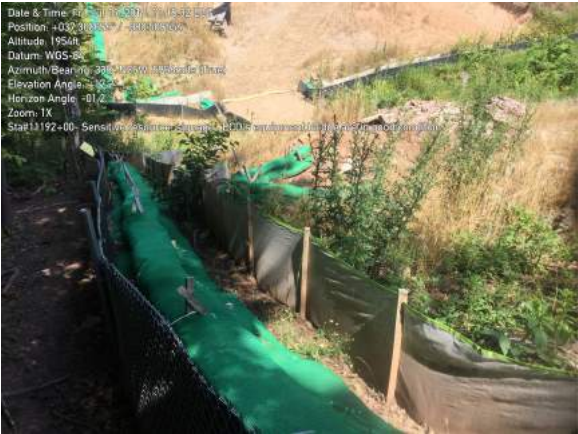
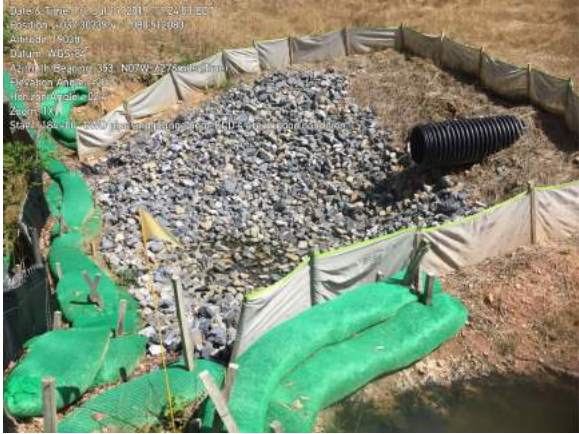
GPS Location	37.30	Field Station#	11192+00	GPS Location	37.30	Field Station#	1184+00
Pic 5 Description	Sensitive resource signage, equipment bridge, ECD's, are in acceptable condition.			Pic 6 Description	CWD pipe, plunge pool & ECD's are in good condition.

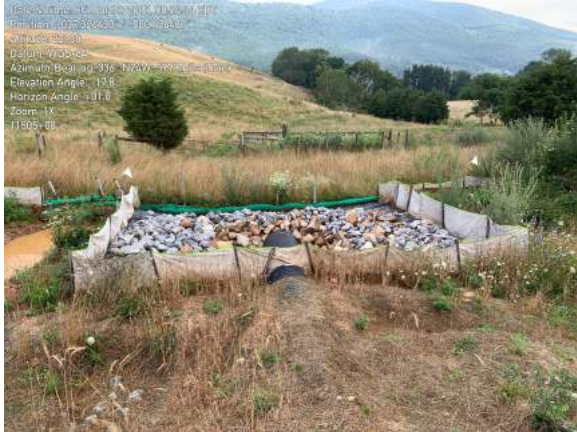
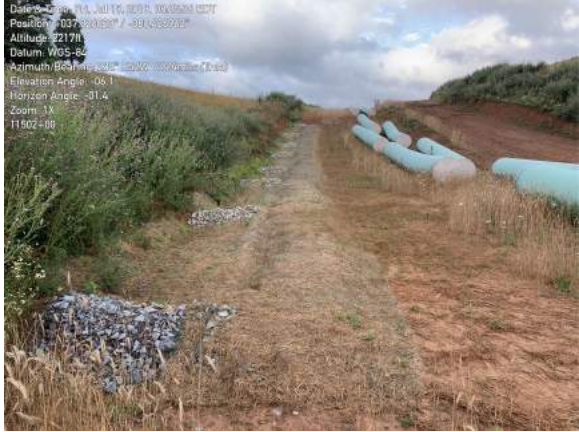
GPS Location	37.18	Field Station#	11505+00	GPS Location	37.18	Field Station#	11502+00
Pic 1 Description	See photo for GPS location. Plunge pool in place.			Pic 2 Description	See photo for GPS location. Conveyance channel with rock checks in place.
