Visual Site Inspection Report

Project Name	H-600 Pipeline Spread G	AFE	124300137	Spread	H-600 Pipeline Spread G
Contractor	Precision			Report #	6
Inspector	Len Kruizenga			Date/Time	7/29/2019 8:42 AM
Permit #	TBD	Inspection Type	VA SWPP	Station Begin	12005+00
State	VA	Inspection Area	Full	Station End	12005+00
County	Giles	Ground	Dry	Temperature (°F)	85.00
Municipality	N/A	Weather	Sunny	Rain Gauge (in)	0.00
				Rain Accumulation Time (days)	1.00

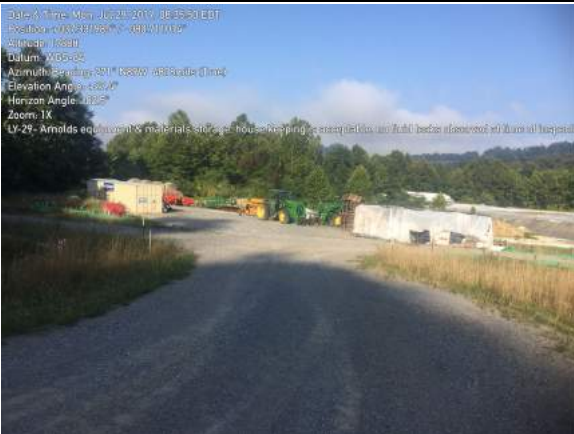
GPS Location	See photo GPS		GPS Location	See photo GPS	
Field Station#	12005+00		Field Station#	12005+00	
Pic 1 Desc.	Arnold's Equipment & Materials storage, house keeping acceptable, no fluid leaks		Pic 2 Desc.	Rock surface is maintained in acceptable condition.

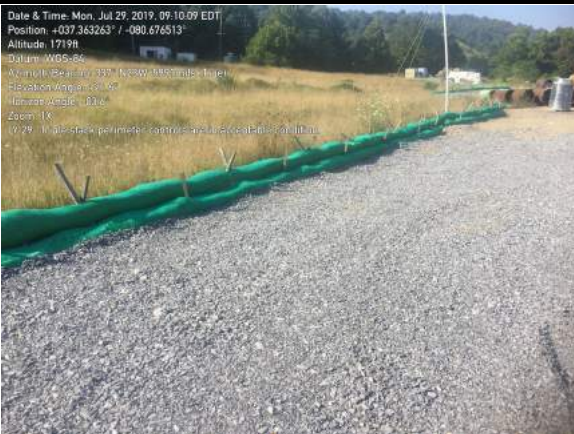
GPS Location	See photo GPS		GPS Location	See photo GPS	
Field Station#	12005+00		Field Station#	12005+00	
Pic 3 Desc.	Triple stack perimeter controls are in acceptable condition.		Pic 4 Desc.	Precision pipe & Materials storage.

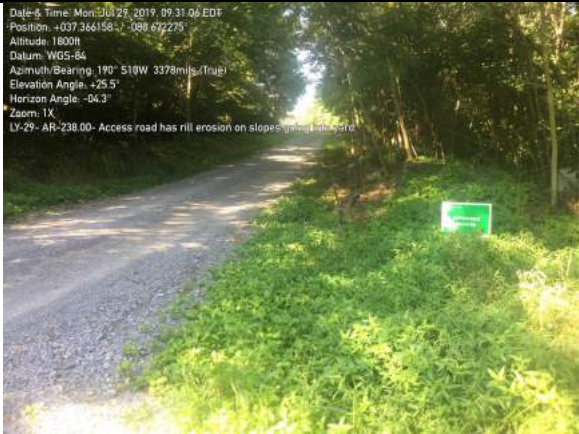
GPS Location	See photo GPS		GPS Location	See photo GPS	
Field Station#	12005+00		Field Station#	12005+00	
Pic 5 Desc.	LY-29- Culvert & drainage feature are in good condition		Pic 6 Desc.	AR-238.00- Access road has rill erosion on slopes going into the yard

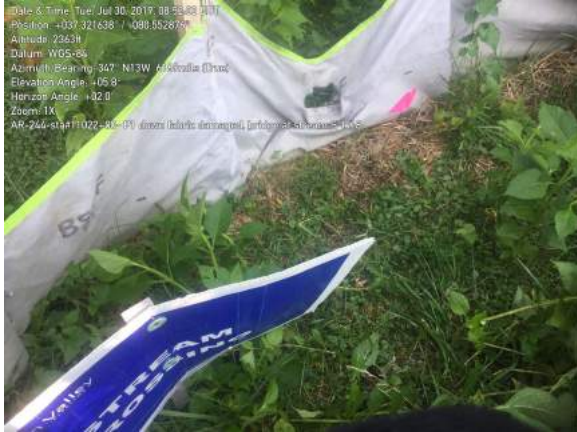
AFE	124300137	Date/Time	7/30/2019 7:35 AM	Report #	48
Pictures					
<p>Date & Time: Tue Jul 30, 2019 09:58:39 EDT Position: +037.321638 / -089.552879 Altitude: 2363ft Datum: WGS-84 Azimuth Bearing: 347° N13W 616mils (True) Elevation Angle: +05.9° Horizon Angle: +02.0° Zoom: 1X AR-244 at bridge, Stream S-IJ18- P1 damaged!</p>

GPS Location	N/A	GPS Location	N/A		
Field Station#	11022+00	Field Station#	10986+00		
Pic 1 Desc.	AR-244 at bridge, Stream S-IJ18- P1 damaged!	Pic 2 Desc.	Stream S-E25- Bridge, ECD's, buffers, signage		
<p>Date & Time: Tue Jul 30, 2019 09:56:40 EDT Position: +037.325597 / -089.560196 Altitude: 2627ft Datum: WGS-84 Azimuth Bearing: 344° N44W 616mils (True) Elevation Angle: +05.9° Horizon Angle: -02.5° Zoom: 1X Stream S-E24 Equipment bridge, ECD's, buffers, signage are in acceptable condition.</p>

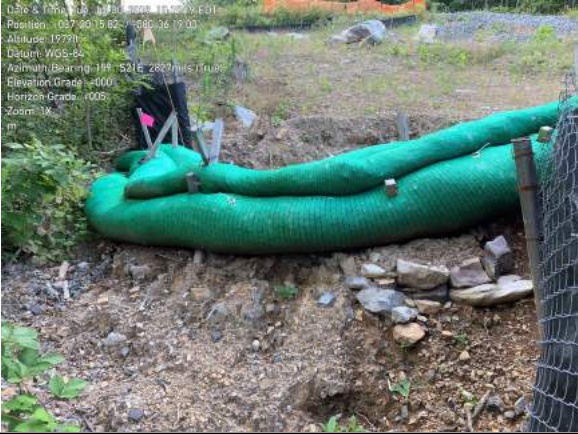
GPS Location	See picture for GPS coordinates	GPS Location	See picture for GPS coordinates		
Field Station#	10856+00	Field Station#	10854+00		
Pic 1 Desc.	End treatment undermined	Pic 2 Desc.	ECD's and row conditions

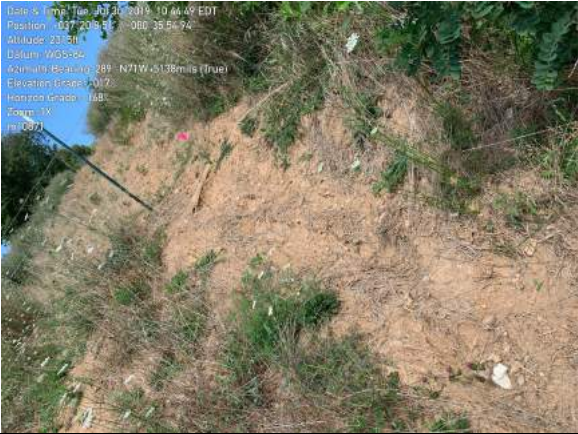
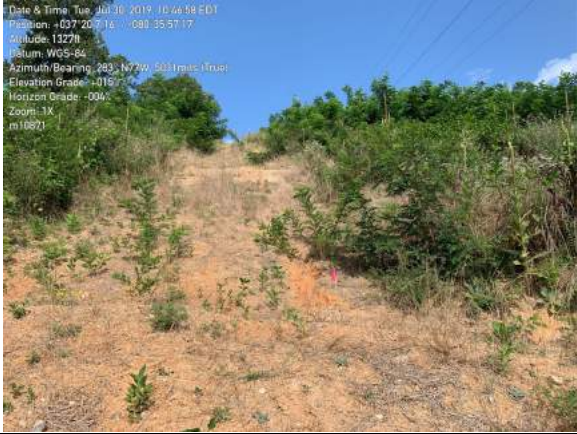
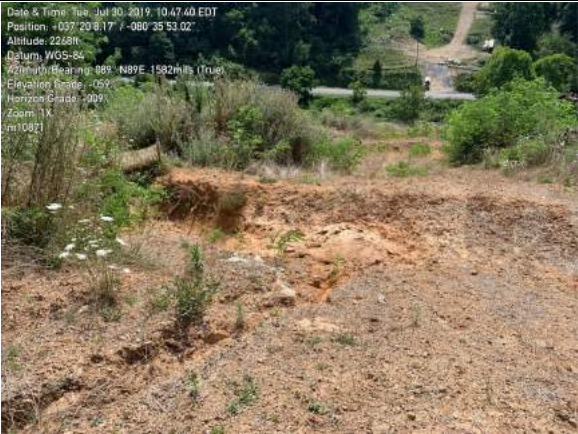
GPS Location	See picture for GPS coordinates	GPS Location	See picture for GPS coordinates		
Field Station#	10880+00	Field Station#	10880+00		
Pic 3 Desc.	Travel lane erosion	Pic 4 Desc.	Travel lane erosion

GPS Location	See picture for GPS coordinates	GPS Location	See picture for GPS coordinates		
Field Station#	10880+00	Field Station#	10880+00		
Pic 5 Desc.	Travel lane erosion	Pic 6 Desc.	Damaged P1SF

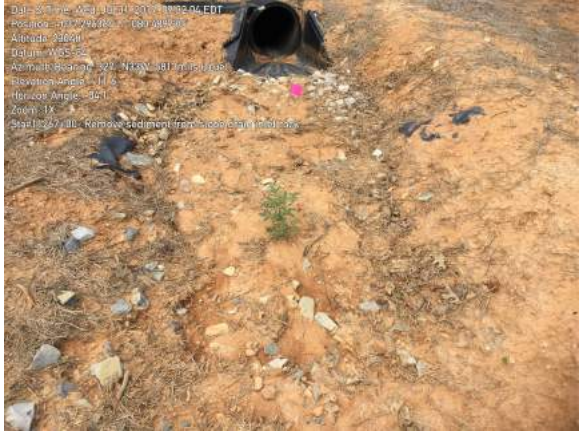
GPS Location	See photo GPS	GPS Location	See photo GPS		
Field Station#	11258+00	Field Station#	11267+00		
Pic 1 Desc.	Sump pits full of sediment, need to be cleaned	Pic 2 Desc.	Slope drain inlet rock full of sediment.

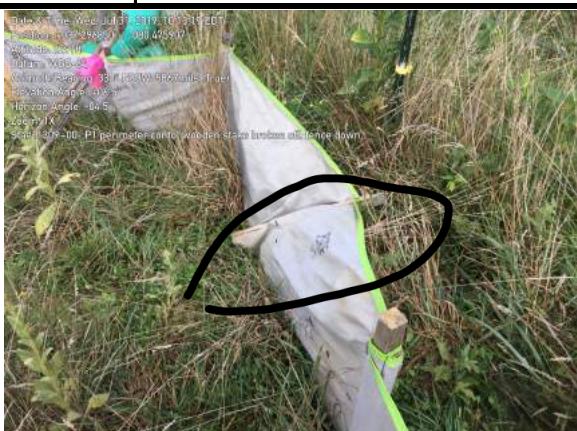
GPS Location	See photo GPS =	GPS Location	See photo GPS		
Field Station#	11309+00	Field Station#	11323+50		
Pic 5 Desc.	P1 perimeter control down.Stake snapped off.	Pic 6 Desc.	Slope drain filter rock full of sediment.

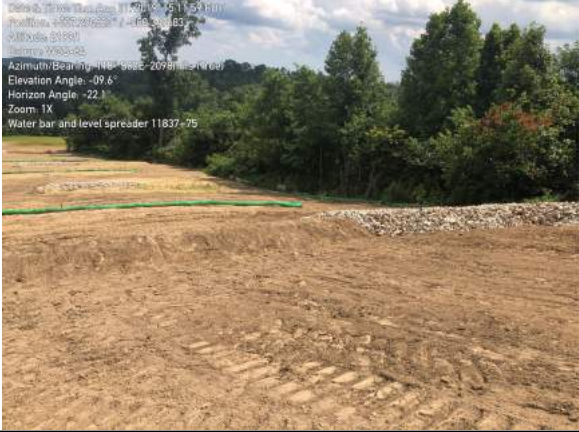
<p>Date & Time: Thu, Aug 01, 2019, 5:03:44 EDT Position: +037.262298 / -080.384937 Altitude: 2164 ft Datum: WGS-84 Azimuth Bearing: 036° N36E 0440mils (True) Elevation Angle: 19.4° Horizon Angle: -21.3° Zoom: 1X Installing level spreader 11837+75</p>

GPS Location	1	GPS Location	2		
Field Station#	118737+75	Field Station#	11837+75		
Pic 1 Desc.	Re-installed permanent water bar and Level spreader	Pic 2 Desc.	Re-stalling level spreader.		
<p>Date & Time: Thu, Aug 01, 2019, 12:34:24 EDT Position: +037.262298 / -080.384937 Altitude: 2196 ft Datum: WGS-84 Azimuth Bearing: 072° N72E 1316mils (True) Elevation Angle: 10.6° Horizon Angle: -25.2° Zoom: 1X Permanent water bar 11837+75</p>

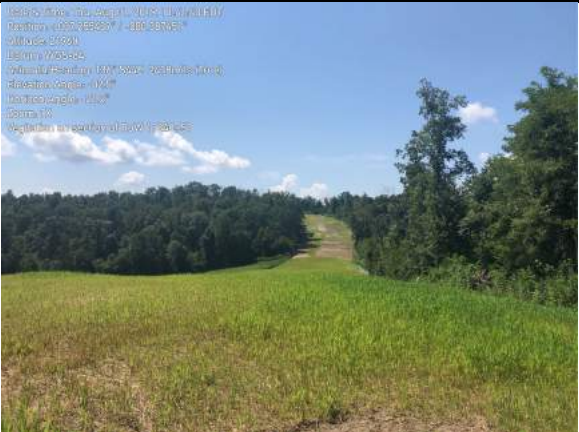
GPS Location	5	GPS Location	6		
Field Station#	11837+75	Field Station#	11841+00		
Pic 5 Desc.	Removed original water bar and level spreader	Pic 6 Desc.	Vegetation on section of RoW.
