Visual Site Inspection Report

Project Name	H-600 Pipeline Spread G	AFE	124300137	Spread	H-600 Pipeline Spread
Contractor	Precision			Report #	340
Inspector	Len Kruizenga			Date/Time	8/5/2019 7:24 AM
Permit #	TBD	Inspection Type	VA SWPP	Station Begin	11022+00
State	VA	Inspection Area	Full	Station End	10930+00
County	Giles	Ground	Dry	Temperature (°F)	75.00
Municipality	N/A	Weather	Sunny	Rain Gauge (in)	0.00
				Rain Accumulation Time (days)	2.00

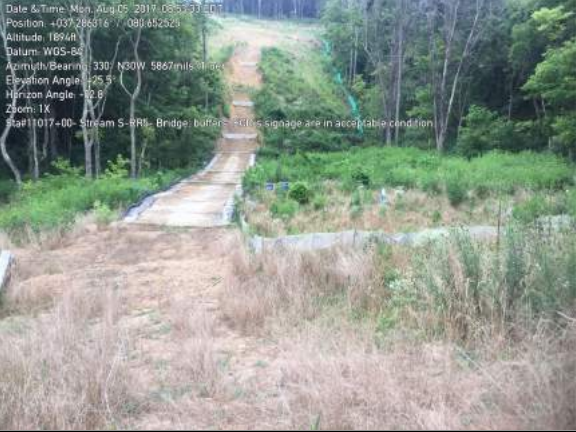
GPS Location	See photo GPS	GPS Location	See photo GPS		
Field Station#	11017+00	Field Station#	11017+00		
Pic 1 Desc.	Stream S-RR5- Controls, bridge, buffers. Signage are in acceptable condition	Pic 2 Desc.	P1 buffer stake snapped off, fence down.

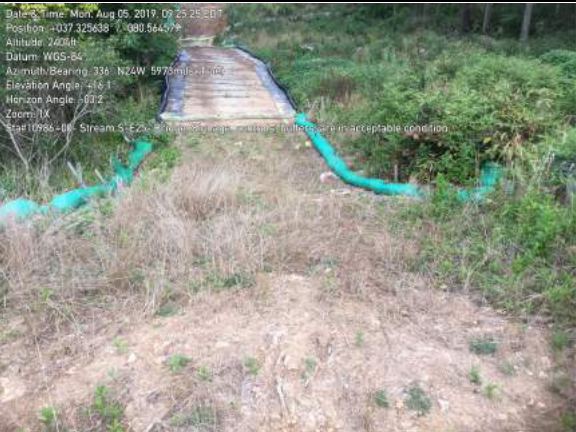
GPS Location	See photo GPS	GPS Location	See photo GPS		
Field Station#	10986+00	Field Station#	10985+00		
Pic 3 Desc.	Stream & controls are in acceptable condition.	Pic 4 Desc.	Stream S-E24- controls in acceptable condition

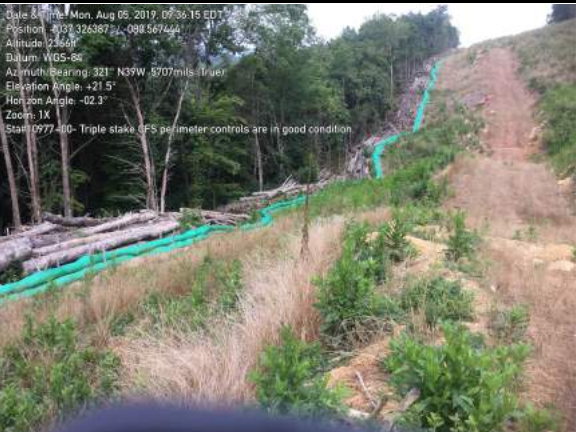
GPS Location	See photo GPS	GPS Location	See photo GPS		
Field Station#	10977+00	Field Station#	10965+00		
Pic 5 Desc.	Triple stake perimeter controls are in good condition.	Pic 6 Desc.	Karst ECD's are in good condition.

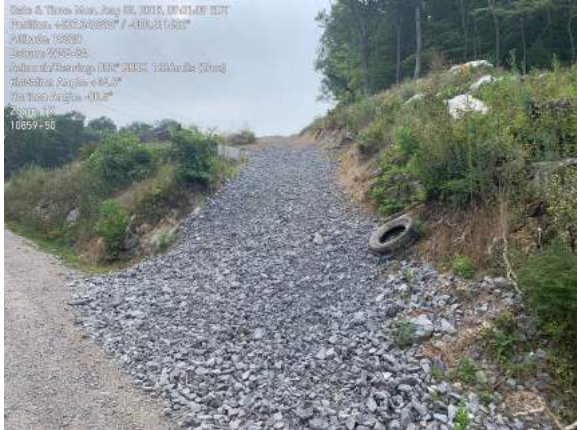
GPS Location	see photo for GPS location.	GPS Location	see photo for GPS location.		
Field Station#	10859+50	Field Station#	10872+00		
Pic 1 Desc.	RCE at Kow Camp Road.	Pic 2 Desc.	Waterbar with triple stack CFS in place.

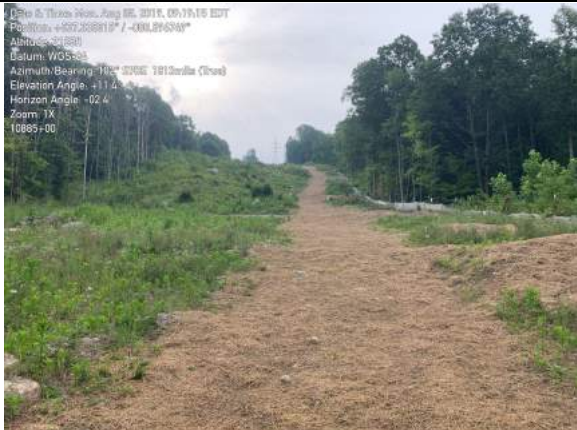
GPS Location	see photo for GPS location.	GPS Location	see photo for GPS location.		
Field Station#	10885+00	Field Station#	10712+50		
Pic 3 Desc.	ROW stabilized with seed, mulch, and natural vegetation	Pic 4 Desc.	Sensitive resource buffer in place at stream.

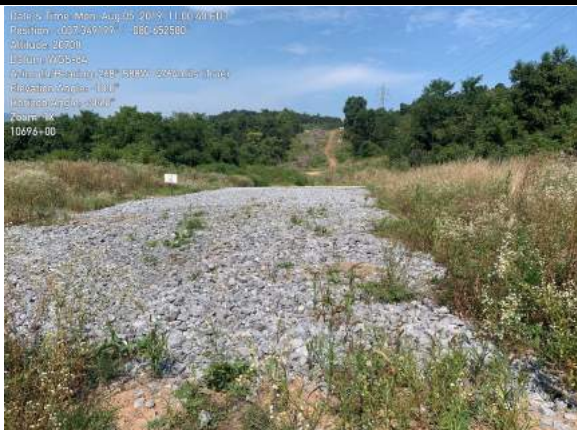
GPS Location	see photo for GPS location.	GPS Location	see photo for GPS location.		
Field Station#	10696+00	Field Station#	10686+25		
Pic 5 Desc.	RCE at Buffalo Anklets Road in place.	Pic 6 Desc.	Triple stack CFS in place at stream buffer.

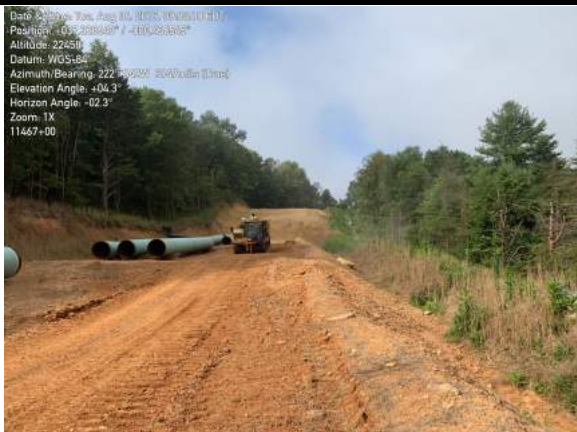
GPS Location	See photo for GPS location.	GPS Location	See photo for GPS location.		
Field Station#	11467+00	Field Station#	11420+00		
Pic 5 Desc.	Environmental crew spreading mulch.	Pic 6 Desc.	Rock lined channel in place.

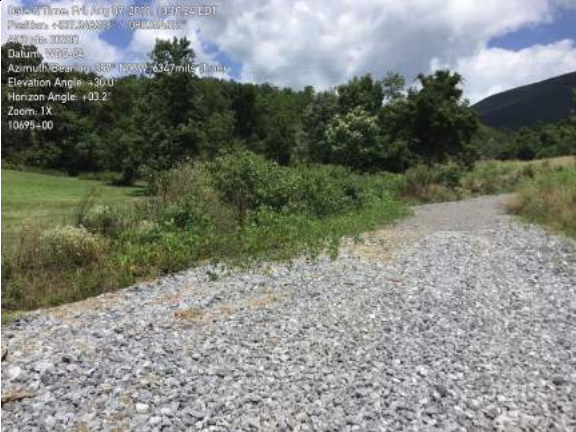
GPS Location	See photo for GPS location.		GPS Location	See photo for GPS location.	
Field Station#	10698+00		Field Station#	10695+00	
Pic 5 Desc.	Triple stack CFS in place at stream bank.		Pic 6 Desc.	RCE and top soil pile stabilized.

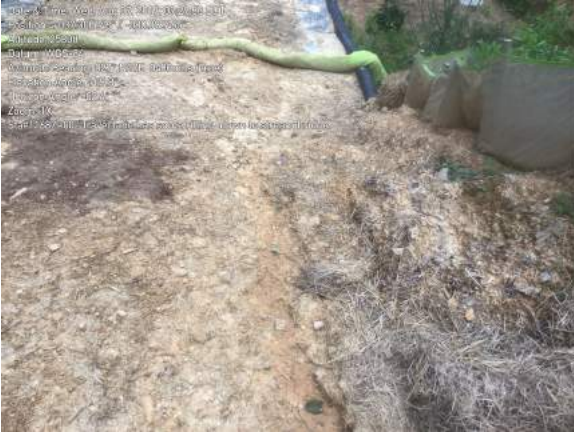
GPS Location	See photo GPS	GPS Location	See photo GPS		
Field Station#	11687+00	Field Station#	11704+00		
Pic 1 Desc.	Travel lane showing rilling down to stream bridge	Pic 2 Desc.	Stream bridge & ECD's. S-MN21

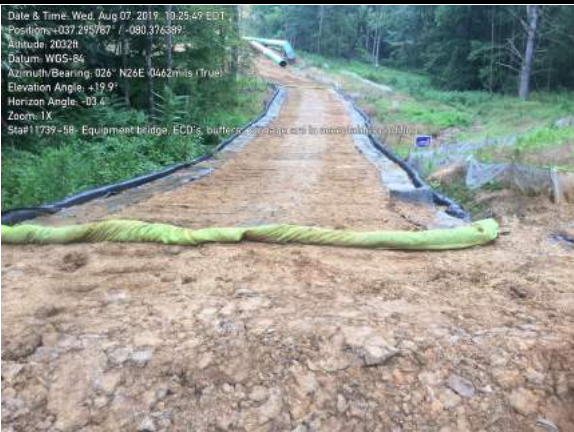
GPS Location	See photo GPS	GPS Location	See photo GPS		
Field Station#	11739+58	Field Station#	11942+00		
Pic 3 Desc.	Equipment bridge, ECD's, signage, acceptable	Pic 4 Desc.	Karst ECD's are in acceptable condition

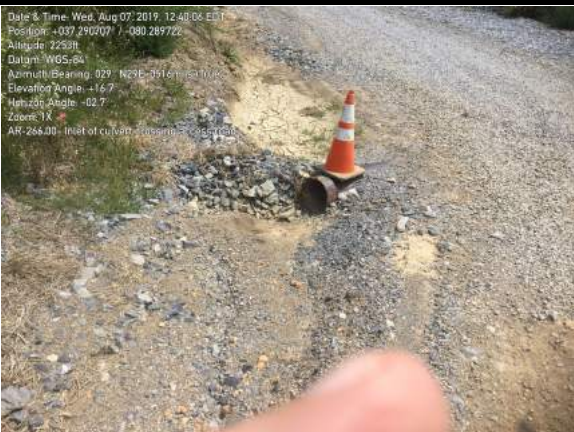
GPS Location	See photo GPS	GPS Location	See photo GPS		
Field Station#	11988+00	Field Station#	1102001+40		
Pic 5 Desc.	AR-266.00- Culvert inlet crossing access road.	Pic 6 Desc.	Wetland ECD's have been reinstalled.

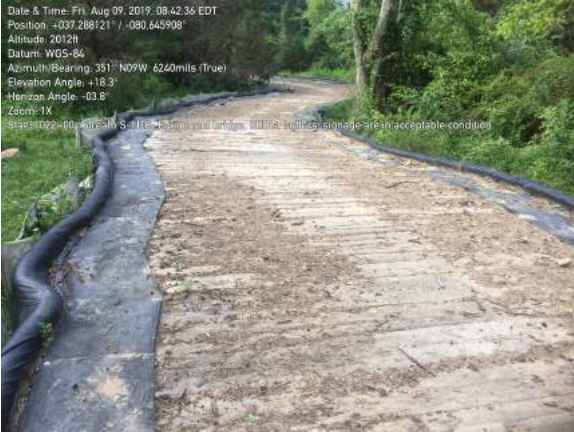
<p>Date & Time: Fri, Aug 09, 2019, 08:43:00 EDT Position: +037.323864° / -090.645908° Altitude: 2311ft Datum: WGS-84 Azimuth/Bearing: 332° N28W 5113mils (True) Elevation Angle: +26.8° Horizon Angle: -02.0° Zoom: 1X Still 11017+00 Stream S-RR5- butiment bridge, ECD's, buffers, signage are in acceptable condition</p>

GPS Location	See photo GPS	GPS Location	See photo GPS		
Field Station#	11022+00	Field Station#	11017+00		
Pic 1 Desc.	Stream S-IJ18- controls, bridge, signage, good	Pic 2 Desc.	Stream RR5 controls buffers, signage- good

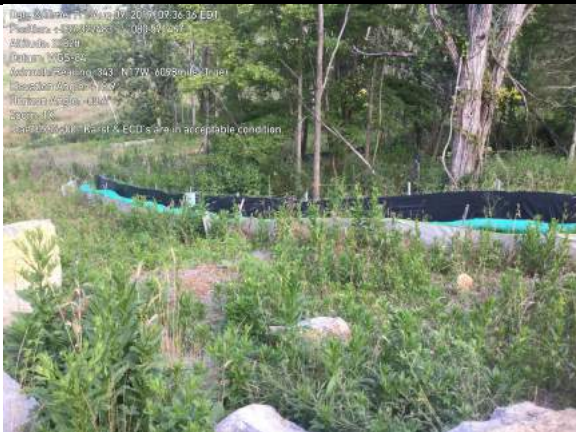
GPS Location	See photo GPS	GPS Location	See photo GPS		
Field Station#	10985+00	Field Station#	10965+00		
Pic 5 Desc.	Stream S-E24- Bridge, buffers controls- good	Pic 6 Desc.	Karst & ECD's are in acceptable condition

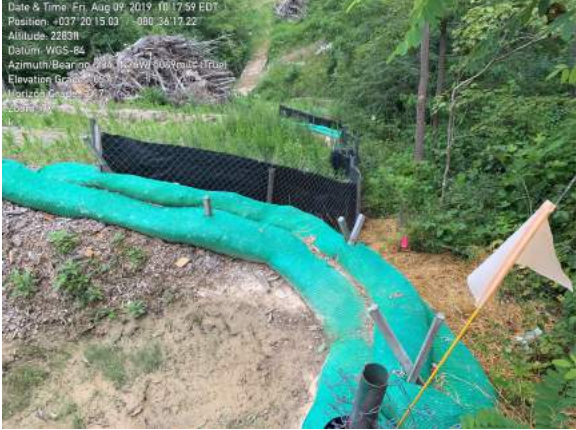
GPS Location	See picture above for GPS coordinates	GPS Location	See picture above for GPS coordinates		
Field Station#	2+34	Field Station#	10832+00		
Pic 1 Desc.	ECD's and row conditions	Pic 2 Desc.	Punchlist item completed

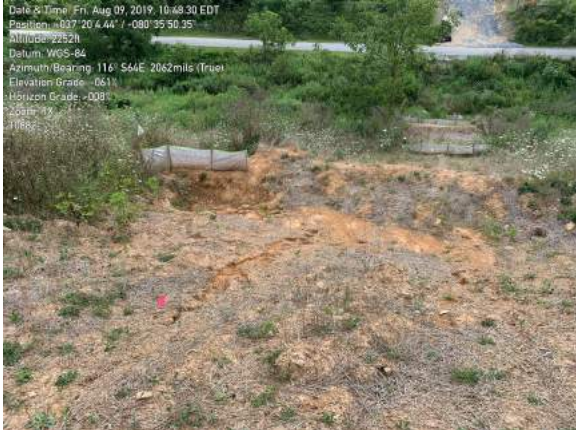
GPS Location	See picture above for GPS coordinates	GPS Location	See picture above for GPS coordinates		
Field Station#	10830+00	Field Station#	10882+00		
Pic 3 Desc.	ECD's and row conditions	Pic 4 Desc.	Rill erosion
